Date of Accident: May 5, 2016

NTSB File No.: CEN16FA172

Aircraft: Cessna 310F

Propeller Teardown Report

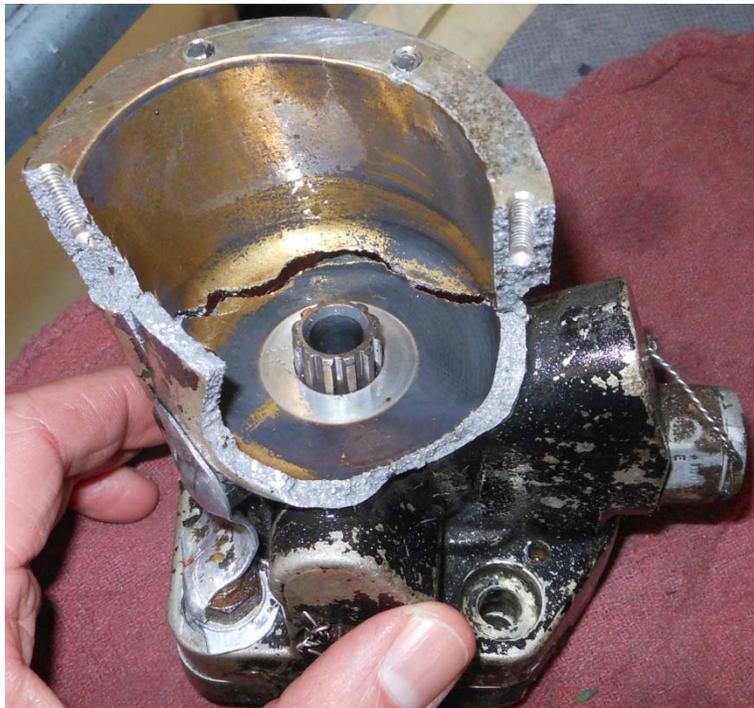
Photo #24 – Left propeller governor after cleaning

The left propeller governor P/N was 210280D, S/N 530241 and is pictured in Photos #22 and #23 as-received. The governor was found at the crash scene fractured from the engine and was packed with dirt. The inlet screen was partially pried from the base and was bent and packed with dirt. The governor body was fractured open and the control arm, spool valve and flyweight assembly were missing. The governor pump shaft was frozen and would not rotate when hand torque was applied. Photos #24 and #25 show the governor after it was cleaned in a solvent tank. No further disassembly or testing of the left propeller governor was conducted.
