PREPARED	NAME R. Birdseye	DATE 1-30-78	LOCKHEED - GEORGIA COMPANY A DIVISION OF LOCKHEED AIRCRAFT CORP.	PAGE	TEMP.	PERM. 4.1
CHECKED	S. K. Brown	1-30-78	TITLE FY 1977 C-130 SERVICE LIFE ANALYSIS SERVICE LIFE SUMMARY	MODEL C-130		
APPROVED	E. S. Hendrix	1-30-78		LG78ER0020 REPORT NO. Vol III

4.0 STRUCTURAL ANALYSIS LOCATIONS

B3.0 MODEL C-130A CENTER WING LOWER SURFACE WS 61

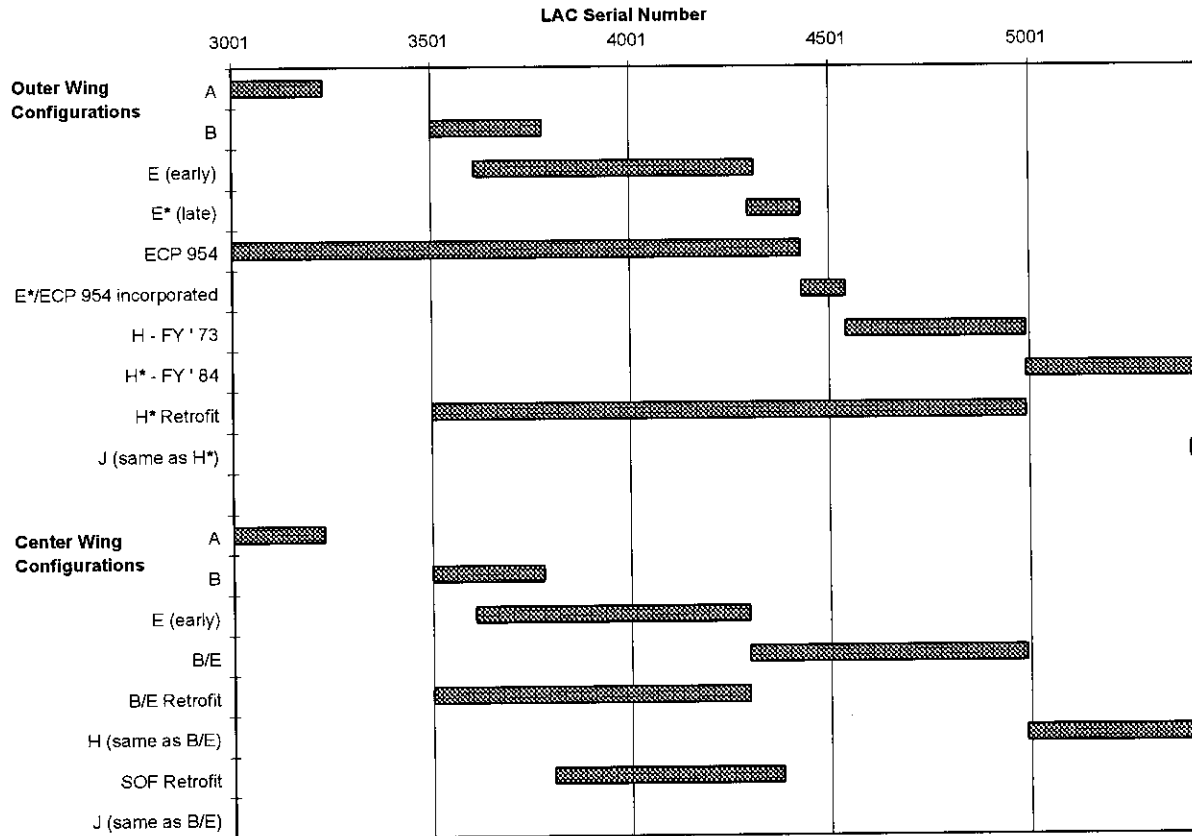
C-130 Wing Design Improvements

Model	Tested to	Remarks
C-130A	89% ultimate Flight Loads	Upper surface failed at OWS 21. Reinforcements added to fleet. No retest.
C-130B	93% ultimate Flight Loads	Upper surface failed at OWS 54. Reinforcements added to fleet. No retest.
C-130E	110% ultimate Flight Load	Upper surface of center wing failed at WS 128. Test acceptable.
