National Transportation Safety Board

Marine Accident Brief

Contact of Crane Barge *Mr Ervin*, Pushed by Towing Vessel *Kristin Alexis*, with Sunshine Bridge

Accident type	Contact	No. DCA19FM003
Vessel name	<i>Kristin Alexis</i>	
Location	Lower Mississippi River, mile 167.4, St. James Parish, about 30 miles downriver of Baton Rouge, Louisiana ¹ 30°05.86' N, 90°54.81' W	
Date	October 12, 2018	
Time	0141 central daylight time (coordinated universal time – 5 hours)	
Injuries	None	
Property damage	\$7 million est.	
Environmental damage	None	
Weather	Clear skies with visibility at 10 miles, winds north-northeast at 6 mph; air temperature 62°F, water temperature 77.5°F	
Waterway information	The Mississippi River at the Sunshine Bridge is about 2,550 feet wide, bank to bank. At the time of the accident, the river gage at Donaldsonville was at 18.37 feet, and the current was about 3 mph. (Flood stage was in effect at 27 feet.)

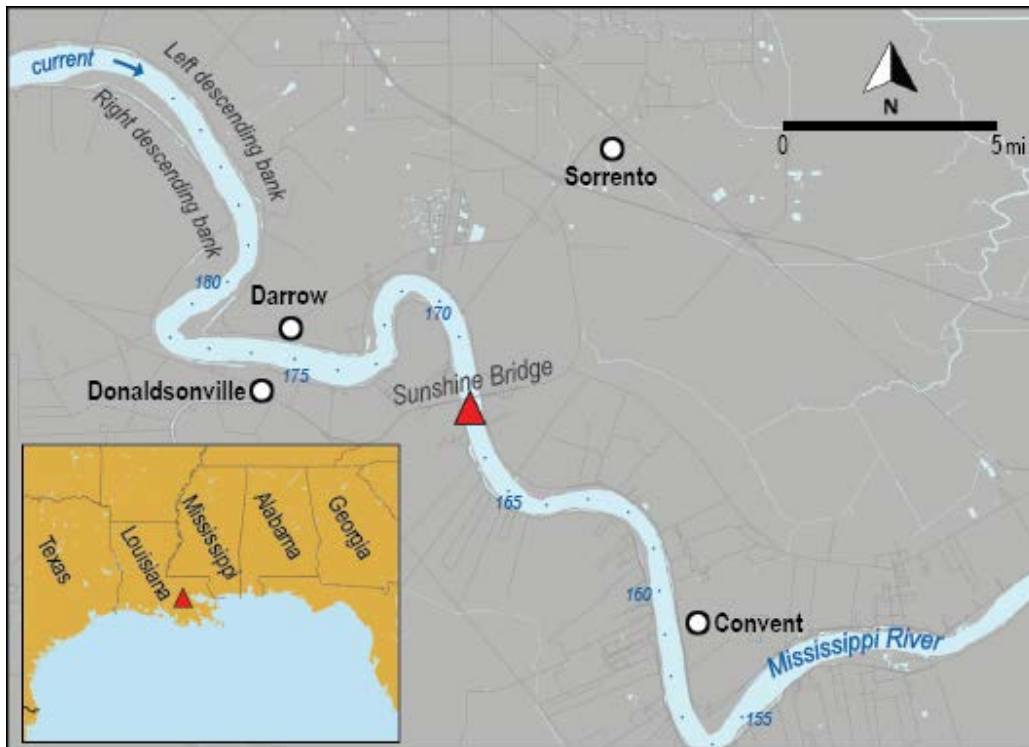
Figure 2. Location where the *Kristin Alexis/Mr Ervin* struck the Sunshine Bridge, marked by the red triangle. (Background source: Google Earth)
