Fire On Board US Small Passenger Vessel *Island Lady*
Pithlachascotee River Near Port Richey, Florida
January 14, 2018

NTSB/MAR-18/02
PB2019-100203

Marine Accident Report

Abstract: This report discusses the fire that destroyed the small passenger vessel *Island Lady* on January 14, 2018, at the mouth of the Pithlachascotee River near Port Richey, Florida. The vessel, with 53 people on board, was on a scheduled transit to an offshore casino boat, the *Tropical Breeze I*, located about 9 miles offshore in the Gulf of Mexico.

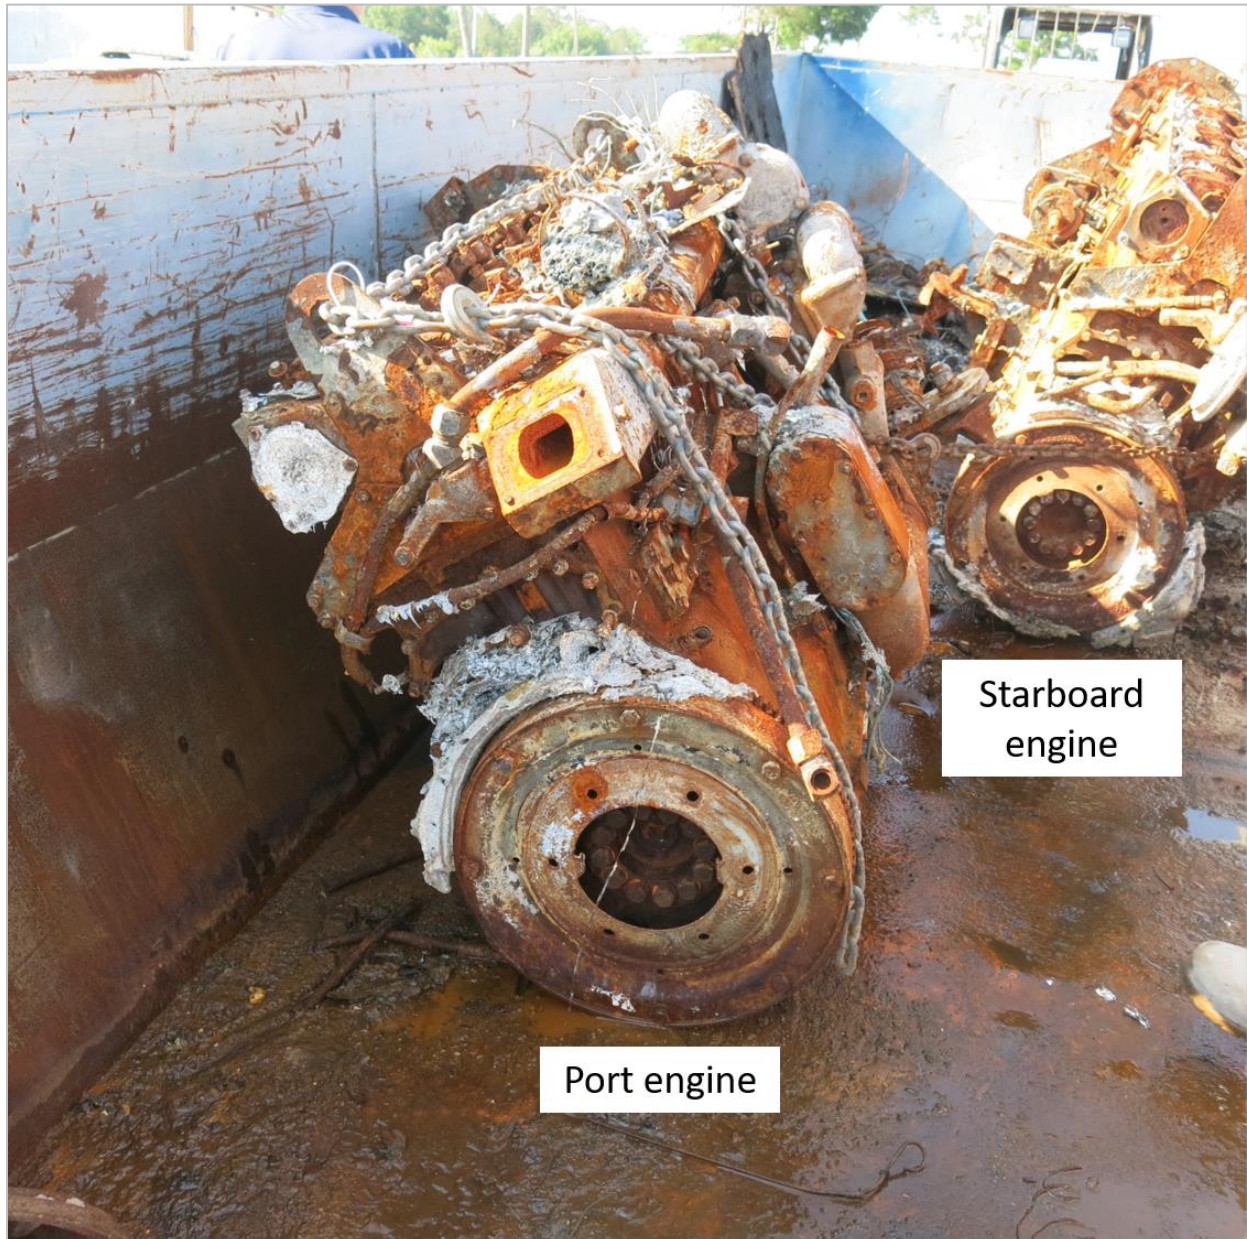
In February 2018, a salvage team recovered the remnants of the *Island Lady*. The components were transported to a secure facility, where investigators examined them in May 2018 (figure 9). After examining the salvaged engines, investigators determined that almost all of the aluminum, bronze, copper, and brass engine components—which included the heat exchanger body, aftercooler housings, front gear covers, flywheel hosing, raw-water pump housings, base and valve covers, oil pans, and other smaller housings—were missing due to the extreme heat generated during the fire.

Figure 9. Port and starboard engines at storage facility after removal from the *Island Lady*.

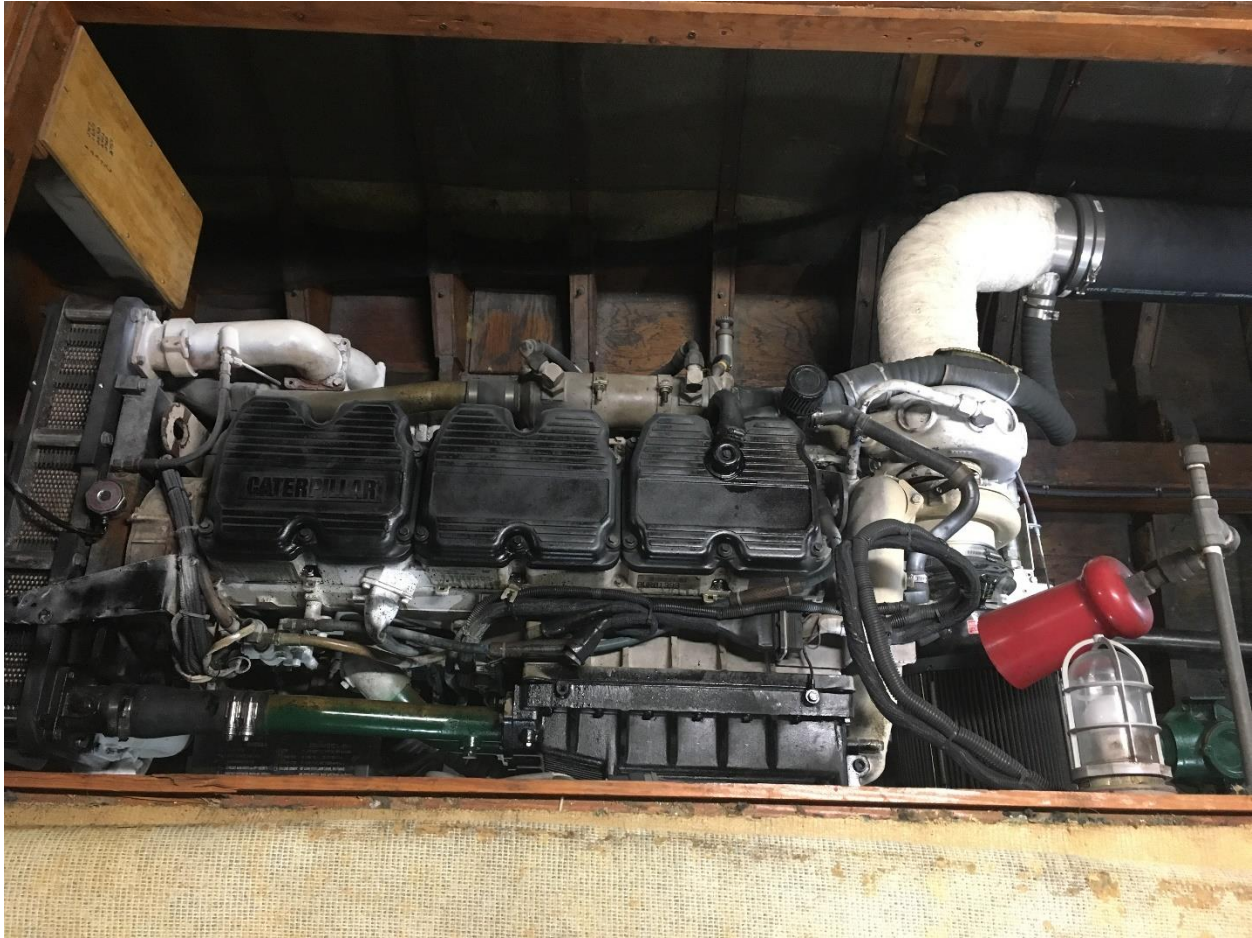
Figure 12. The *Island Lady*'s starboard engine in May 2017. (Photo provided by the Coast Guard)

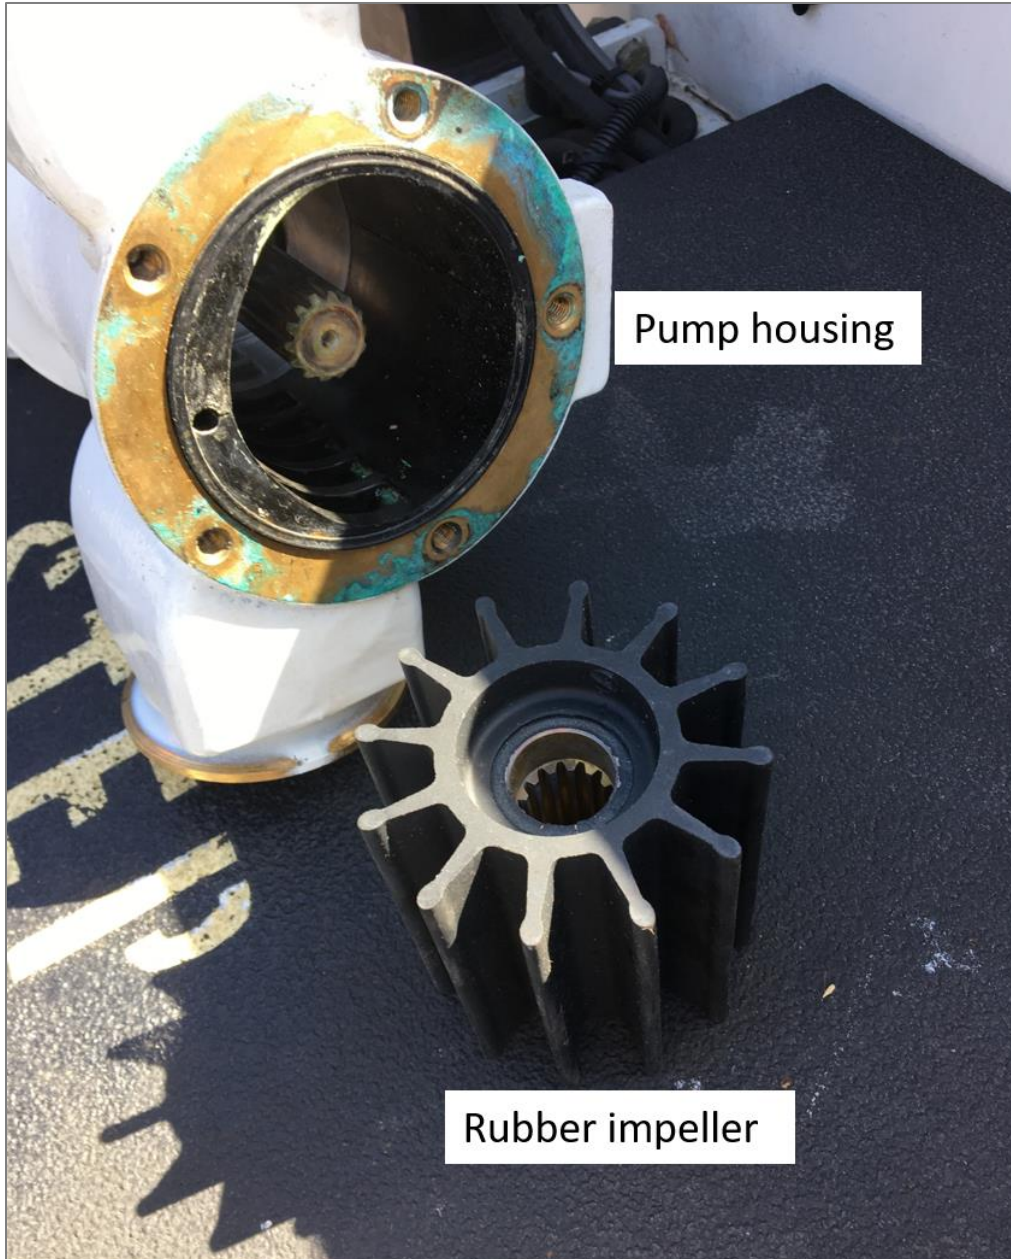
Each engine was directly cooled by a closed-type jacket-water system via cooling passages in the engine block. An engine-driven raw-water pump (figure 13) drew seawater for cooling by way of a through-hull inlet pipe. An inline sea strainer prevented debris from entering into the pump casing. The gear-driven raw-water pump impeller was constructed of rubber and fitted onto a splined shaft that rotated at a speed proportional to the engine rpm. According to Caterpillar specifications for the 3406E engine, the nominal operating temperature of the jacket-water system was 192°F. The setpoint for the high-temperature alarm was 217°F after a 30-second delay.

Figure 13. Upper left: Housing for raw-water pump. Center: New rubber impeller.

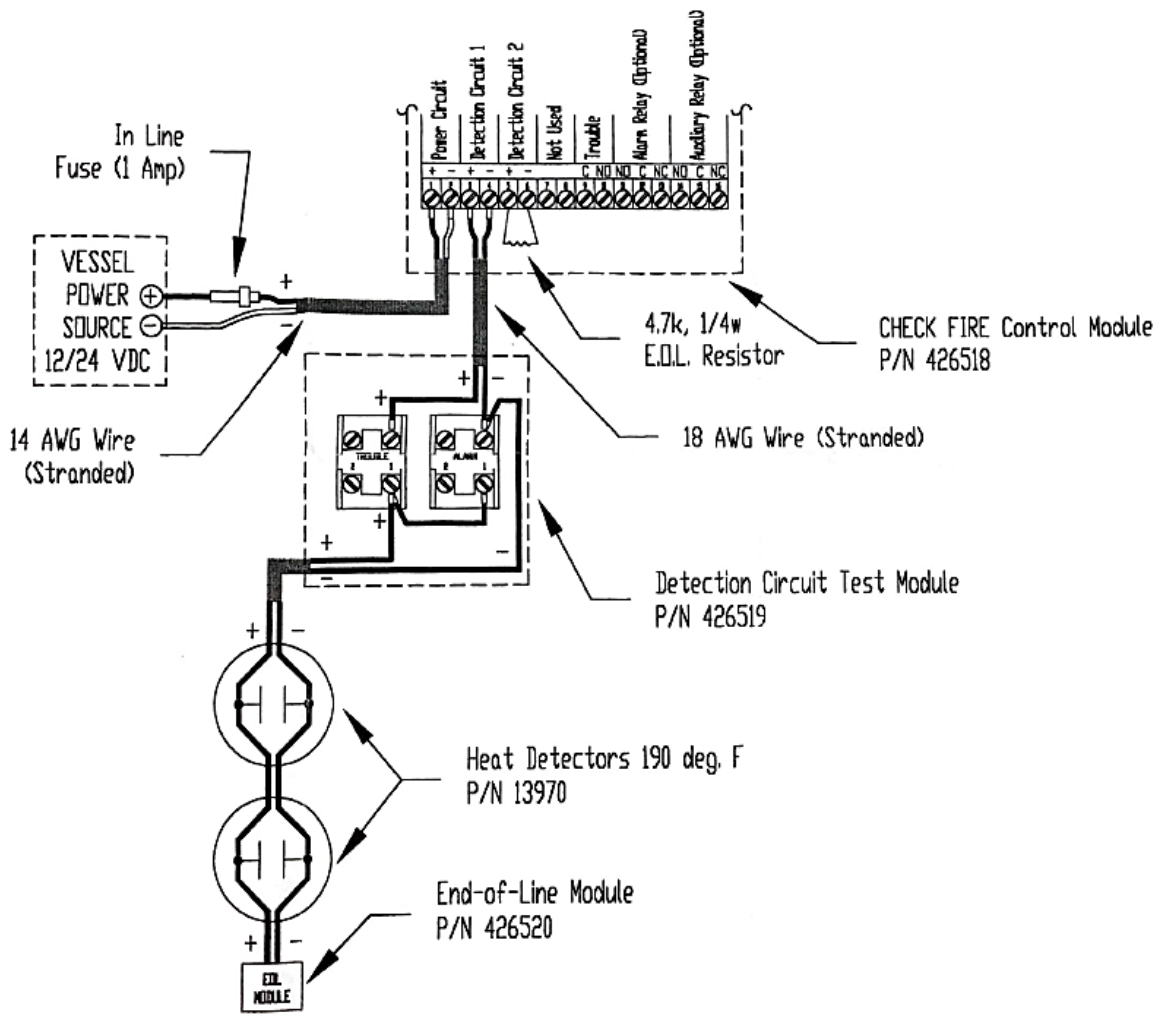
Figure 17. Drawing of the fire detection system layout. (Drawing by Checkfire, provided by the Coast Guard)

The fire detection system was to be tested annually; however, investigators could not find a record of the last test. The captain said in an interview that the heat detectors had been tested but that the records were destroyed in the fire. A Coast Guard “New to Zone” inspection of the *Island Lady* in November 2015 indicated that the overall firefighting system was inspected and found satisfactory. The Coast Guard’s most recent inspection report of the *Island Lady* (March 2017) listed the vessel’s firefighting system as “inspected with deficiencies noted,” but the deficiencies were not related to the detection system, and the owner addressed them during the inspection.¹⁴ Neither Coast Guard inspection narrative specifically mentioned testing of the fire detection system. After the fire, investigators could not locate the two heat detectors or the engine room alarm panel; they were likely destroyed in the blaze.

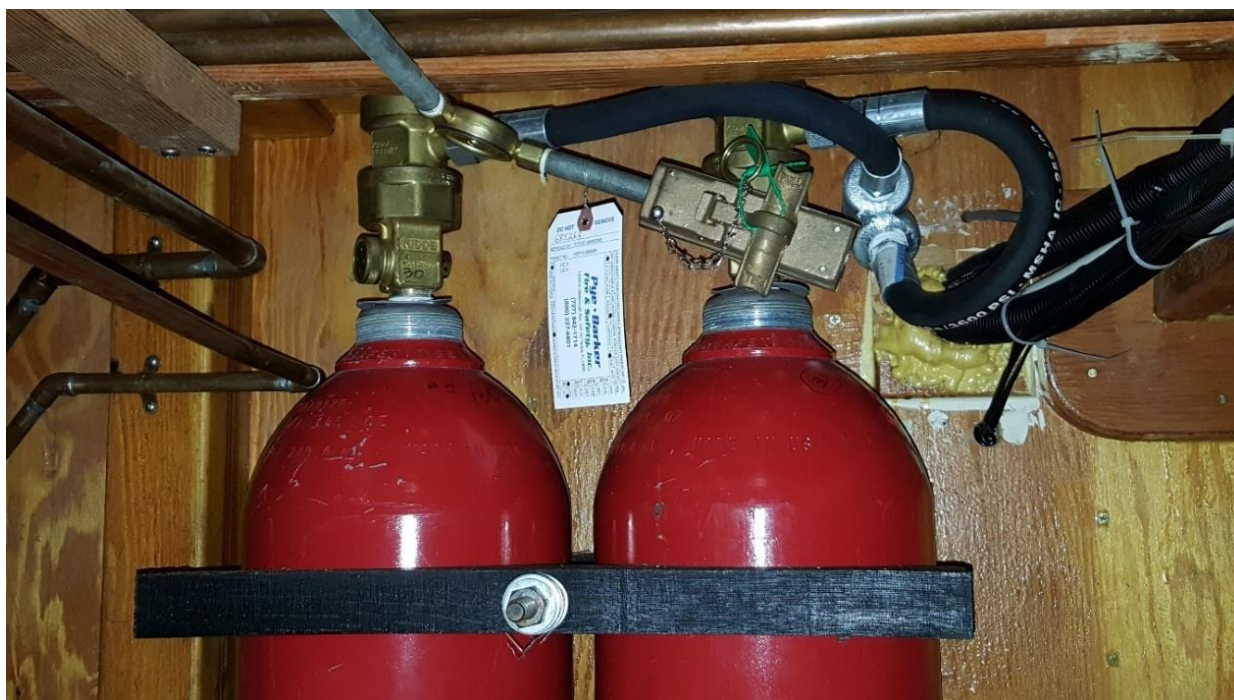
Figure 18. Components of the *Island Lady*'s fixed fire suppression system in March 2017 before the fire. (Photo by the Coast Guard)

¹⁶ The May 2017 suppression system maintenance report contained a note that stated the CO₂ cylinders were due for hydrostatic testing. Investigators were not able to determine if this testing was completed before the fire occurred. Required tests of CO₂ systems include weighing the gas cylinders (they must be recharged if their weight loss exceeds 10 percent of the charge); testing time delays, alarms, and ventilation shutdowns according to the manufacturer's instruction manual; and making sure hoses and nozzles are clean.

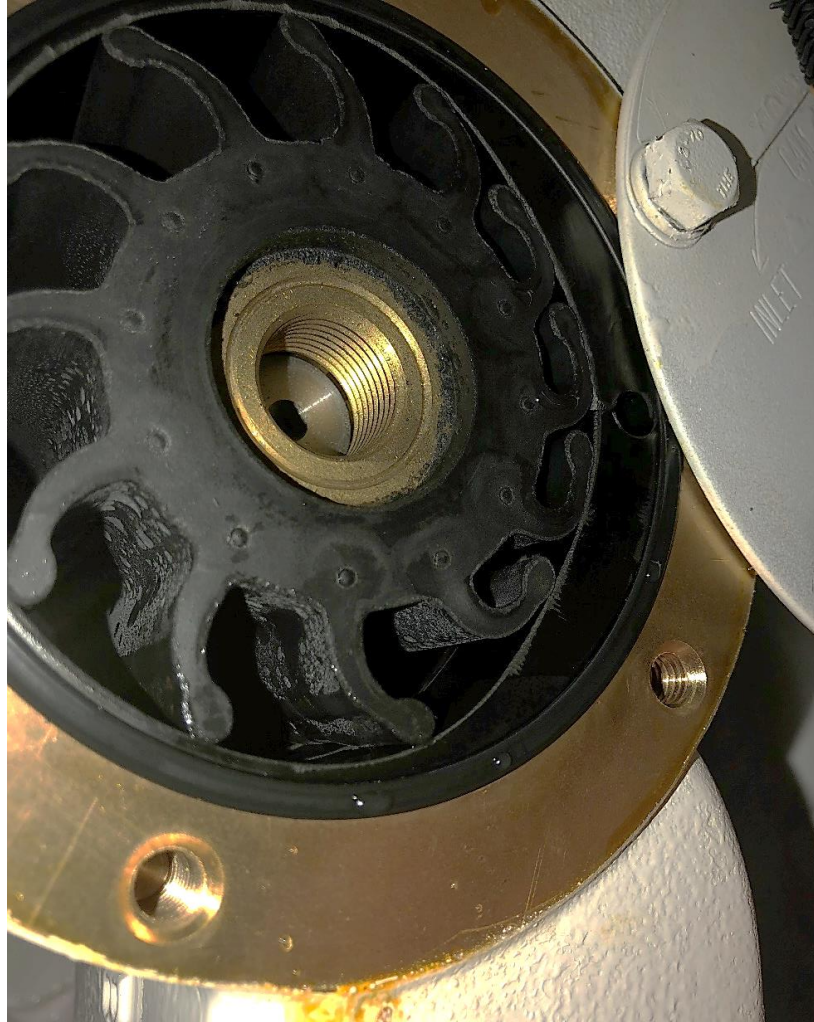
Ring Power provided a photo to show the condition of a newly installed rubber impeller in a raw-water pump housing (figure 24).

Figure 24. New raw-water pump impeller installed in its pump housing. (Photo by Ring Power)
