## Continental Motors, Inc. Magneto Analysis Report

| Engine Model: | Lycoming IO-540-K1B5 | Engine S/N: | L-15134-48A C (converted) | |
| Aircraft Make/Model: | Piper PA-32-300 | Aircraft S/N: | 32-40641 | Registration N4267R |

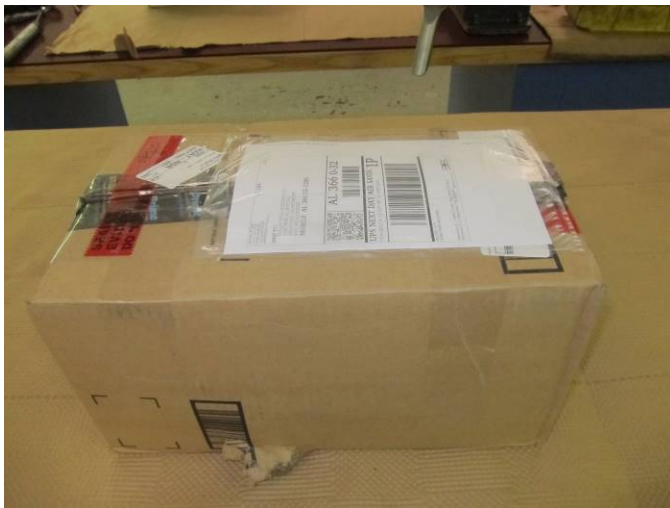
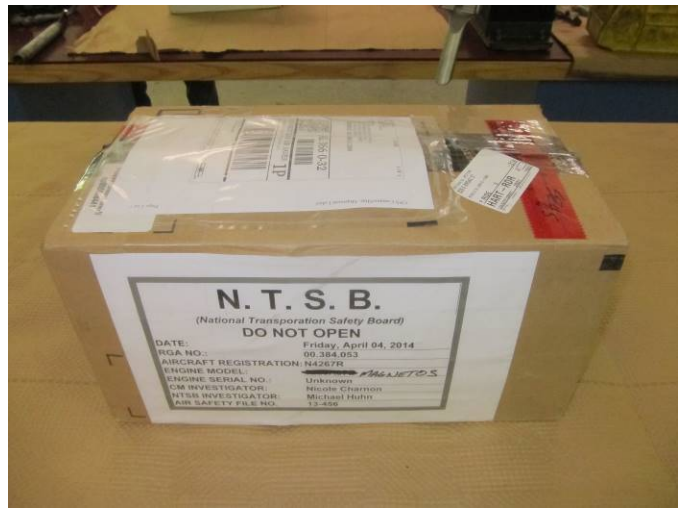
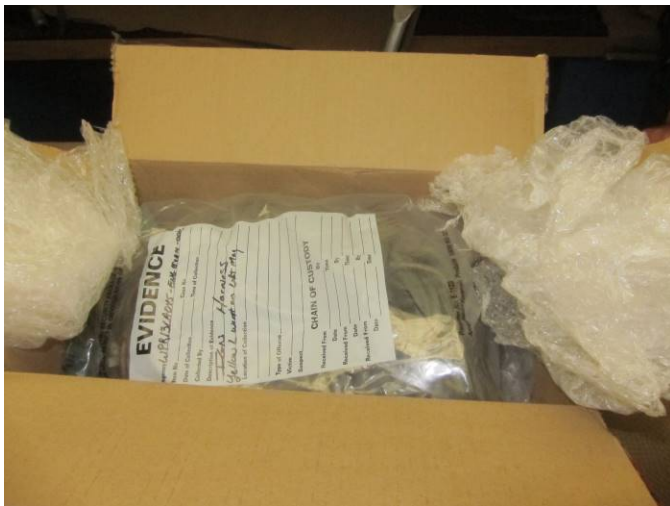
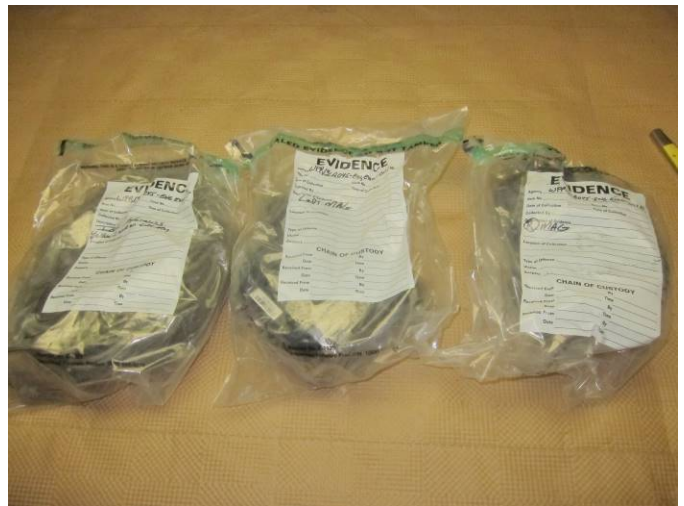
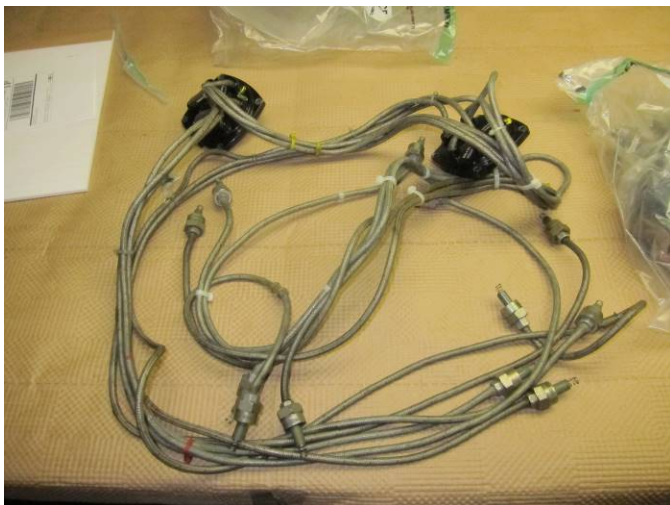
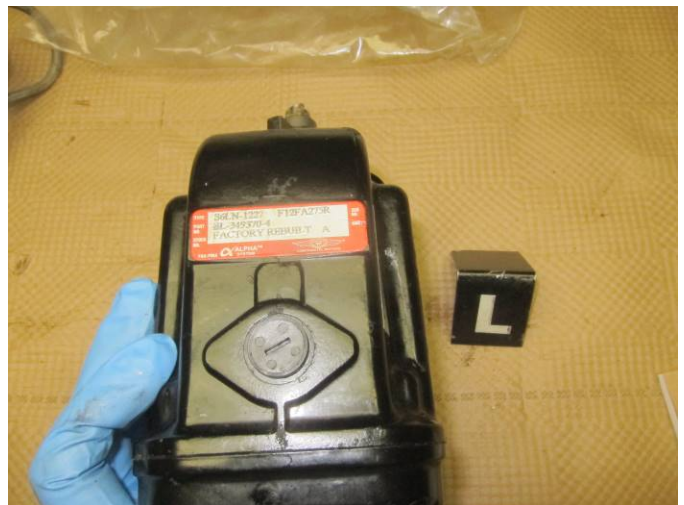
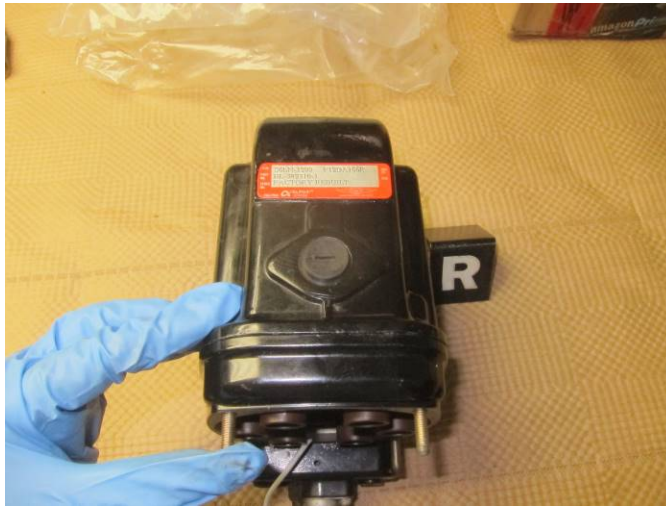
| <p>Analytical Report: The examination revealed that the right magneto's internal timing was off by three distributor gear teeth. Examination of the distributor gear while the axle was installed in the distributor block bushing revealed there was a significant angular displacement between the gear and the block. The bushing that is normally bonded within the distributor block was loose. The loose bushing permitted the distributor gear axle to tilt far enough to disengage the distributor gear from the drive gear, permitting a migration of the internal timing. Maintenance history and magneto total time is unknown as of this report's writing.</p> | | | | |
