**NATIONAL TRANSPORTATION SAFETY BOARD
Office of Aviation Safety**

**MAINTENANCE GROUP CHAIRMAN'S FACTUAL
DCA12MA020**

Operator: Sundance Helicopters, Inc.
Location: Henderson, NV
Date: December 7, 2011
Time: 1630 Pacific standard time
Aircraft: N37SH, Eurocopter AS-350B2

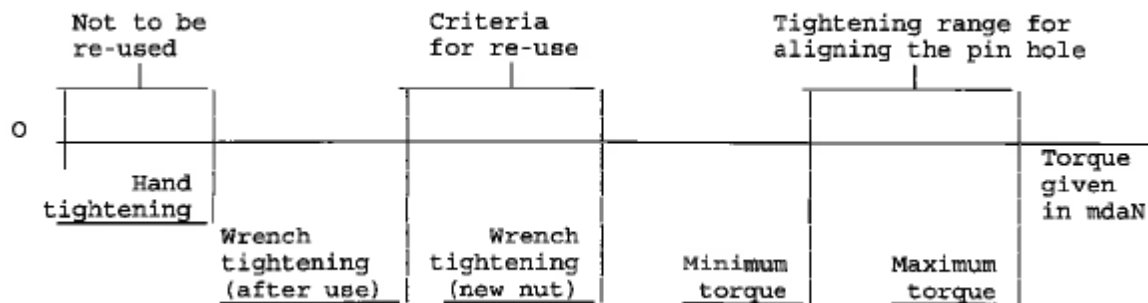
Figure 6. Nut Reuse Guidance (Eurocopter Standard Practices Guidance MTC.20.02.05.404, 2009.11.2)

- Make sure nylon lock is not excessively damaged
- Fit the nut by hand:
 - If nut can easily be tightened, it is to be discarded
 - If nut is hard and cannot be tightened by hand, it may be reused
 (In a workshop, the minimum locking torque value can be read using a torque wrench)."
