EXHIBIT NO. 11K

NATIONAL TRANSPORTATION SAFETY BOARD
WASHINGTON, D.C.

SERVICE BULLETIN 747-28A-2194

SUBJECT: FUEL - DISTRIBUTION - FUEL BOOST AND OVERRIDE/JETTISON PUMPS - INSPECTION

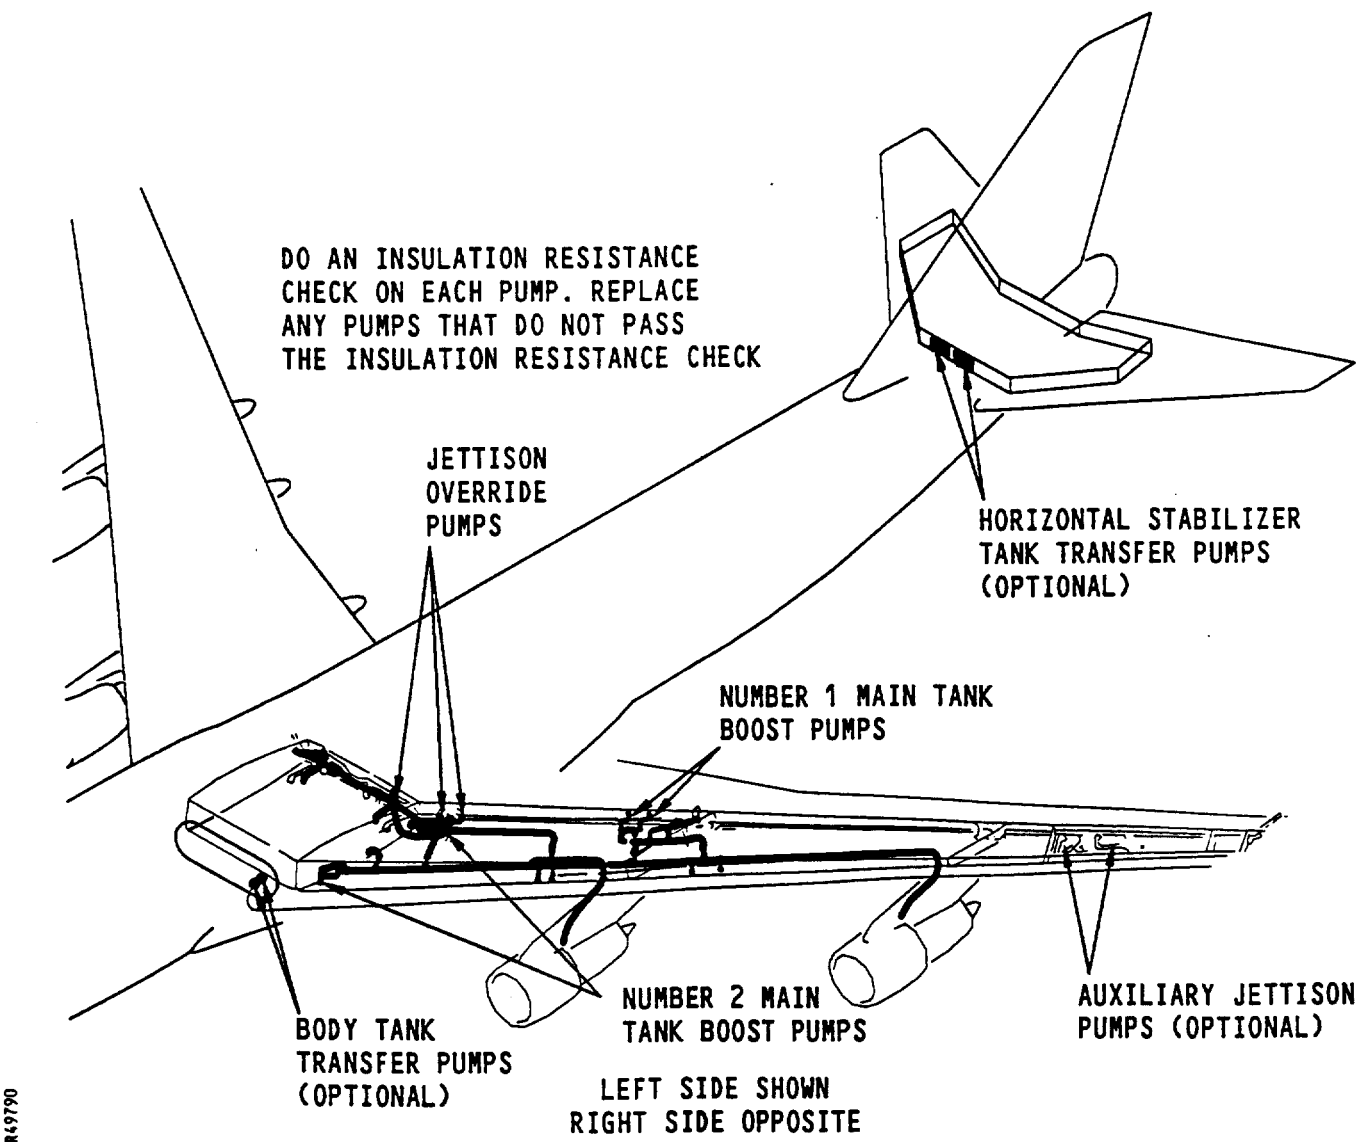
Operators have sent reports of fuel leaks at the fuel boost and override/jettison pumps. The reports tell that eight fuel pumps have been removed for this reason. The removed fuel pumps had between 34,000-67,000 hours since new or since overhaul. The leaks occurred at the pump/wire bundle interface. The result of one leak was a fire at an inboard main tank jettison pump during maintenance.

It is believed that after a long time, water can get inside the potting of the wire terminal assembly and cause corrosion. The corrosion in the wire terminal assembly can cause arcing between the power pins and the pump case. The arcing causes thermal expansion of the materials inside the cap. This expansion causes failure of the cap attachment flange or the attaching screws and a subsequent fuel leak.

High current during arcing can also melt a hole through the pump end case and connector, which also causes a fuel leak.

Get access to all of the 747 fuel pumps. Do an insulation resistance check on each pump. Replace any pumps that do not pass the insulation resistance check.

Boeing recommends that the initial inspection be accomplished at the next opportunity when manpower and facilities are available. For pumps with insulation resistance between 1 and 5 megohms when the 500VDC is done, it is recommended that the pump be replaced. If the pump is not replaced, do the inspection of this pump at every A-check or an equivalent time. For pumps with insulation resistance greater than 5 megohms when the 500VDC is done, the inspection should be repeated at every C-check or an equal time period after the initial inspection.
