# NATIONAL TRANSPORTATION SAFETY BOARD

## Group Chairman's Factual Report

### Maintenance Records Group Chairman's Report

WPR10FA371

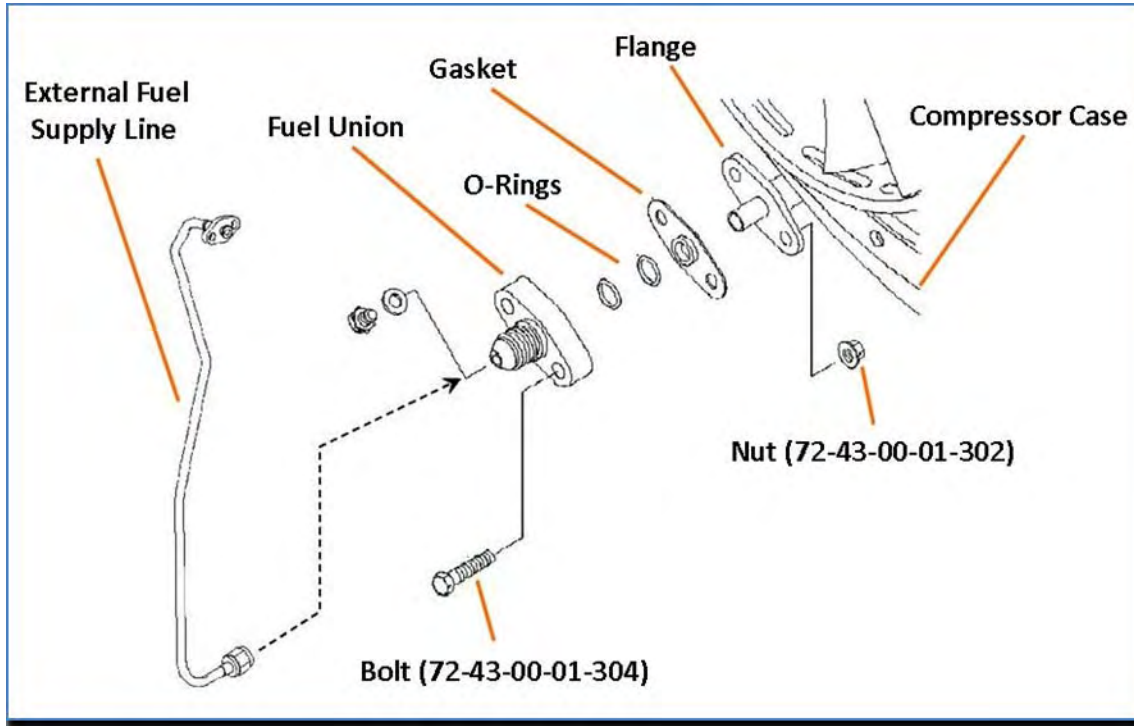
**Figure 1. Exploded View of Fuel Inlet Union**

External examination of the engine at the accident site revealed that the fuel inlet union, located on the lower right-hand-side of the engine, had become detached from the boss on the compressor case. The fuel supply line remained attached to the union and to the hydro-mechanical unit (HMU). The intermediate gasket was located in the fuselage debris, directly below the union. The remaining wreckage and ground area were extensively examined utilizing a

series of magnets and sifting grates, but did not reveal the presence of the two five-point bolts and self locking nuts for mounting the union to the compressor case flange." Figure 1 shows a view of the fuel inlet union, its associated hardware, and its attach point to the engine. Photo 3 shows an exemplar fuel inlet union as it should be installed.
