WRECKAGE AND IMPACT

The Safety Board investigator-in-charge performed an on-scene wreckage documentation the day following the accident followed by the initial examination.

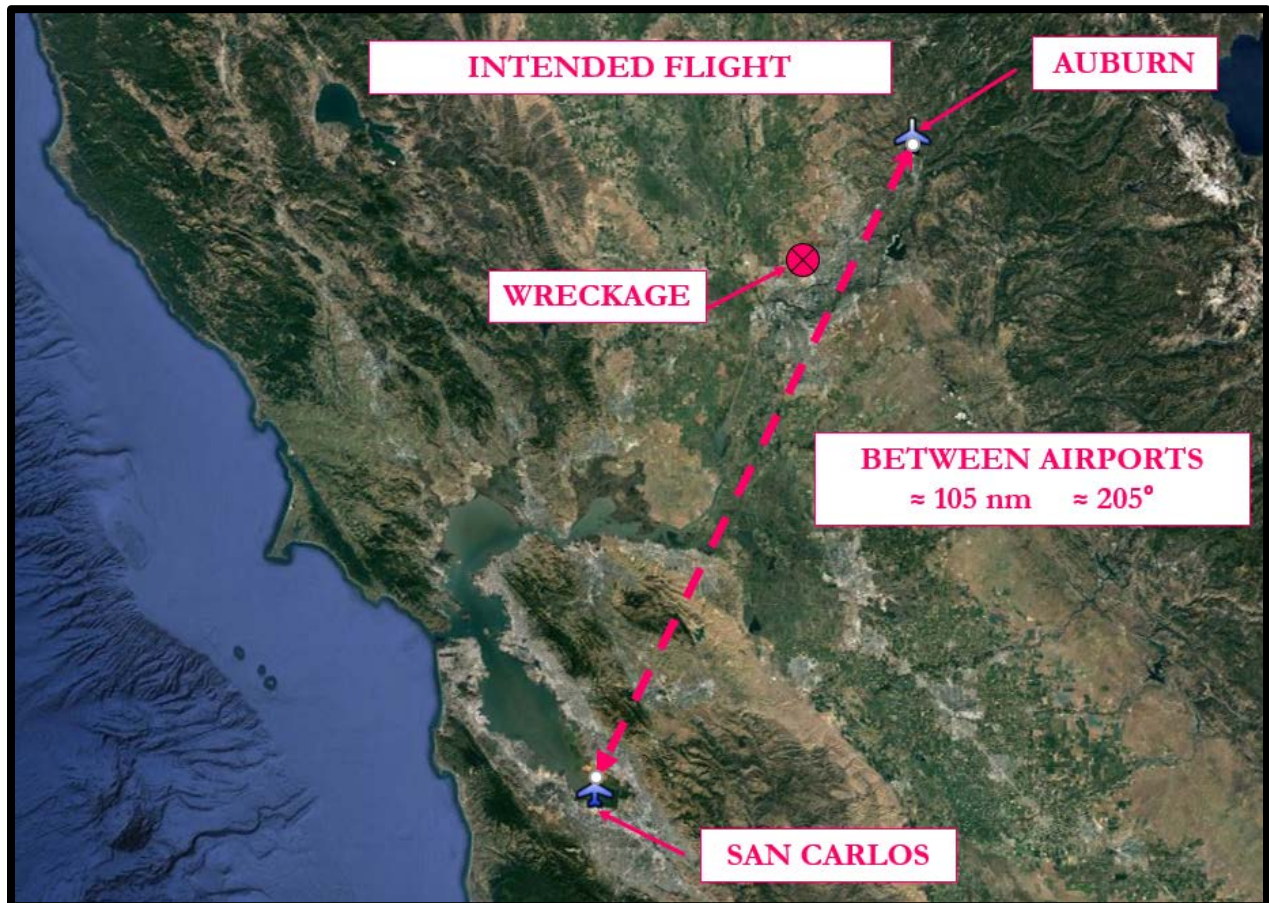
Figure 1: Intended Flight

The destination airport in San Carlos, California (elevation 54 ft msl) was about 105 nm from Auburn Municipal Airport (elevation 1,550 ft msl) on a bearing of about 205-degrees. About 5 minutes after becoming airborne, the pilot diverted to McClellan Airfield.

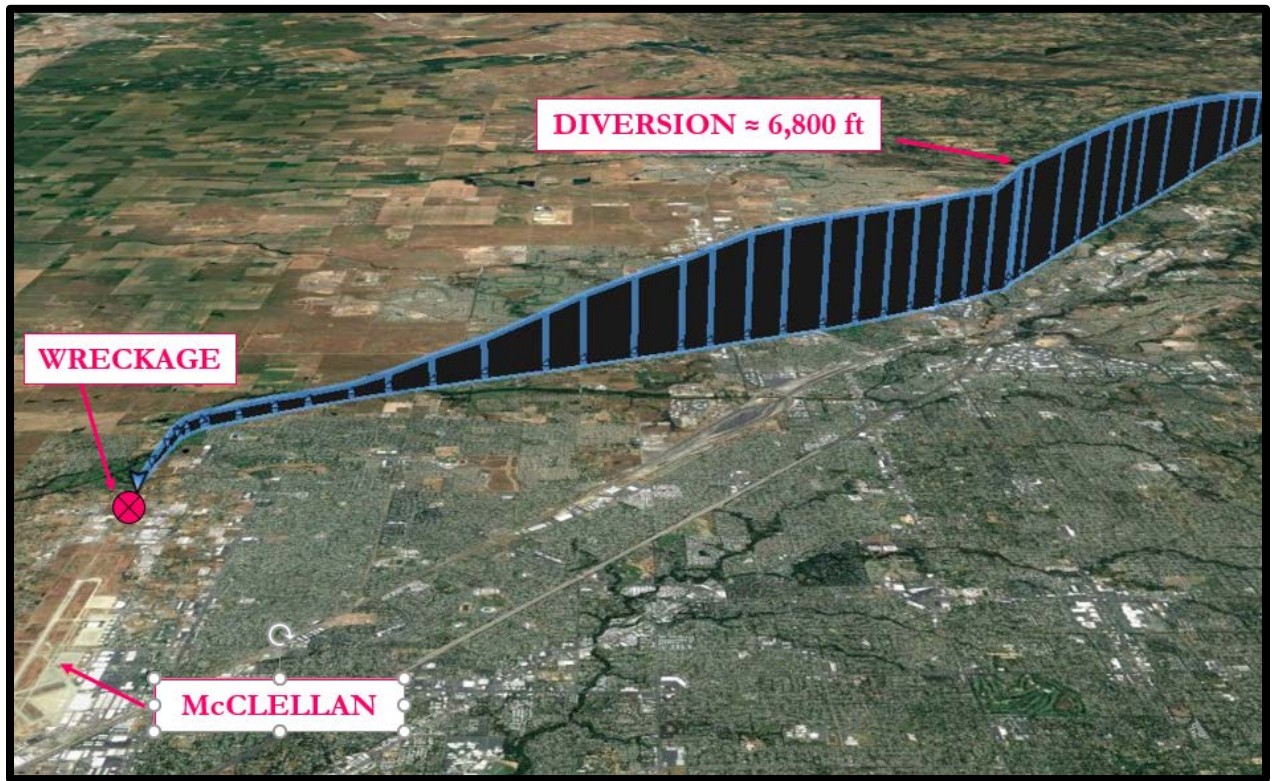
Figure 4: Accident Flight Recorded in the Handheld GPS with Altitude Profile

Located in the wreckage was a Garmin GPSMAP 396, battery-powered portable GPS receiver. The unit stores date, route-of-flight, and flight-time information; all recorded data is stored in non-volatile memory. Recorded data plots were recovered for the time frame that matched the anticipated flight track of the airplane departing from Auburn. The track indicated that the airplane departed from runway 25 about 1455. After becoming airborne, the airplane climbed and headed toward San Carlos on a heading of about 220 degrees. At 1459:28, with the airplane about 6,800 ft msl, the airplane began a gradual descent and shifted to a 240-degree heading. The airplane continued in the direction while cruising between about 215-200 kts until 1502:02 when the airplane made a left turn to adjoin the final approach leg to runway 16 at McClellan Airfield.

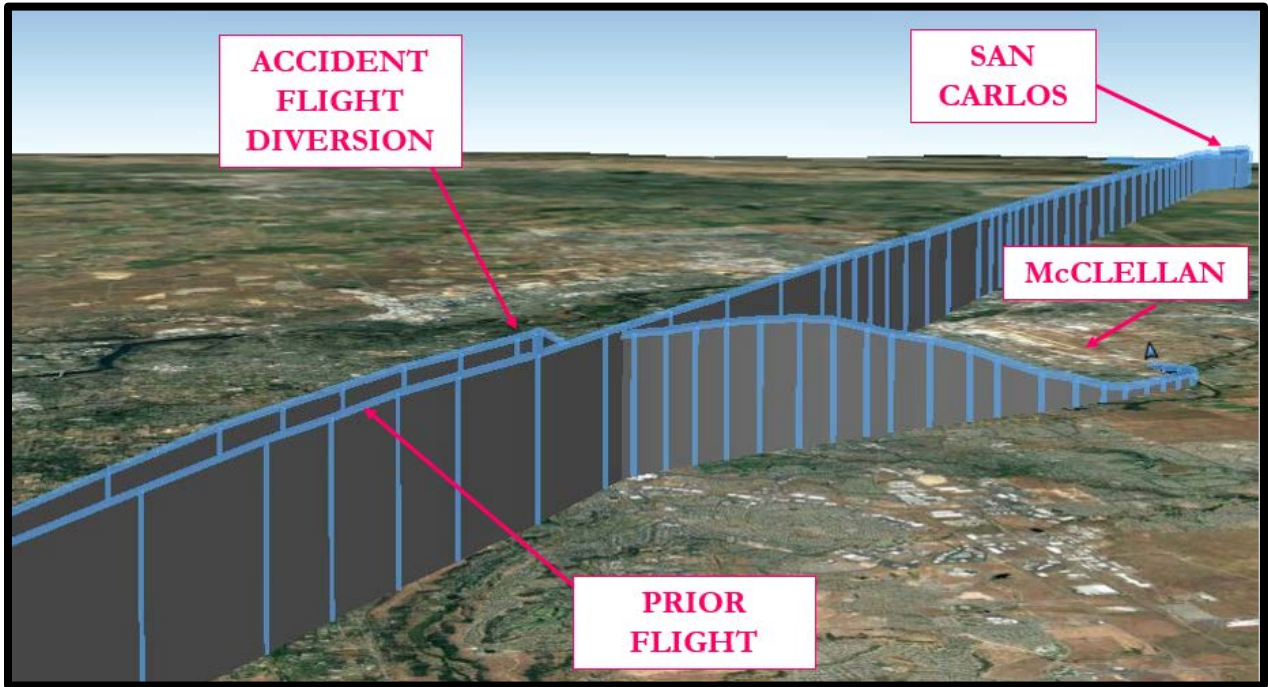
Figure 6: Accident Flight Compared to Prior Flight Showing Altitude Profile

A comparison was made between the accident flight and a prior flight from Auburn to San Carlos. Lateral and perpendicular distances were measured between the prior flight path, and compared to the accident. Comparing the flight paths revealed that the accident flight was similar in speed and altitude gain until reaching the diversion point.

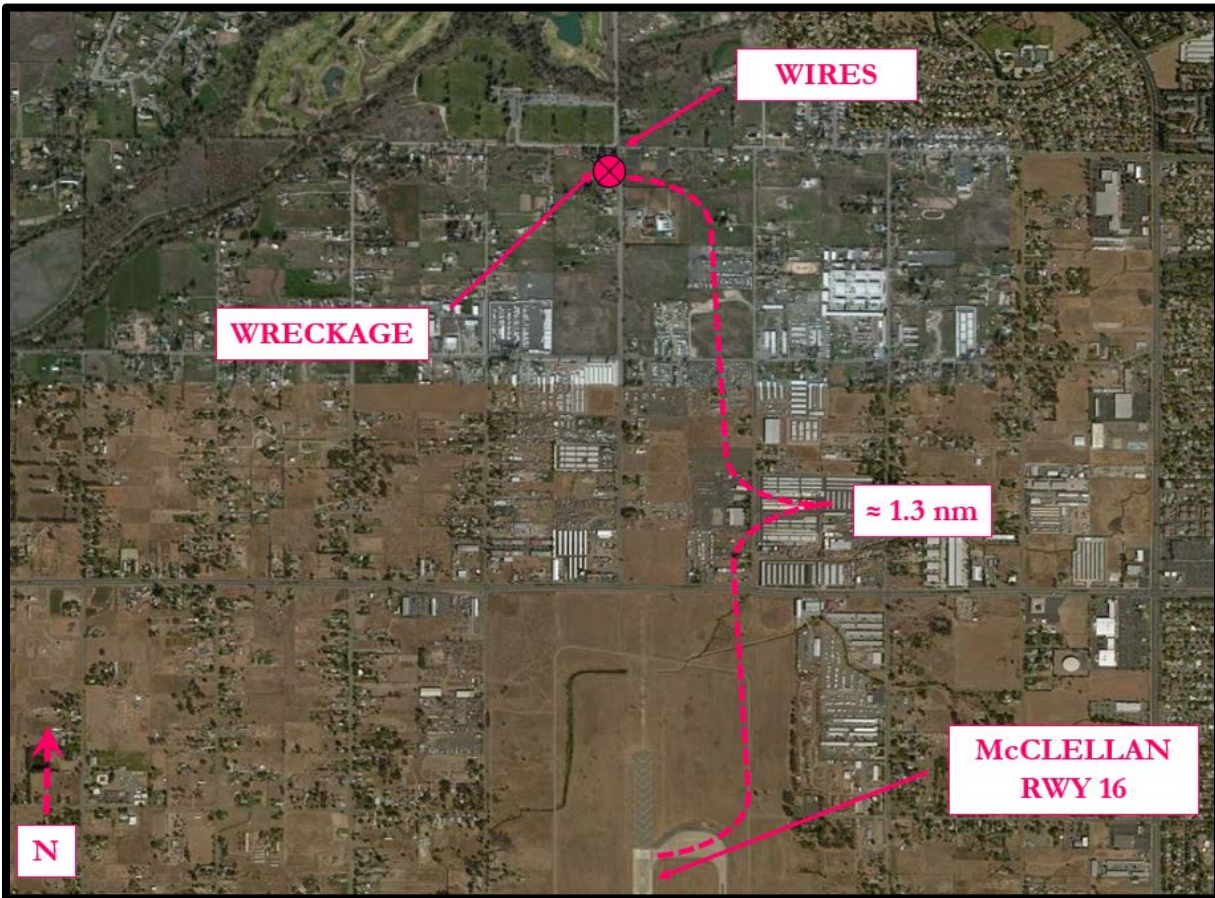
Figure 7: Wreckage Relative to Diversion Airport

The accident site was in a back yard of a residence located on the corner of U street (east-west oriented) and 28th street (north-south oriented). Powerlines were located 190 ft north of the wreckage with two support structures (wood poles) on both sides of 28th street (the south side of U street), at a distance of 73 ft apart. The lines had been separated from the west structure attach fittings (35-ft high) but remained attached to the east structure (about 55 ft high). The upper powerline had several bends in the center area consistent with the airplane having made contact with the wire. Situated on the level terrain, the airplane came to rest in upright with the nose oriented on an about 100-degree magnetic bearing. The main wreckage, which consisted of a majority of the airframe and engine, was located about 1.3 nm from the edge of the runway 16 at McClellan. The global positioning satellite (GPS) coordinates for the main wreckage were approximately 38 degrees 42 minutes and 14.35 seconds north latitude and 121 degrees 24 minutes and 6.28 seconds west longitude, at an elevation of about 70 ft mean sea level (msl).

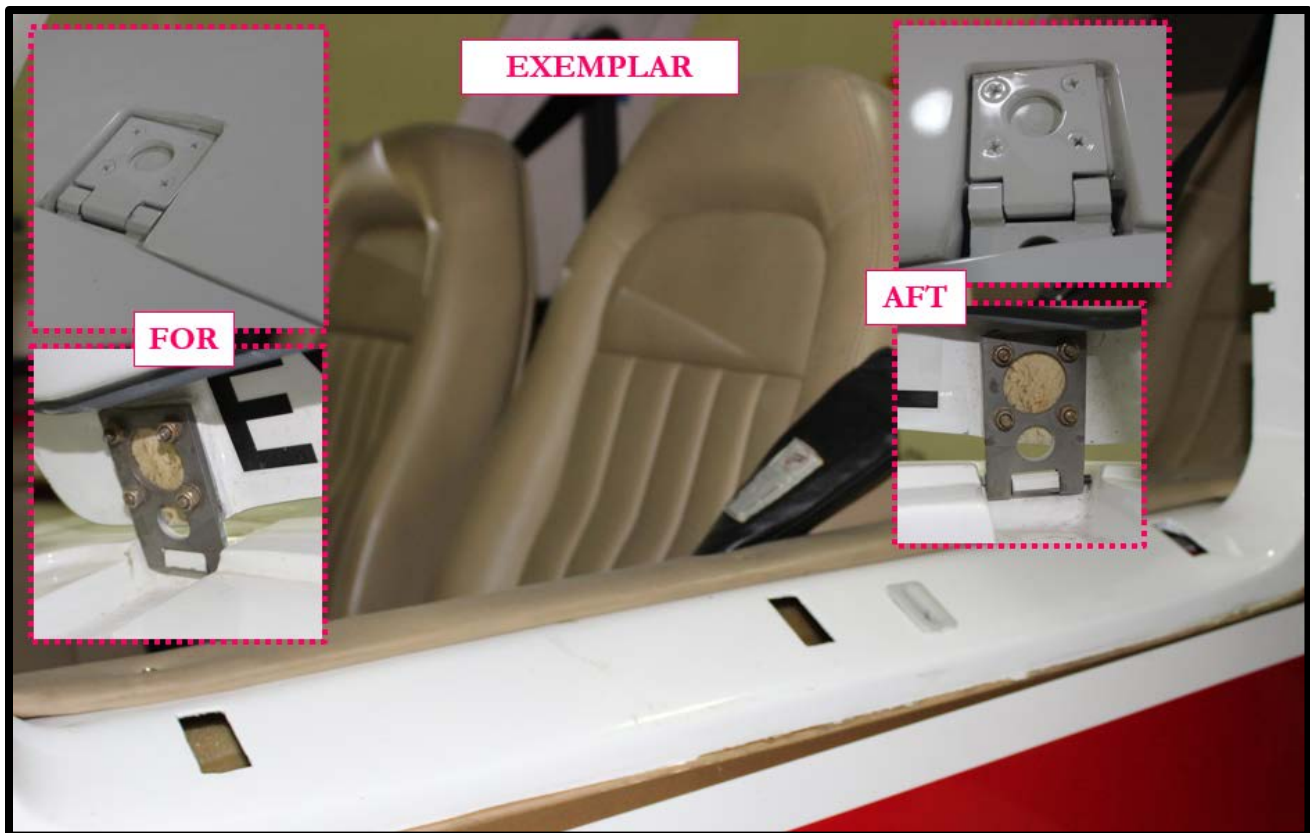
Figure 20: Exemplar Airplane Door Hinges

The door was not located. The door actuator hinge was located in the cockpit.

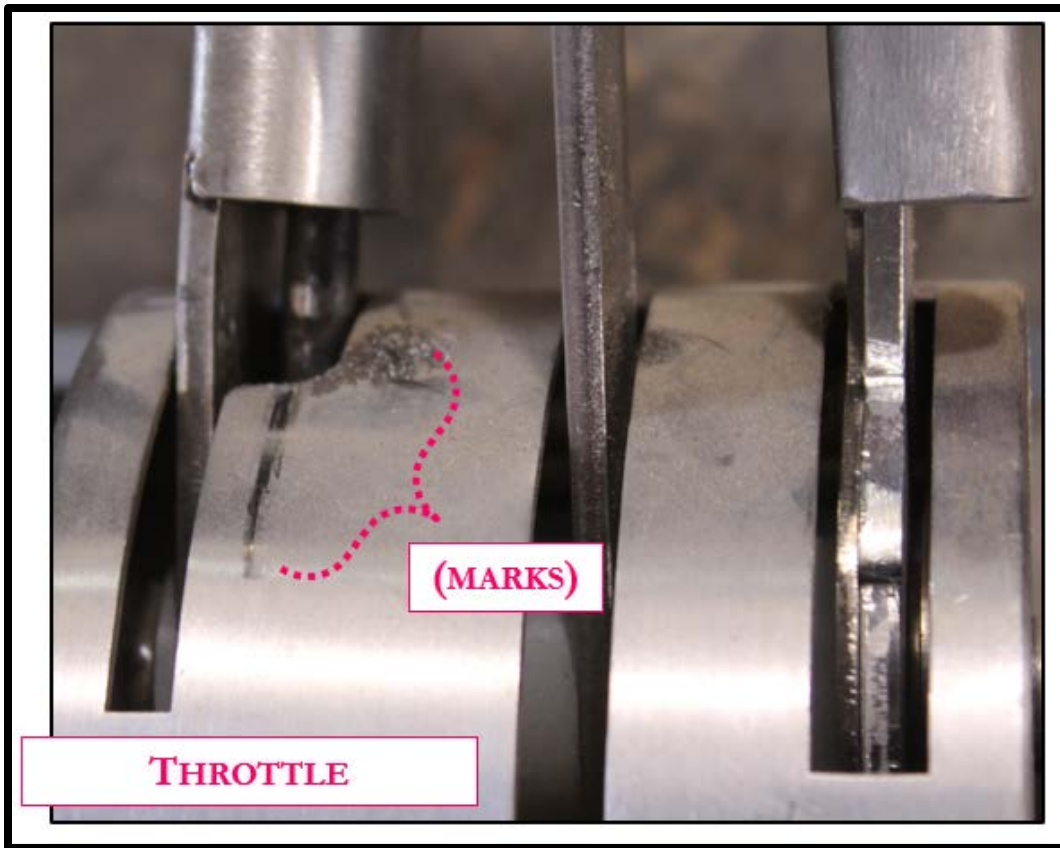
Figure 22: Rub Marks

The airframe remained relatively intact and there was only minor crush damage to the cockpit. The throttle was between mid and full throttle (not in the emergency detent); the propeller lever was at feather and the condition lever mid-range. The throttle quadrant retention clip was displaced and the throttle lever was slightly bent. It is unknown if the clip displacement was a result of the cockpit deformation at impact.
