Enbridge Incorporated
Hazardous Liquid Pipeline Rupture and Release
Marshall, Michigan
July 25, 2010

NTSB/PAR-12/01
PB2012-916501

Pipeline Accident Report

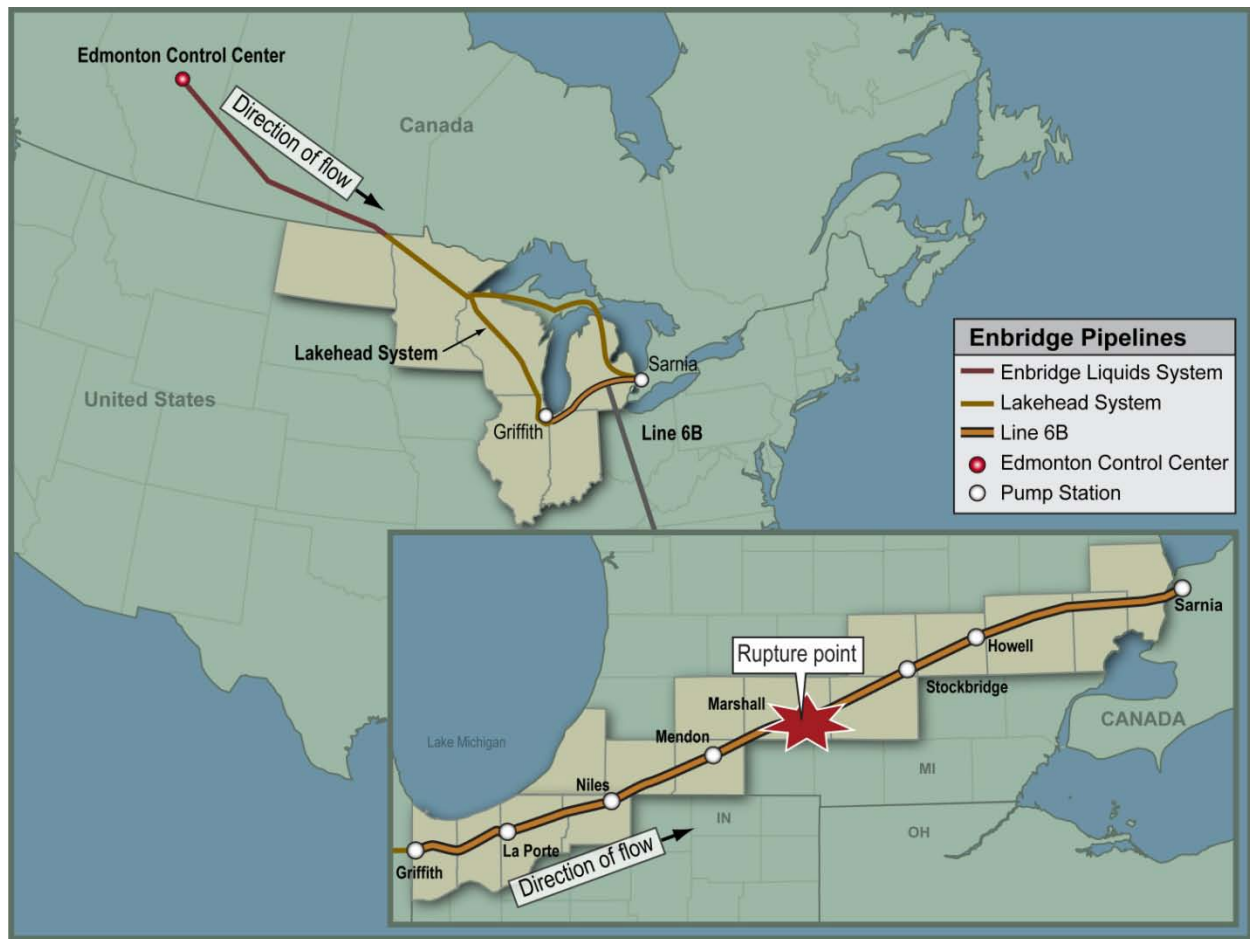
Figure 1. Enbridge’s Liquids System and the 1,900-mile Lakehead System (the U.S. portion). Inset shows Line 6B, the 293-mile extension from Griffith to Sarnia installed in 1969.

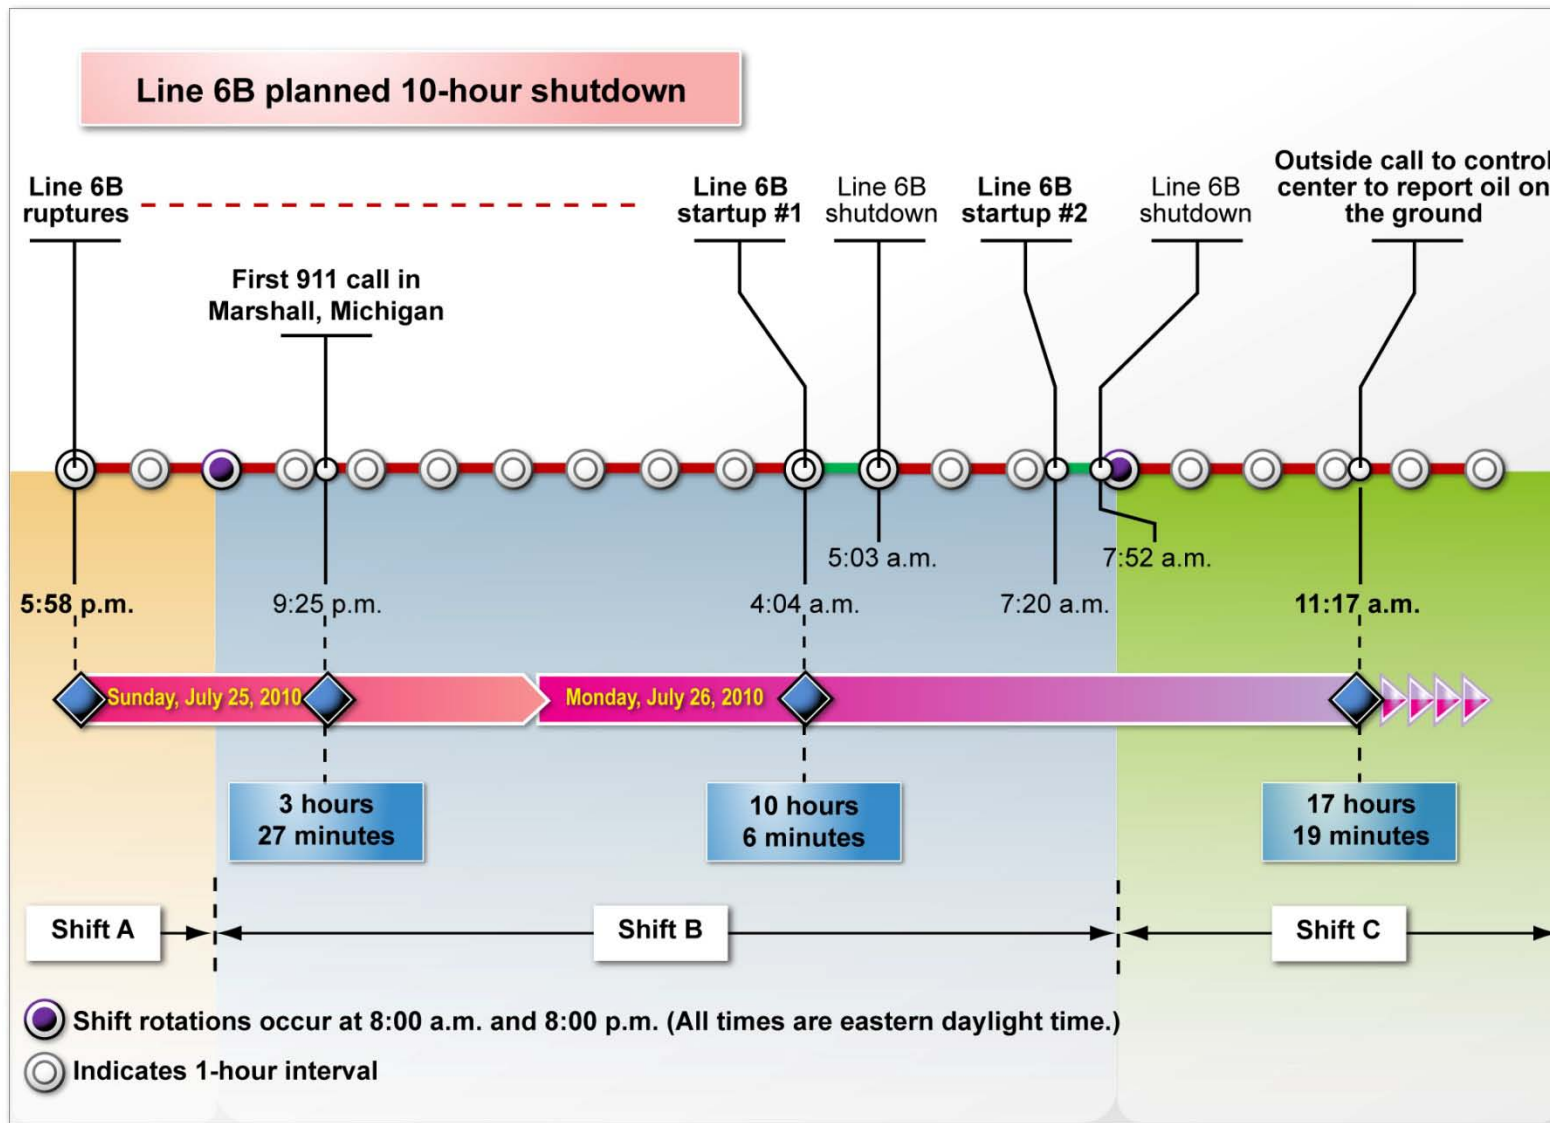
Figure 5 shows a timeline highlighting the accident events that spanned over 17 hours from the time of the rupture until the Enbridge control center was made aware of it. Figure 6 shows the key Enbridge staff involved.

Figure 5. Key events timeline of the Line 6B rupture in Marshall, Michigan, showing the events from the time of rupture on July 25, 2010, to the time of discovery on July 26, 2010.

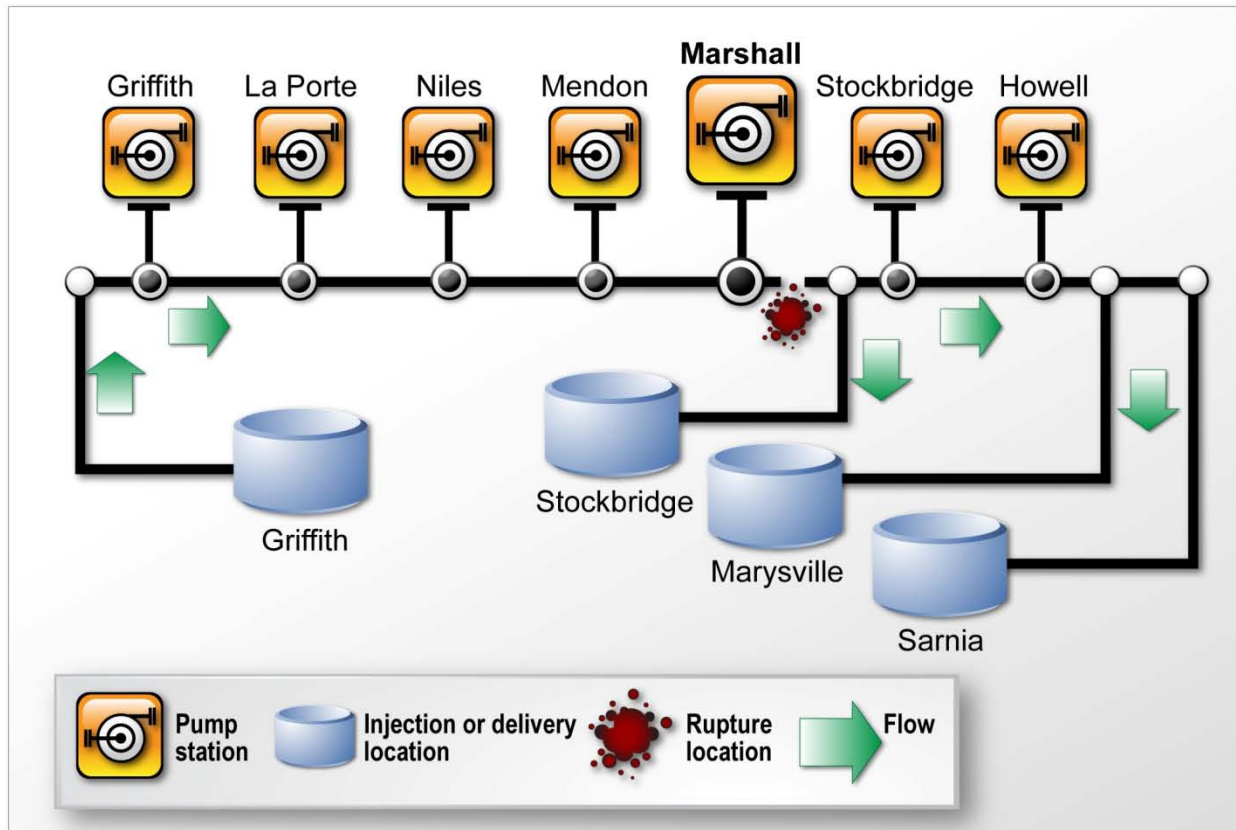
The planned shutdown of Line 6B was scheduled to begin following the last crude oil delivery to the Stockbridge Terminal, located downstream of the Marshall PS (see figure 7). A shutdown was to be performed by pipeline operator A1, sequentially, in the direction of flow, by turning off the pumps at the following PSs: Griffith, La Porte, Niles, Mendon, and Marshall. The shutdown was started at 5:55 p.m. by stopping two pumps at the Griffith PS and a pump at the La Porte PS. At 5:57 p.m., operator A1 increased the upstream pressure at a pressure control valve⁸ at the Stockbridge Terminal before stopping a pump at the Niles PS and a pump at the Mendon PS about 1 minute later.

Figure 7. Simplified schematic of Line 6B, showing pump stations and delivery locations.

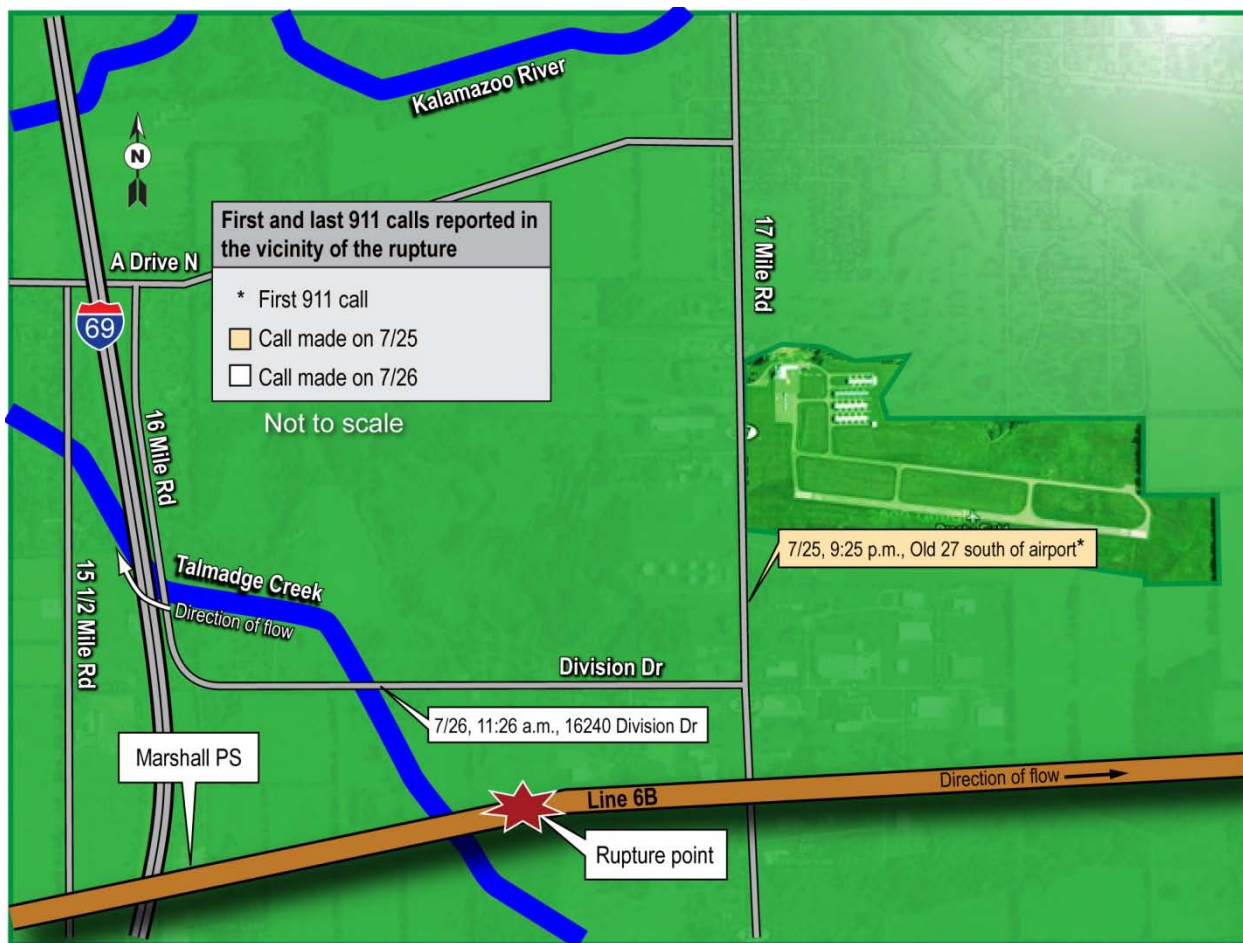
Marshall City Fire Department personnel responded to the area near the airport and requested the Marshall Township Fire Department to respond as well. To find the source of the odor, fire department personnel investigated several pipeline facilities and industrial buildings around Division Drive and 17 Mile Road, using a combustible gas indicator²¹ to try to locate the origin of the odor. No combustibles were detected. The Michigan Gas Utilities senior service technician crossed paths with some of the fire department personnel also trying to locate the source; he found no evidence of a gas leak. The fire department personnel departed the scene at 10:54 p.m. to return to the station. At 11:33 p.m., an employee at a business called 911 to report a natural gas odor. The 911 dispatcher explained that the fire department had already responded to calls in the area, and no more personnel were dispatched.²² (See figure 8.)

Figure 8. Emergency response and 911 calls from nearby residents. First and last calls are noted.
