NATIONAL TRANSPORTATION SAFETY BOARD

MATERIALS LABORATORY FACTUAL REPORT

Report No. 11-055

Place : Marshall, Michigan
Date : July 25, 2010
Vehicle : 30-inch diameter crude oil pipeline
NTSB No. : DCA10MP007
Investigator : Matt Nicholson, RPH-20

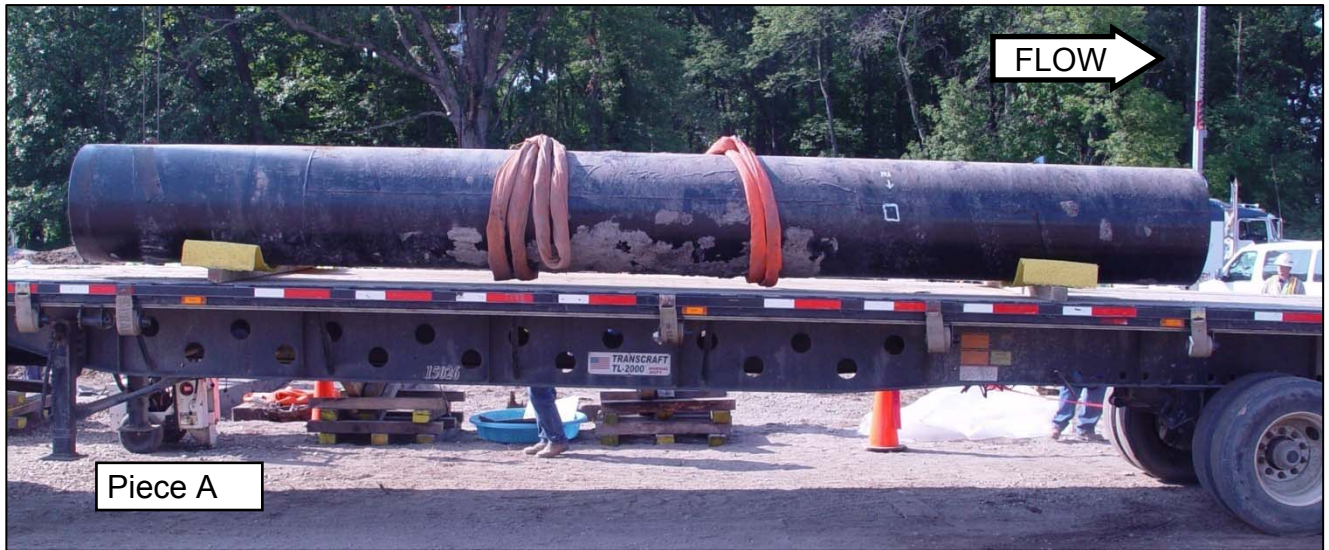
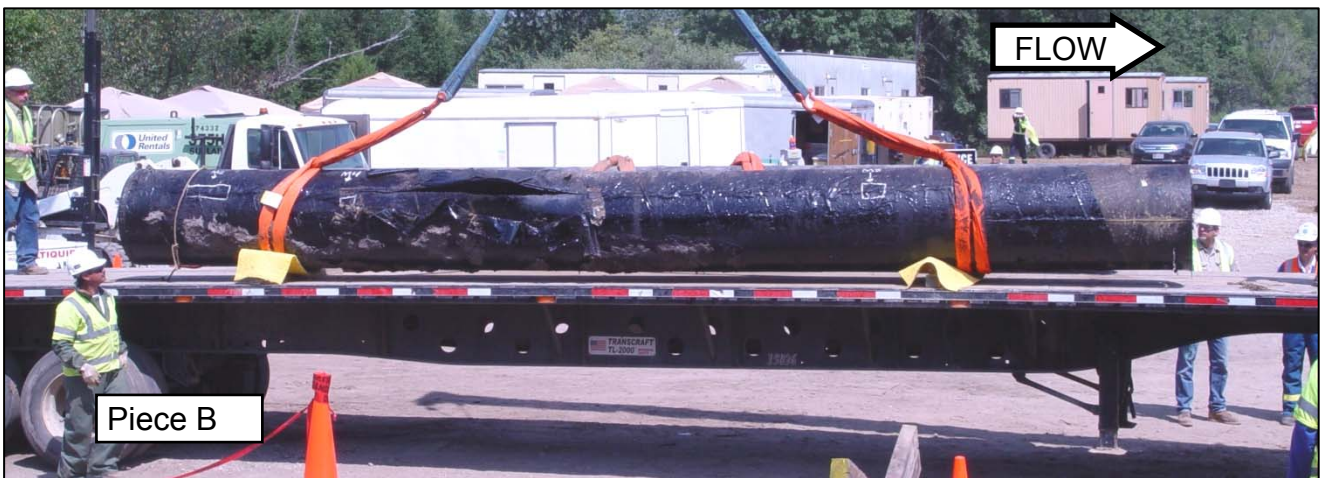
Figure 4. Overall views of Pieces A and B submitted to the NTSB Materials Laboratory as viewed during removal of the pipe pieces on scene.

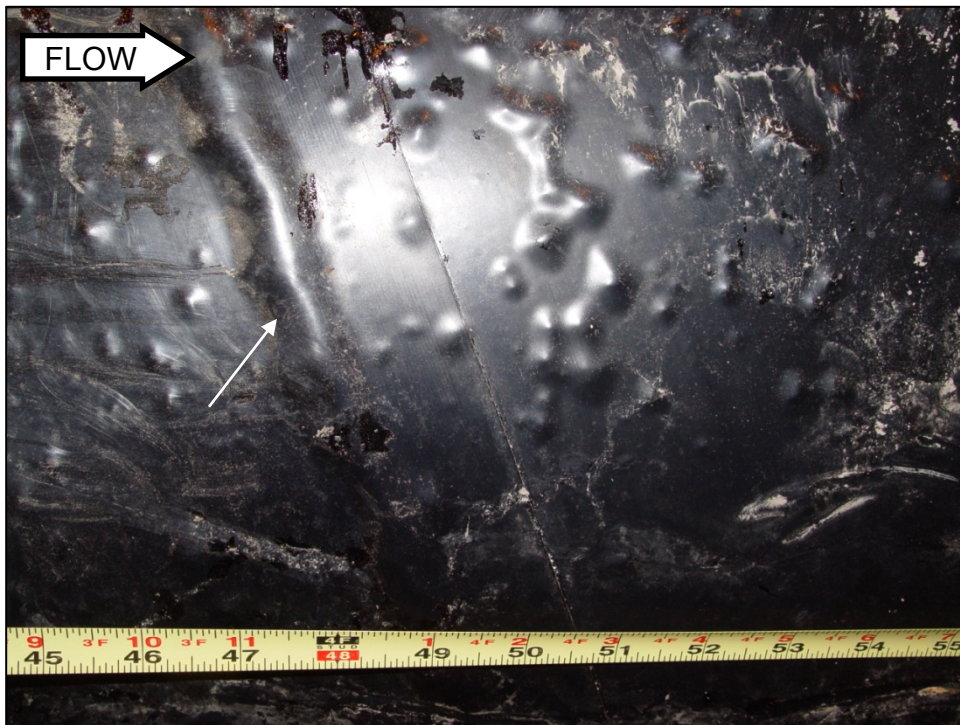
Figure 6. View of piece B showing a wrinkle at the upstream edge of a tape overlap as indicated by an arrow.

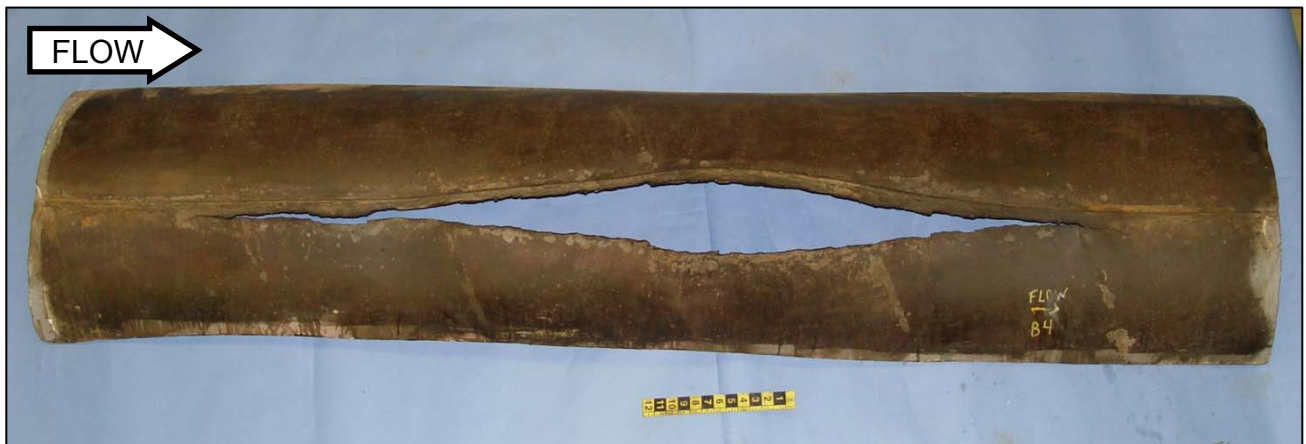
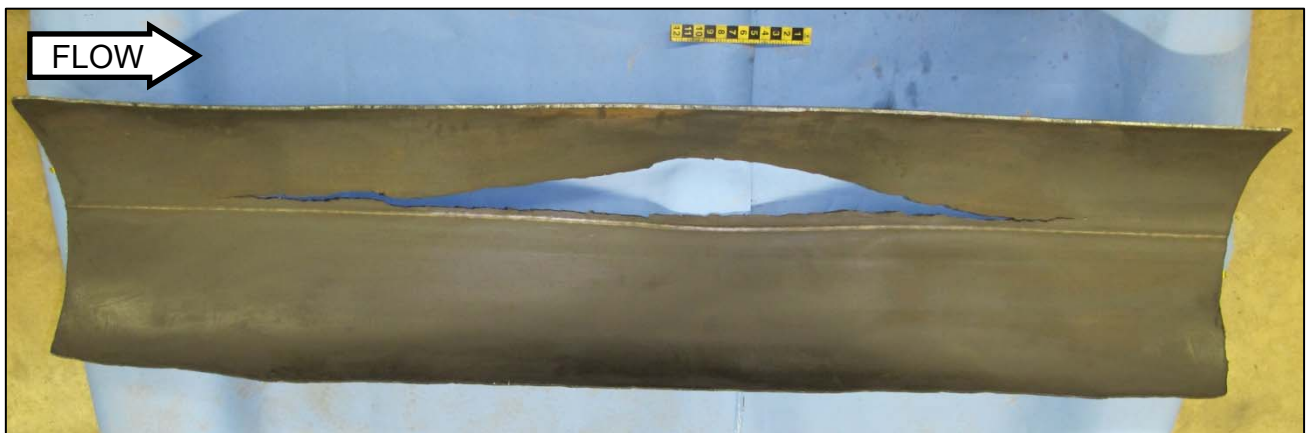
Figure 16. Overall views of the exterior (upper photo) and interior (lower photo) surfaces of piece B4 after coating removal and cleaning.

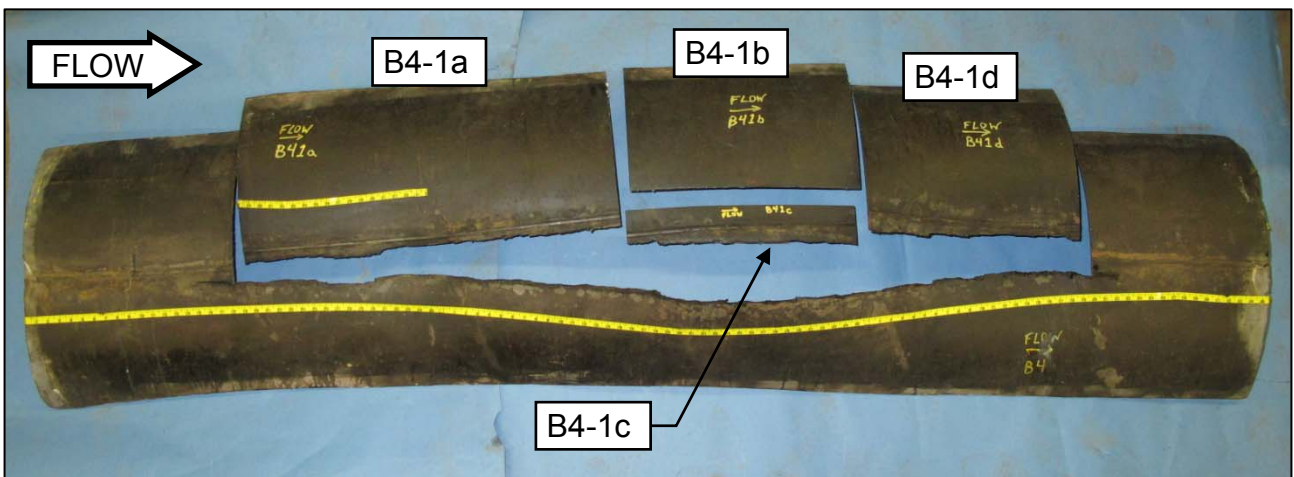
Figure 17. Piece B4 after sectioning for closer examination of the fracture surface on piece B4-1c.

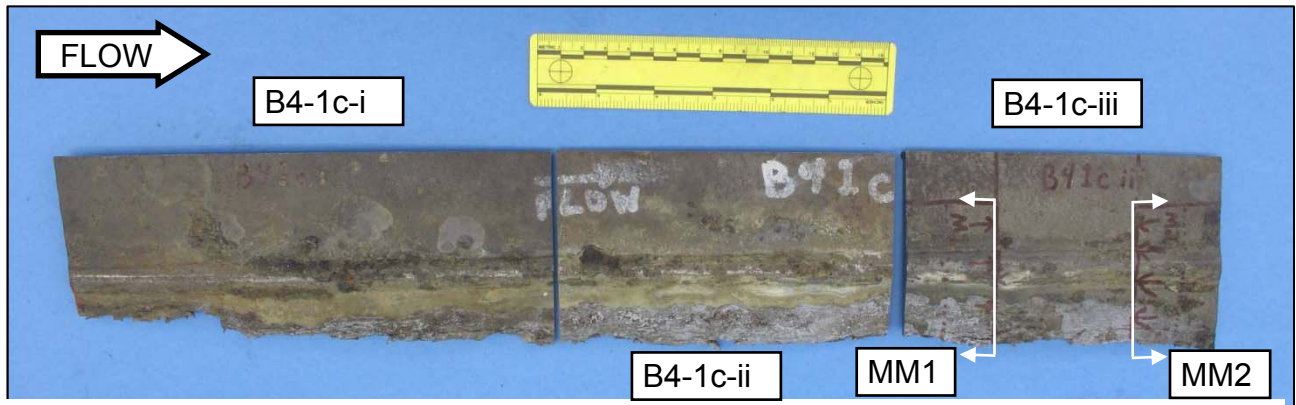
Piece B4-1c was cut circumferentially at two locations using an abrasive cut-off saw to facilitate further cleaning and examination using scanning electron microscopy (SEM). The 3 pieces were labeled B4-1c-i, B4-1c-ii, and B4-1c-iii, as shown in figure 19.

Figure 19. Overall view of the outer surfaces of pieces B4-1c-i, B4-1c-ii, and B4-1c-iii after cutting and cleaning with oxide-removing chemicals. Locations where metallurgical samples MM1 and MM2 were taken are marked on piece B4-1c-iii.

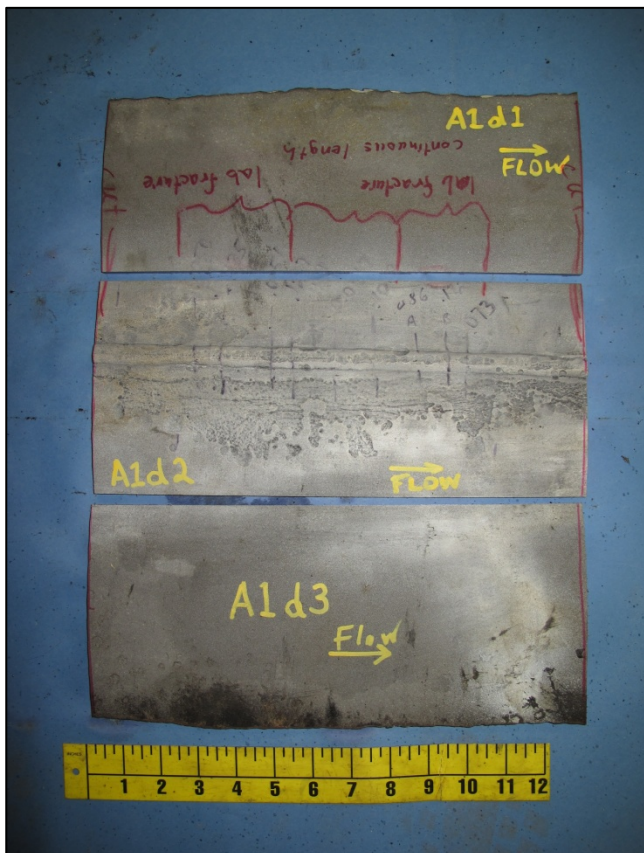
At the location corresponding to the downstream end of the lab fractures from sample A1d2, the 2004 USWM inspection report listed a metal loss feature measuring 11.6 inches long and 0.3 inch wide with a maximum depth of 0.047 inch with the upstream end located 11.73 feet from GWD217720. The local wall thickness at this location was reported as 0.260 inch. A graphical representation of the upstream end of this feature relative to the post-accident measured crack profile is shown in figure 40. An adjacent feature measured 7 inches long and 0.2 inches wide with a maximum depth of 0.047 inch, with an upstream end located 10.22 feet from GWD217720, and with a local wall thickness of 0.268 inch.

Figure 30. View of piece A1d2 cut from piece A1 to conduct lab fractures of crack indications detected by NDI.

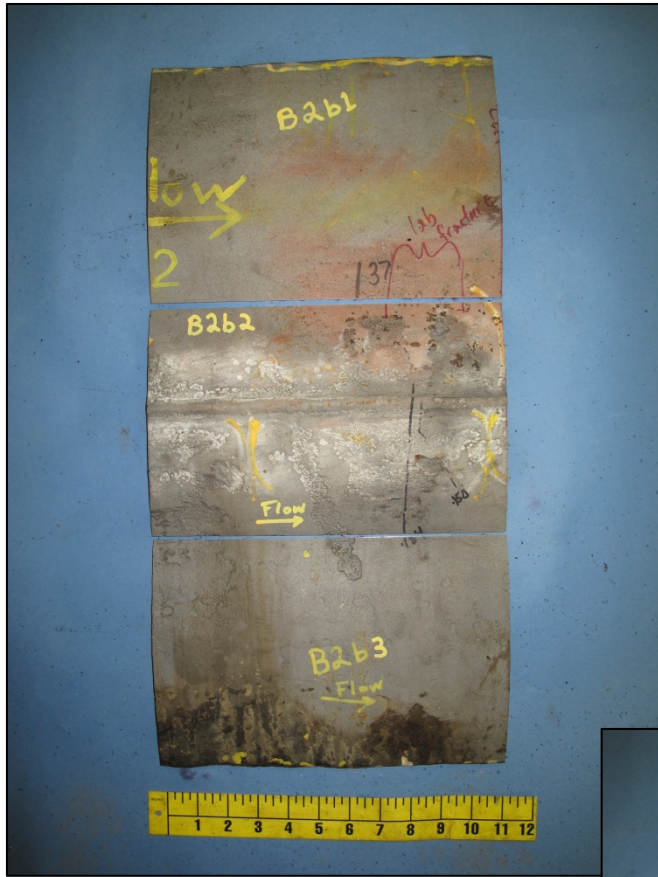
Figure 31. View of piece B2b2 cut from piece B2 to conduct lab fractures of crack indications detected by NDI.

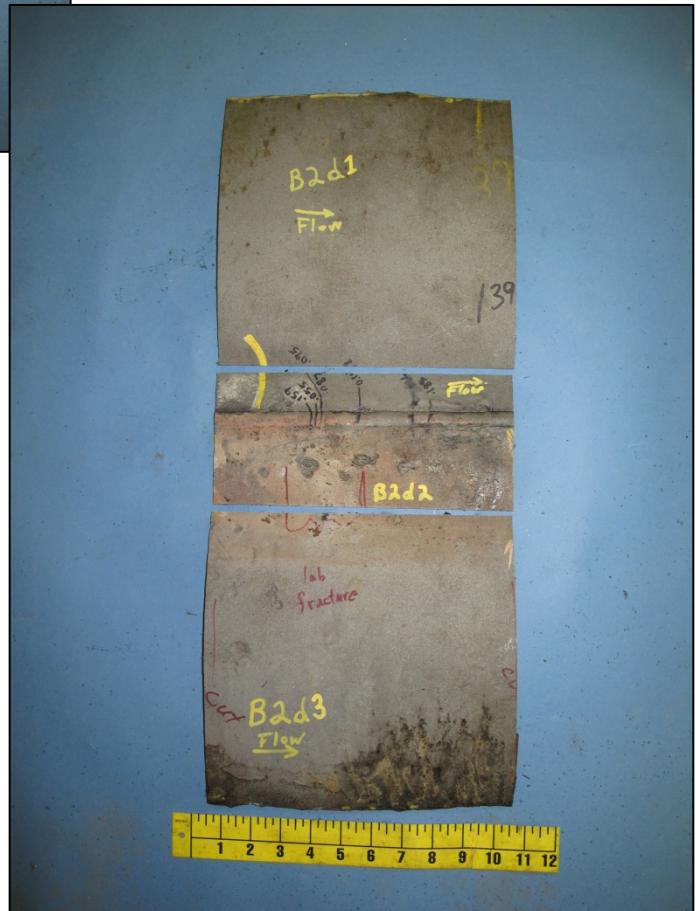
Figure 32. View of piece B2d2 cut from piece B2 to conduct lab fractures of crack indications detected by NDI.

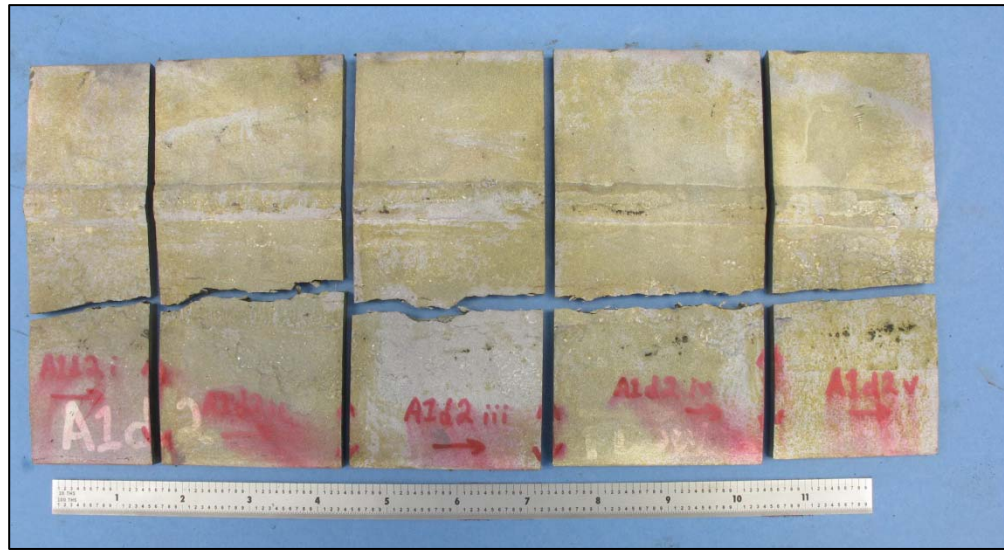
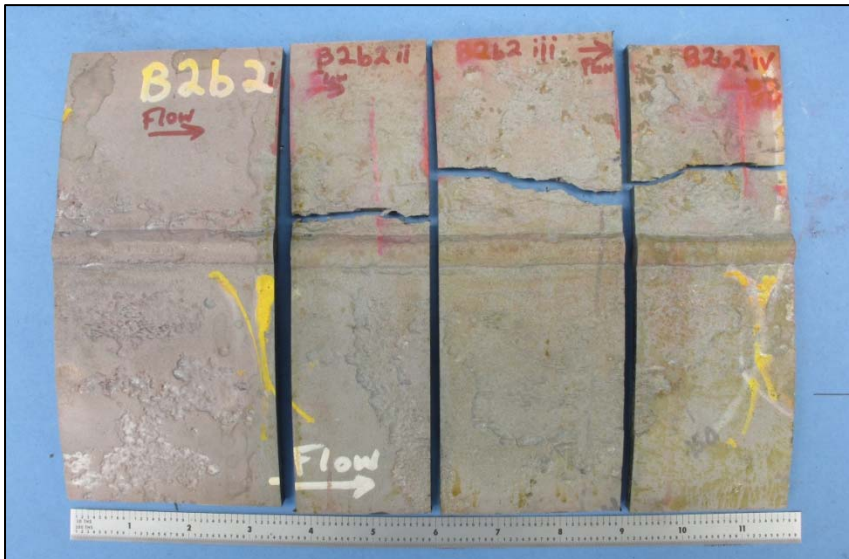
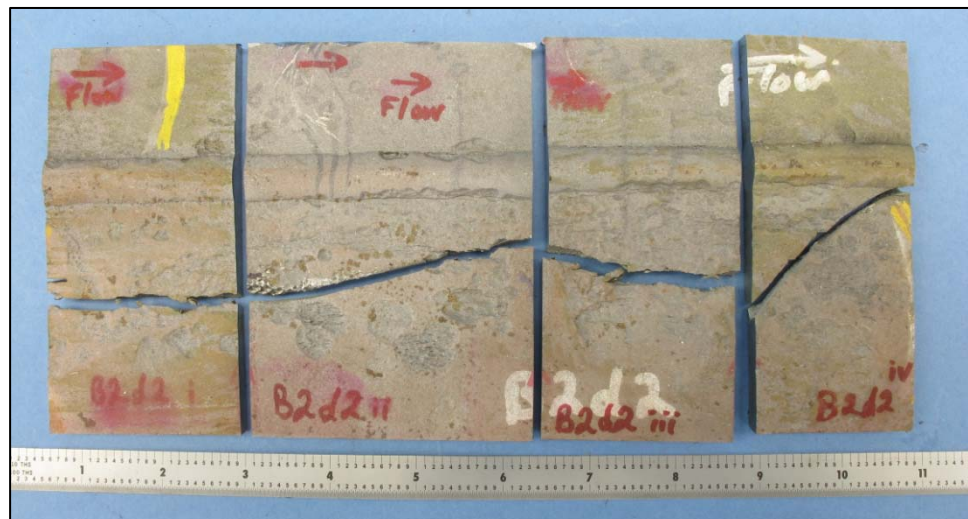
Figure 33. Post-fracture overall views of lab fracture samples.

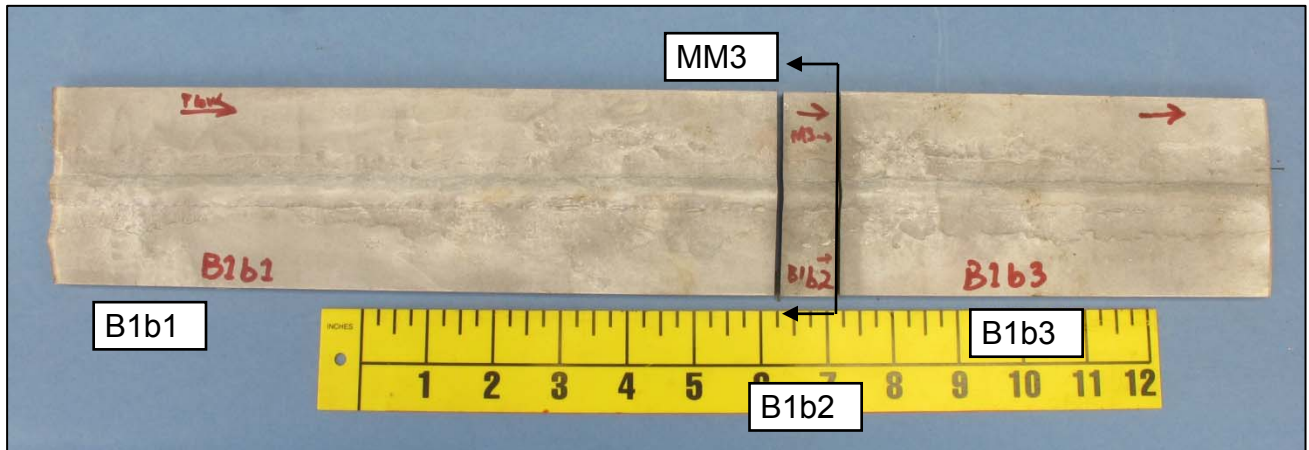
Figure 41. View of sample MM3 prepared from piece B1 for metallographic examination of the crack-like features at the weld toe in the longitudinal seam in joint 217730.

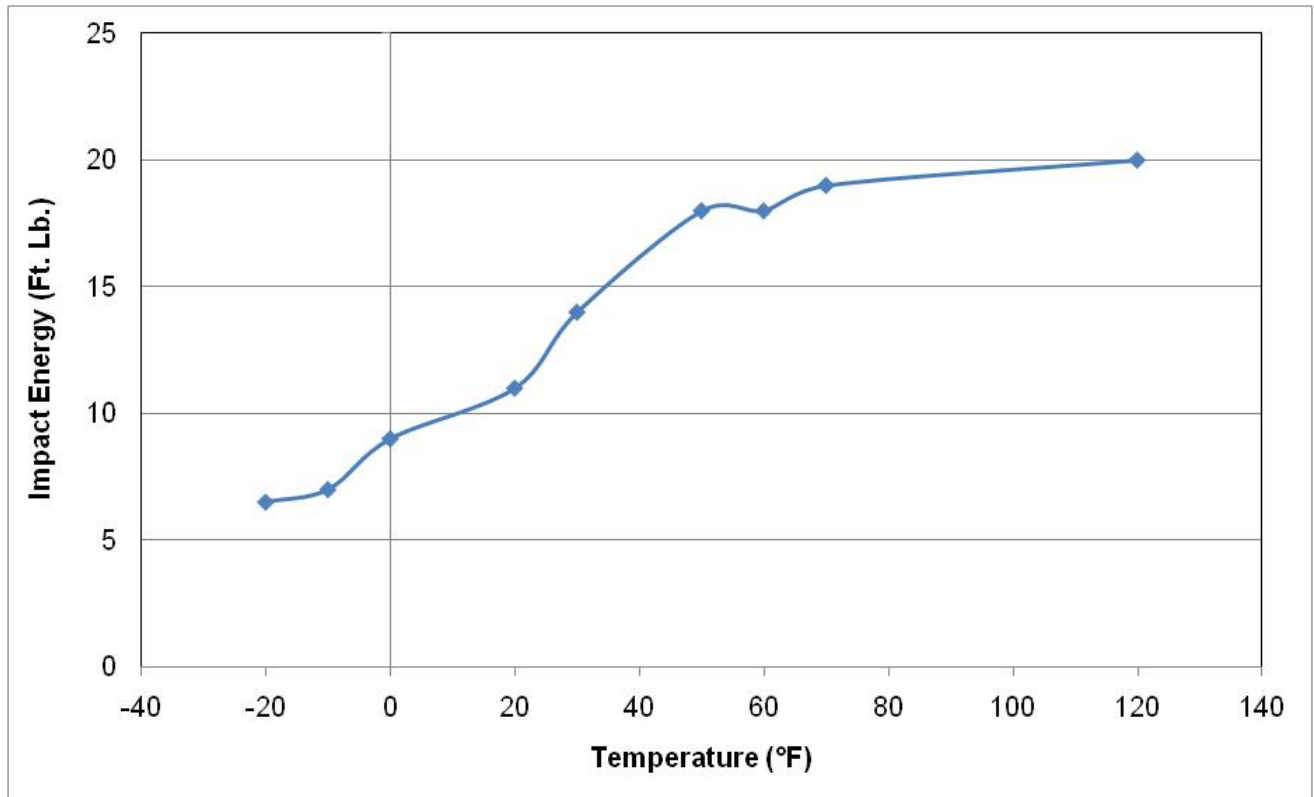
Figure 43. Plot of impact energies of Charpy specimens machined from the pipe wall of joint 217720 and tested at temperatures ranging from -20 °F to 120 °F. Each data point represents the average of two tests.

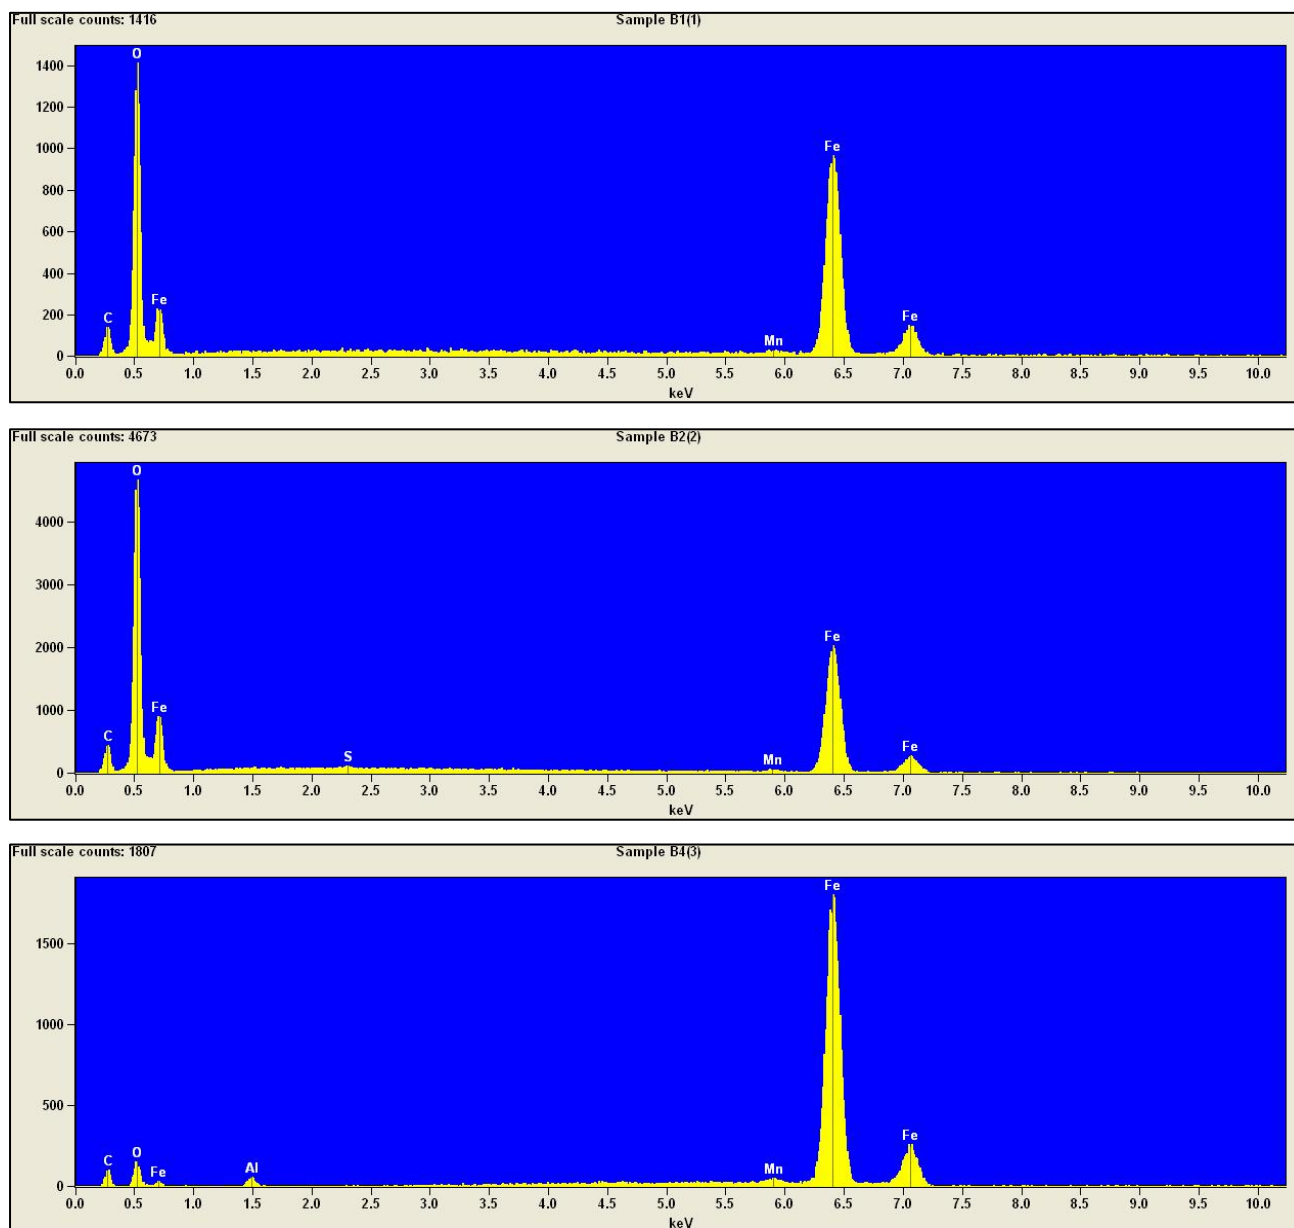
Figure 44. Typical EDS spectra obtained from corrosion samples. The upper spectrum shows results typical for most of the area of each sample. The middle spectrum shows results of an area analyzed on sample B2 showing a small peak of sulfur. The lower spectrum shows results for an area analyzed on sample B4 with a small peak of aluminum.

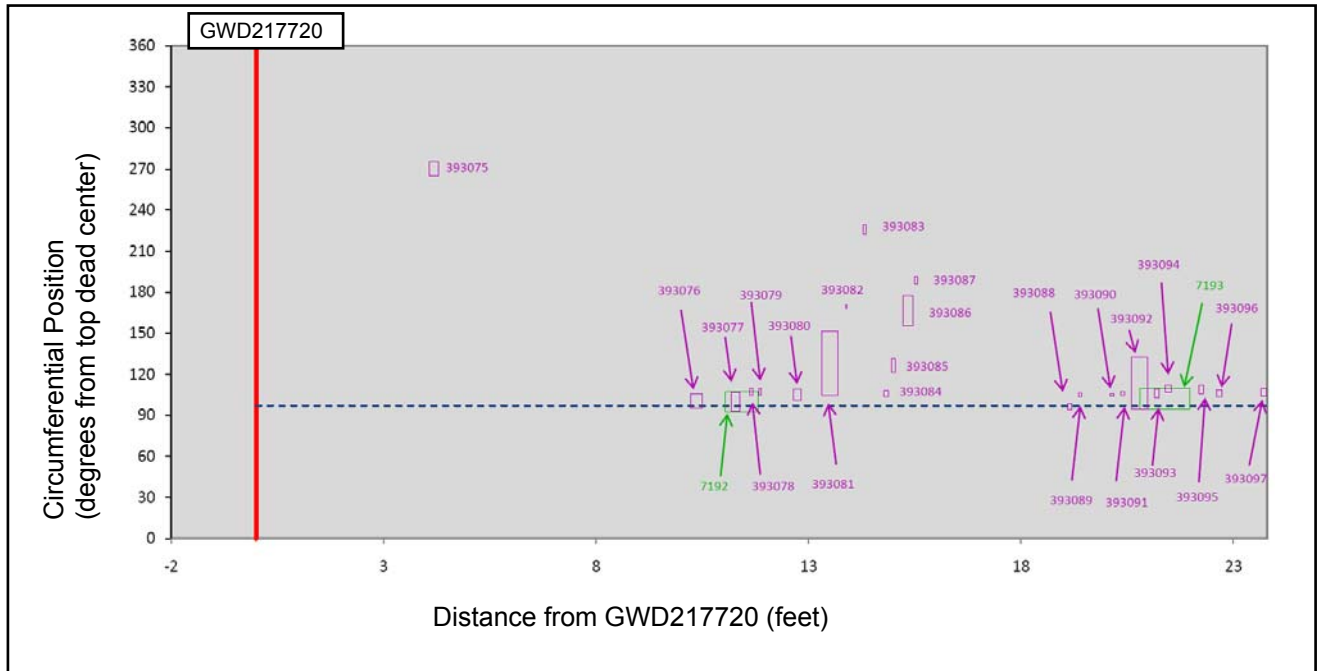
Data from the 2005 USCD ILI tool was first analyzed by PII. Six indications of crack-like features¹⁵ within joint 217720 were reported. The locations and extents of the features are shown in both figure 45 and 46 for reference. The deepest of the six features was located 11 feet 0.5 inch from GWD217720. The feature was 9.3 inches long, and depth was categorized within a range of 25 percent to 40 percent of the wall thickness.¹⁶ Among the remaining crack-like features on joint 217720, two of the features were categorized within a depth range of 12 to 25 percent of the wall thickness. These features were 25.5 inches and 51.6 inches long, located 23 feet 11 inches and 26 feet 8 inches from GWD217720, respectively. The maximum depth and location of the 25.5-inch and 51.6-inch long features relative to the post-accident measured crack profile are shown graphically in figure 27. The remaining three crack-like features had depths that were categorized as less than 12 percent of the wall thickness. These features were 14.1 inches, 40.1 inches, and 27.8 inches long, located 20 feet 10 inches, 31 feet 2 inches, and 36 feet 10 inches from GWD217720, respectively.

Results of the 2007 MFL ILI for joint 217720 are shown in figure 45. The inspection report for the 2007 MFL ILI included calculations of the RPR for each MFL feature shown in figure 45. The remaining strength was calculated using the Modified B31G method. The feature with the lowest RPR in joint 217720 was feature 393122 at 34.14 feet from GWD217720 measuring 6.9 inches long, 5.5 inches wide, and up to 19 percent of the wall thickness deep with an RPR of 1.079. The deepest feature was feature 393131 at 37.03 feet from GWD217720, which had a maximum depth of 30 percent of the wall thickness and was 3.3 inches long and 5.4 inches wide with an RPR of 1.091. Both features were analyzed using the length adaptive pressure method developed by PII,²⁰ and by that method the RPR values were 1.110 and 1.116 for features 393122 and 393131, respectively.

Figure 45. Plot of inspection data for joint 217720 showing locations of crack-like features from the 2005 USCD tool (green boxes) and locations of metal loss from the 2007 MFL tool (pink boxes). Red lines indicate girth weld locations, and a dashed blue line indicates the location of the seam weld.

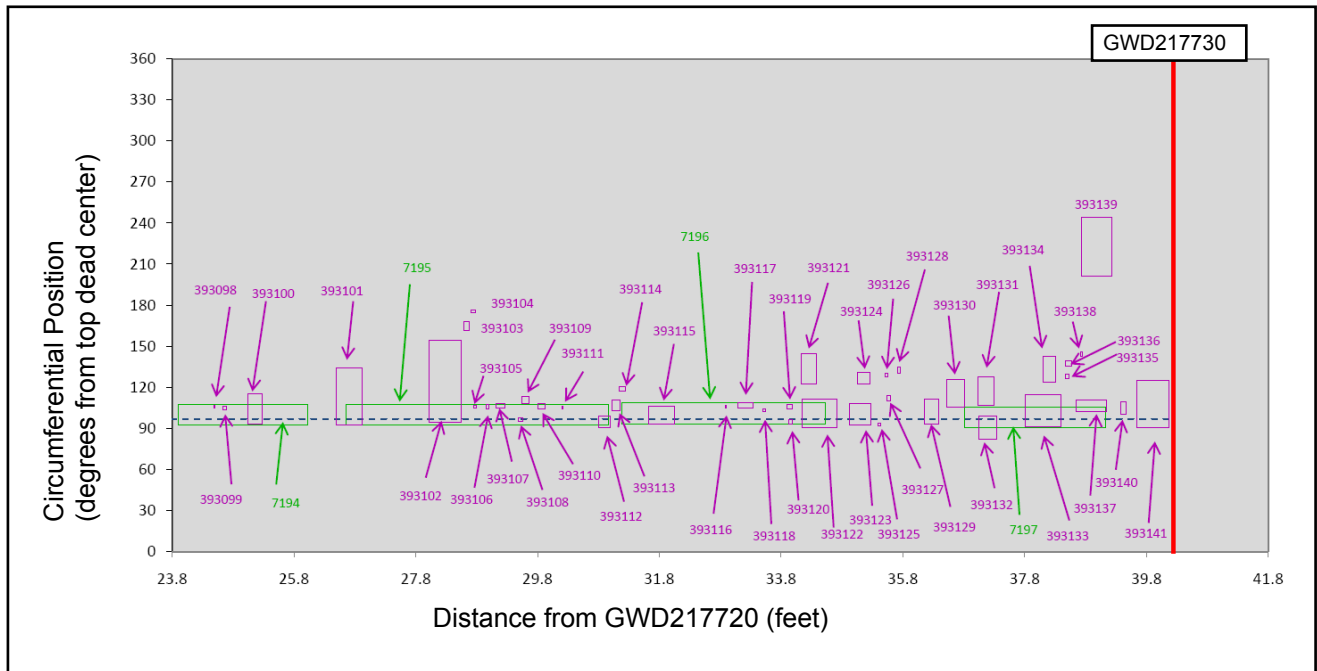
Results of the 2009 USWM inspection of joint 217720 are shown in figure 46. The inspection report for the 2009 USWM ILI included calculations of the RPR for each

USWM feature shown in figure 46. The feature with the lowest RPR in joint 217720 was feature 62278 located 28.2 feet from GWD217720. Feature 62278 measured 68.03 inches long and 17.05 inches wide with a peak depth of 27 percent of the local wall thickness and had an RPR of 0.925. One other feature (number 62279 located 34.24 feet from GWD217720) also had an RPR of less than 1.0 at 0.935. Both features were also analyzed using an effective area method, and in that calculation, the effective area RPR's were 1.056 and 1.049 for features 62278 and 62279, respectively. The deepest feature was feature 62279, located 34.03 feet from GWD217720, with a depth of 30 percent of the local wall thickness.

Figure 46. Plot of inspection data for joint 217720 showing locations of crack-like features from the 2005 USCD tool (green boxes) and locations of metal loss from the 2009 USWM tool (blue boxes). Red lines indicate girth weld locations, and a dashed blue line indicates the location of the seam weld.
