# NATIONAL TRANSPORTATION SAFETY BOARD

MATERIALS LABORATORY FACTUAL REPORT

Report No. 13-037

Place : Paulsboro, New Jersey  
Date : November 30, 2012  
Vehicle : Freight Train FC4230  
Operator ; Consolidated Rail Corp. (Conrail)  
NTSB No. : DCA13MR002  
Investigator : Cy Gura, RPH

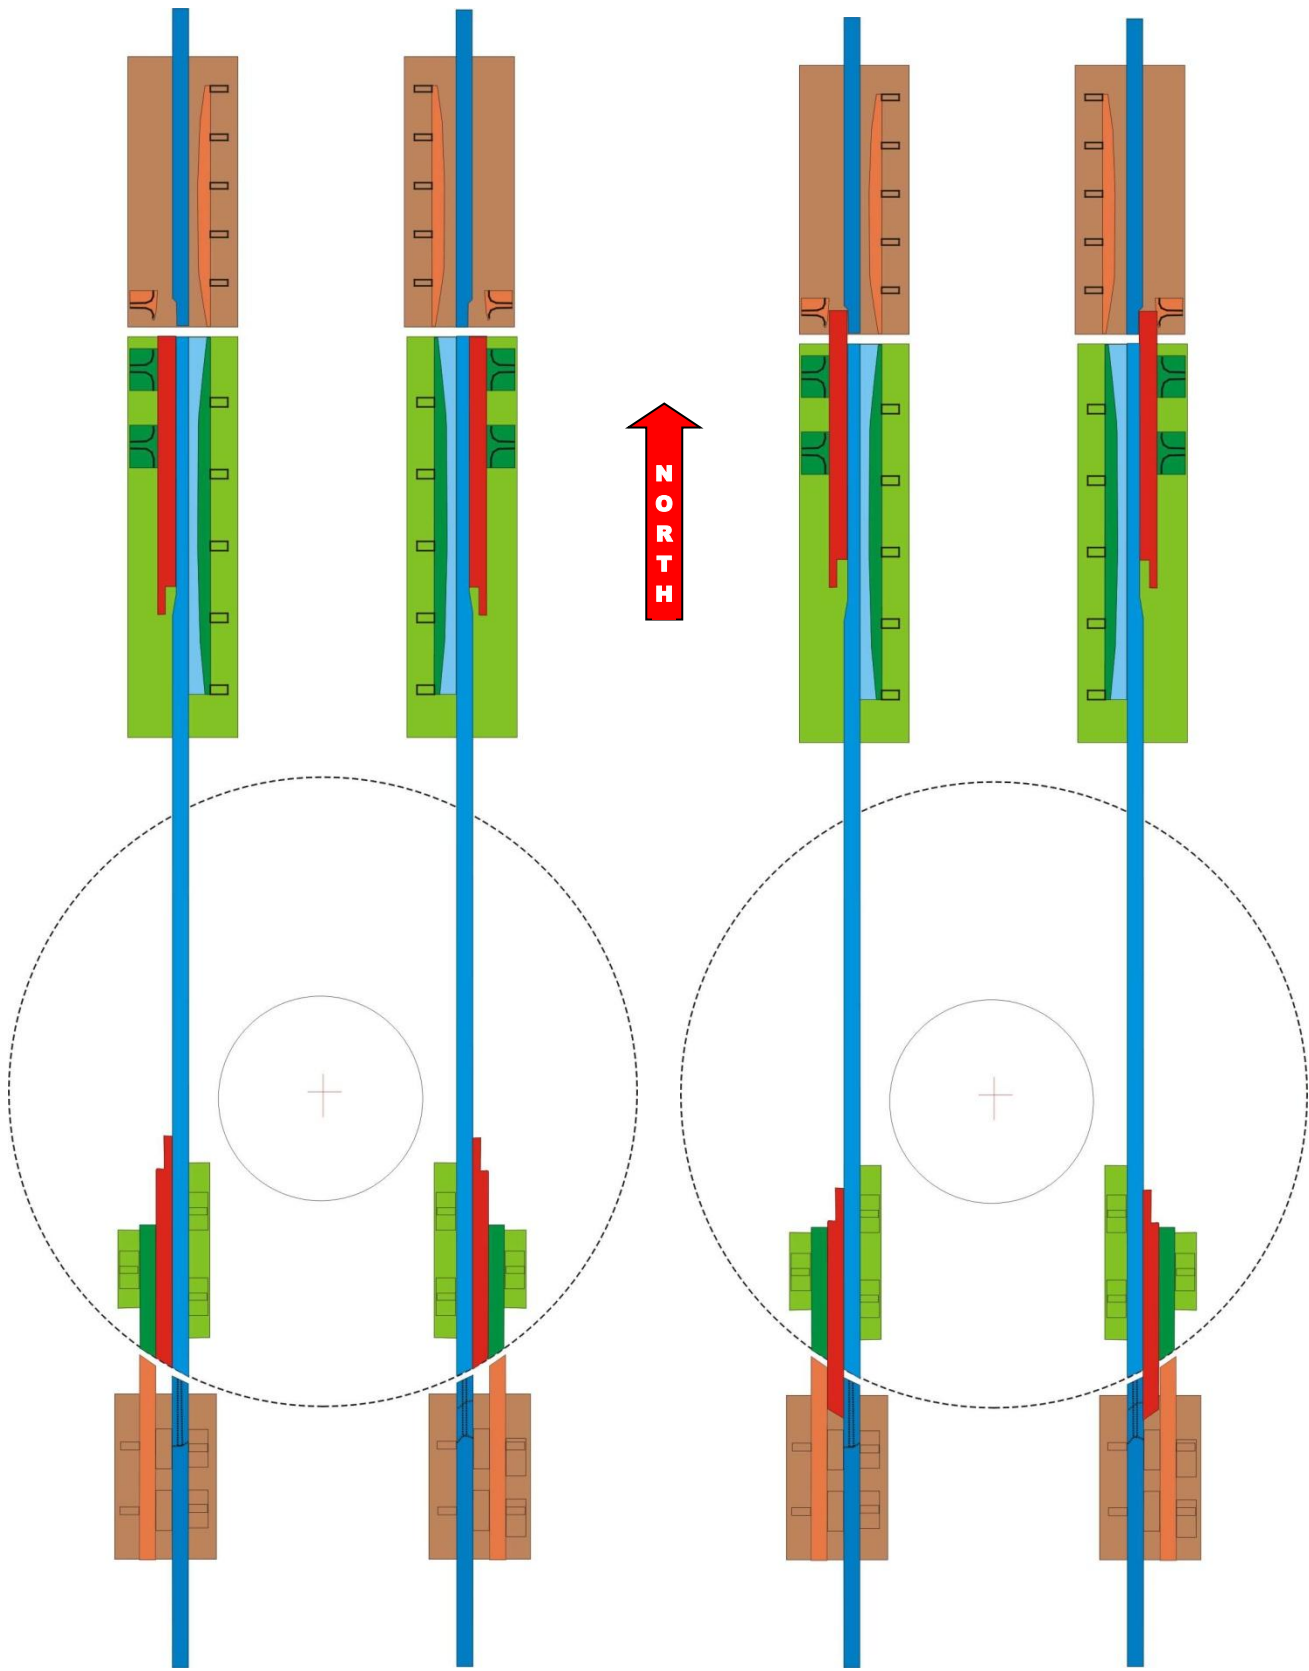
The north and south ends of the bridge contained independent locking mechanisms. Though of different mechanical component details, they operated on the same principle. With the bridge structure in the closed position (closed to marine traffic open to rail traffic), sliding blocks on the swing span were actuated through deck side operating rods by under deck mechanisms. The sliding blocks extend outward from the swing span and engaged slots on the land side fixed structures. Both the north and south ends had mirrored locking components associated with each of the running rails (east and west). According to Conrail representatives, with the bridge closed the gap between running rails at the bridge to land interface was specified as 2  $\frac{3}{4}$  inches. Figure 2 contains an illustration of the bridge showing the locking mechanisms in both the unlocked (left) and locked (right) positions. Note the positions of the red sliding blocks in each illustration.

Figure 2. Illustrations of the bridge locking mechanisms at the north and south ends. Not to scale. Left illustration shows the sliding blocks (red) in the unlocked (retracted) position. The right illustration shows the blocks in the locked (extended) position.
