# NATIONAL TRANSPORTATION SAFETY BOARD

MATERIALS LABORATORY FACTUAL REPORT

Report No. 03-078

Place : Miami, Florida  
Date : May 25, 2003  
Vehicle : Cruise ship S/S Norway  
NTSB No. : DCA03MM032  
Investigator : Robert Ford

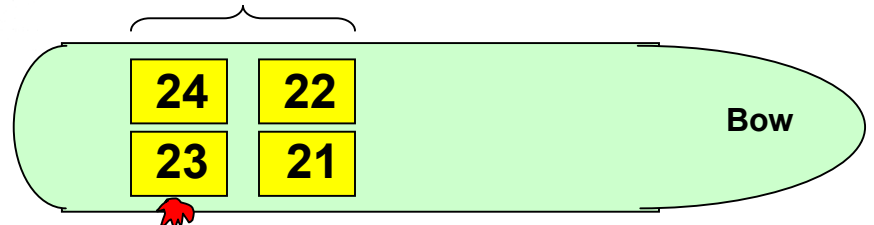
Failure in Header of Boiler #23

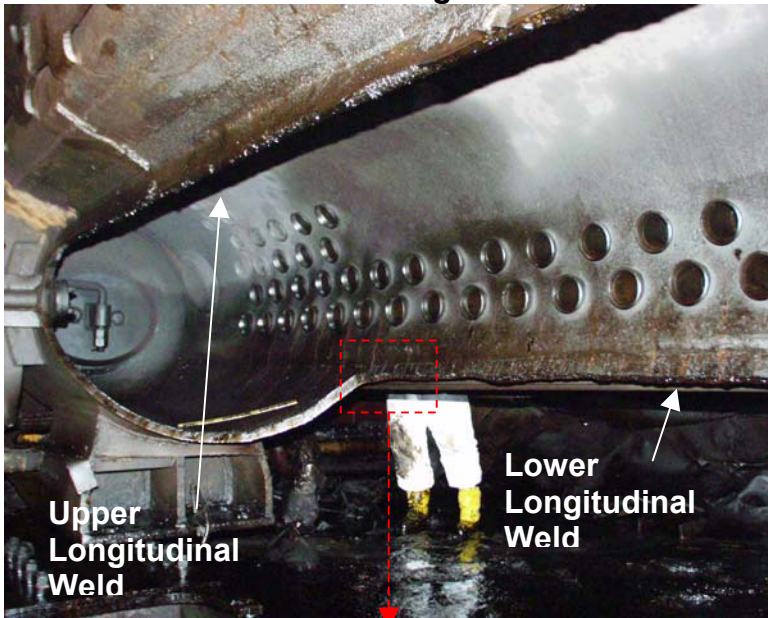
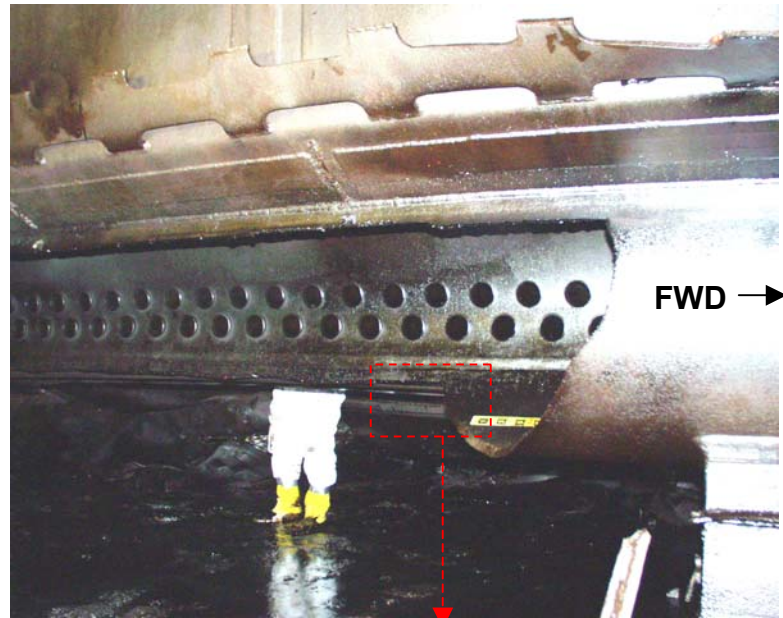
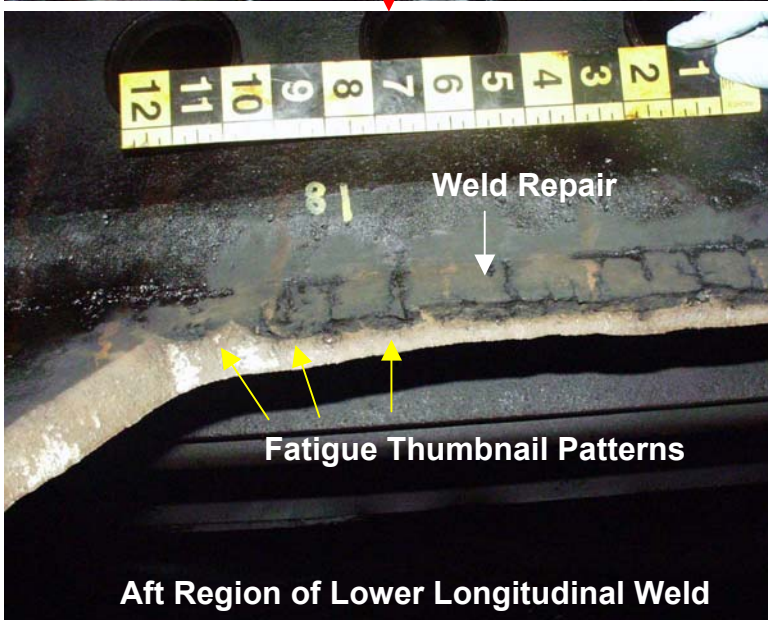
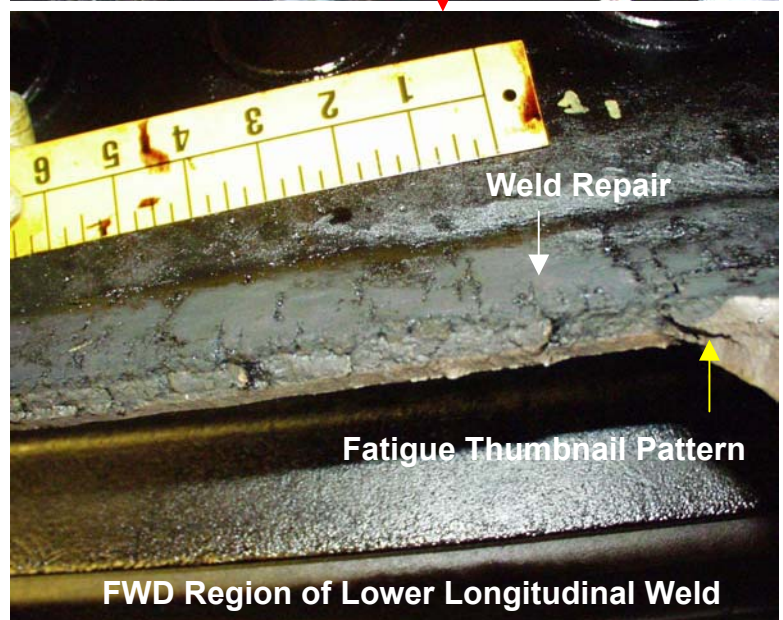
**Figure 3:** Additional optical views of the lower longitudinal weld in the fractured region (middle and top left image) and in an intact region near the forward manhole (top right image). The lower images show portions of the fracture at the upper longitudinal weld.

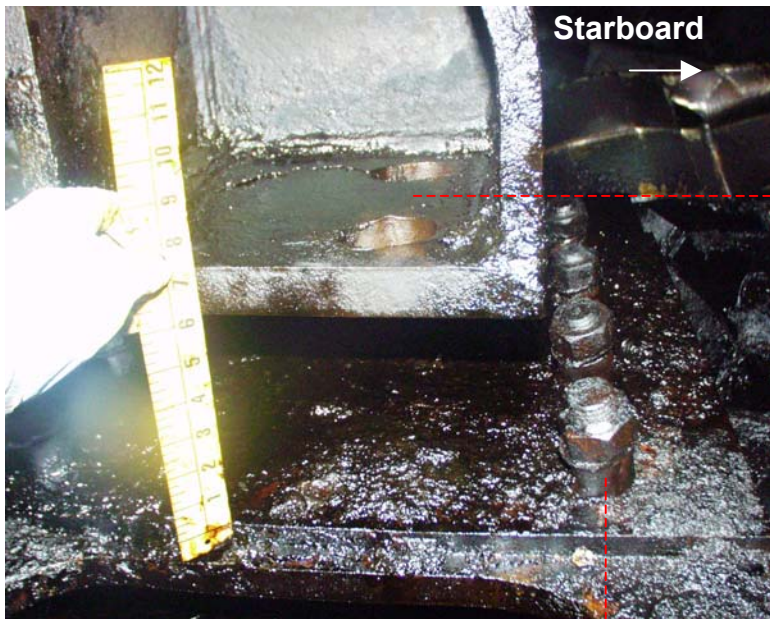
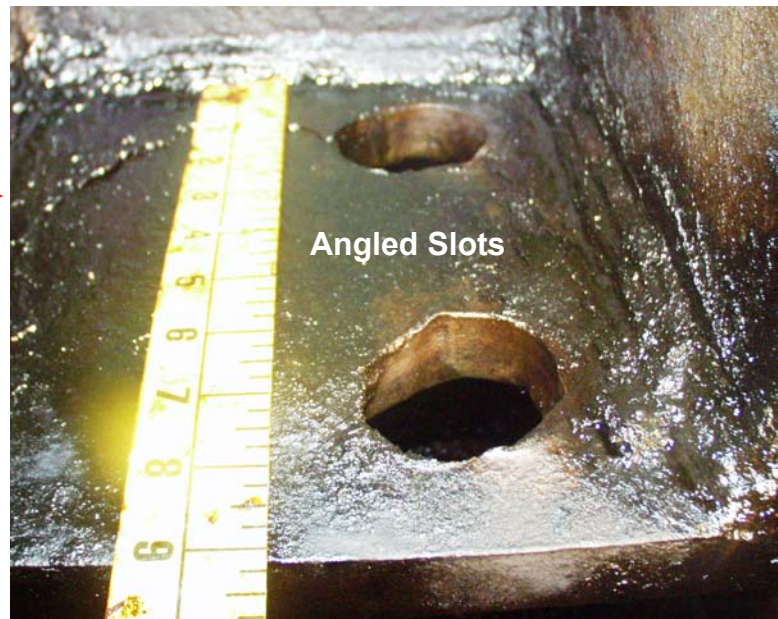
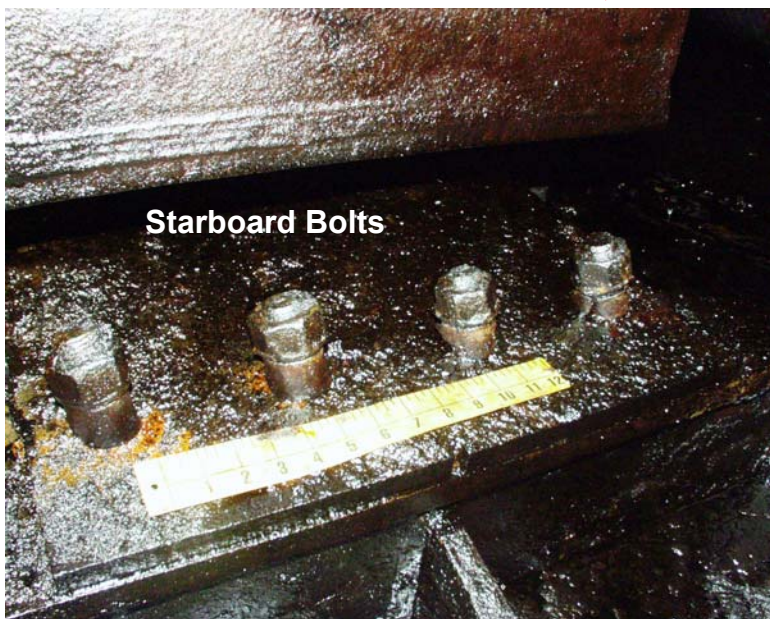
**FORWARD FOOT**

**Figure 6:** Views of the forward support foot slots (top two images) and starboard bolts (lower image) for header 23.

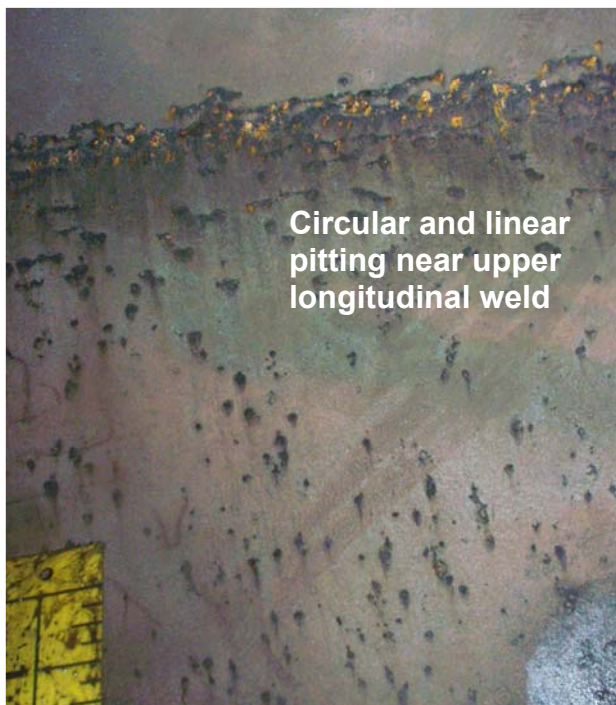
**Longitudinal and transverse cracking in 1.5" wide repair weld**

**Circular and linear pitting near upper longitudinal weld**

**12 inch repair weld in-line with tubes 5 & 7 from aft end on lower longitudinal weld**

**Figure 7:** Views of selected areas of the interior of header 22.

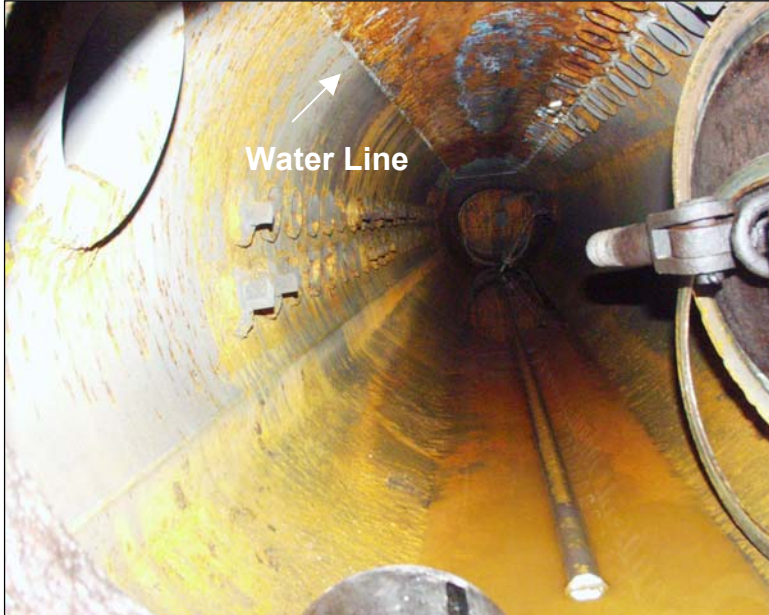
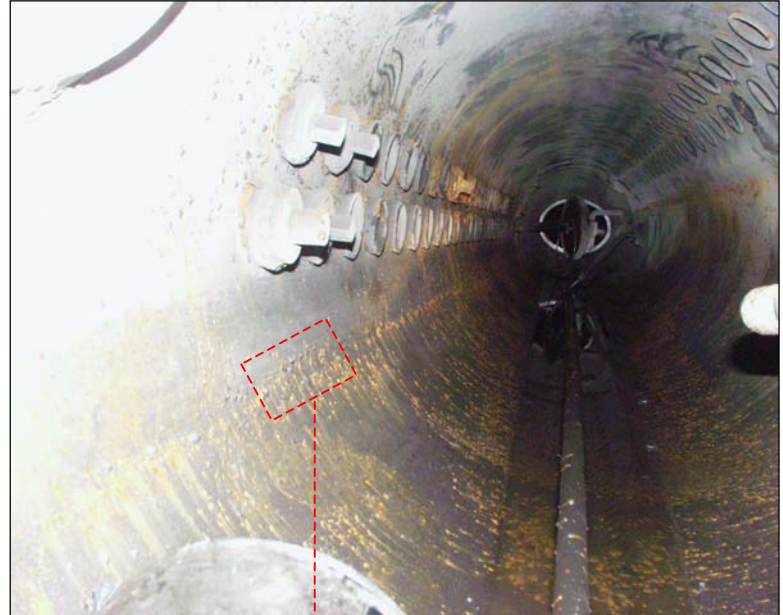
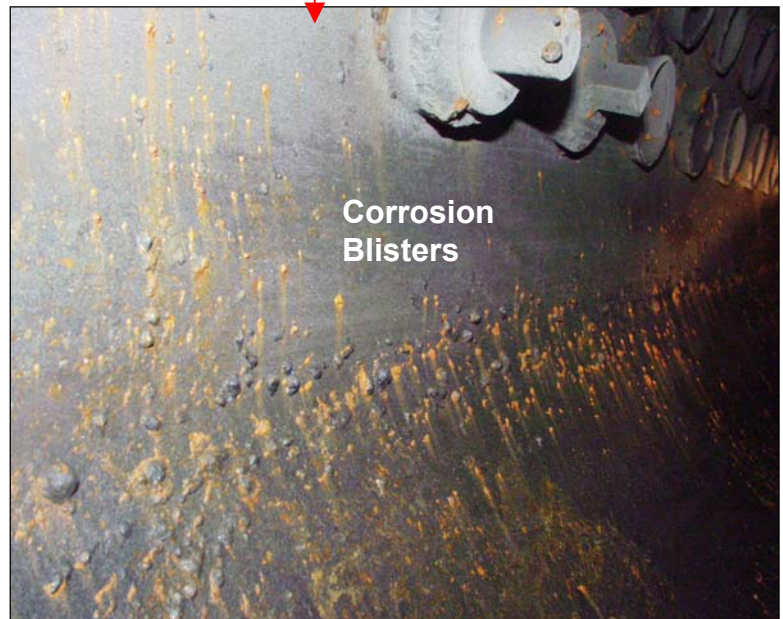
**Figure 8:** Views of selected areas of the interior of headers 21 and 24.

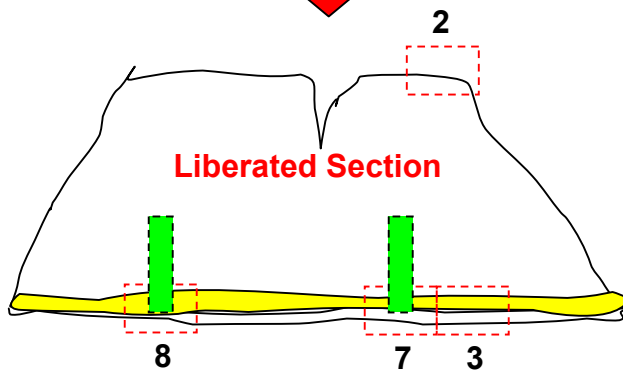
Header sections from boiler 23 from the cruise ship S/S Norway operated by Norwegian Cruise Lines (NCL). The sections examined were as follows (see Figure 9):

on the ID surface. No evidence of copper nuggets was found visually. The ID surface of these samples contained many transverse cracks in the wrapper sheet in a region removed from the repair weld. However, the samples were bent toward the OD surface, where the large vertical welds from the outer housing supports were located (green boxes shown in Figure 9).

**Figure 9:** The upper image is a schematic of the fractured header from boiler 23. The numbered regions identify the sections removed from the header for analysis, which can be seen in the lower image.

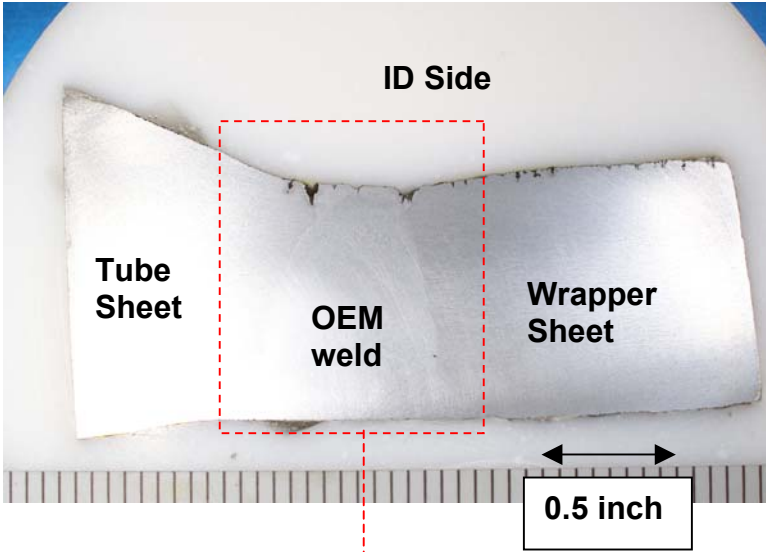
**SECTION 4**

**Figure 11:** Views of the cross-section of Section 4 in the original weld area.

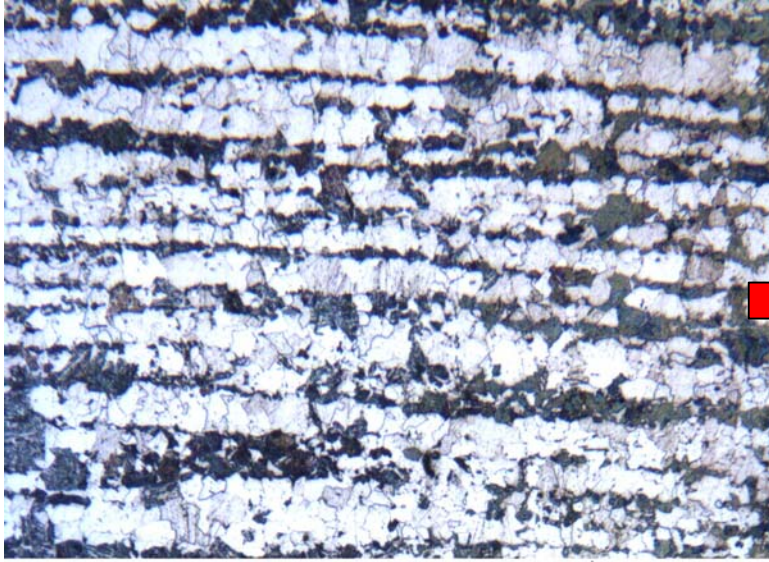
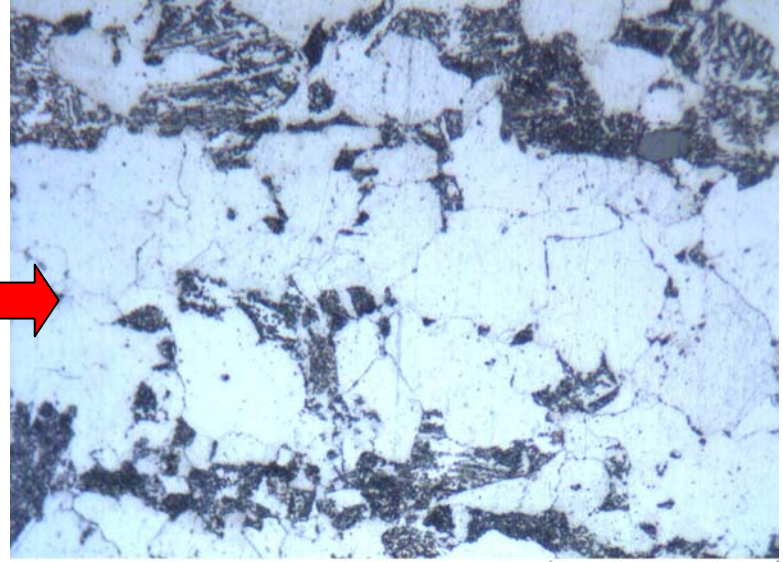
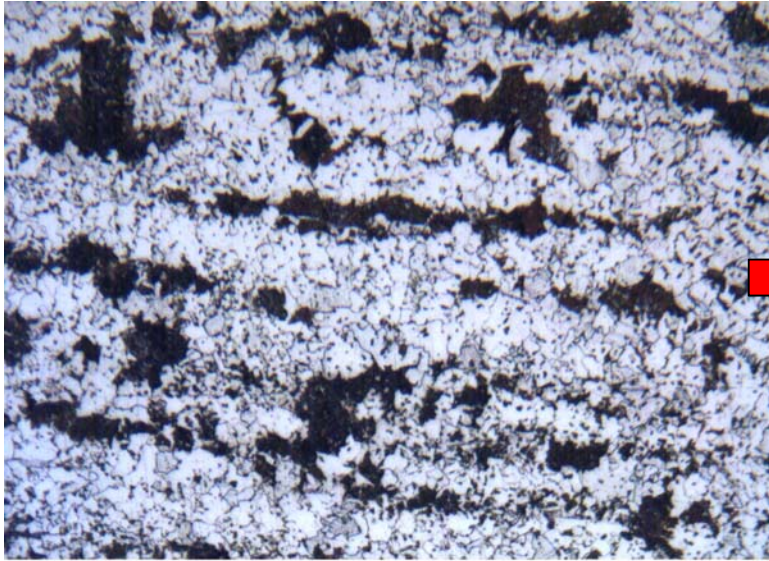
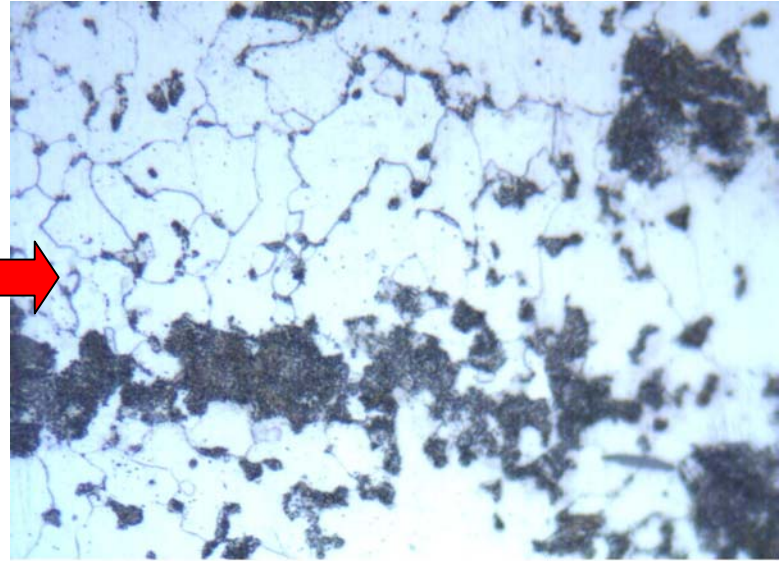
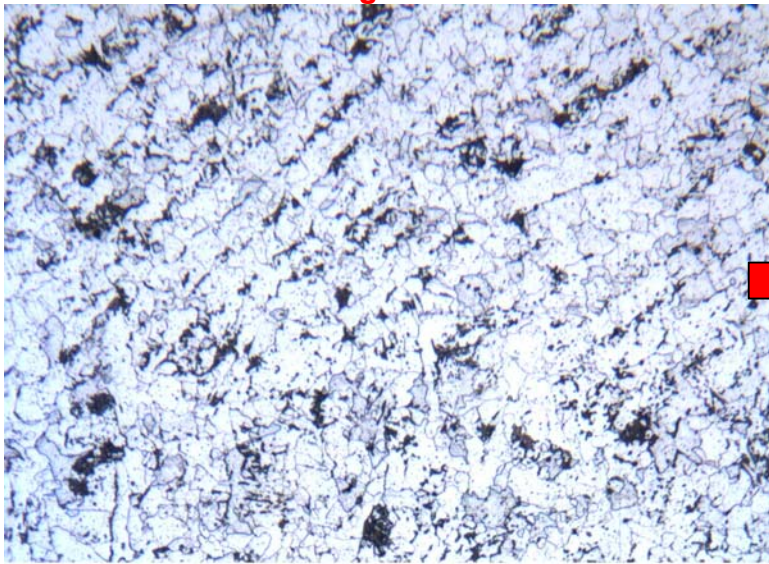
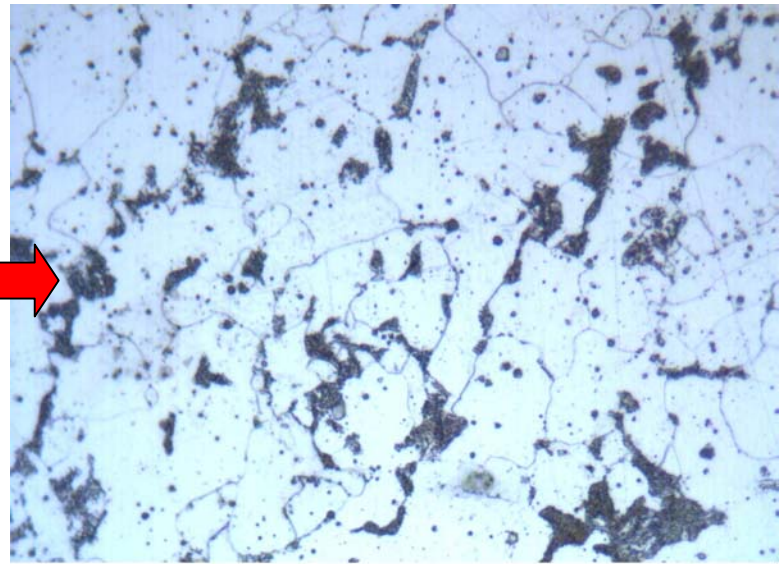
Baseline micrographs of the tube sheet, wrapper sheet, and original weld can be seen in Figure 14 at varying magnifications. Both sheets show a banded structure consisting of ferrite layers (white regions) and pearlite layers (a mixture of ferrite and lamellar cementite which appears dark). The original weld appeared to have a lower volume fraction of pearlite compared to either sheet. Additional micrographs of the OEM weld HAZ, repair weld, and associated HAZ can be seen in the images in Figure 15. The original weld did not appear to show a HAZ at the interface with the wrapper sheet (top right image in Figure 15), whereas a HAZ approximately 0.010 inch thick is present at the weld interface with the tube sheet (top left image in Figure 15). The HAZ from the repair weld was approximately 0.050 inch thick (lower right image in Figure 13). The repair weld itself showed a columnar microstructure with a Widmanstätten morphology indicative of rapid cooling.

**Figure 14:** Microstructures at varying magnifications of the wrapper sheet, tube sheet, and original weld.

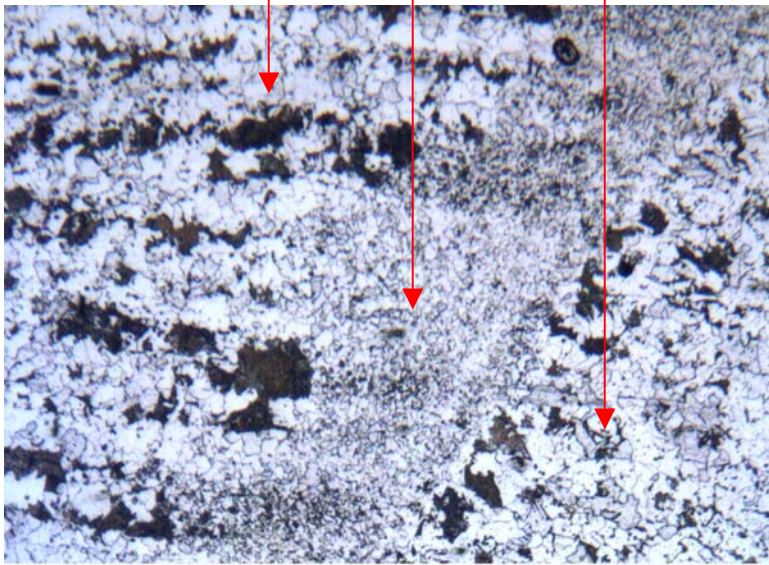
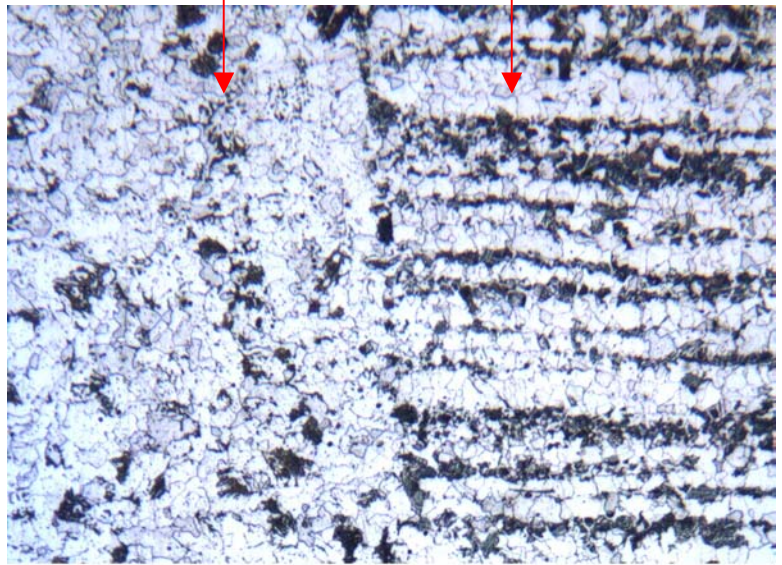
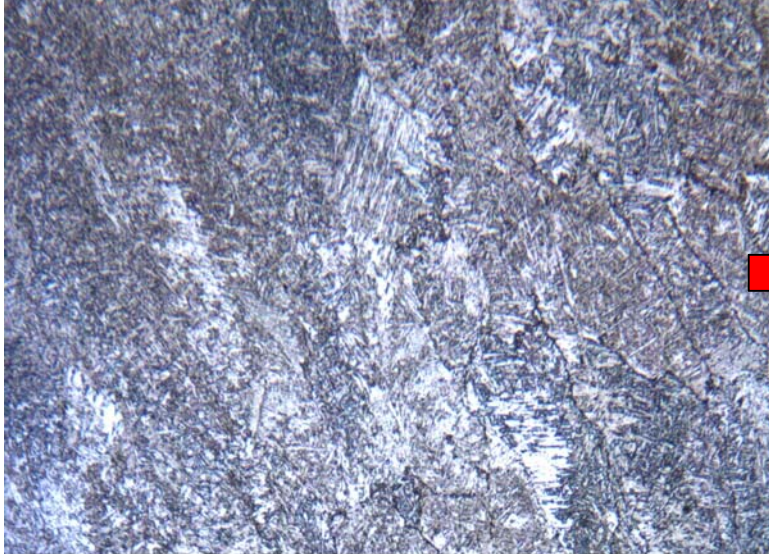
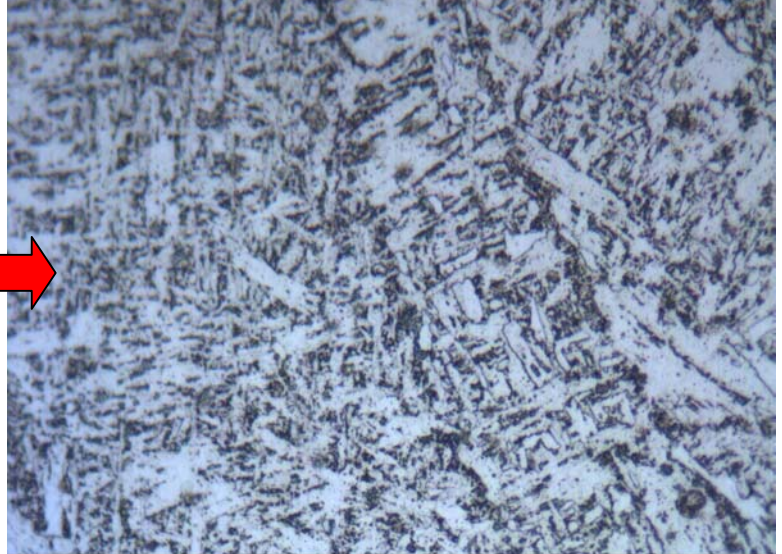
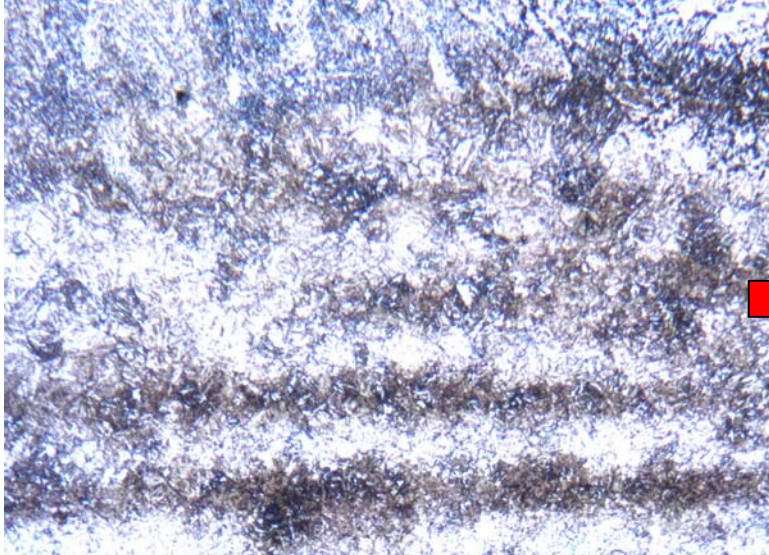
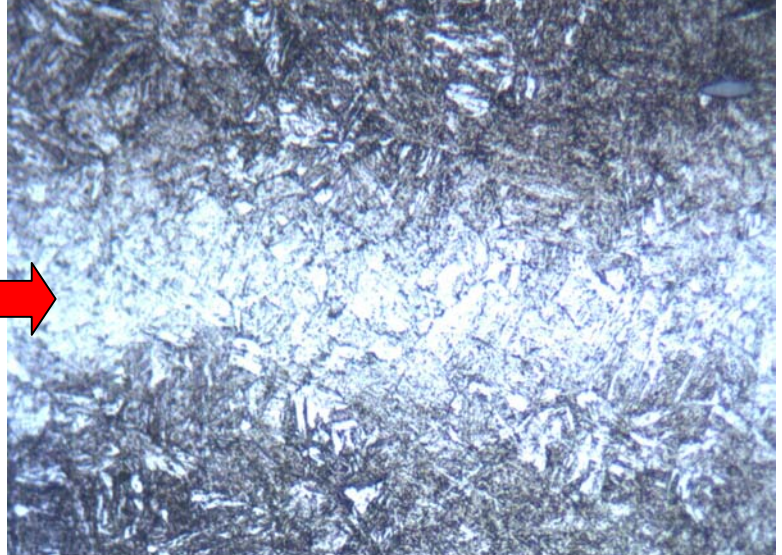
**Figure 15:** Microstructures of the original weld HAZ, the repair weld, and the repair weld HAZ.

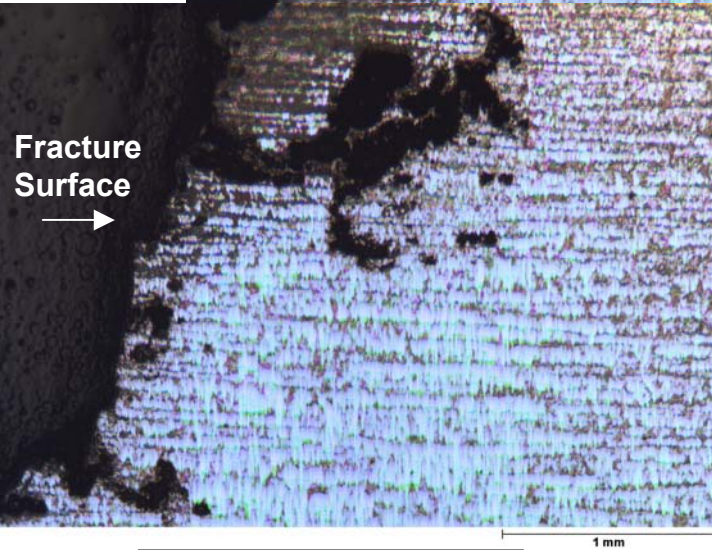
**AREA 6- Section 2**

**Figure 17:** Micrograph showing the edge of the repair weld at the fracture surface location and the ID surface of the wrapper sheet (left image). The lower right image shows the pitting/cracking in the repair weld itself.

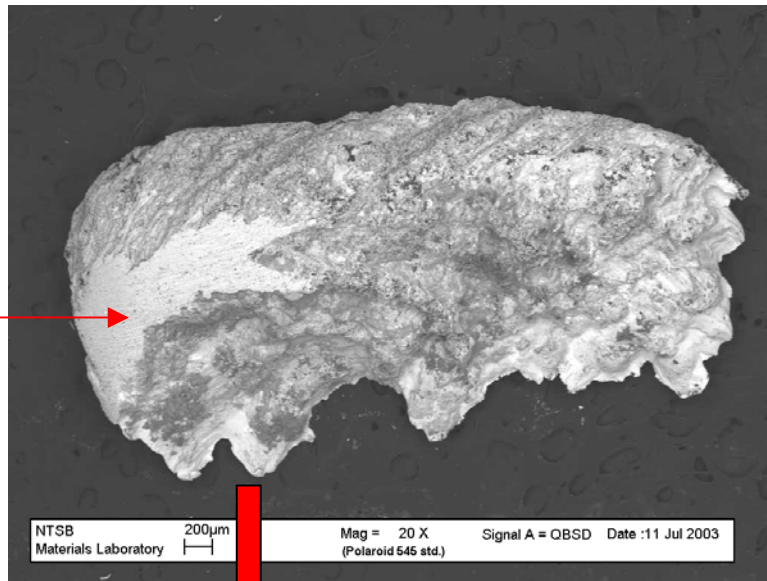
**Area 1- Piece A on Section 2**

The yellow arrows in Figure 12 indicated the copper colored nuggets were found on the fracture surface of Section 2. A small section of the nugget, identified as Piece A in Figure 12, was removed from the fracture by light hand forces, ground slightly in one area and examined in the SEM as shown in the top image in Figure 18. The piece was rounded on the interior side of the crack (side visible in Figure 18). The side exposed to the ID surface was flat. Energy dispersive spectroscopy (EDS) identified the material as being almost pure copper with the addition of small amounts of iron, silicon, and calcium, likely from debris on the surface of the nugget (EDS 1- Figure 19).

material (lower image in Figure 18). X-ray fluorescence spectroscopy (XRF) compositional analysis<sup>c</sup> confirmed that it was almost pure copper (XRF1- Figure 19).

**Figure 18:** SEM view of the underside of copper nugget Piece A that was flaked off from Section 2 (upper image). The lower image is a lay-down etched micrograph of the nugget microstructure.

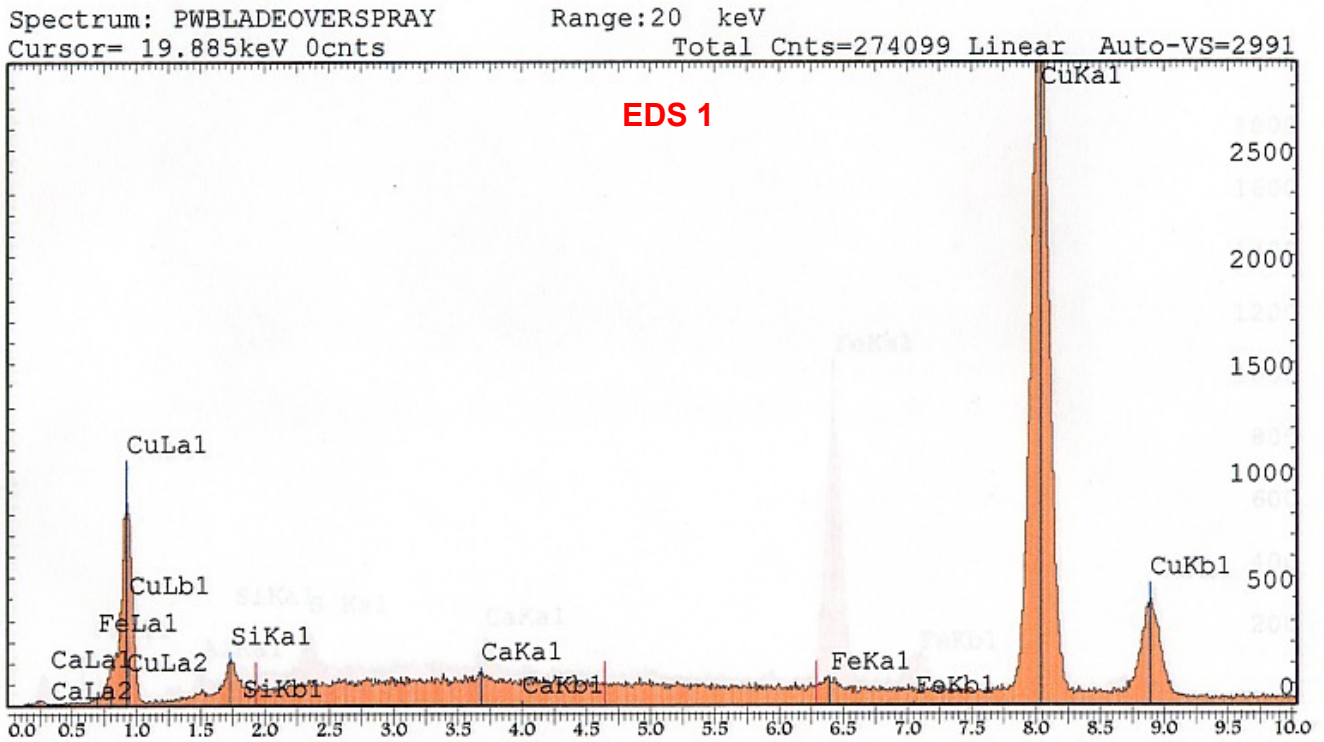
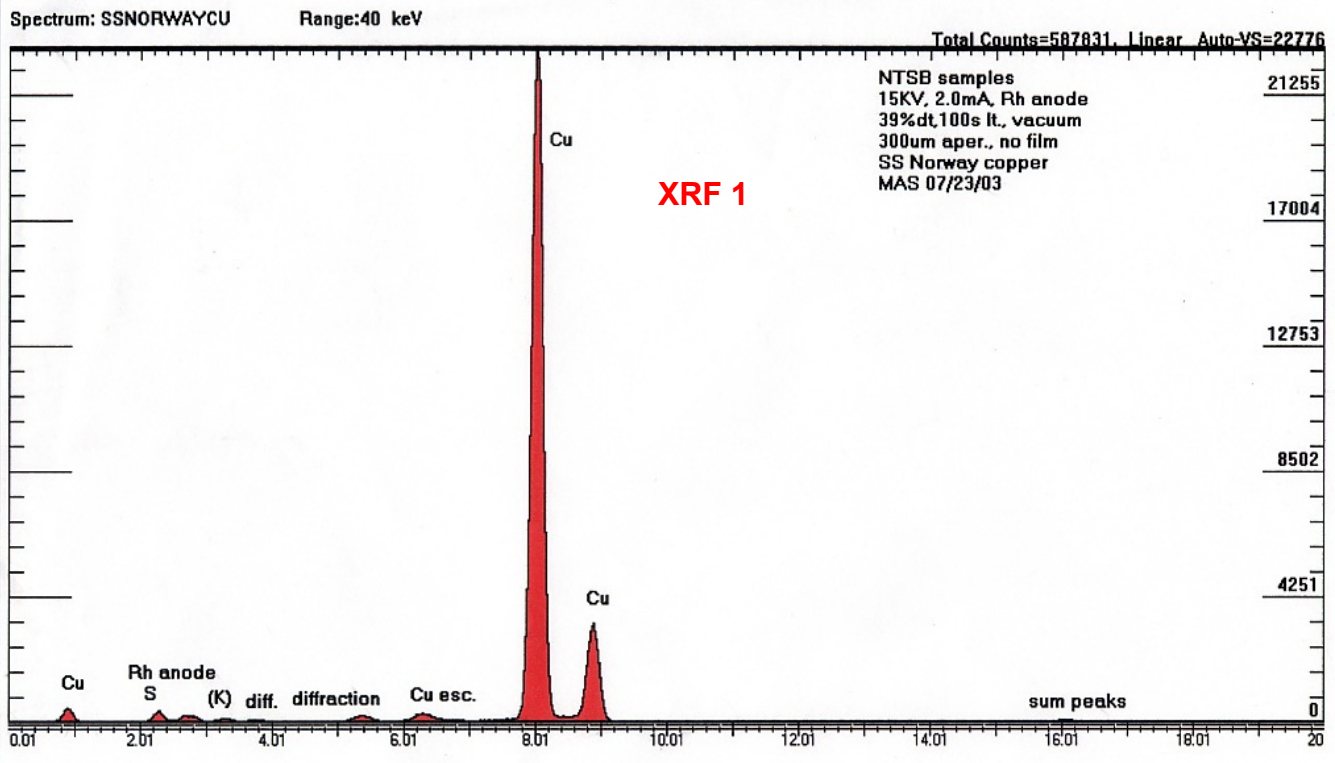
Figure 19: EDS (top) and XRF (bottom) spectra of the copper nugget shown in Figure 18.

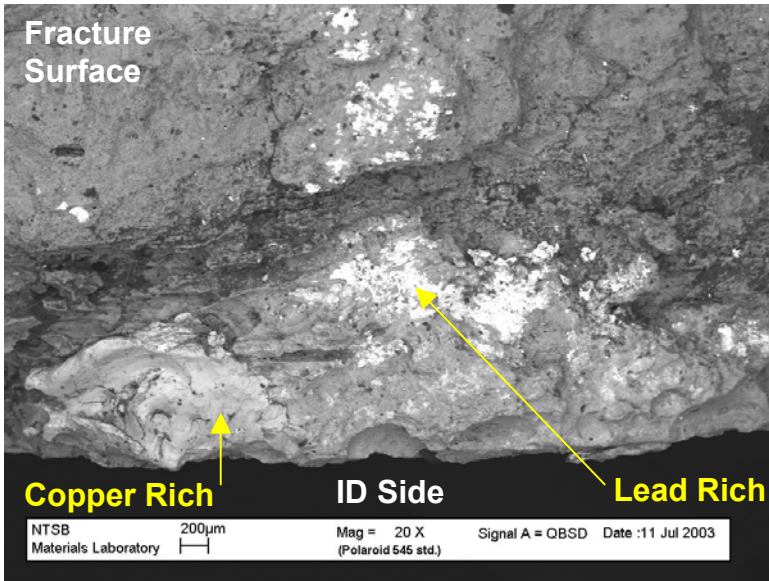
**Area 2 on Section 2- Near ID Surface**

SEM examination and EDS analysis of selected areas on the fracture surface of Section 2 revealed that on the interior of the fracture (away from either the ID or OD surfaces) and at some of the locations along the ID surface deposits of almost pure copper were observed (lighter gray areas in Figure 20, EDS 3 in Figure 21). Deposits rich in lead (white regions in Figure 20- EDS 2 in Figure 21) were observed on top of portions of the copper deposits and, in some areas, directly on the fracture surface adjacent to the copper deposits. The lead and copper regions were separate and EDS analysis of multiple areas did not show any location where the copper and lead were mixed together. In the interior of the fracture the deposits appeared smeared on to the fracture. An overall EDS analysis of one of the interior smeared areas showed the presence of lead and copper, though still separate materials (lower image in Figure 20, EDS 4 in Figure 21).

**Figure 20:** Varying magnification SEM views of additional location along the fracture surface of Section 2. In these locations EDS readings were taken as shown in Figure 21.

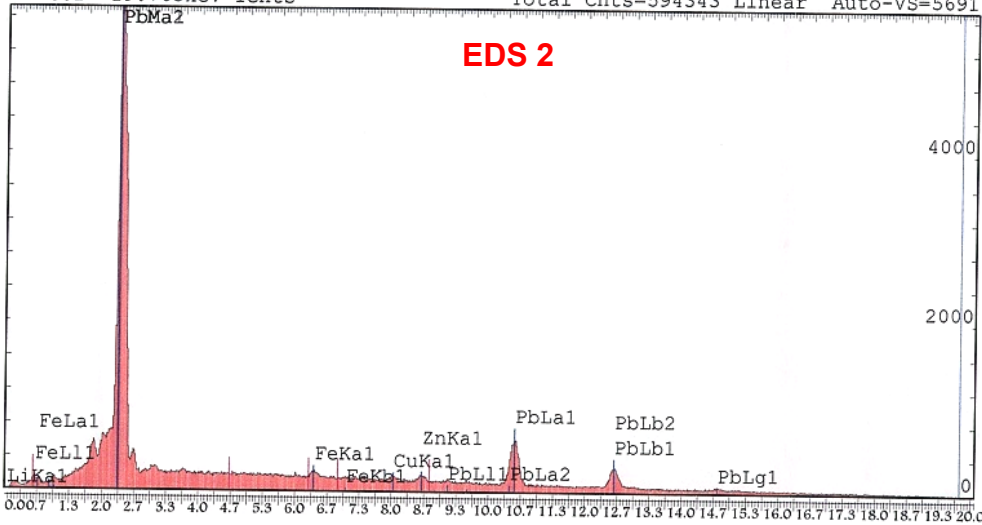
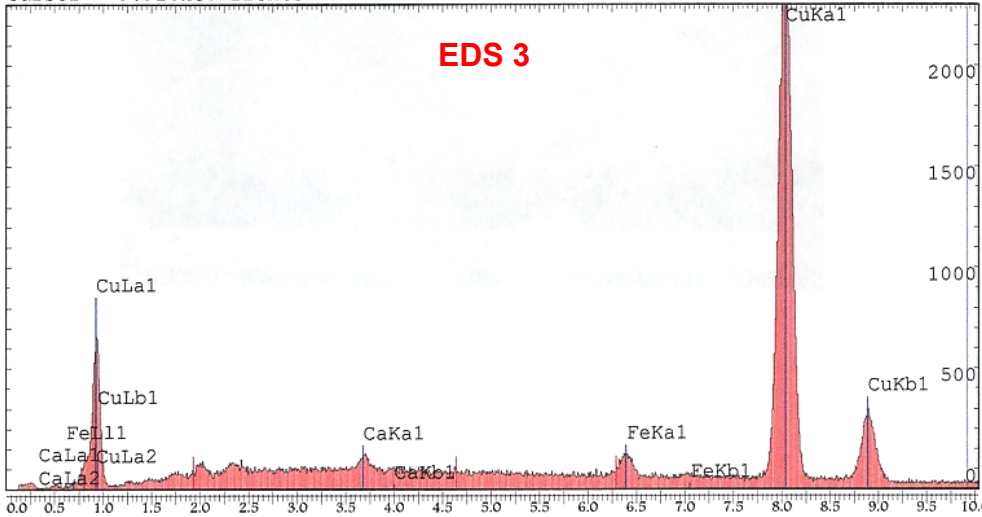
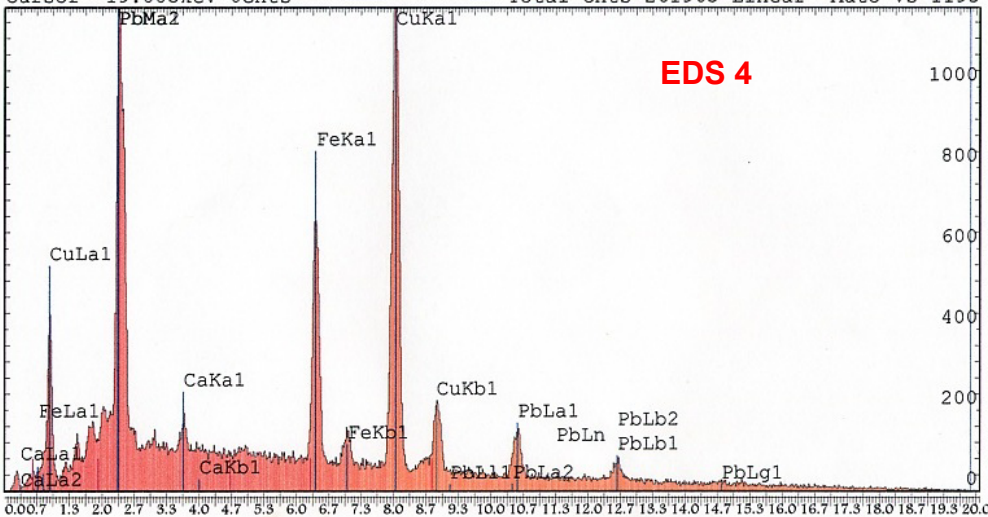
Figure 21: EDS spectra of the locations shown in Figure 20 on the fracture surface of Section 2.

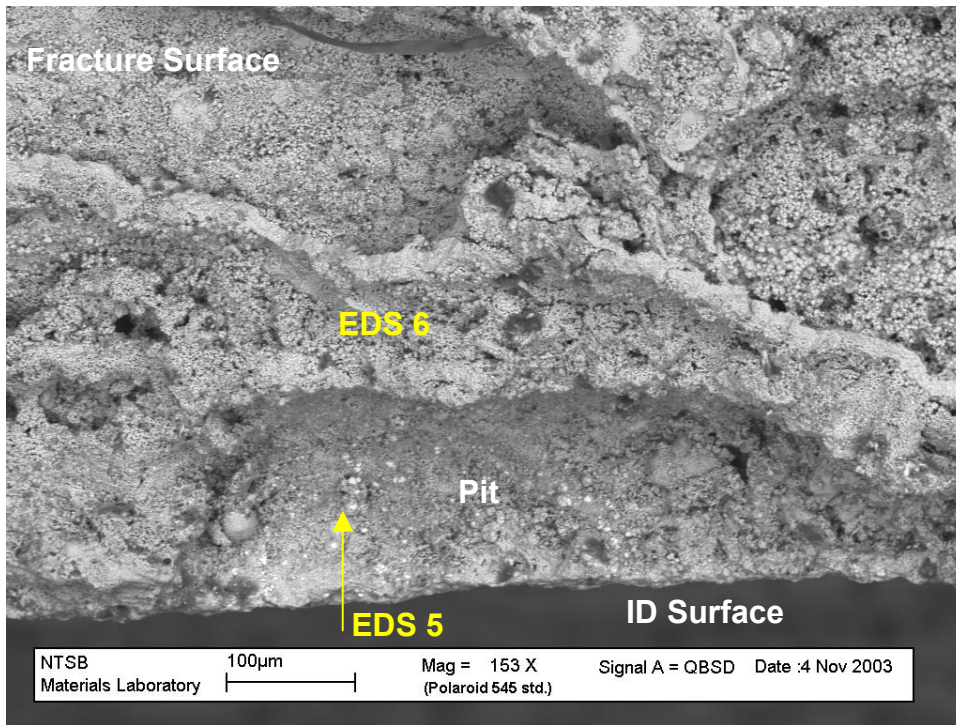
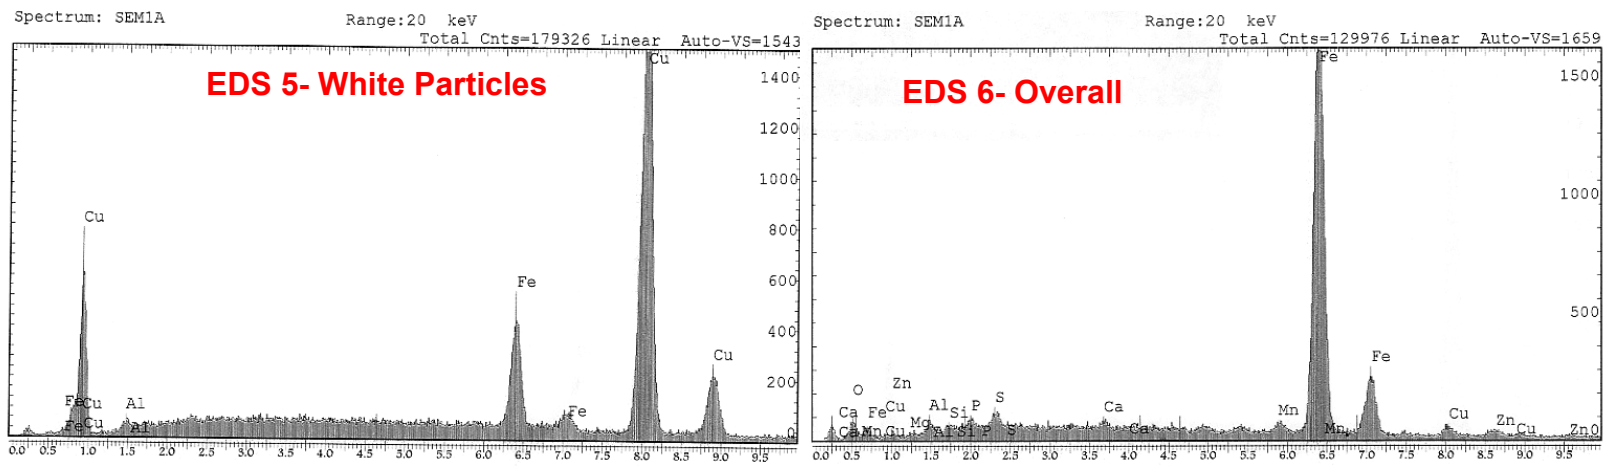
SEM examination of the fracture surface revealed that the fracture near the ID surface was pitted (left and lower right images in Figure 23). From the pits thumbnail shaped fatigue arrest marks were observed propagating toward the OD. The arrest marks extended to a depth of approximately 0.1 inch. The fracture continued in a flat, transgranular manner to the final fatigue depth of approximately 0.45 to 0.55 inch. Beyond that point rough features with ductile dimples indicative of tensile overstress were observed. All along the fatigue fracture secondary micro-cracking was observed (left and top right images in Figure 23). SEM examination of the interior of one of the corrosion pits is shown in the top image in Figure 24. Within the pit very small circular deposits less than 0.0002 inch in diameter were observed (white spots). Compositional analysis of the white spots showed that they were composed primarily of copper, with the addition of iron, likely from the base metal (EDS 5- Figure 24). The fracture surface composition was primarily composed of iron, with traces of calcium, sulfur, phosphorus, silicon, aluminum, zinc, and oxygen (EDS 6- Figure 24).

Figure 24: SEM image of the fracture surface of Section 5 near the ID surface (top image). The lower images are EDS spectra taken at the locations shown in the top image.

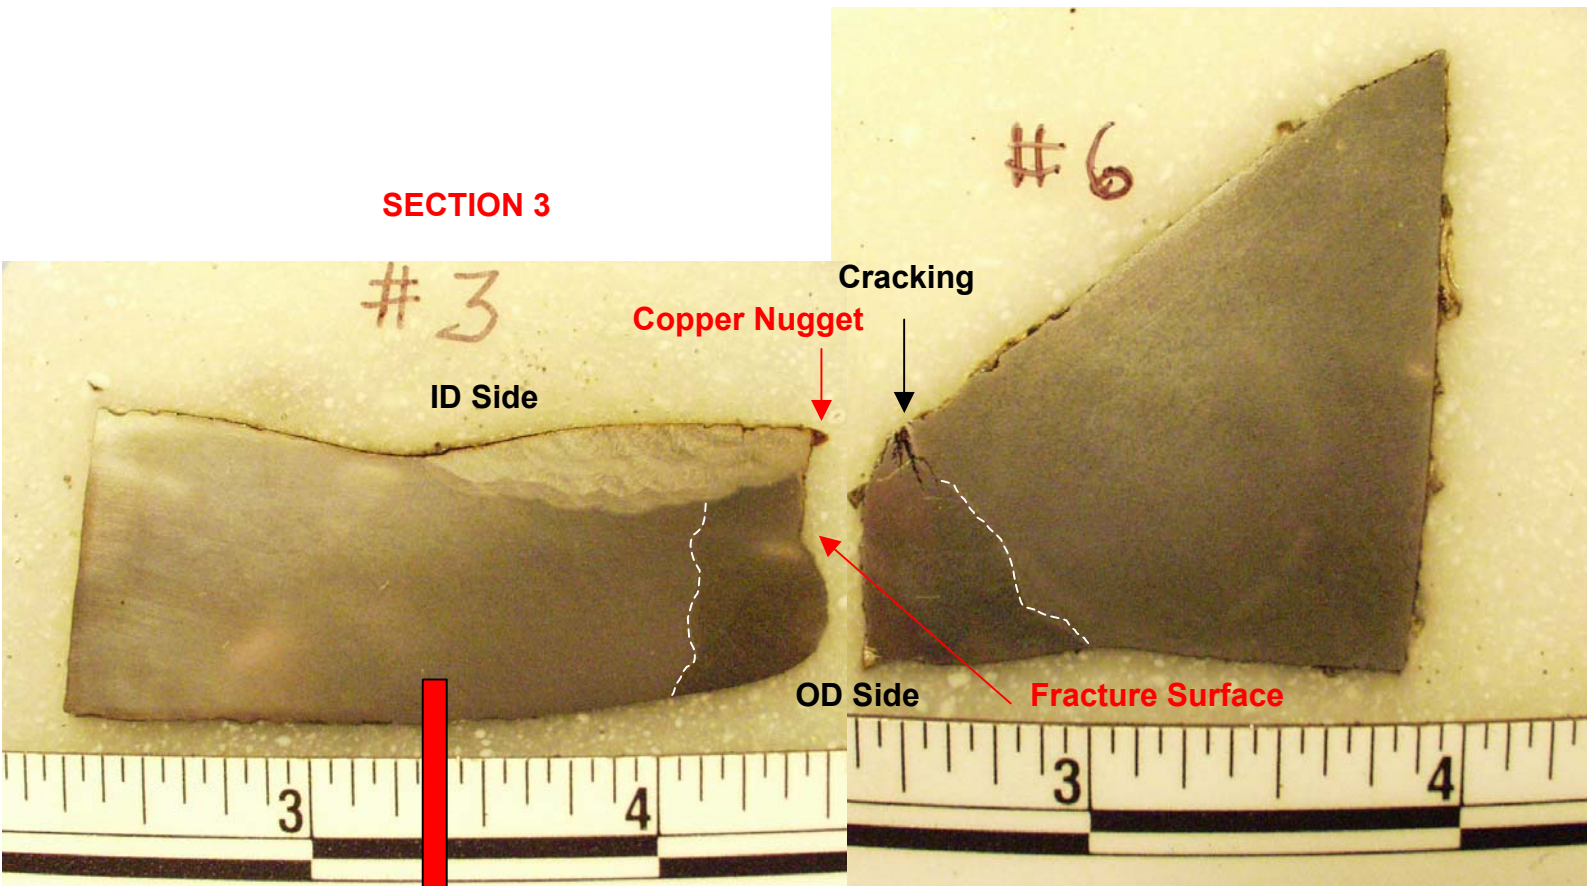
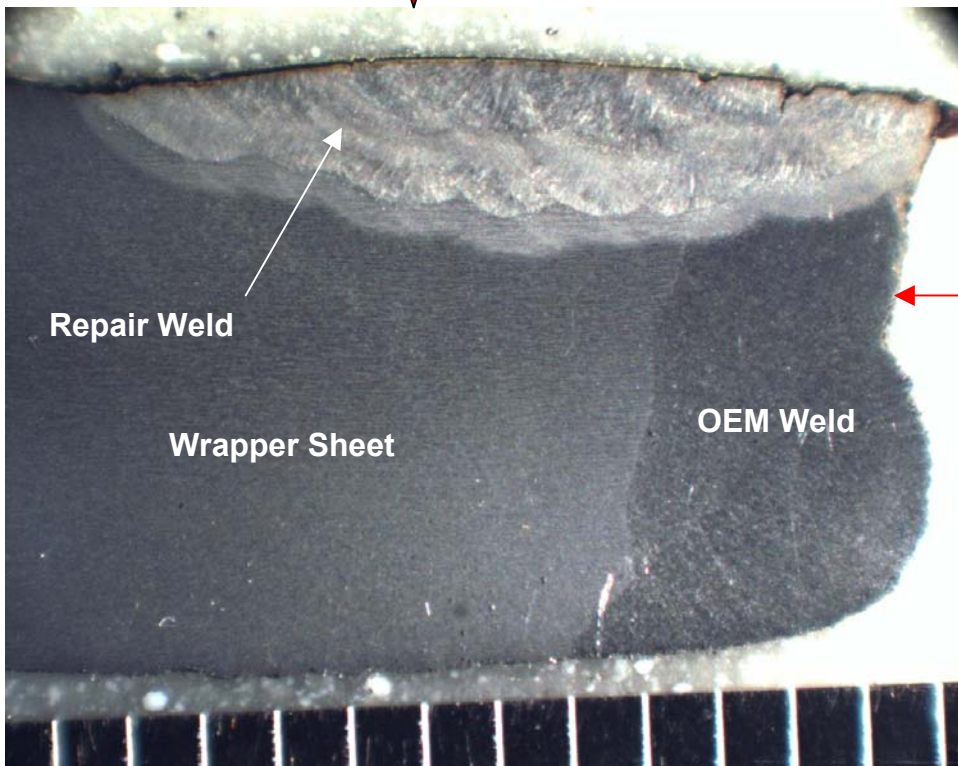
On Section 3 (from the liberated portion of the header) semi-continuous copper nuggets were observed along a 2.5 inch region of the fracture on the ID surface (upper and lower images in Figure 32). These nuggets can be seen in the photographs in Figure 27, on the cross section in Figure 31, and in closer views in Figure 32. On the ID surface the nuggets were flat, flush with the ID surface of the header, and contained transverse marks consistent with grinding marks (middle left image in Figure 32). On the ID surface smaller amounts of copper were observed inside some of the corrosion pits adjacent to the large copper nuggets found on the fracture surface (middle left image in Figure 32). On the interior side the copper nuggets were rounded and contained longitudinal cracks (middle right and lower images in Figure 32). When both fracture halves were put together it appeared that the nuggets matched the fracture contours very closely (upper image in Figure 32). The nuggets were up to approximately 0.1 inch wide and were up to approximately 0.09 inch deep into the crack. SEM examination confirmed that the nuggets were rounded on the interior side and contained many longitudinal cracks throughout (upper images in Figure 33). These nuggets were confirmed by EDS analysis to be composed of almost pure copper (EDS 8- Figure 33). An EDS spectrum of the base metal is shown in EDS 7 in Figure 33. Optical and SEM examination of a transverse cross-sectional metallographic mount through the copper nugget on the fracture of Section 3 (Figure 31) showed a banded, wrought structure, which contained many longitudinal cracks on the interior side adjacent to the fracture surface (images in Figure 34).

**Figure 32:** View of mating Sections 3 and 6 set next to each other as seen by looking at the ID surface (upper image). The middle left image is a view of the copper nuggets on the fracture as seen by looking at the ID surface. The middle right image is a view of the underside of the copper nuggets (interior to the crack) as seen by looking from the OD toward the ID. The lower image is a montage of the fracture surface of Section 3 in the area where copper nuggets were observed in Figure 27.
