# NATIONAL TRANSPORTATION SAFETY BOARD

MATERIALS LABORATORY FACTUAL REPORT

Report No. 03-078

Place : Miami, Florida  
Date : May 25, 2003  
Vehicle : Cruise ship S/S Norway  
NTSB No. : DCA03MM032  
Investigator : Robert Ford

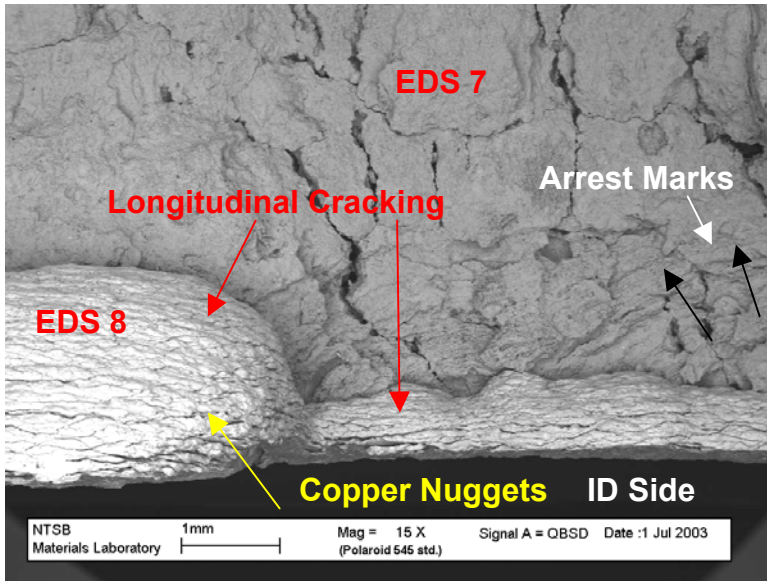
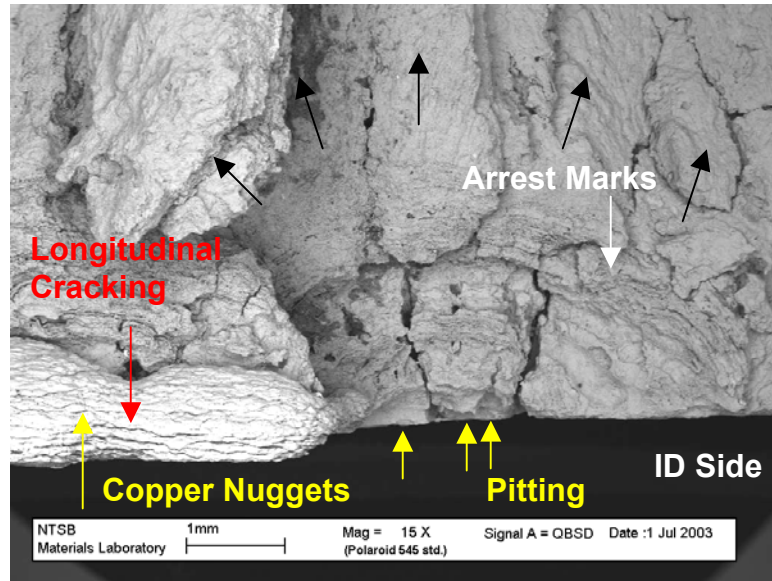
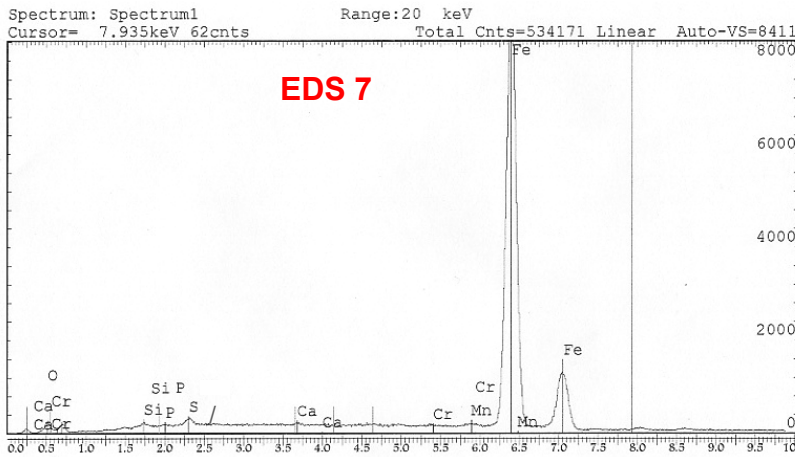
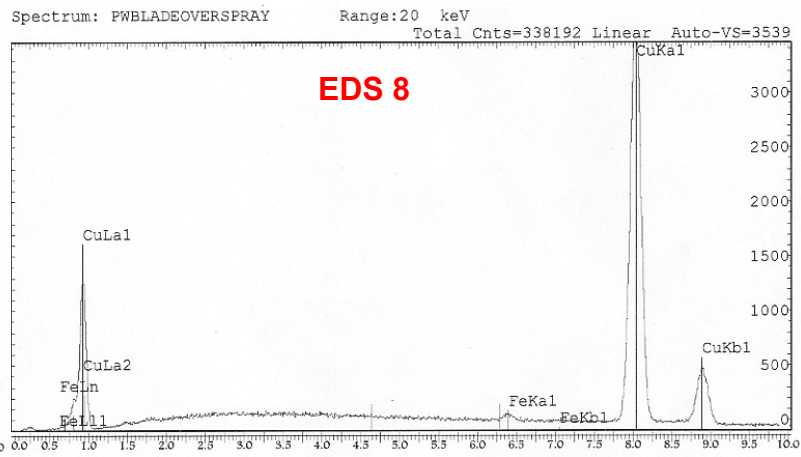
**Figure 33:** The top images are views of the copper nuggets on the fracture surface of Section 3 near the ID surface. The lower images are EDS spectra taken at the locations shown in the upper left image.

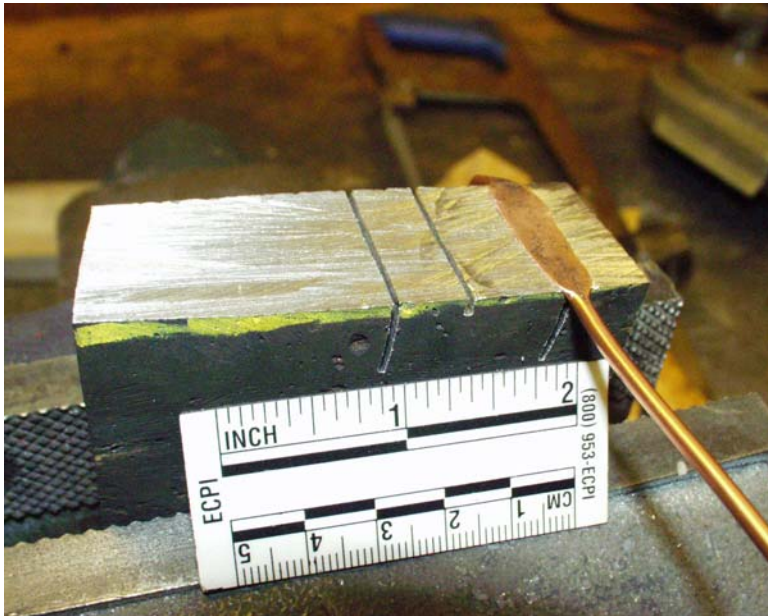
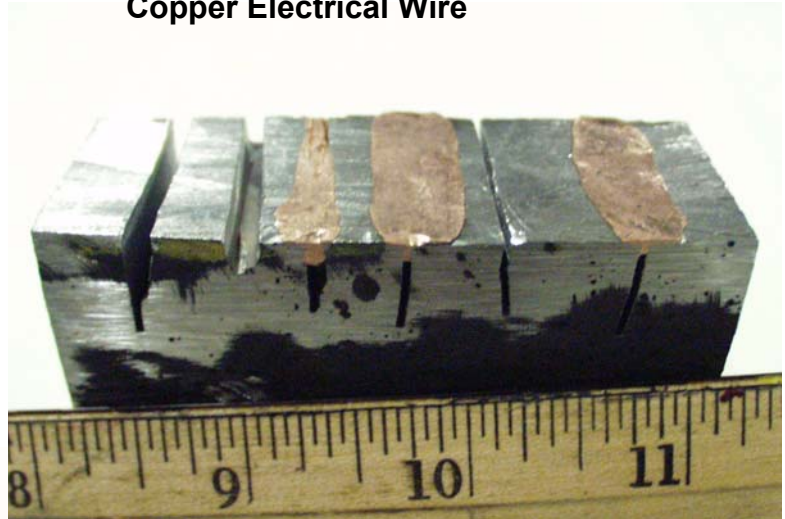
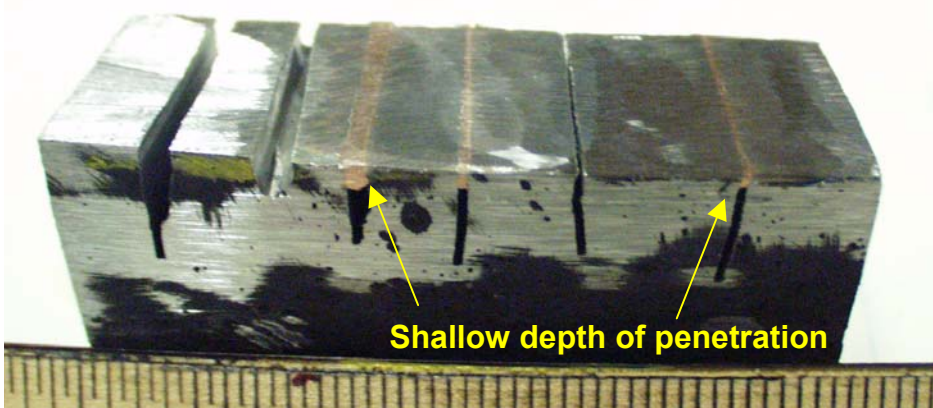
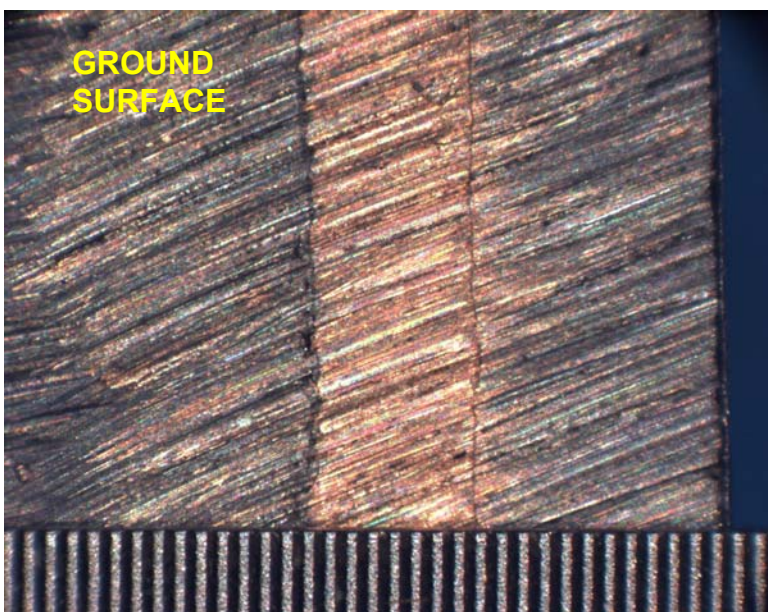
A view of how the copper was hammered into the cracks and ground is visible in Figure 36. Views of how the copper looked inside the crack after the first five tests were performed are visible in Figure 37 (after opening up the simulated cracks). Laydown metallographic mounts of the copper from the first five tests are shown in Figure 38, along with the structure from Piece A for comparison. A view of the copper refrigeration line from test 6 (after removing it from the simulated crack) can be seen in Figure 39, while a longitudinal metallographic mount through the material can be seen in Figure 40 at varying magnifications.

**Figure 36:** Images showing varying steps in an experiment performed in the lab. The top right images show how copper electrical wire looked after being hammered into a simulated crack. The middle image shows the profile of the cracks after hammering in the copper wire and grinding the surface flush. The lower image is a head-on view of one of the cracks filled with copper after grinding.

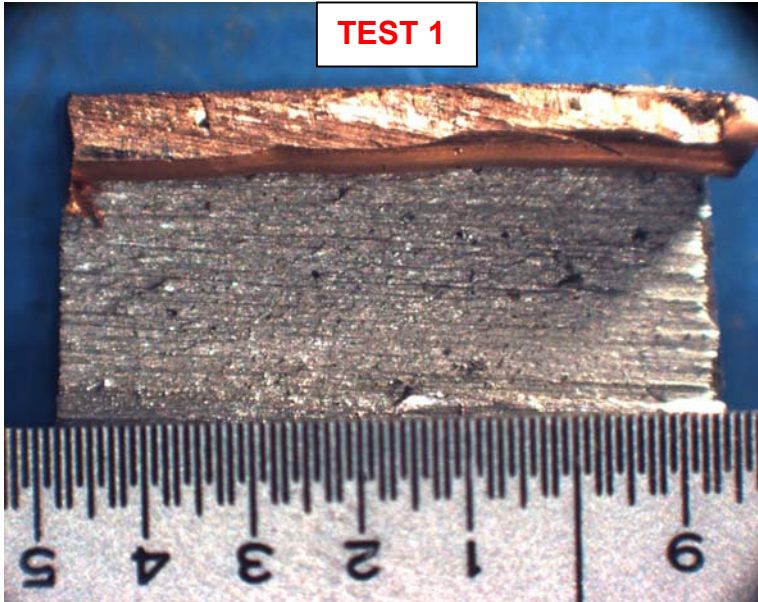
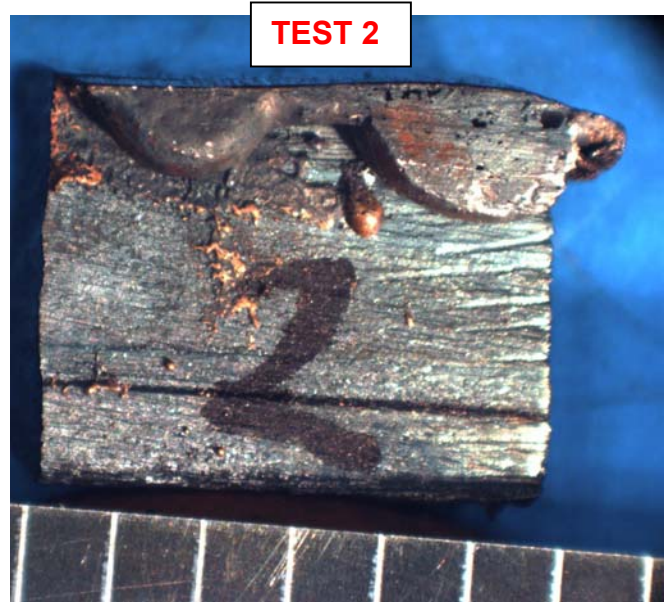
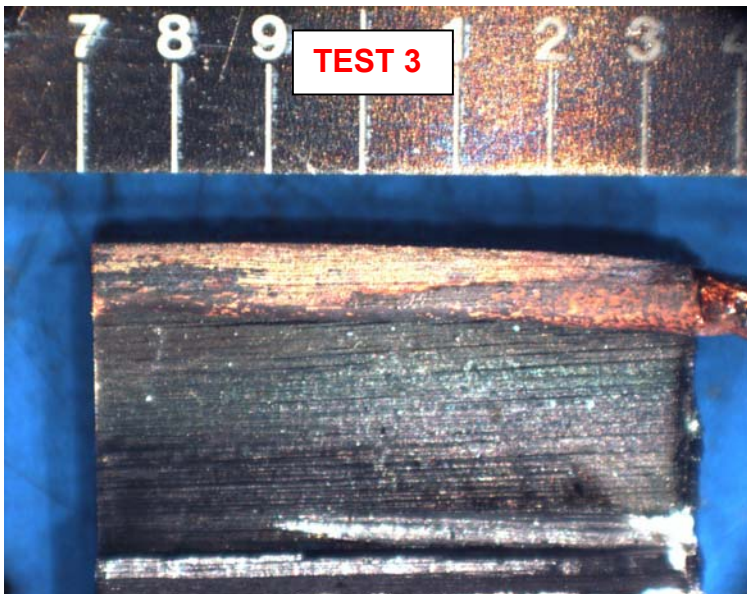
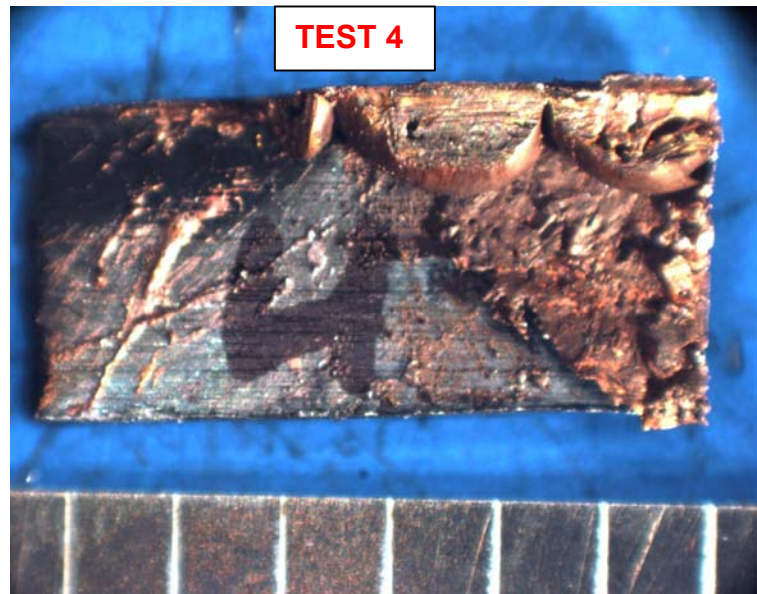
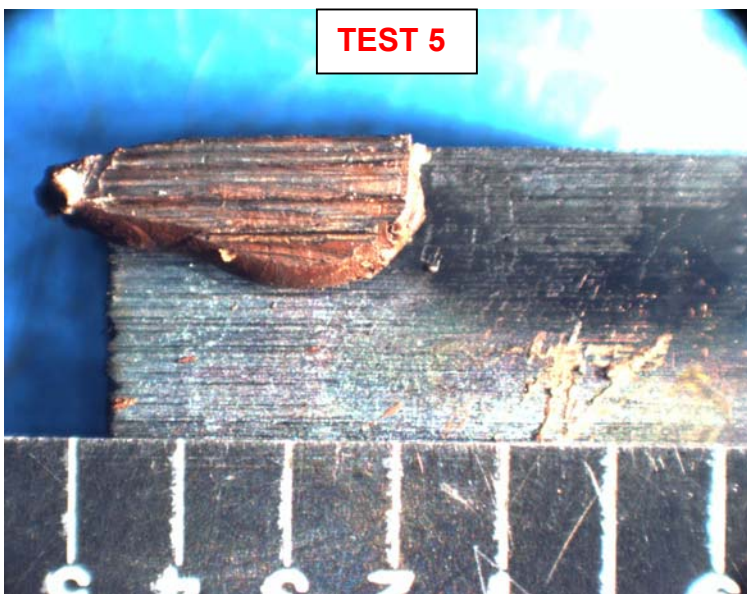
- 1) The cast (melted) copper wire (tests 2, 4, and 5 in Figure 37) showed rounded internal features, but had splatter on the crack interior that was not found on the samples from the ship. Examination of the micrographs showed that the cast structure showed internal porosity and much larger, strain free grains (test 2, 4, and 5 on Figure 38) compared to the wrought structure on the S/S Norway (lower right image in Figure 38). The cast structures did not appear to match the structure of the copper nuggets.

**Figure 37:** Copper wire forced into a simulated crack by varying methods. The images show the copper after the cracks were opened up in the lab. The following tests show how the copper was forced in to the simulated cracks:

- Test 1-** Hammered in copper wire (wrought)
- Test 2-** Heat base + melt in copper wire
- Test 3-** Hammered in copper wire + heat with torch
- Test 4-** Heat base metal, melt in copper wire + hammer copper when cool
- Test 5-** Heat base metal, melt in copper wire, and hammer copper while hot.

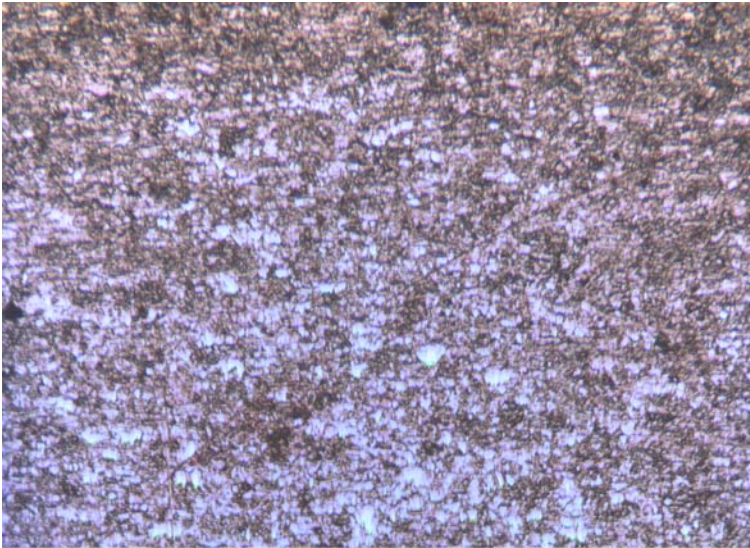
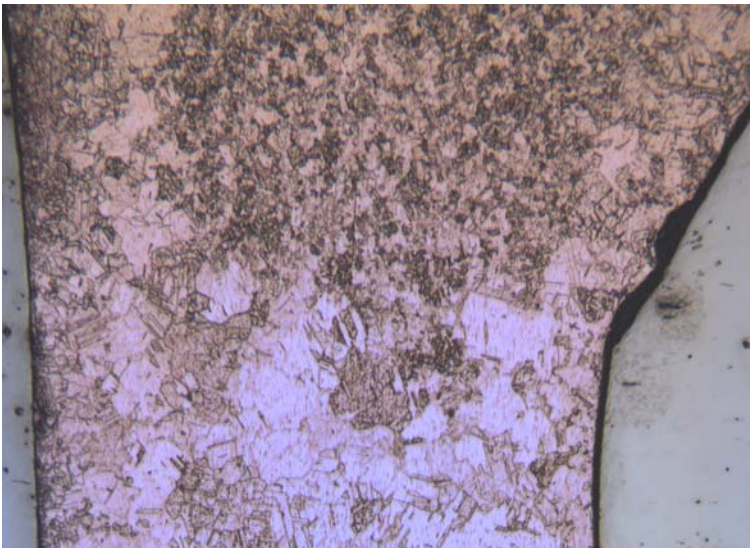
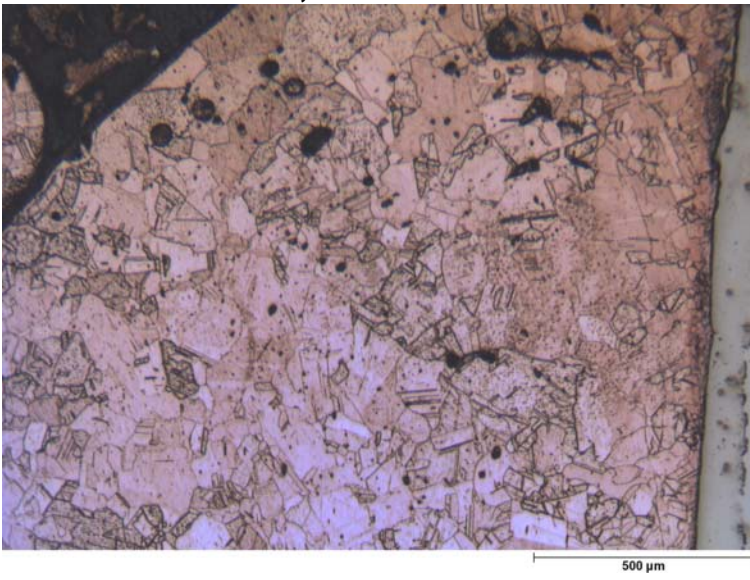
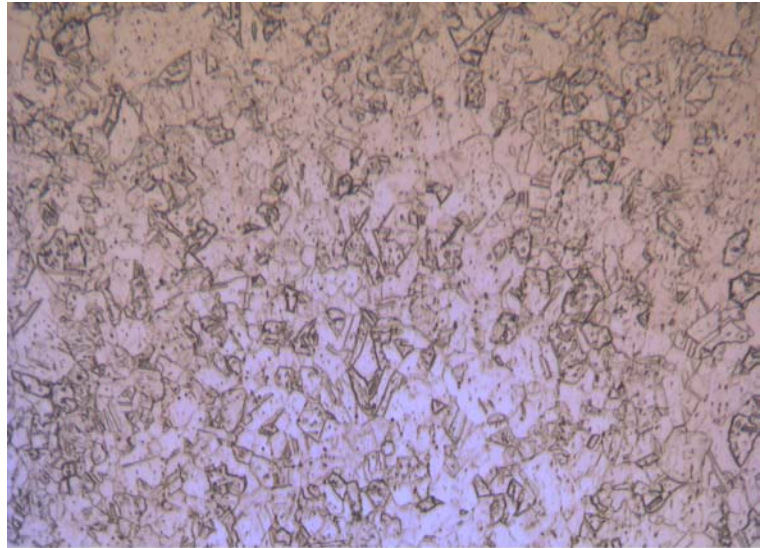
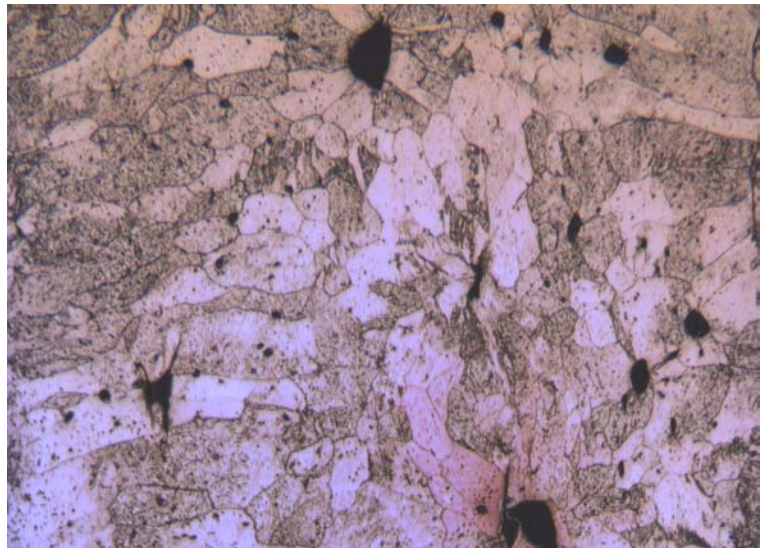
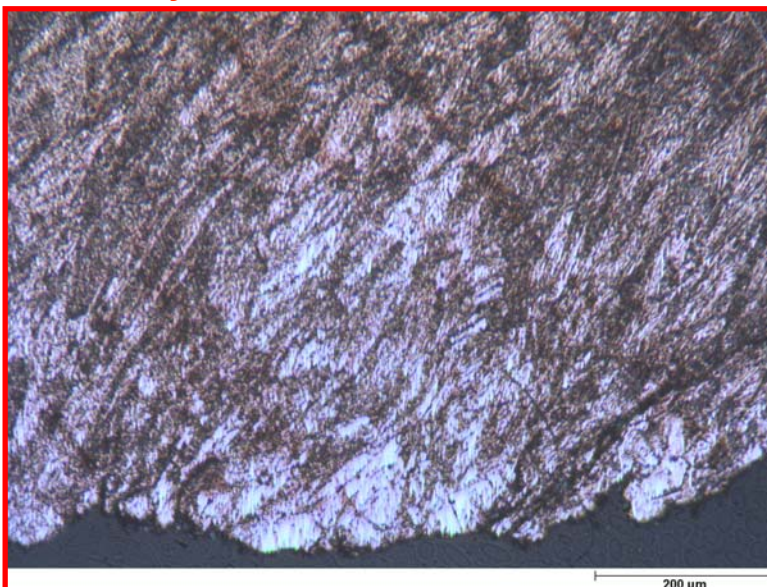
- 2) Comparison of the wrought structure produced by hammering the copper into the simulated crack showed that the macroscopic features of the copper from test 1 and 3 were not very rounded and no evidence of the longitudinal cracking was observed. The microstructure of the worked wire (test 1) was much closer in appearance to the ship sample than the cast structure. No internal porosity was observed and the grains were finer and were more worked than the cast structure. However, no significant banding was observed and the structure was not worked enough to say they were similar (Figure 38). The worked structure that was then heated (test 3) showed large, strain-free, recrystallized grains adjacent to the smaller worked grains. The structures from test 1 and test 3 did not match the structure on the S/S Norway (Figure 38), though the structure from test 1 was closer in appearance than that produced by casting.

**Figure 38:** Laydown cross-sectional micrographs of the test specimens from Figure 37 and a comparison lay-down mount of Piece A from Section 2 from the S/S Norway.

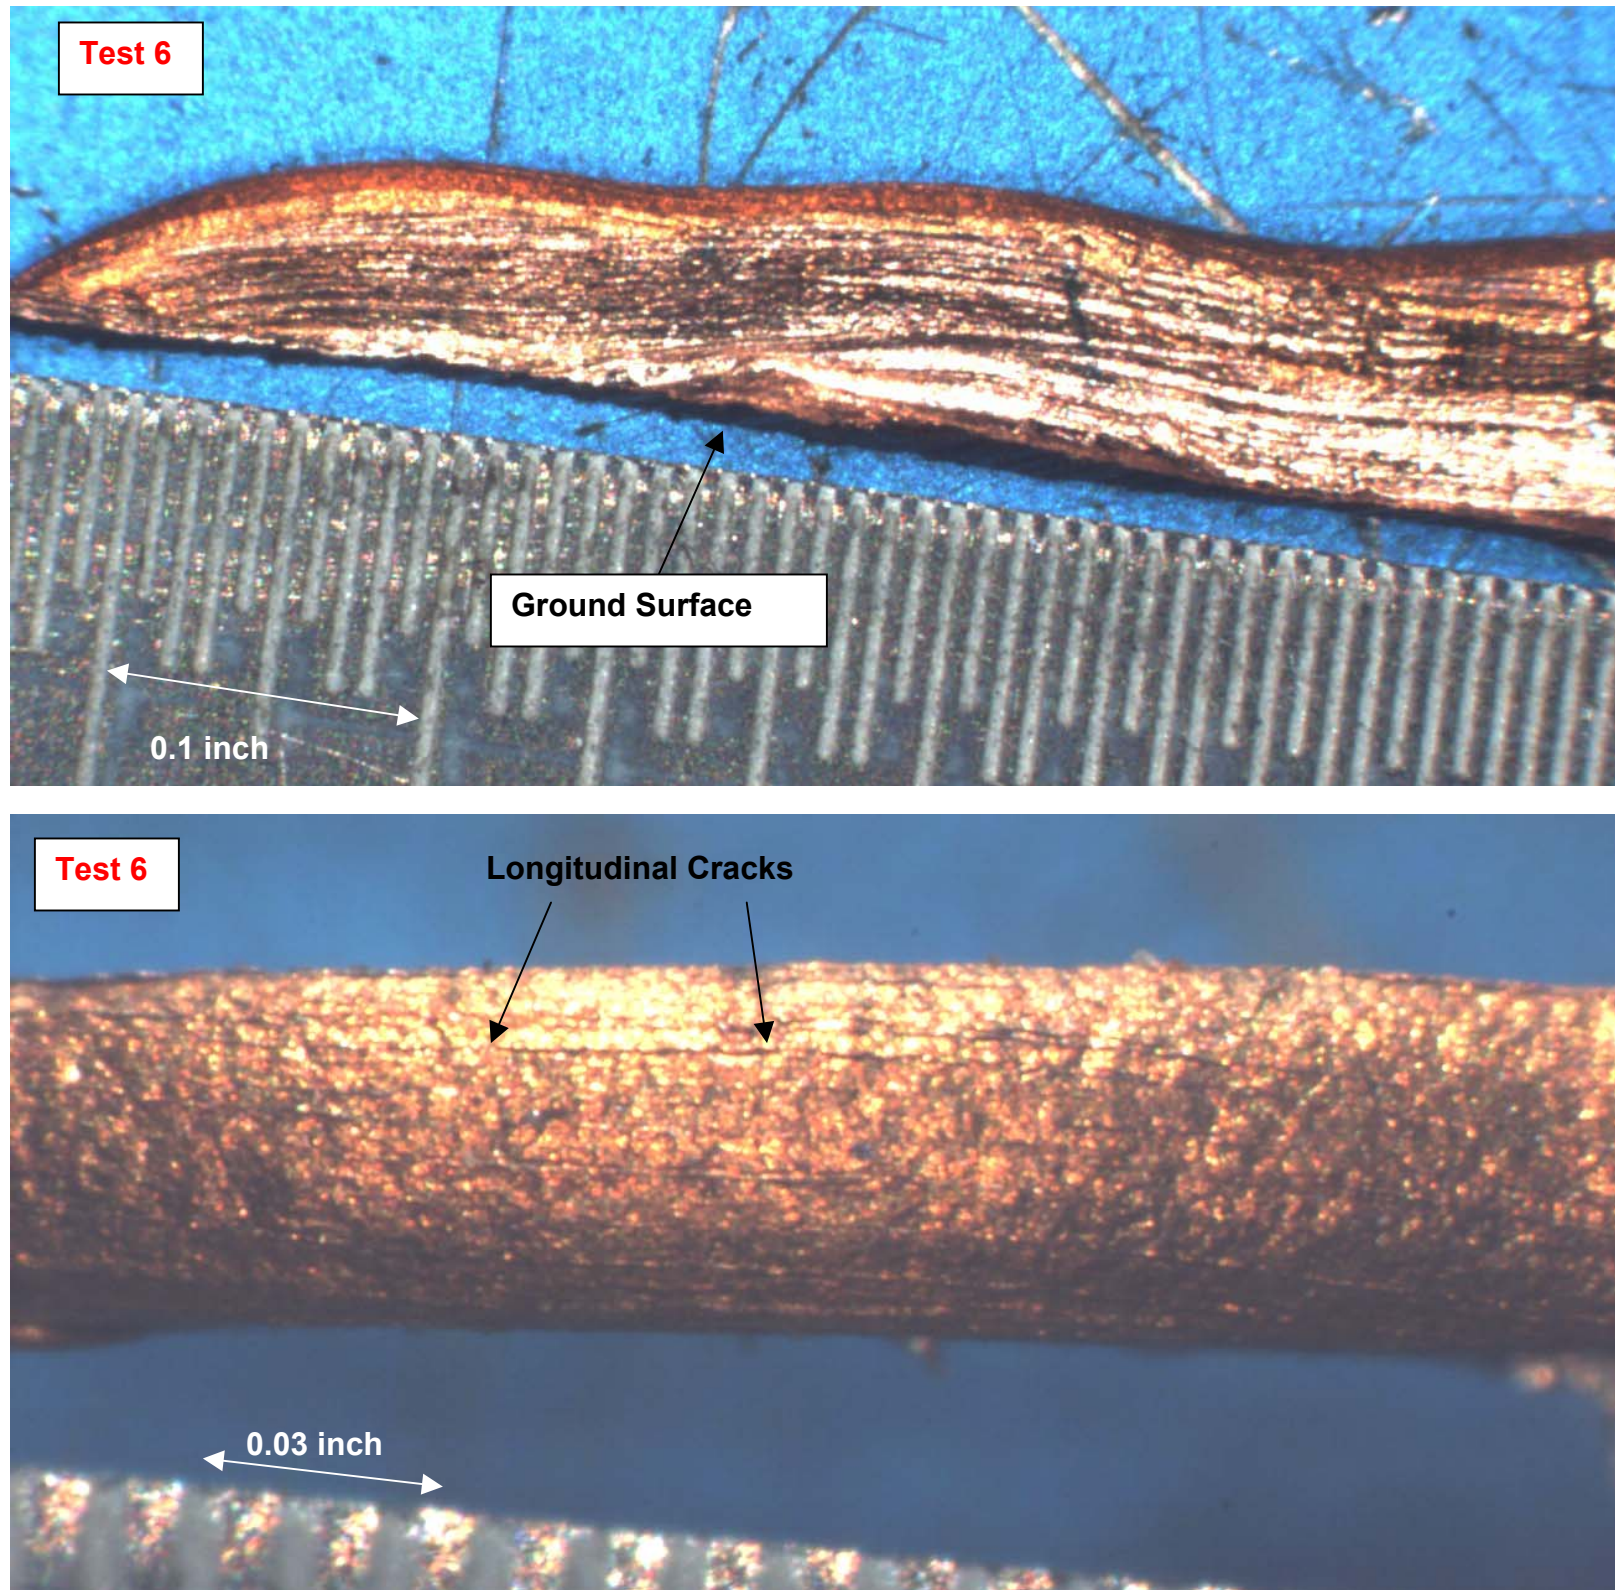
- 3) To produce a higher level of work in the structure, copper refrigeration line was hammered into a simulated crack (test 6). When this was done the copper internal to the crack showed some rounded features and some longitudinal cracking (images in Figure 39) similar to what was observed on the S/S Norway nuggets, though to a lesser extent. Examination of the structure showed that the highly worked areas of the tube appeared to show significant banding, was

**Figure 39:** Varying magnification views of copper refrigeration line after having been hammered into a simulated crack, ground on the exposed surface, and removed from the crack.

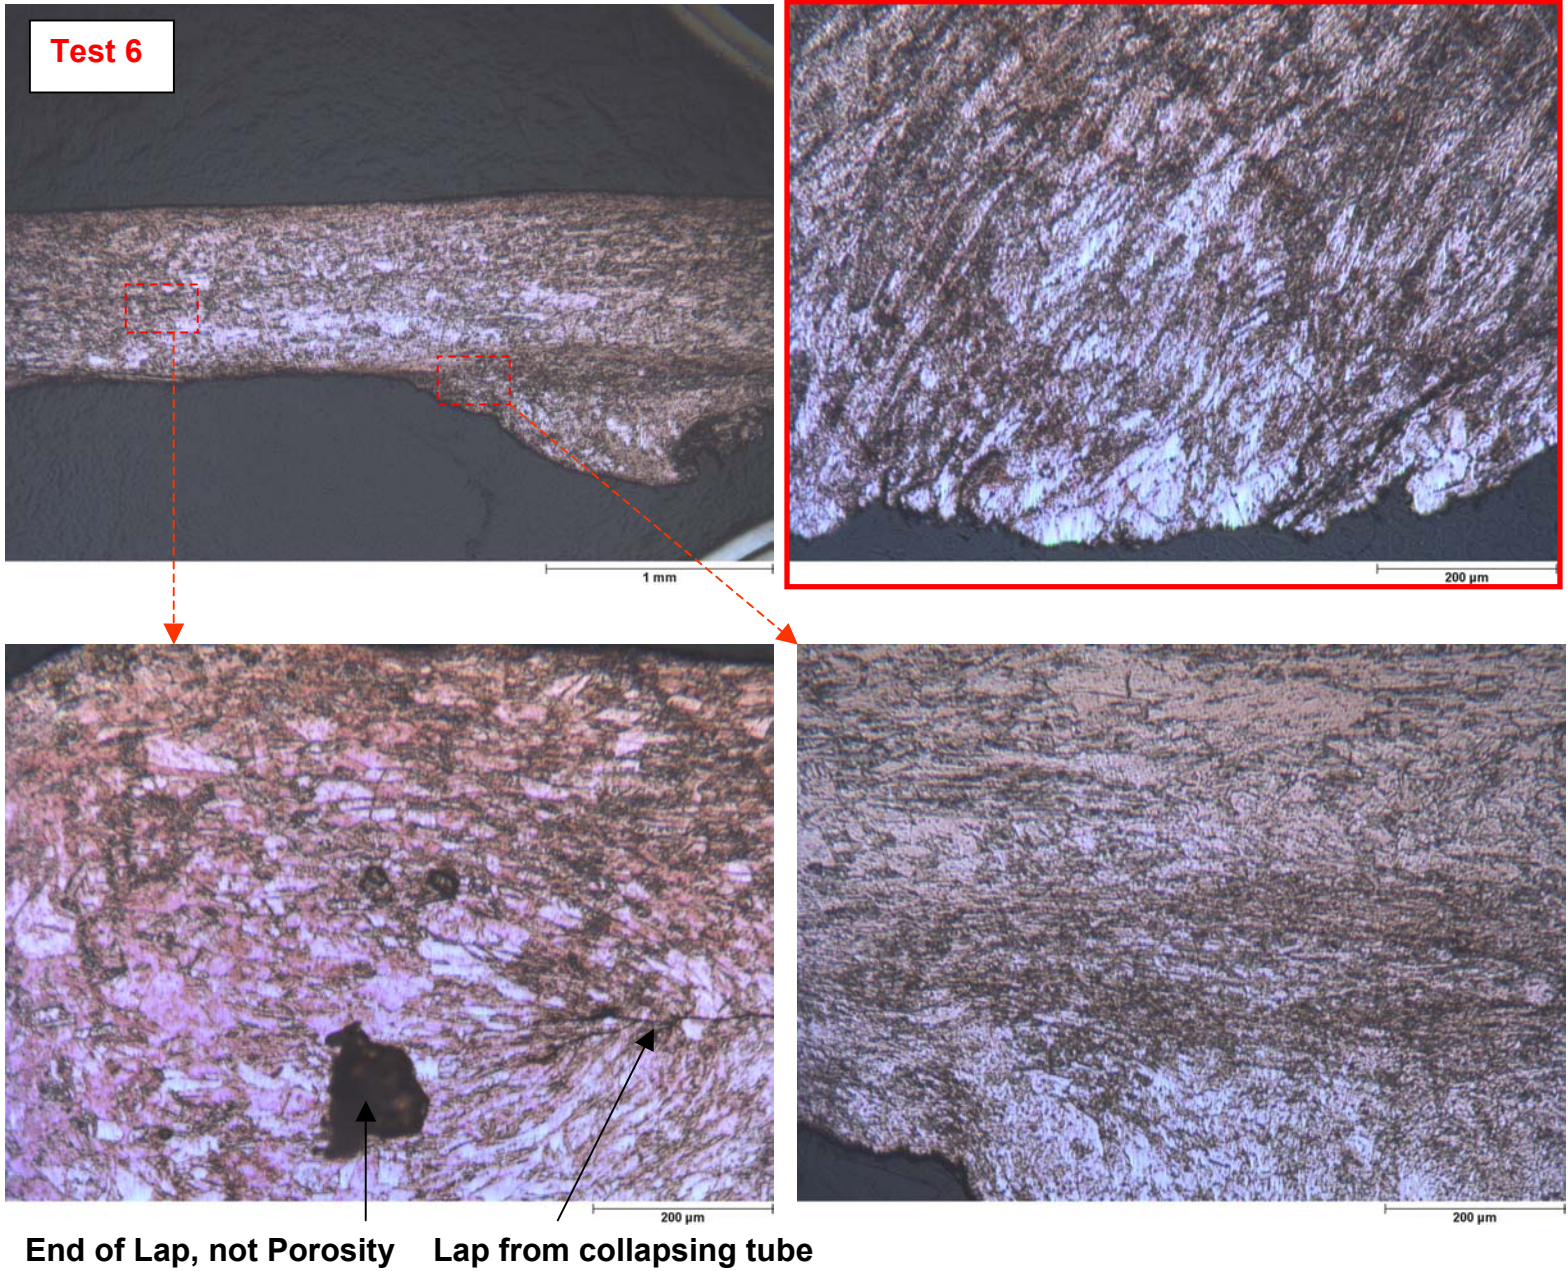
- duplexed, and had highly worked grains similar in appearance to the ship sample (Figure 40).
- 4) When both the copper wire and refrigeration line were worked into the cracks (not cast), the copper never filled a significant portion of the crack; it only filled approximately 10-30% of the crack depth (see middle image in Figure 36, middle left and top left images in Figure 37, and top image in Figure 39). The copper nuggets on the ship only extended to a maximum depth of approximately 0.090 inch, in a cracked area that extended to a depth of 0.4 inch (Section 3) or 0.55 inch deep (Section 2) at the time of the fracture. The copper experiments in the laboratory filled the simulated cracks to a similar degree as was observed on the ship nuggets.

**Figure 40:** Longitudinal micrographs at varying locations and magnifications of a section of copper refrigeration line that was hammered into a simulated crack (see Figure 39). A comparison microstructure from Piece A taken from Section 2 on the S/S Norway is shown in the top right image.
