# NATIONAL TRANSPORTATION SAFETY BOARD

MATERIALS LABORATORY DRAFT FACTUAL REPORT

Report No. 05-071

Place : Graniteville, South Carolina  
Date : January 6, 2005  
Vehicle : Tank Car UTLX 900270  
NTSB No. : DCA05MR008  
Investigator : Jim Henderson (RPH-30)

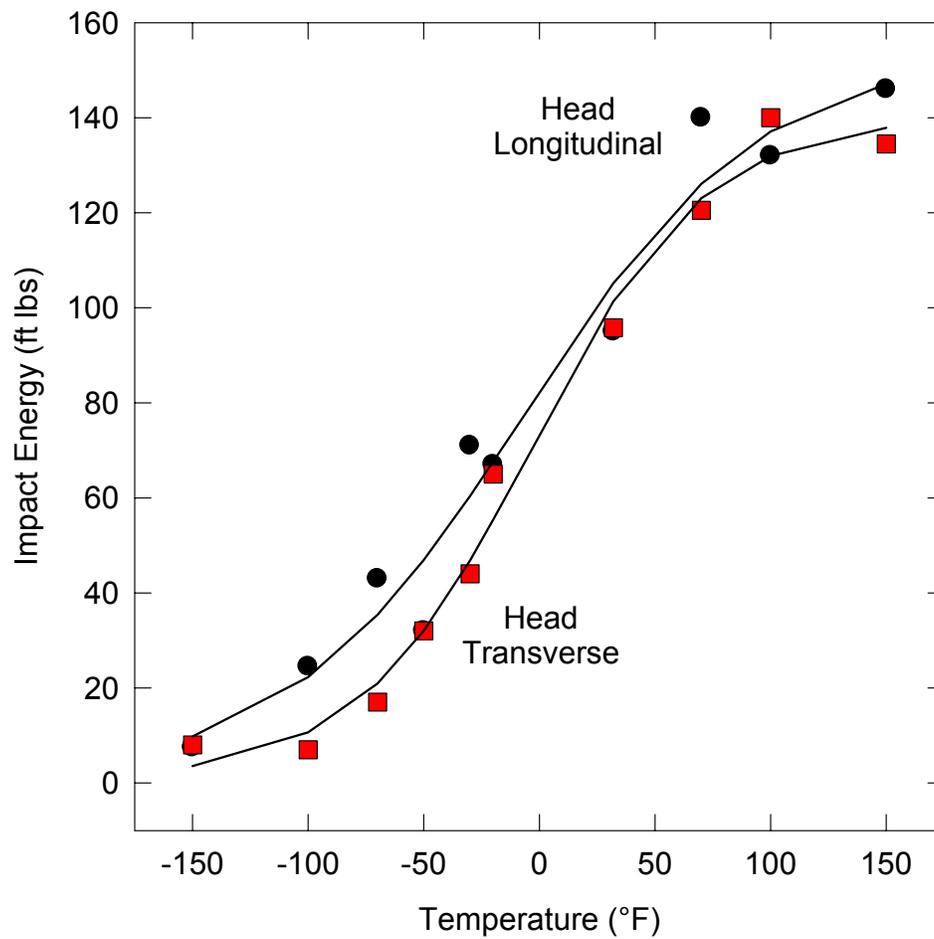
### DBTT Curve for Head Longitudinal and Transverse Orientations

The fracture faces of Charpy specimens from the head that were tested at and above 70 °F in both orientations of testing showed 100% fibrous (ductile) features. The fracture faces of the head specimens that were tested at minus 100 °F and lower in both orientations of testing showed 100% brittle features. The fracture faces of the head specimens that were tested between minus 100 °F and 70 °F showed mixed-fracture features (combination of ductile and brittle fractures). The fracture faces of head specimens that were tested at 32 °F showed nearly equal distribution of the two fracture features (nearly 50% of the specimen fracture area showed brittle features and the remaining fracture showed ductile features), an indication that the FATT for specimens in both orientations of testing was approximately 32 °F.

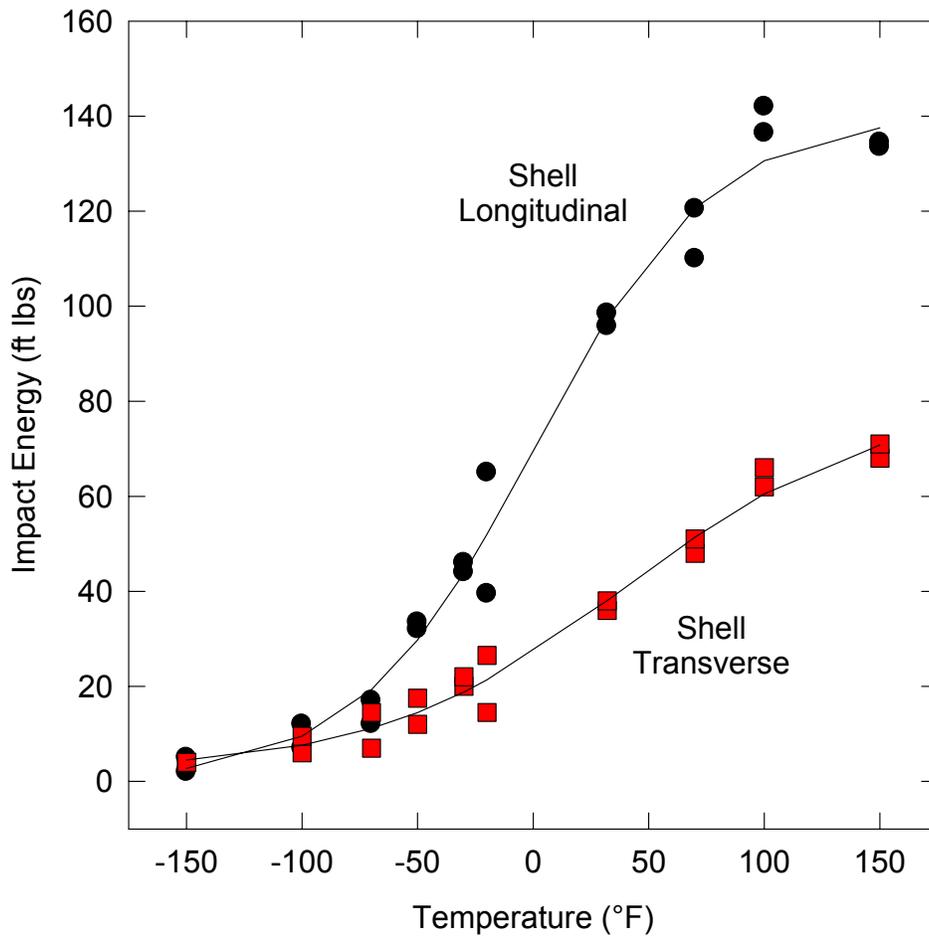
### DBTT Curve for Shell Longitudinal and Transverse Orientations

The fracture faces of Charpy specimens from the shell that were tested at and above 100 °F in both orientations of testing showed 100% ductile features. The fracture faces of the shell specimens that were tested at minus 50 °F and lower in both orientations of testing showed brittle features. The fracture faces of the shell specimens that were tested between minus 50 °F and 100 °F showed mixed-fracture regions (combination of ductile and brittle fractures). Based on the appearance of the fractures, the FATT for the longitudinal and transverse specimens from the shell was 32 °F and 70 °F, respectively.
