NATIONAL TRANSPORTATION SAFETY BOARD

MATERIALS LABORATORY FACTUAL REPORT

Report No. 01-120

Place : Near Port Hueneme, California
Date : January 31, 2000
Vehicle : Boeing MD-83, N963AS
Operator : Alaska Airlines, Flight 261
NTSB No. : DCA00-M-A023

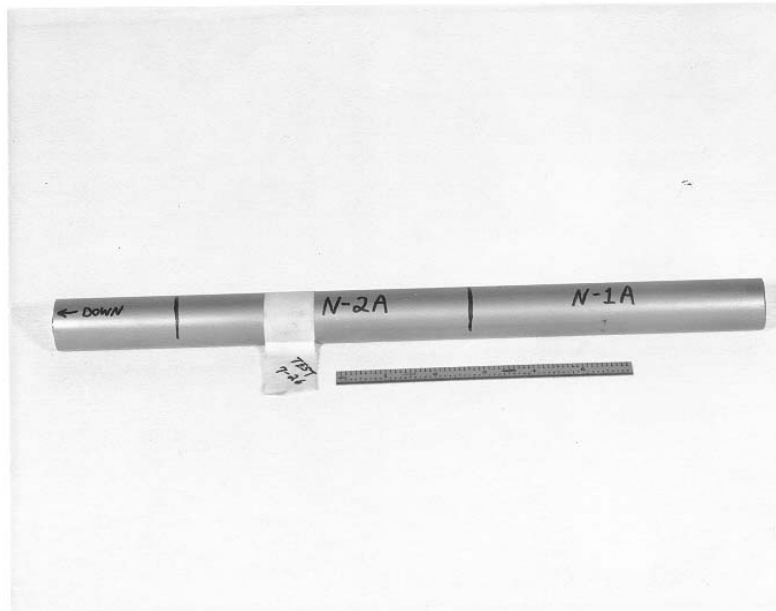
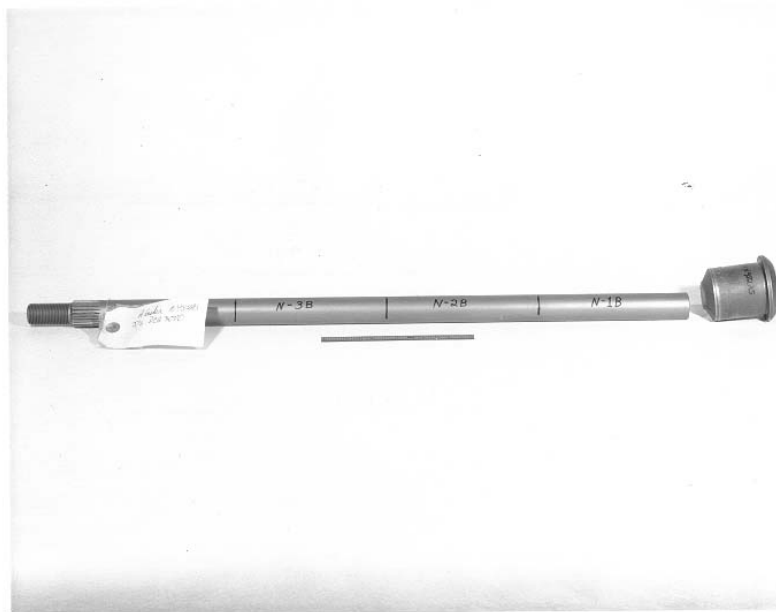
To perform the test a total of five standard configuration ASTM E-8 0.5-inch nominal diameter tensile specimens were machined from the new torque tube used in QST I and from the original torque tube installed in jackscrew assembly DCA3000 removed from aircraft N982AS². Figure 1 shows the pieces of torque tube from which the specimens were removed.

Figure 1--The test specimens were cut from the new torque tube used in QST I (top) and from the tube removed from N982AS (bottom).

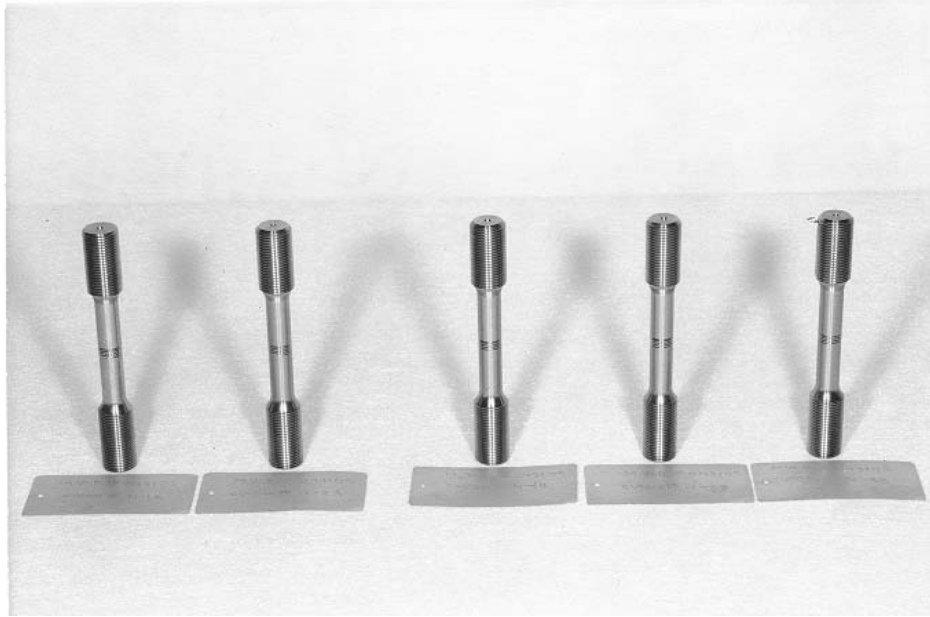
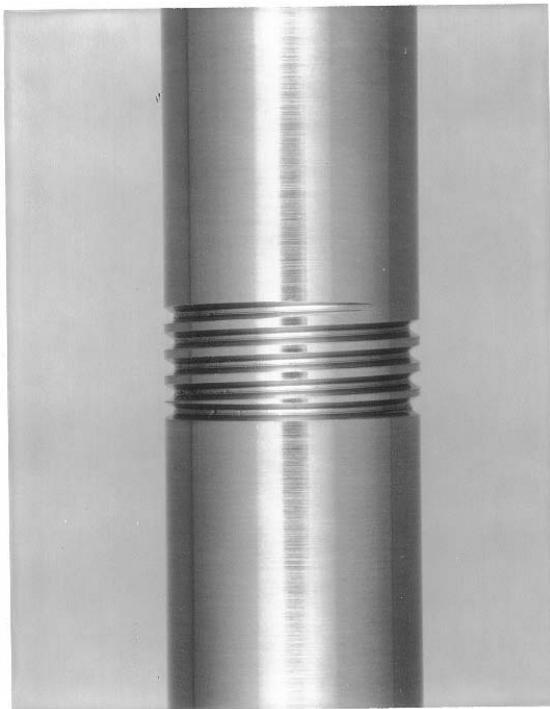
The standard tensile test specimens were modified by machining partial thread profiles into the central portion of the gage length of each specimen. The threads cut into the tensile bars had modified profiles based on 1/2-20UNF-3A threads³. However, the maximum depth of the threads approximately 0.025-inch and the thread roots were filleted. At least four full threads were present between starter threads. Following the tests, the thread root radii on all specimens were measured using an optical comparator. The measurements averaged 0.0085 inch. Figure 2 displays the specimens and a close up view of a typical threaded area.

Figure 2--An overall view of the test specimens (top) and a closer view of typical threading in the center of the spemens.
