NATIONAL TRANSPORTATION SAFETY BOARD

MATERIALS LABORATORY FACTUAL REPORT

Report No. 02-077

Place : Belle Harbor, New York
Date : November 12, 2001
Vehicle : Airbus A300-600, N14053
NTSB No. : DCA02MA001
Investigator : Brian Murphy, AS-40

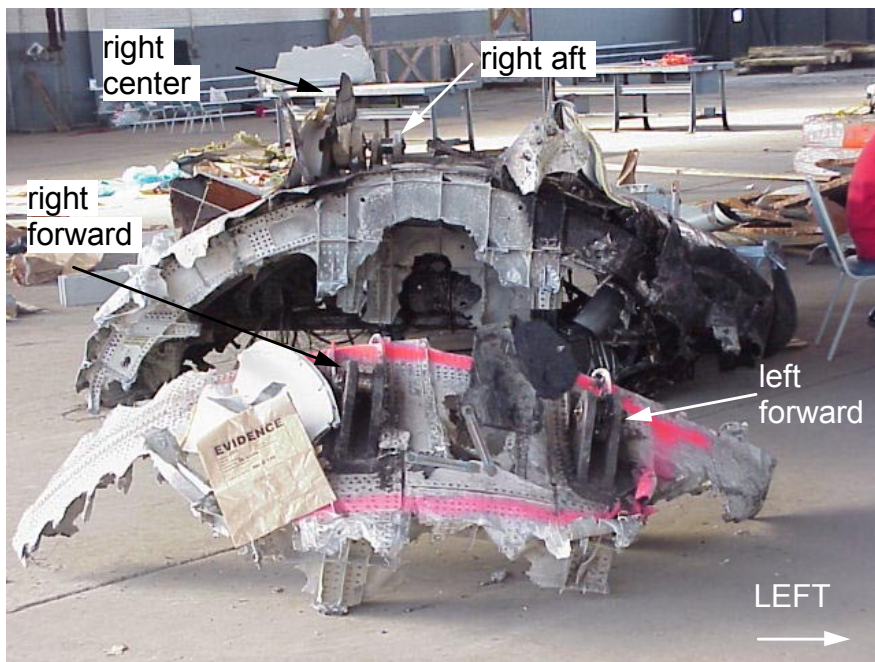
Figure 2. The fuselage pieces as viewed looking aft.

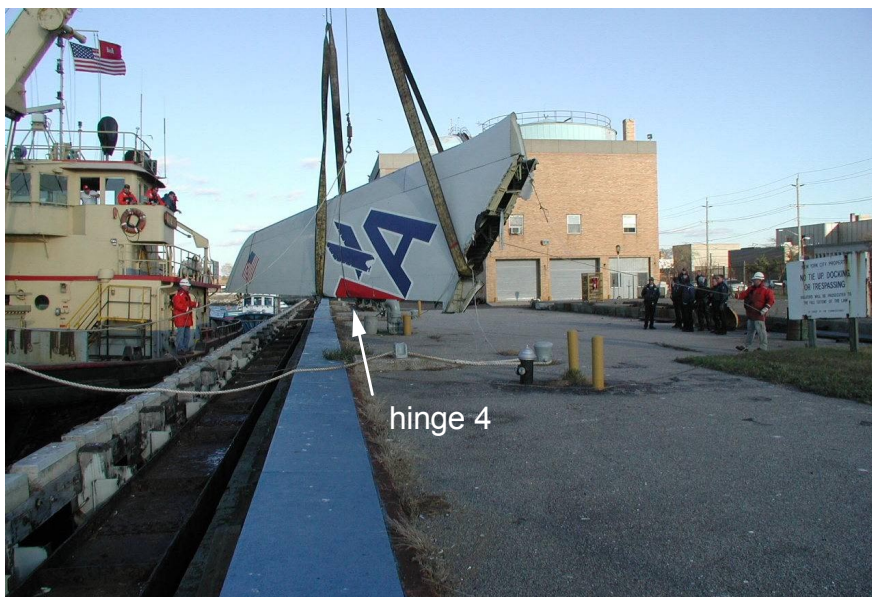
Figure 4. Another recovery photo showing the right side of the vertical stabilizer. Note the location of the hoist line just above hinge 4.

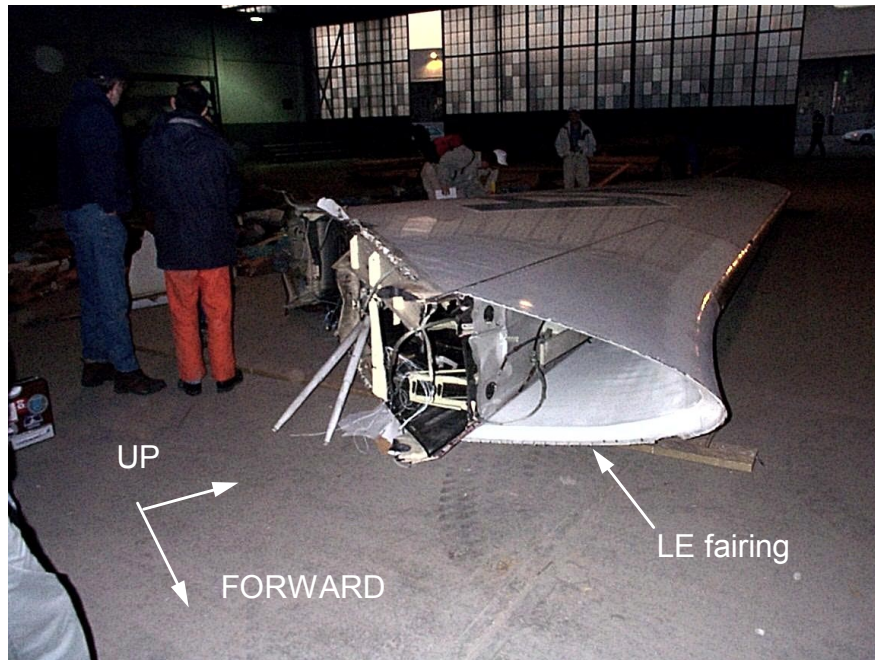
Figure 5. View of the lower end and leading edge of the vertical stabilizer as it was first placed at Floyd Bennett Field.

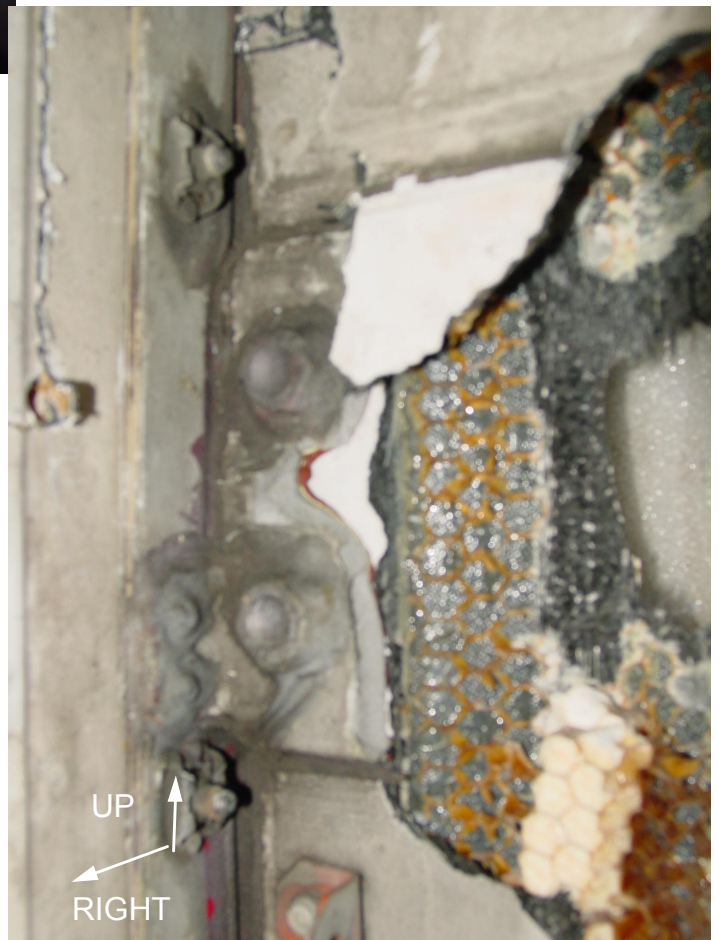
Figure 34. View of the right hinge 3 aft fitting pieces that remained attached to the rudder.

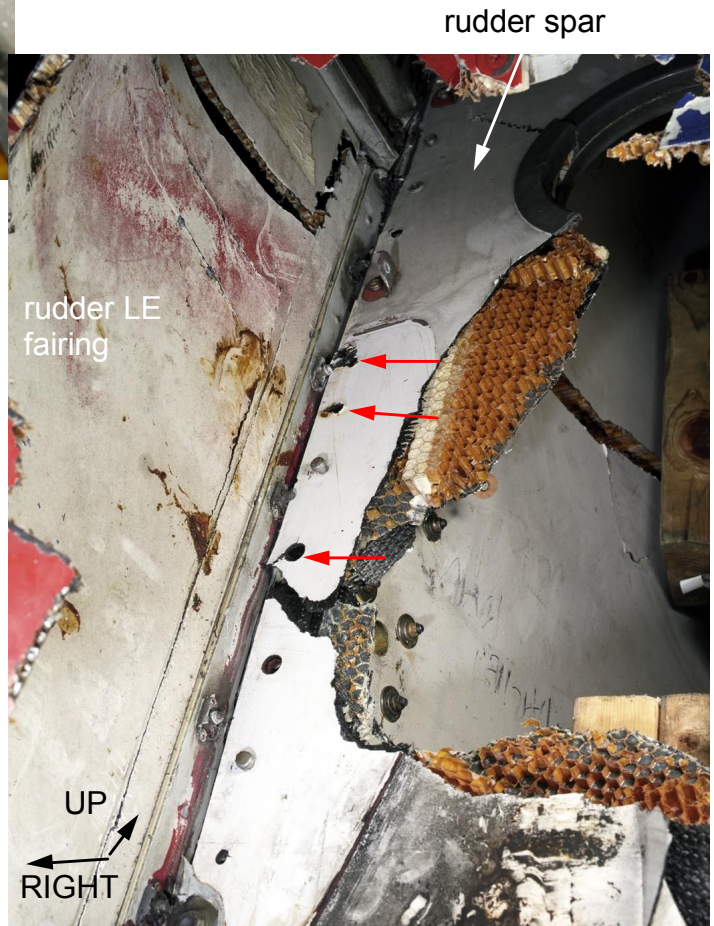
Figure 35. View of the right hinge 4 aft attach area on the rudder spar. The piece of the aft fitting that remained attached to the rudder is shown. Unlabeled arrows indicate attach bolt holes that remained with the large upper rudder piece (including skin piece BRHS and CLHS).

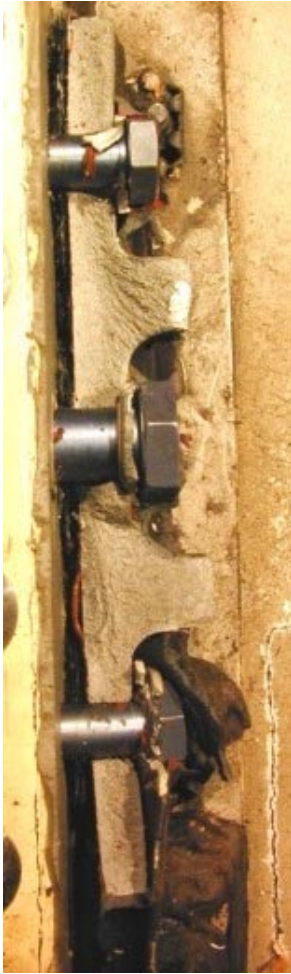
Hinge 2

Figure 36. View looking to the left of the left sides of the hinge 2, 3, and 4 aft fitting pieces that remained attached to the rudder, showing fracture surfaces and deformation.

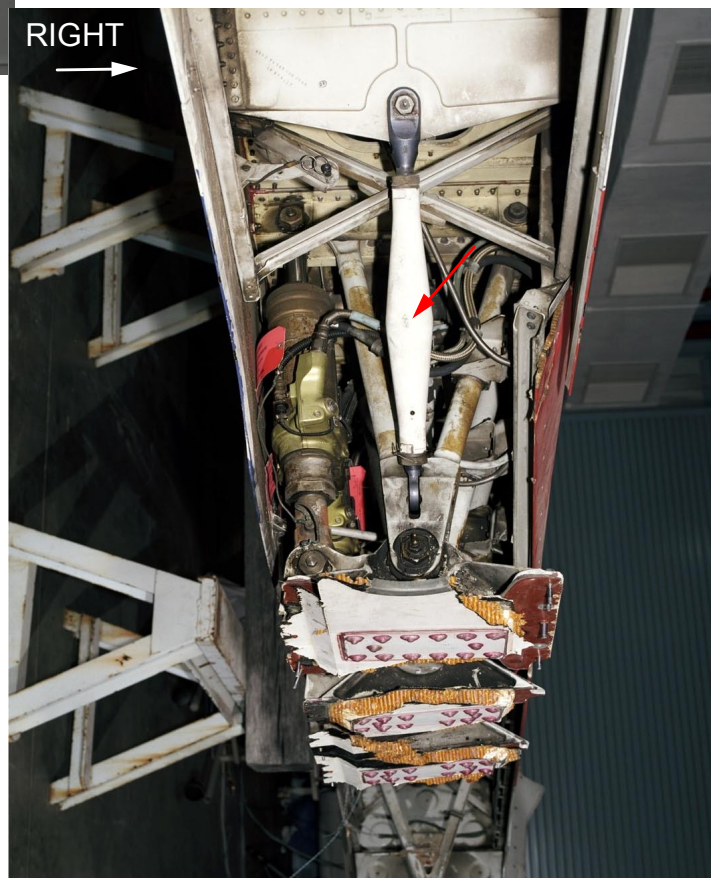
Figure 39. A closer view of the damage on the upper side of the vertical support strut.

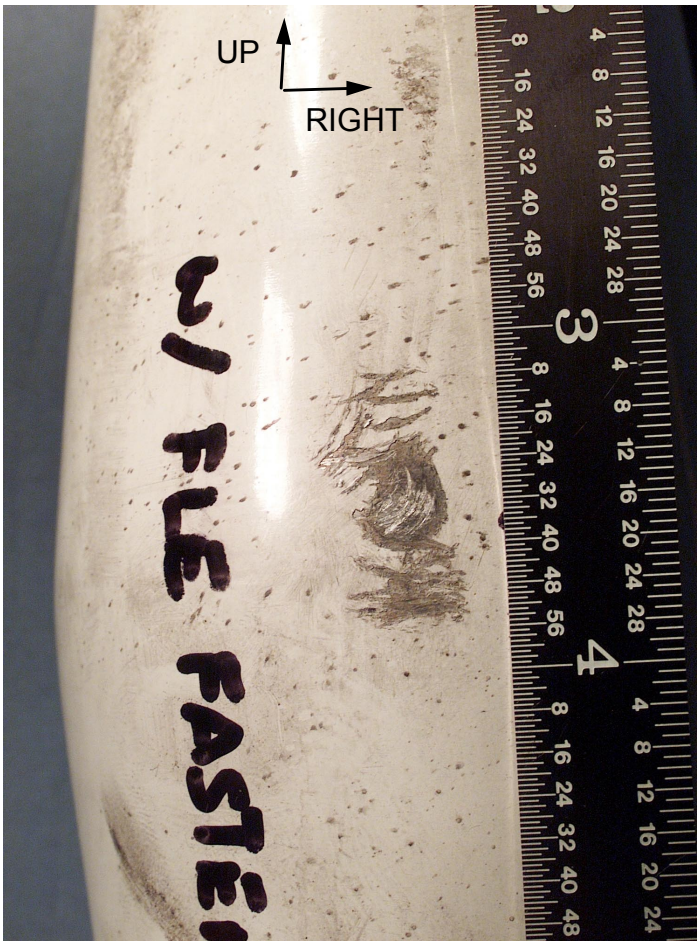
Figure 40. A close view of the damage on the left side of the vertical support strut.

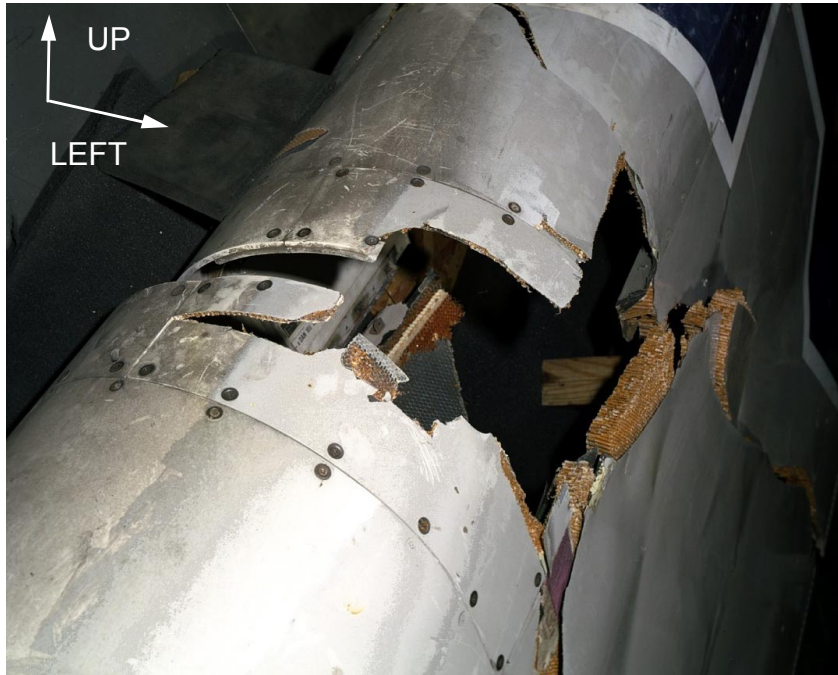
Figure 48. The left side of the LE fairing at hinge 1 as viewed looking mainly aft.

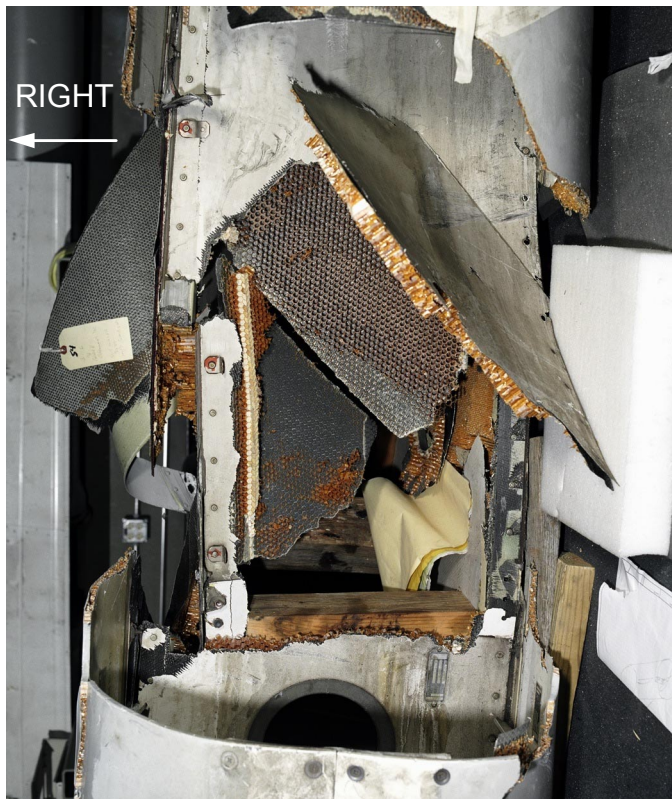
The internal face sheet of the spar web was fractured from the core in an area above hinge 1, as shown in figure 51. Blind rivets at the left side of the spar pulled through the external facesheet in this area. This fracture was consistent with a tensile or peeling force perpendicular to the plane of the spar web.

Figure 51. View of the rudder spar at hinge 1 looking mainly aft with fractured pieces of the LE fairing removed.

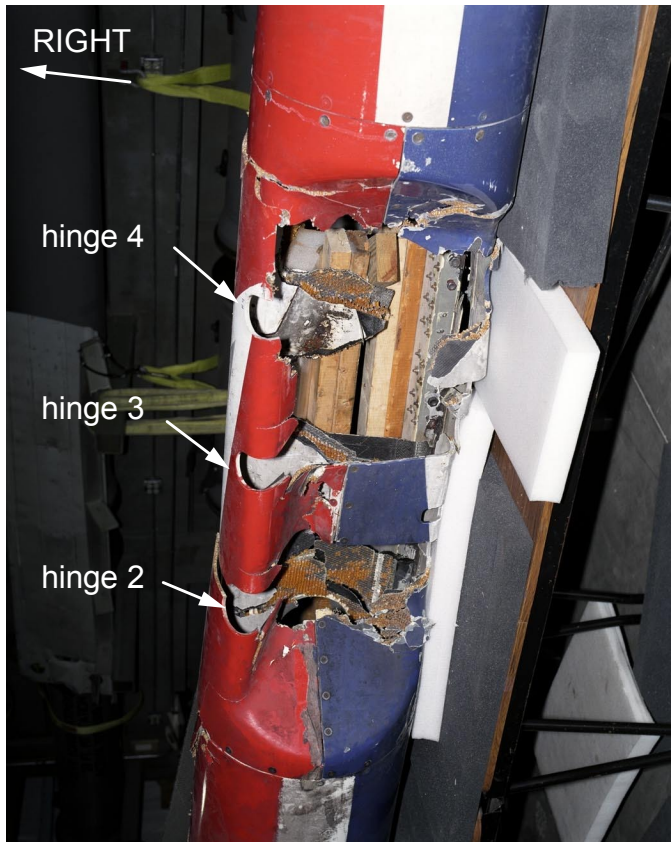
Figure 52. The LE fairing at hinges 2 to 4 as viewed looking mainly down and aft.

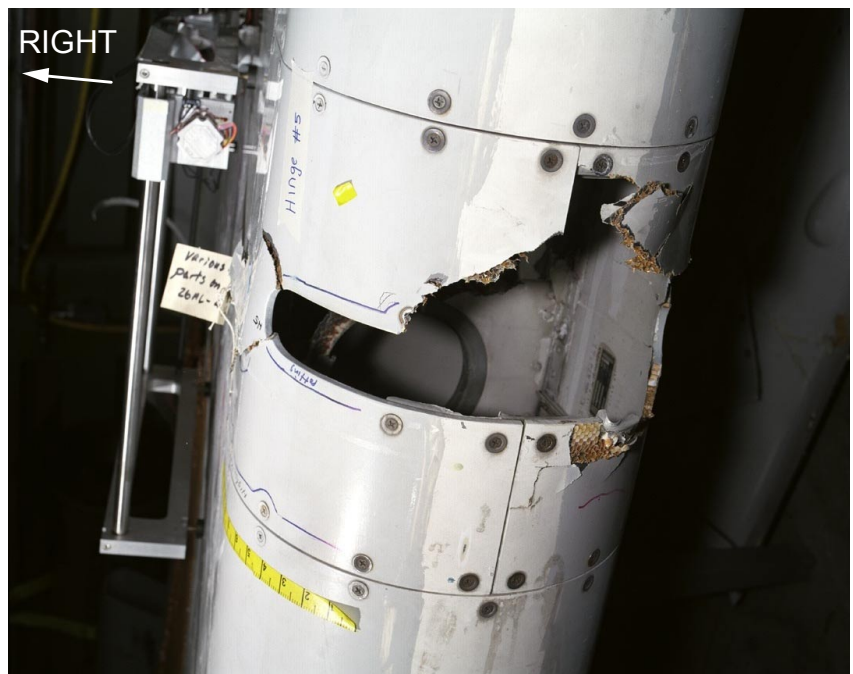
Figure 53. The LE fairing at hinge 5 as viewed looking mainly down and aft. Lamb wave equipment used for nondestructive examination is shown in the background on the right skin panel.

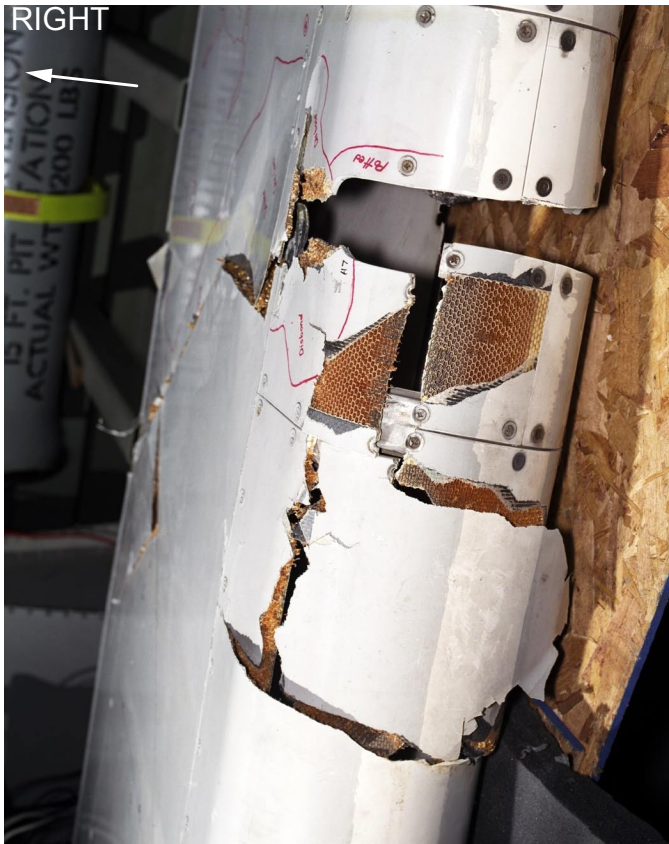
An overall view of the LE fairing at hinge 7 is shown in figure 57. The LE fairing had multiple fractures below the hinge 7 cutout. One of the pieces below the cutout was recovered on land. Material was missing from both the right and left ends of the cutout, and the width of the missing material appeared to correspond to the width of the forward fitting arms.

Figure 57. View of the LE fairing at hinge 7.

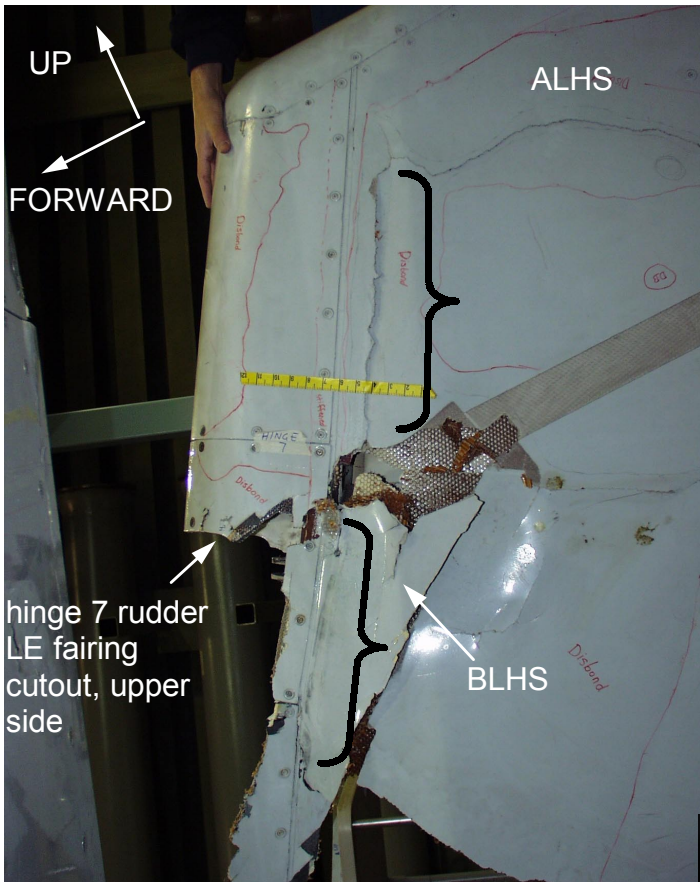
Pieces ALHS and BLHS had damage corresponding to heavy contact between the rudder left side and the vertical stabilizer left TE panel. A view of the damage on the rudder is shown in figure 63 with pieces ALHS and BLHS shown in their respective positions. Above hinge 7 on piece ALHS, the line of contact damage was nearly parallel to the rudder spar. Below hinge 7 on piece BLSH, the damage was not parallel to the rudder spar.

Figure 63. Left side view of pieces near hinge 7 where bracket indicate damage consistent with contact with the vertical stabilizer TE panel.

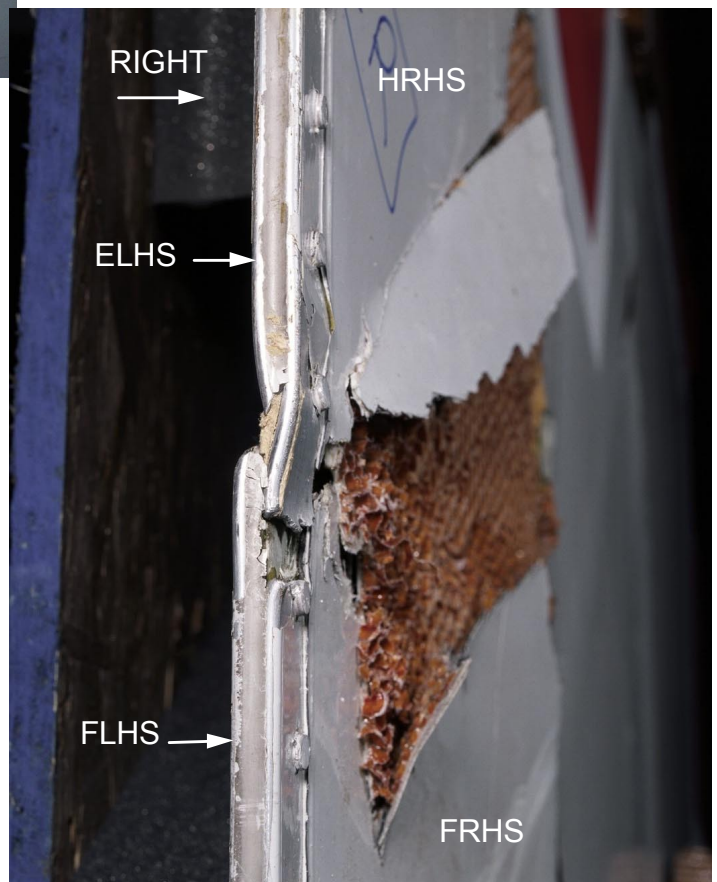
The metal trailing edge strips were fractured at many locations along the length of the rudder. The lowest fracture, shown in figure 64, was 36 inches above the lower rib,⁵

Figure 64. Fracture at the trailing edge between pieces FRHS and FLHS and pieces HRHS and ELHS showing local deformation of the metal trailing edge strips.

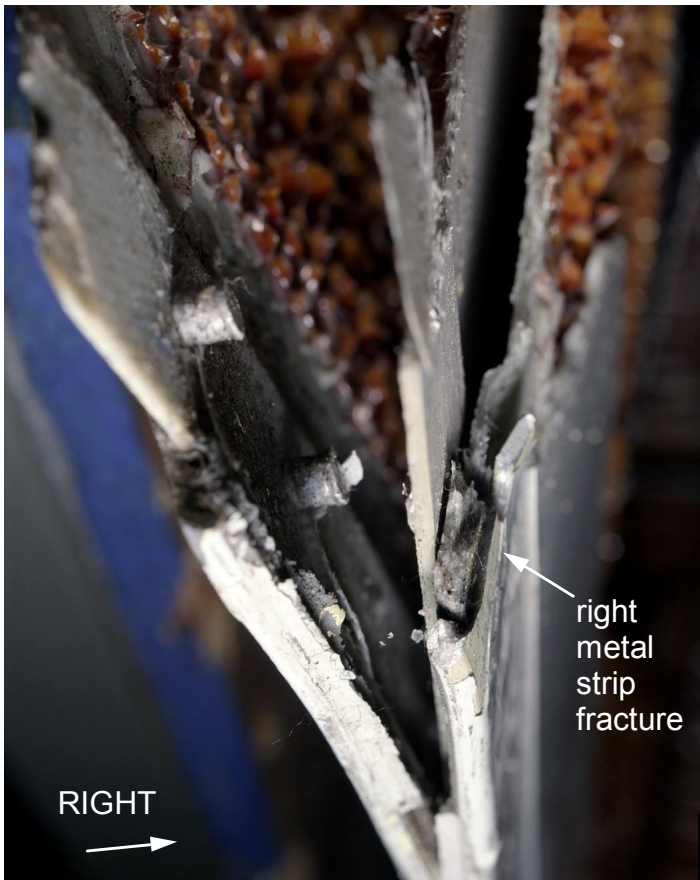
On the right side moving upward, the next two fractures in the metal trailing edge strips were at 75 inches and 99 inches above the lower rib, locations corresponding to the lower and upper sides of CRHS at the trailing edge. The metal piece between these fractures was missing. The fractures, shown in figures 65 and 66, had local twisting deformation that appeared symmetric, consistent with piece CRHS rotating counterclockwise relative to the upper and lower pieces as viewed looking up.

Figure 65. View looking down at the fracture at the upper end of piece HRHS showing local deformation of the metal trailing edge strips.

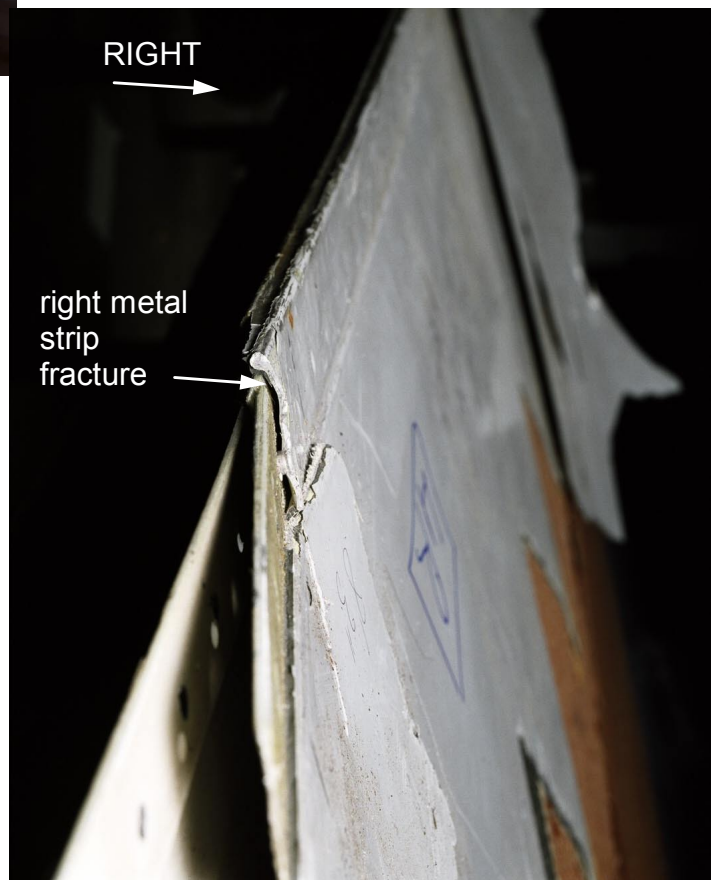
Figure 66. View looking up at the fracture at the lower end of piece DRHS showing local deformation of the metal trailing edge strip.

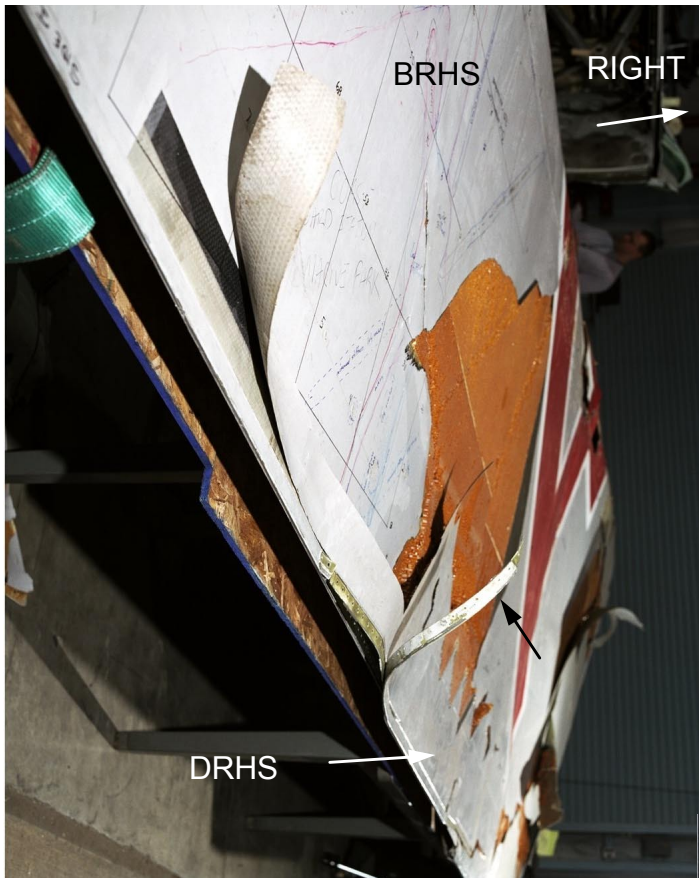
On the right side, the metal strip was separated at 159 inches above the lower rib, a location corresponding to a junction between the manufactured ends of two metal strip pieces. The upper portion of the metal strip had a general bend and twist as shown in figure 67 consistent with piece DRHS rotating upward and twisting counterclockwise (as viewed looking up) relative to piece BRHS.

Figure 67. The trailing edge of the rudder as view looking down and forward. An unlabeled arrow indicates the right trailing edge strip generally deformed near the upper end of piece DRHS.

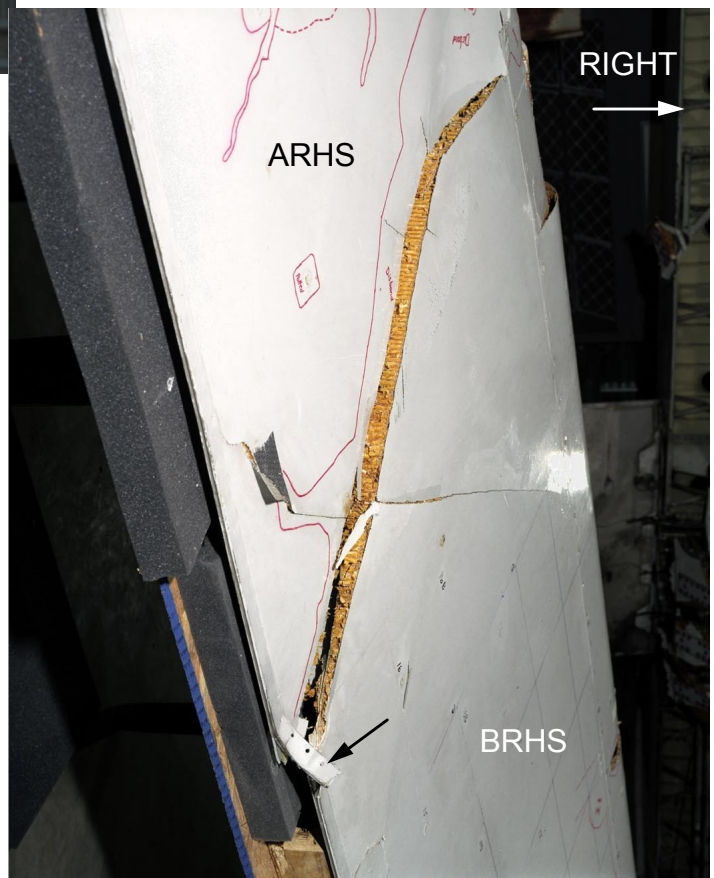
The uppermost fractures of the trailing edge metal strips were aft and below hinge 7 between pieces BRHS and ARHS on the right and between pieces CLHS and ALHS on the left. An overall view of the right side is shown in figure 68. The local deformation on both sides of the fracture was consistent with pieces ARHS and ALHS bending to the right and aft relative to pieces BRHS and CRHS.

Figure 68. The rudder trailing edge aft of hinge 7 as viewed looking mainly forward. An unlabeled arrow indicates the fracture at the trailing edge between pieces ARHS and BRHS showing local deformation of the metal trailing edge strip.

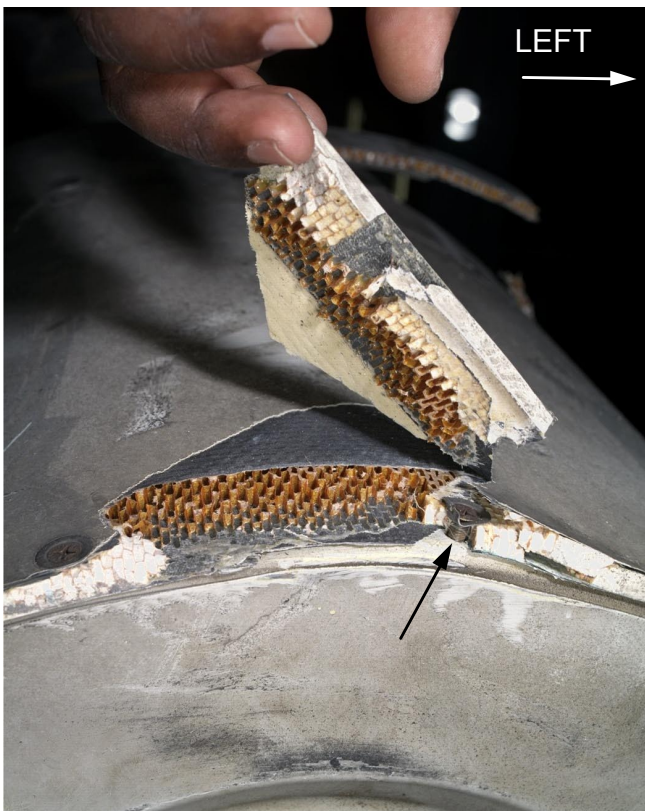
At the lower end of the LE fairing near the centerline, material was peeled from right to left as shown in figure 70. The fiberglass filler in the honeycomb cells was sheared on the right side of the damage. The right side of the washer for the fastener at the centerline was bent forward.

Figure 70. Damage at the lower end of the LE fairing as viewed looking upward and aft. An unlabeled arrow indicates the bent washer at the centerline fastener.
