INSPECTION PROTOCOL

Subject: Fin box and rudder inspection on aircraft A300-600, MSN 420 at NASA Langley Research Center in Hampton, Virginia / USA.

Title: Ultrasonic PHASED ARRAY inspection of vertical stabilizer A300-600 MSN 420, concerning delamination in the area of CFRP-stringers and CFRP-ribs.

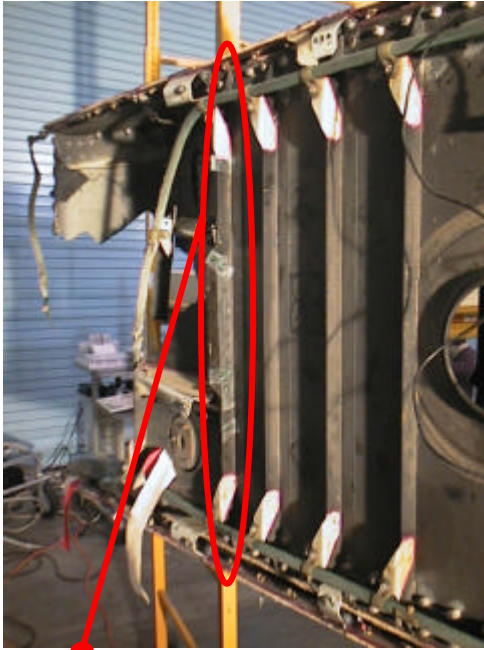
Stiffener no.1 / front spar

- (b1) Front Spar /Stiffener No. 1 (see also photo no. 1)
 ! Length Dimension of debondings between Skin and Front Spar angle are illustrated in Fig. 02/03

Delamination in stiffener no. 1 area at front spar

Photo no. 01: Delamination at front spar; stiffener no. 1

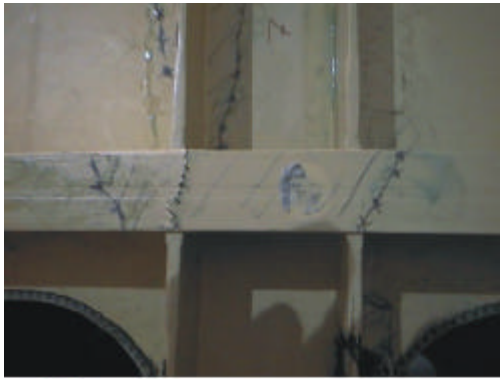
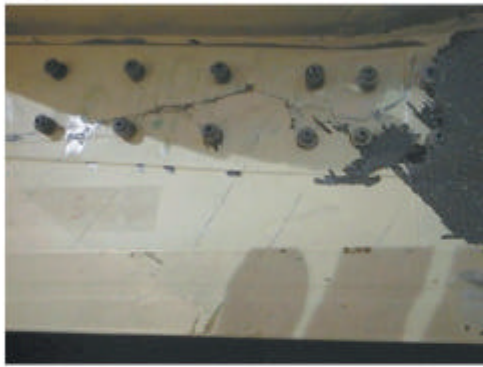
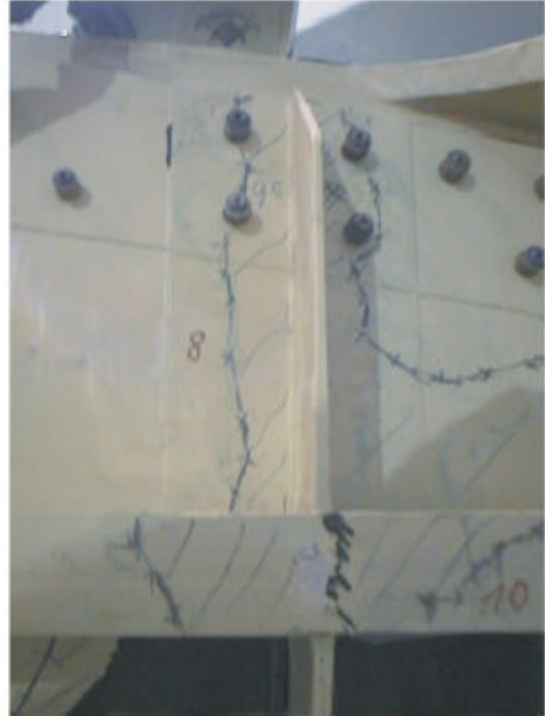
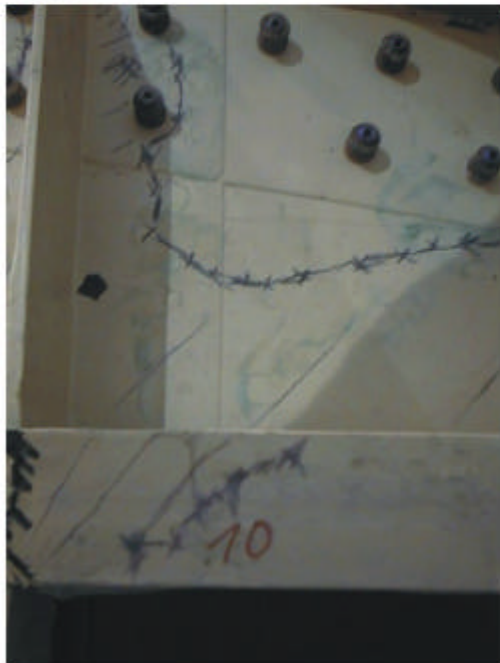
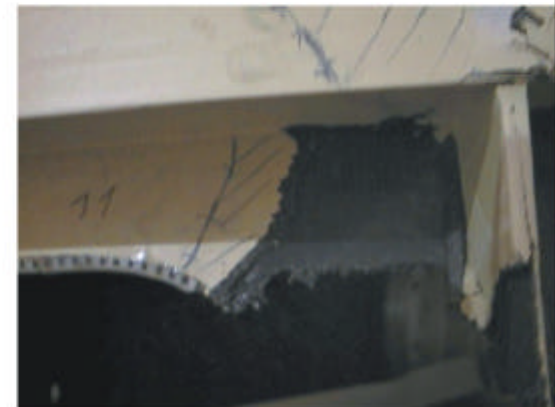
Fig.10: Photo documentaion of Findings 7-11 between center spar and front spar

(d2) UT-results from rest of rib no. 1 between center spar and front spar (refer to Fig.08 and documentation photos).

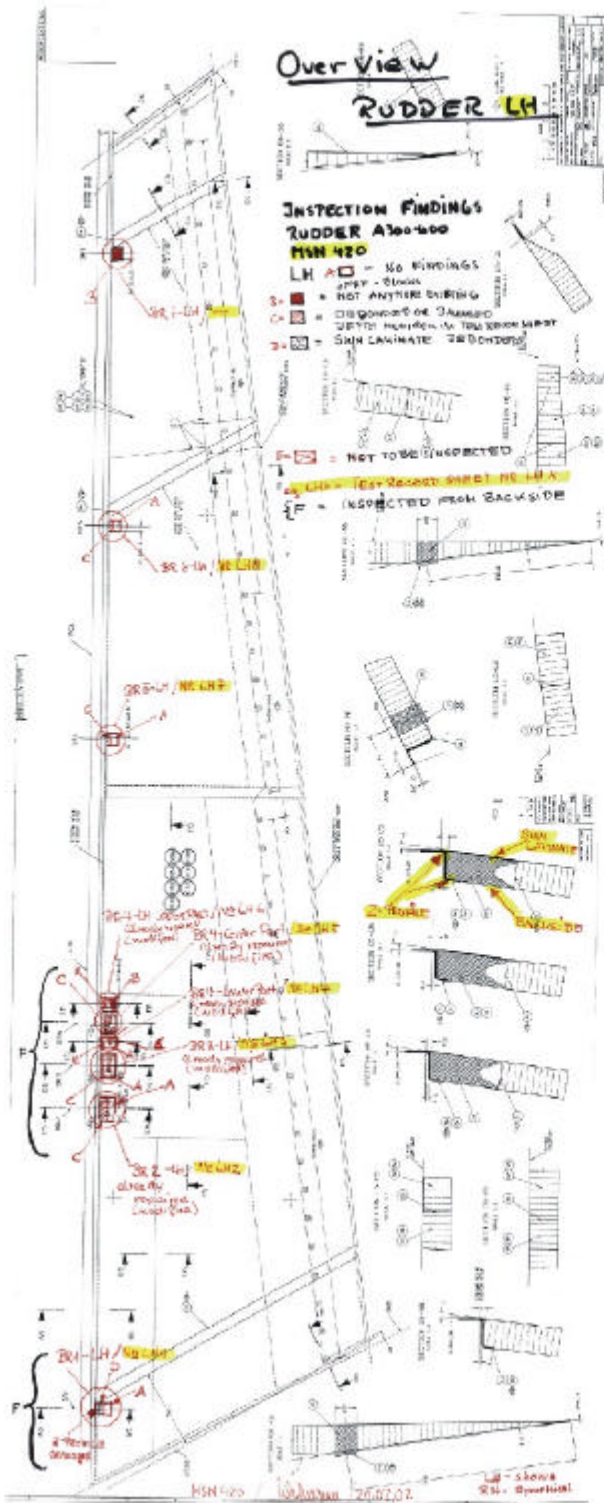
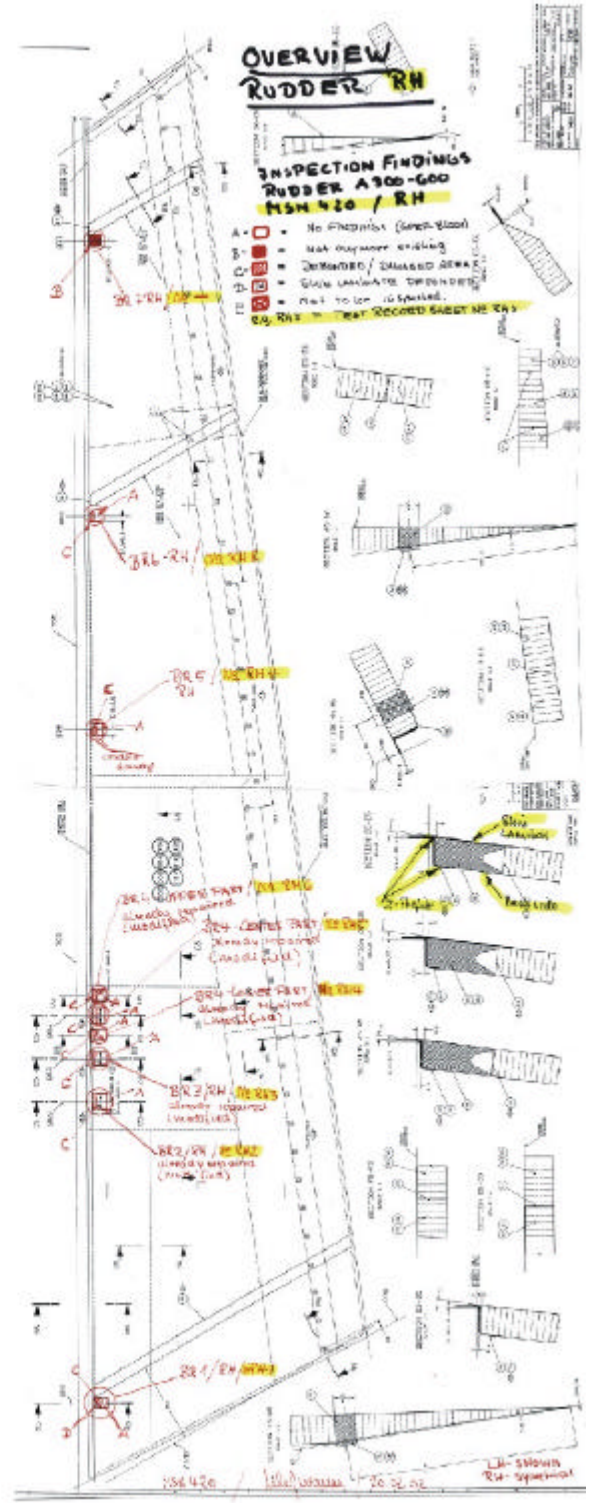
PART 4
Record Sheet - Hinge Attachment Area BR1 LH **55-40-04**
Figure 408

Rudder -
 Debondings, delaminations and damages were found in and at fiber glass hinge attachment blocks

- (a) Ultrasonic inspection results of the glass fiber hinge attachment blocks of rudder in accordance with NTM A300-600 SSI no. 55-40-04 in not repaired or modified areas.
 UT-inspection in glass fiber hinge attachment blocks already modified or repaired.

Z-PROFILE DEBONDED

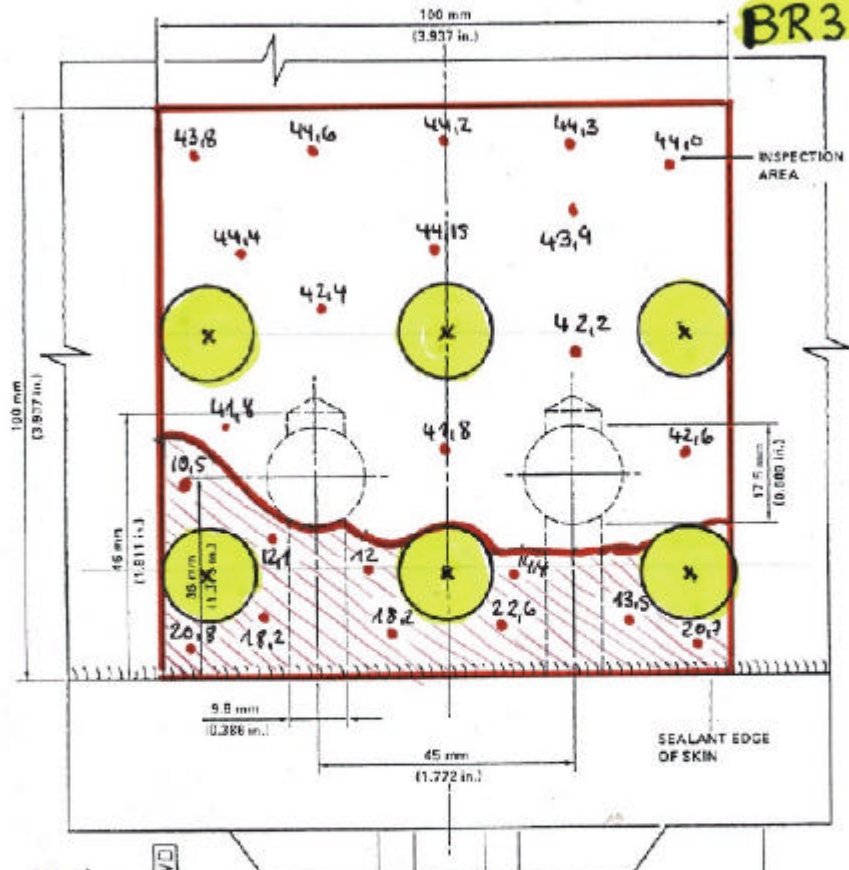
BR3-RH

X Rivets already repaired

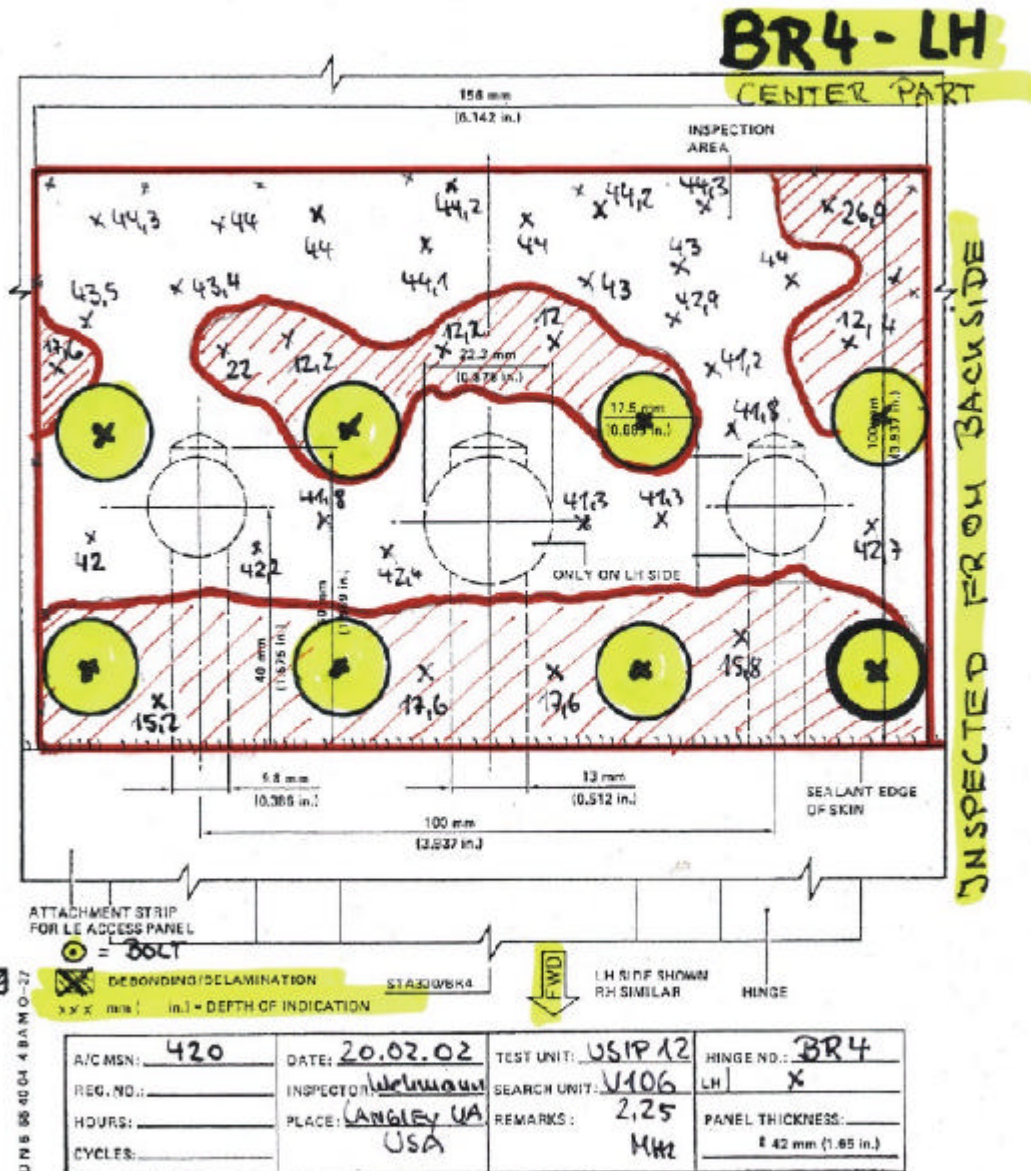
Record Sheet - Hinge Attachment Area BR4 (center LH)
Figure 412

= DAMAGED AREA (NO BACKWALL ECHO)
 = Not inspectable (space between bolts)

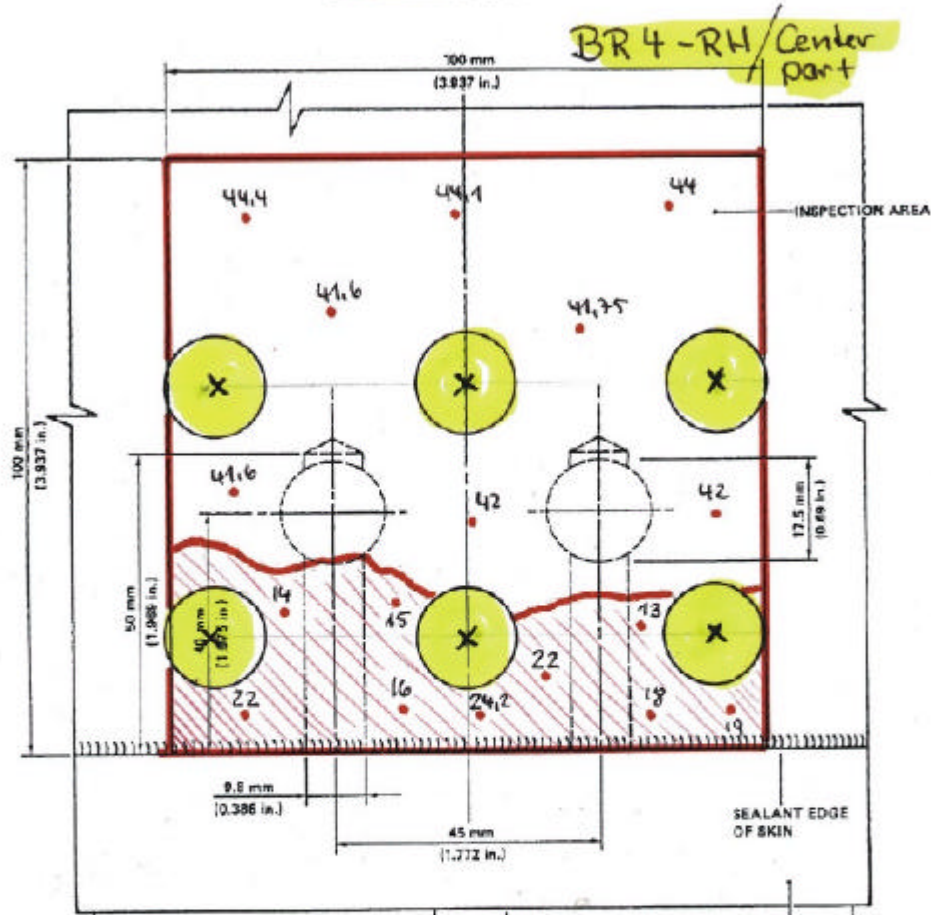
(X) Rivets/bolts (area already repaired.) STA330/R34
 DEBONDING/DELAMINATION HINGE
 RH SIDE SHOWN
 ATTACHMENT STRIP FOR LE ACCESS PANEL
 x x x mm (in.) = DEPTH OF INDICATION

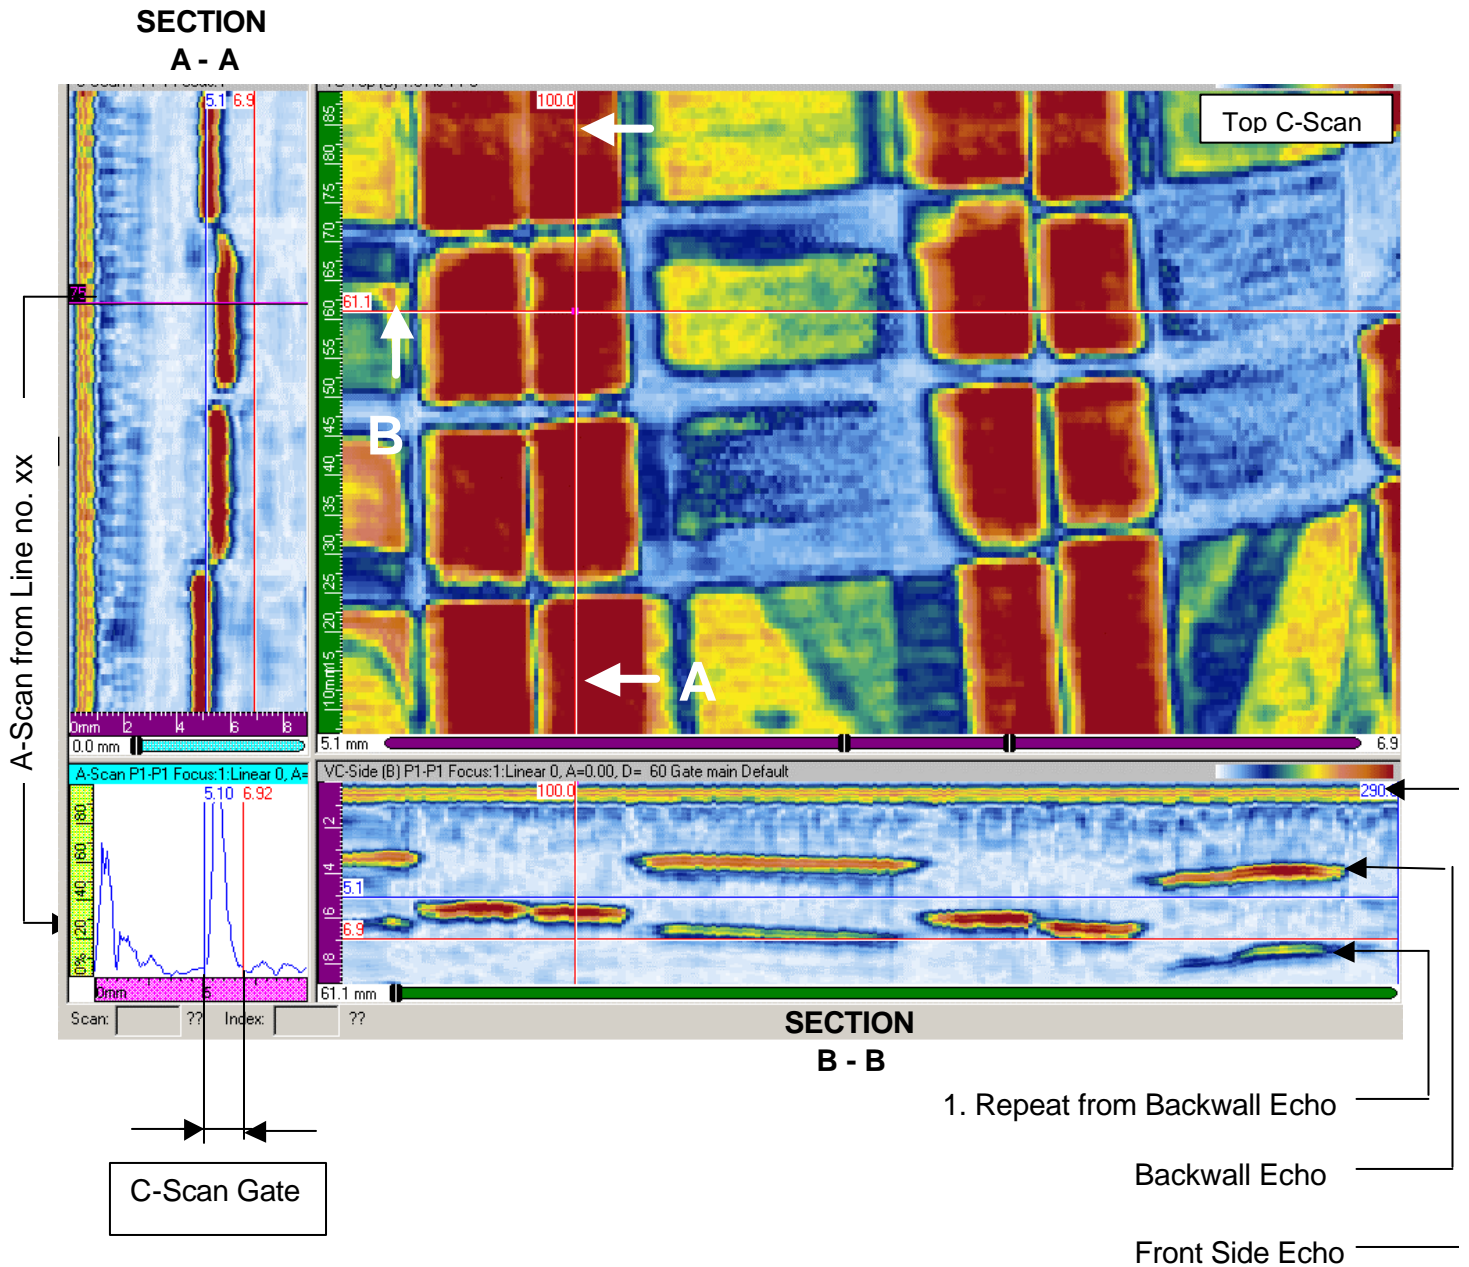
Example for an area without indication

NOTE: All above documented indications are below the size to be registered in accordance with the quality requirements (see also the following detail sketches).
