# NATIONAL TRANSPORTATION SAFETY BOARD

MATERIALS LABORATORY FACTUAL REPORT

Report No. 02-083

Place : Belle Harbor, New York  
Date : November 12, 2001  
Vehicle : Airbus A300-600, N14053  
NTSB No. : DCA02MA001  
Investigator : Brian Murphy, AS-40

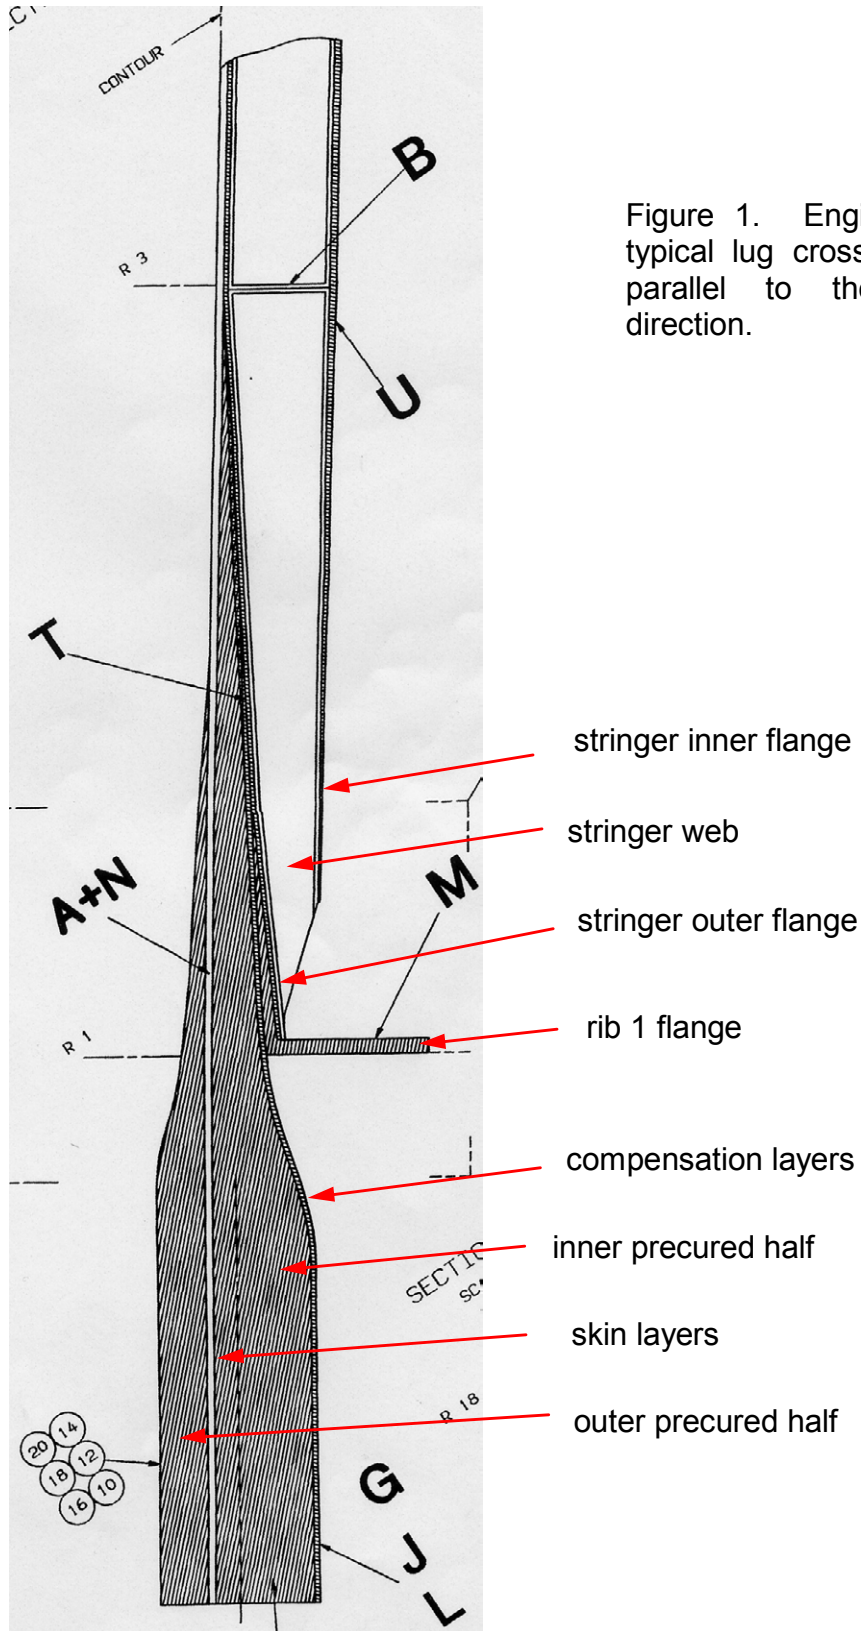
Figure 1. Engineering drawing of a typical lug cross section in the plane parallel to the zero-degree fiber direction.

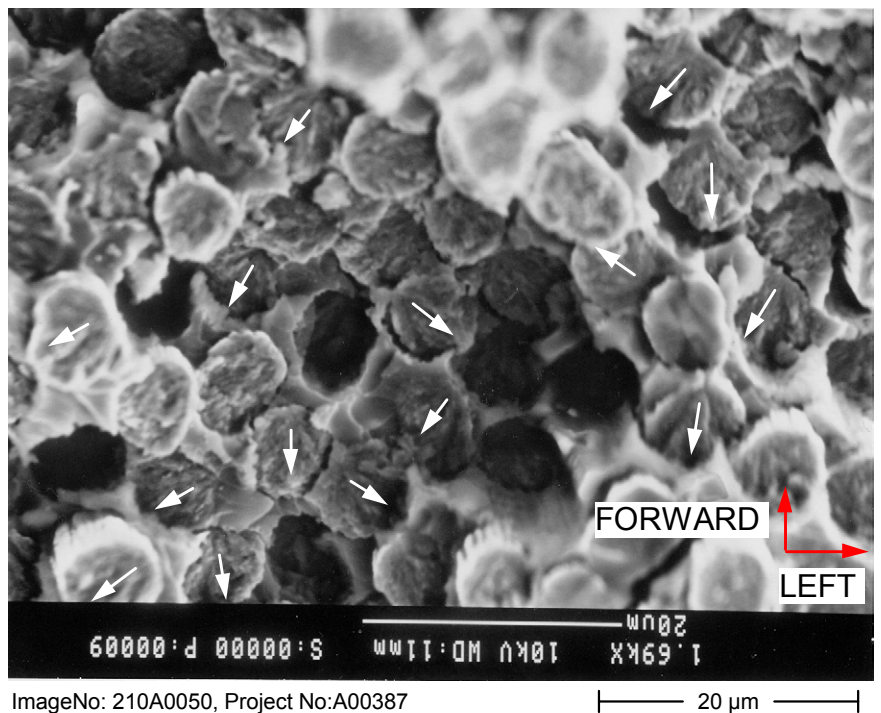
Figure 8. Typical appearance of the fractured zero-degree fibers on specimen RA3-2 near the center of the total lug thickness. Arrows on fractured fibers indicate direction of fracture propagation through the fiber.

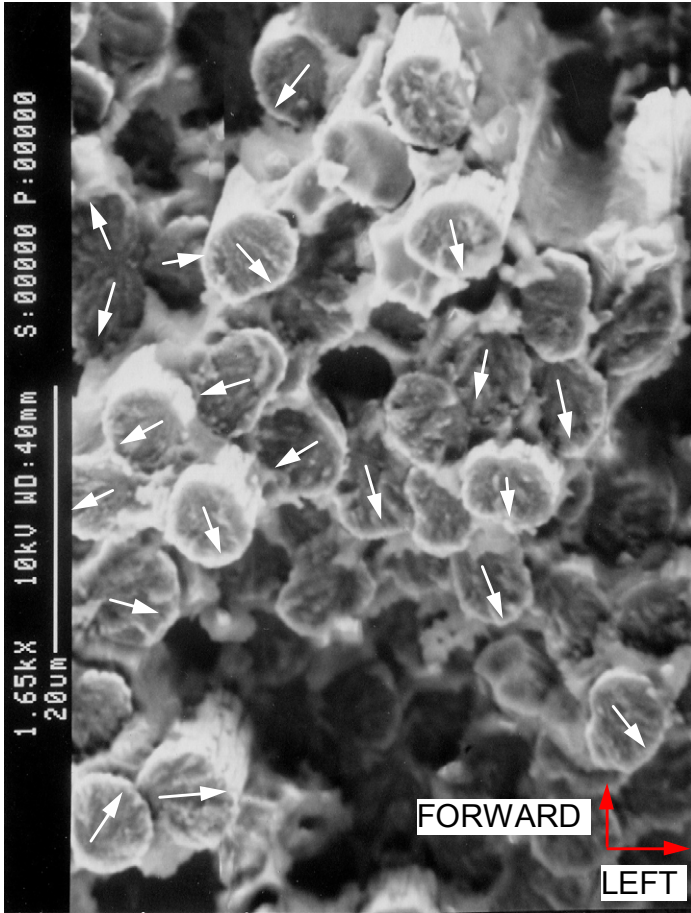
Figure 21. Typical appearance of the fractured zero-degree fibers on sample RF2a near the exterior surface. Arrows on fractured fibers indicate direction of fracture propagation through the fiber.

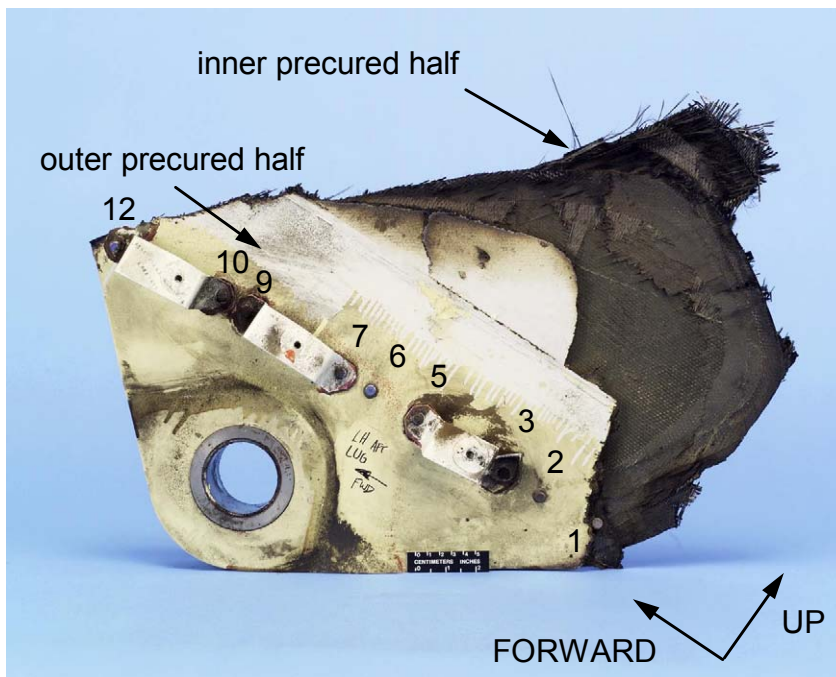
Figure 26. Overall view of the lower piece containing the lower portion of the fracture at the left aft lug, viewed looking to the right.

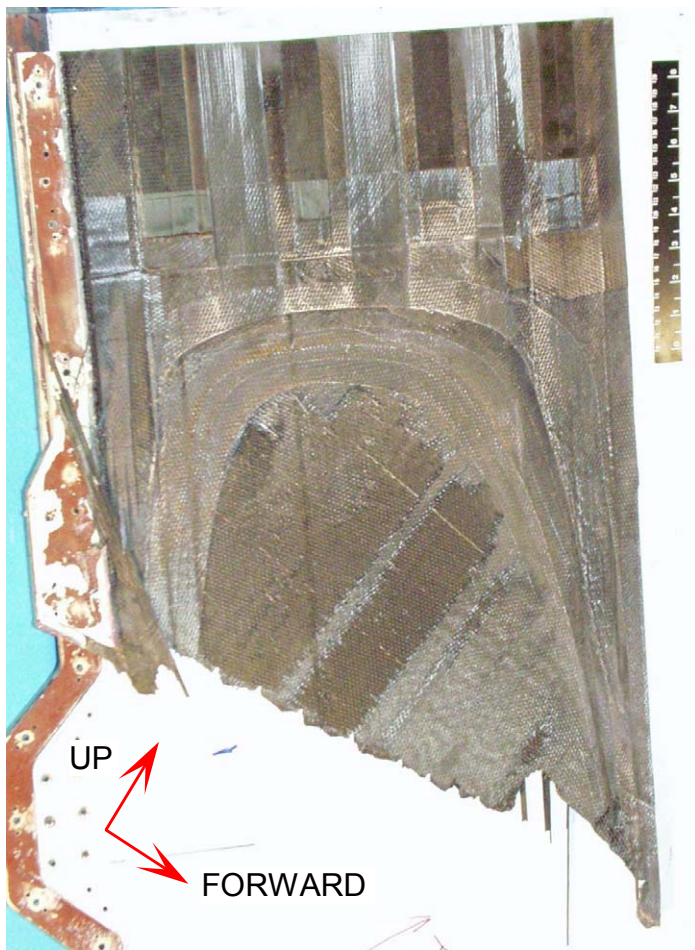
Figure 28. Inner surface of the vertical stabilizer skin section at the left aft lug after cutting from the upper piece. The lower portion of this interlaminar surface mates to the outer surface of the inner precured lug half.

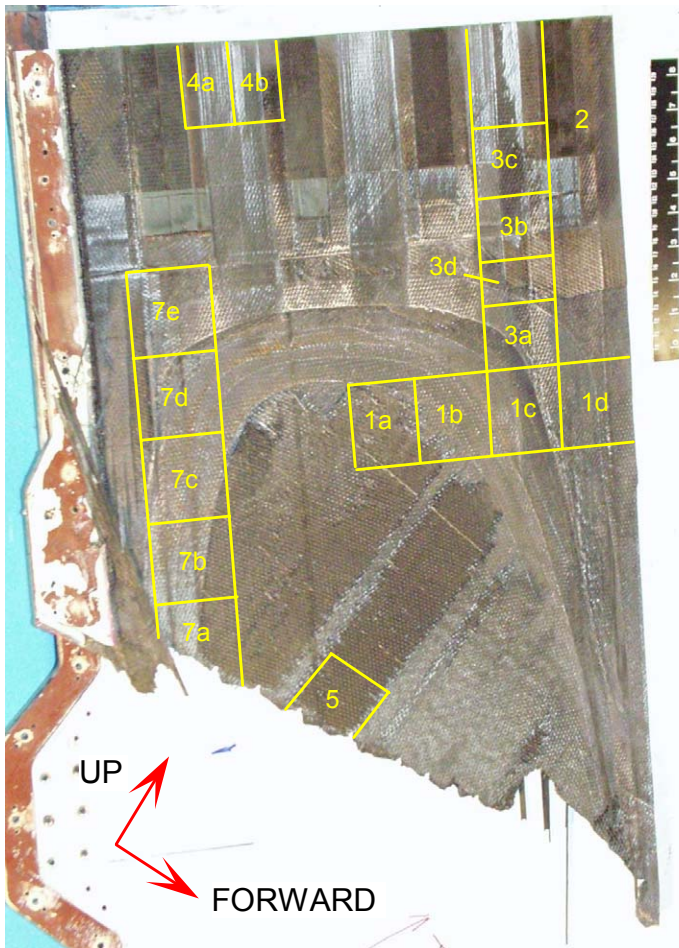
Figure 29. Specimens cut from the skin section at the left aft lug fracture area for examination using SEM.

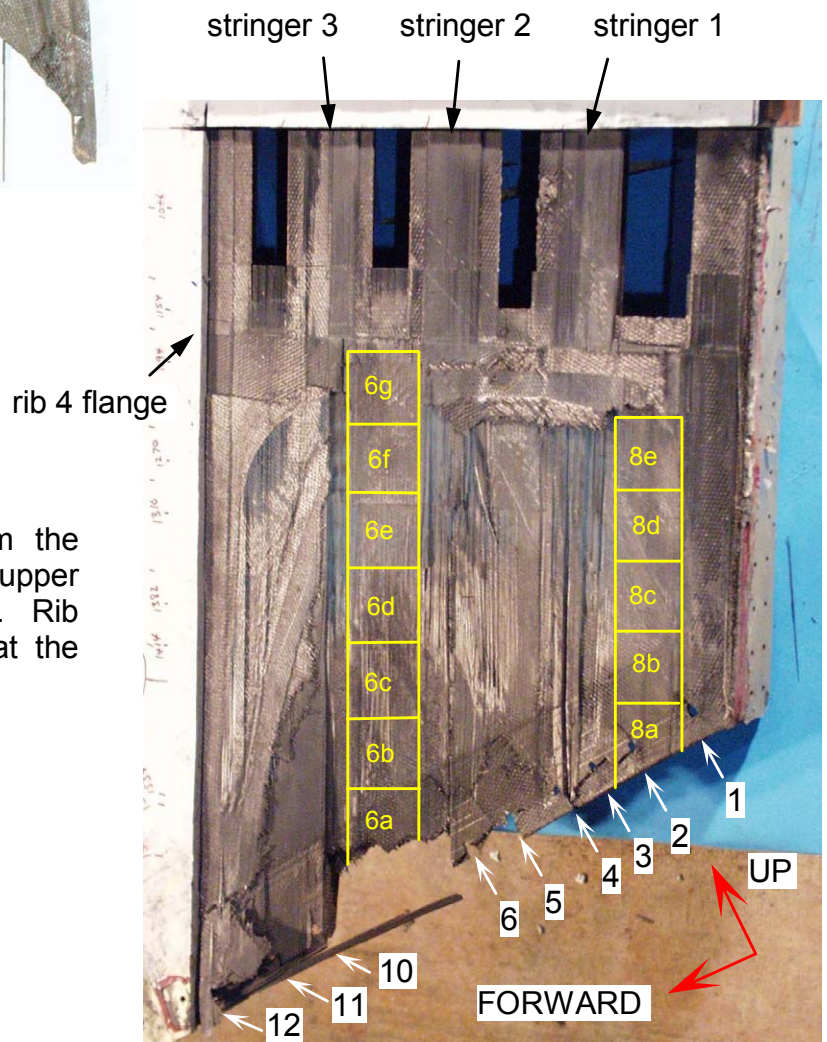
Figure 30. Specimens cut from the stringer module structure of the upper piece for examination using SEM. Rib 1 fastener holes are numbered at the bottom of the part.

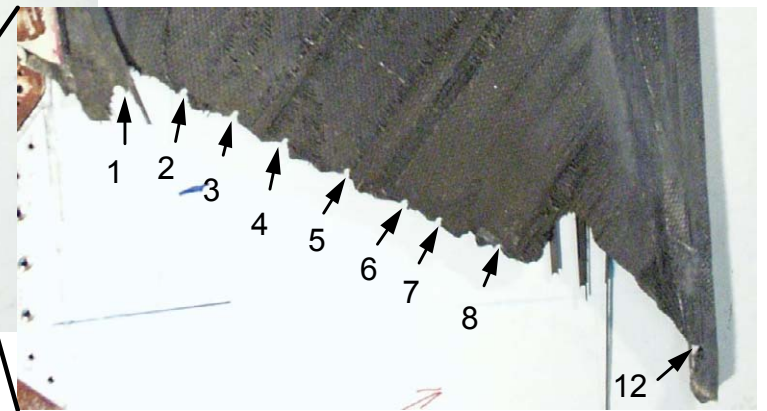
Figure 32. Vertical stabilizer skin fracture at a rib 1 fastener hole in the vicinity of the left aft lug, viewed looking upward.

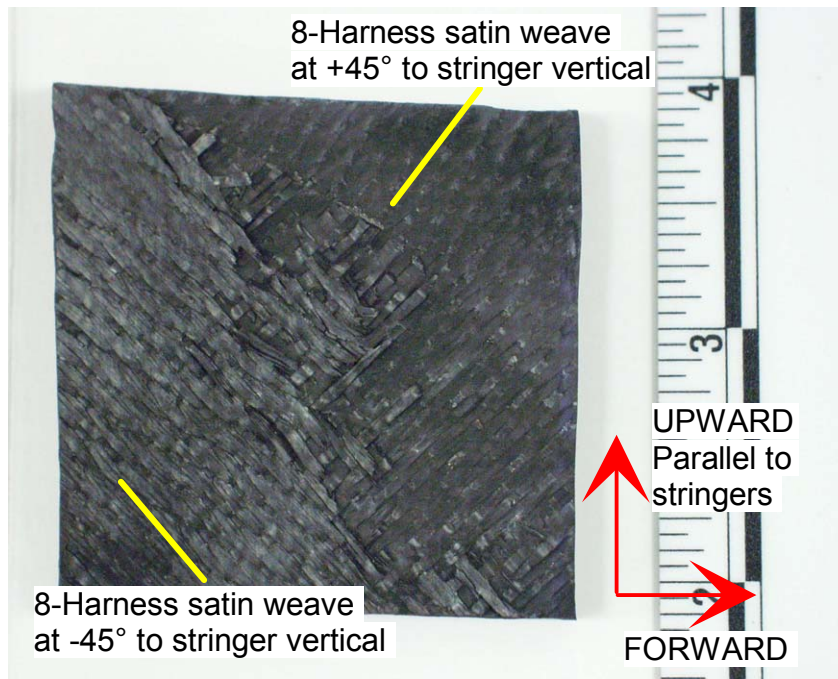
Figure 35. Fracture surface of specimen LA1a.

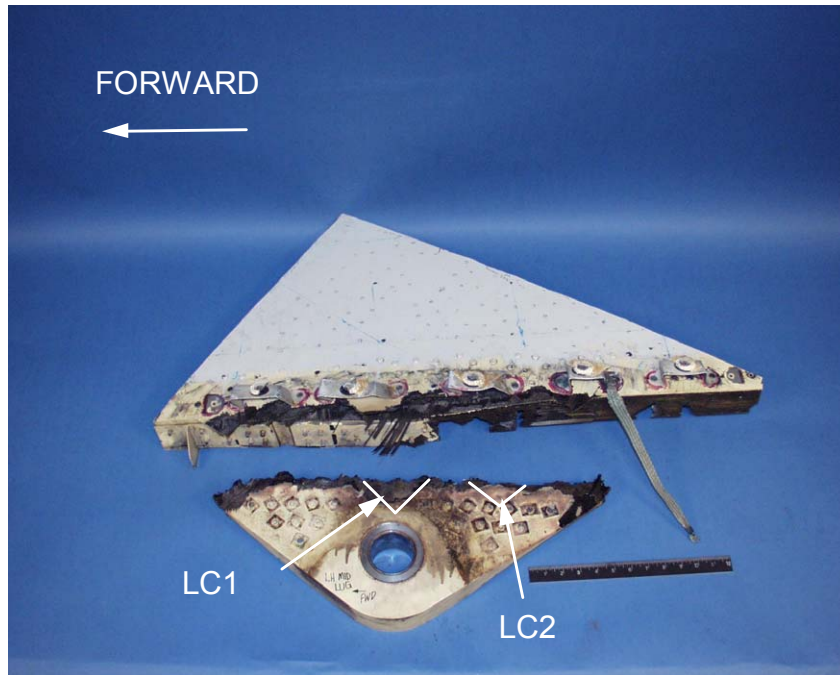
Figure 41. Overall view of the two portions of the fractured structure at the left center lug viewed looking from the left.

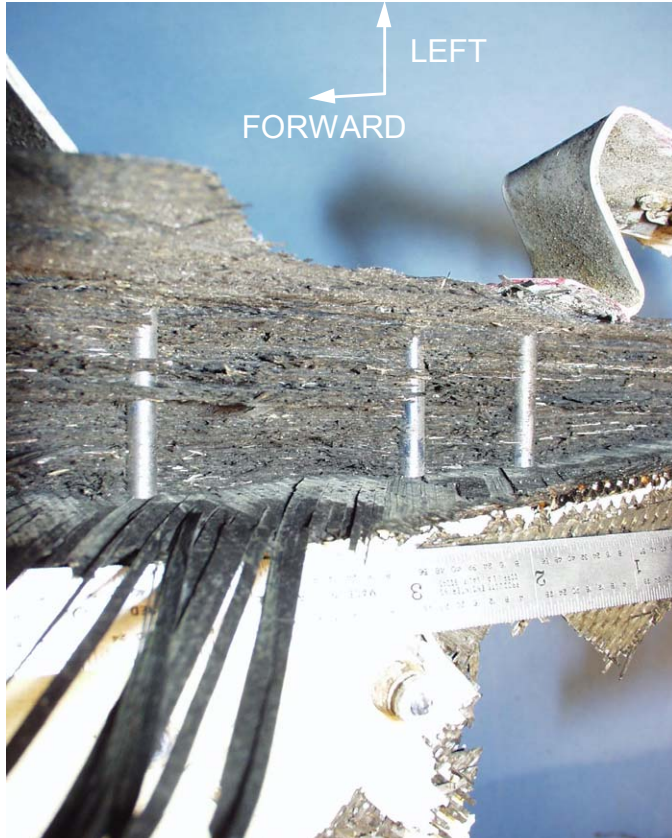
Figure 42. Upper fracture surface at the left center lug, viewed looking upward parallel to zero-degree fibers.

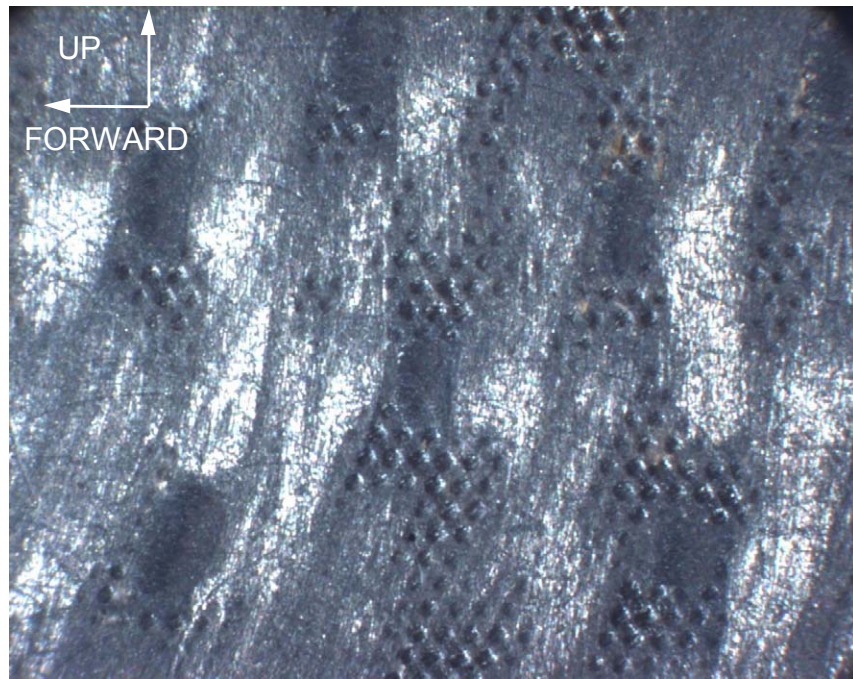
Figure 43. Interlaminar fracture surface on the inboard piece of specimen LC2.

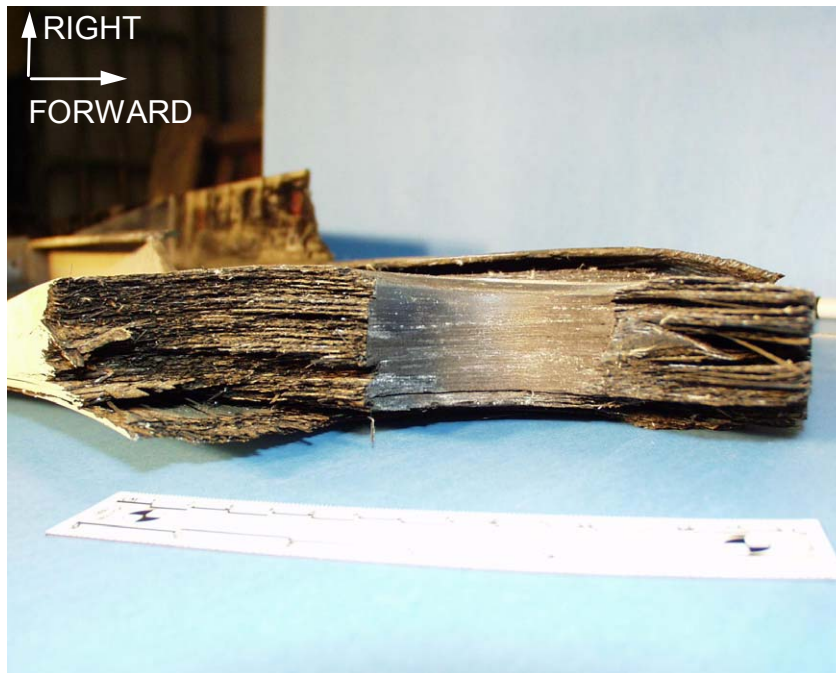
Figure 46. Upper fracture surface of the left forward lug, viewed looking up.

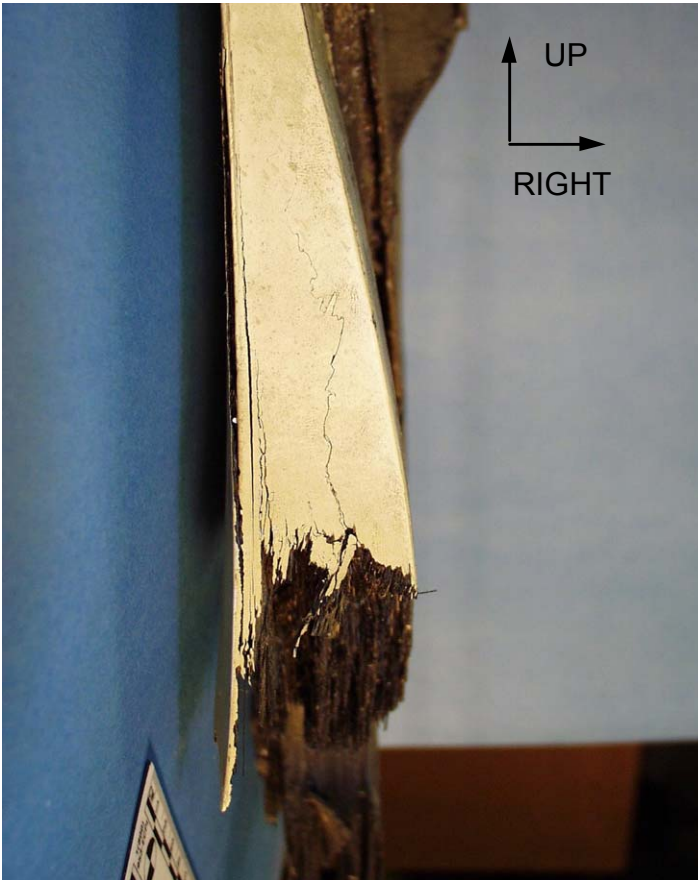
Figure 47. View of the aft surface of the left forward lug.

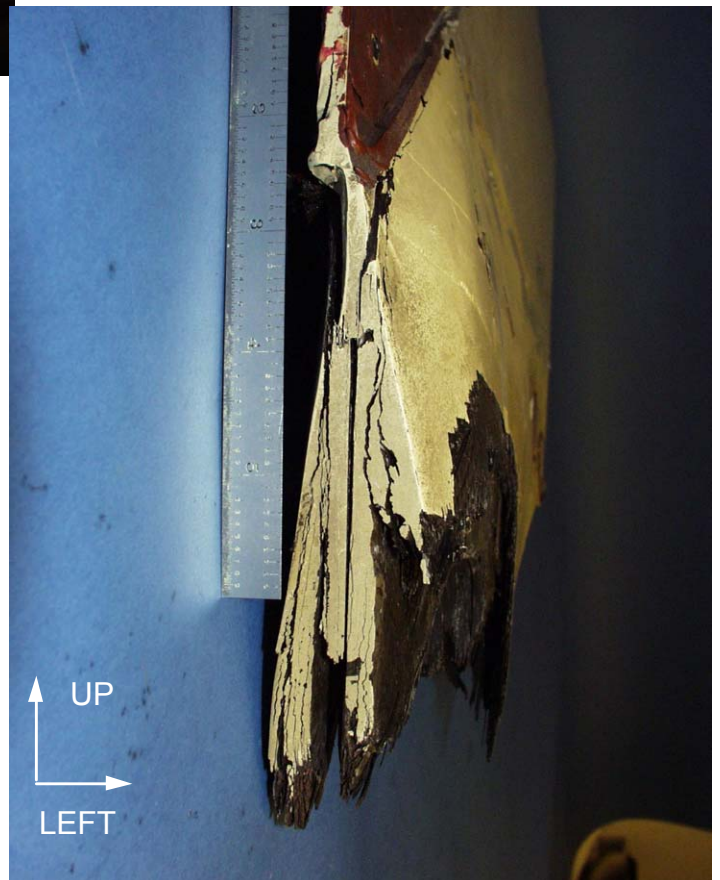
Figure 48. View of the forward surface of the left forward lug.

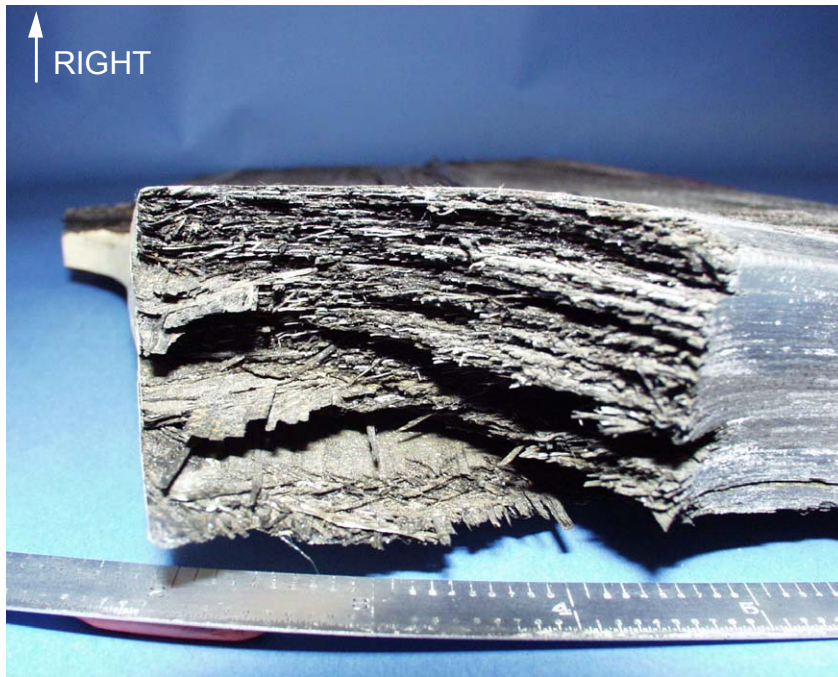
the ply separation at the aft and forward surfaces of the lug are shown in figures 49 and 50. On the outboard side of the hole above the bore, a bearing indentation was observed as shown in figure 45. The indentation was approximately 1/8 inch deep and the shape corresponded to the profile of the upper end of the outboard lug on the fuselage clevis attach fitting.

Figure 49. Closer view of the left forward lug upper fracture surface, aft leg, as viewed looking upward parallel to the zero-degree fiber direction.

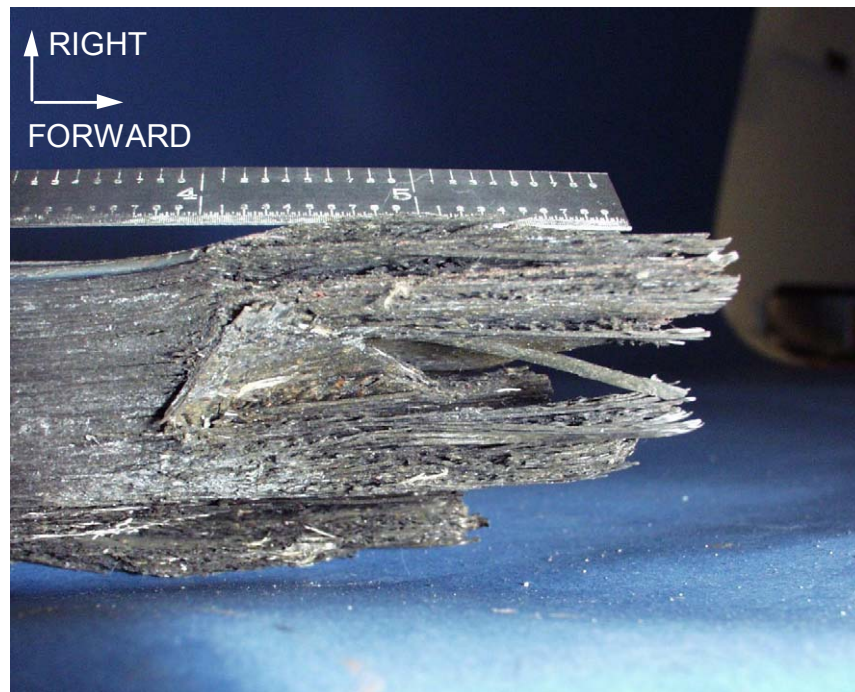
Figure 50. Closer view of the left forward lug upper fracture surface, forward leg, as viewed looking up.

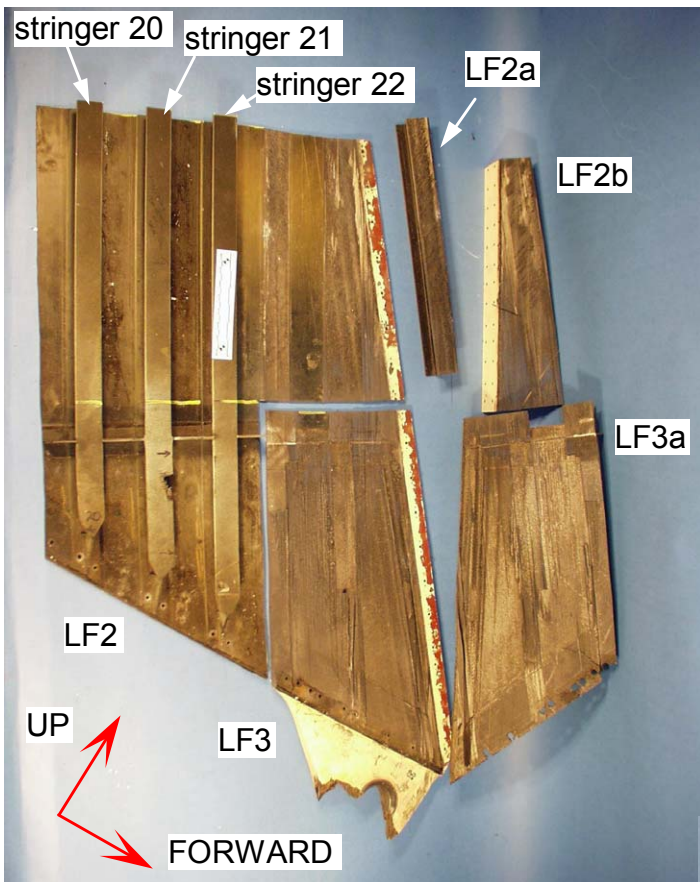
In order to expose the interlamina fracture surfaces between the stringer module and outer flange layers above rib 1, three cuts were made using a diamond bandsaw. The mating pieces are shown after cutting in figure 54. The first cut was 19 inches from the top of the part (9 inches below rib 3 and 19 inches above rib 2). The second cut was made approximately 2 inches above rib 2 from the front spar back to just aft of the flange of stringer 23. After making these first two cuts, the lengths of the stringer 23 and front spar flange between those two cuts (pieces LF2a and LF2b, respectively, in figure 54) came free from the rest of the part. The third cut was made just aft of the flange of stringer 23 up from the position of rib 1 to 2 inches above rib 2, where it intersected the second cut. Three ribbons of zero-degree tape, each approximately 1 inch wide, bridged between the two pieces and were snipped with wire cutters to finish separating the piece (piece LF3a in figure 54). One ribbon of tape that bridged the two pieces was along the aft flange of stringer 24, and was cut at a location approximately 8 inches above rib 1. The second ribbon of tape was along the forward flange of stringer 23, and was cut approximately 2 inches below rib 2. The third ribbon of tape was along the aft flange of stringer 23, and was cut approximately 4 inches below rib 2.

Figure 54. Mating pieces after cutting to expose the interlaminar fracture above the left front lug. Arrows indicate UP and FORWARD for the main pieces LF2 and LF3.

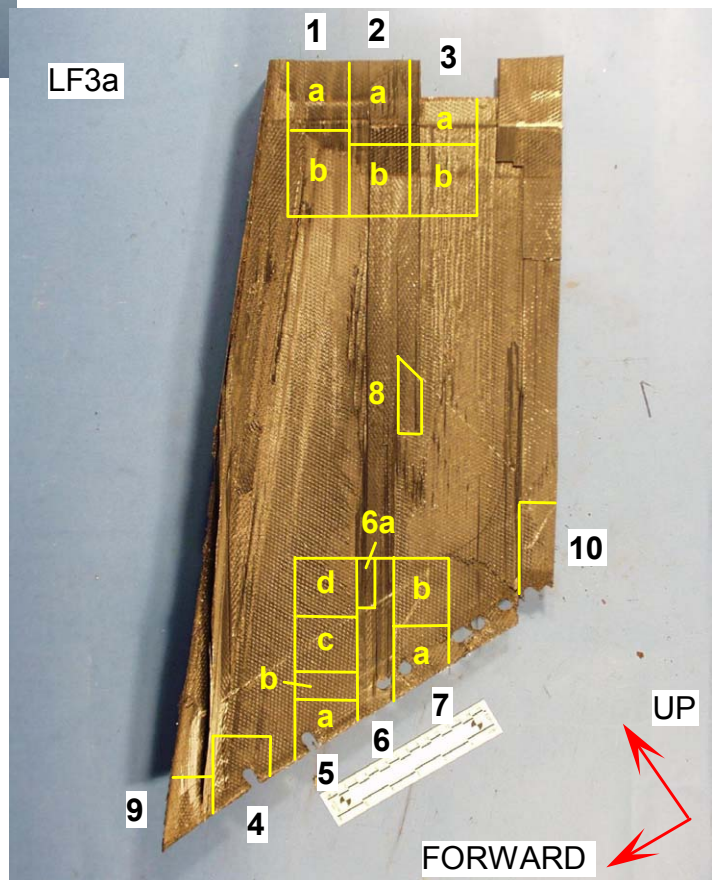
Several specimens were cut from the inner part containing the stringer structure labeled piece LF3a (as shown in figure 55) for microscopic examination of the fracture surfaces in the SEM. The specimens (LF3a-1, LF3a-2 and LF3a-3) at the top of piece LF3a straddled the position of rib 2. Specimens LF3a-1a and LF3a-1b were cut apart directly through the rib 2 web. Specimens LF3a-2a and LF3a-2b also straddled the web of stringer 24, which ran up from rib 1 but ended at rib 2. Two specimens were also cut from the top and bottom of piece LF2a (part of stringer 23), and a specimen was cut from the fracture surface at the top of piece LF2b (part of the front spar flange). Each specimen was cut into a piece approximately 2 inches on a side using the diamond bandsaw and/or a low-amplitude vibrating saw with the diamond-edged blade.

Figure 55. Specimens cut from section LF3a for examination in the SEM.

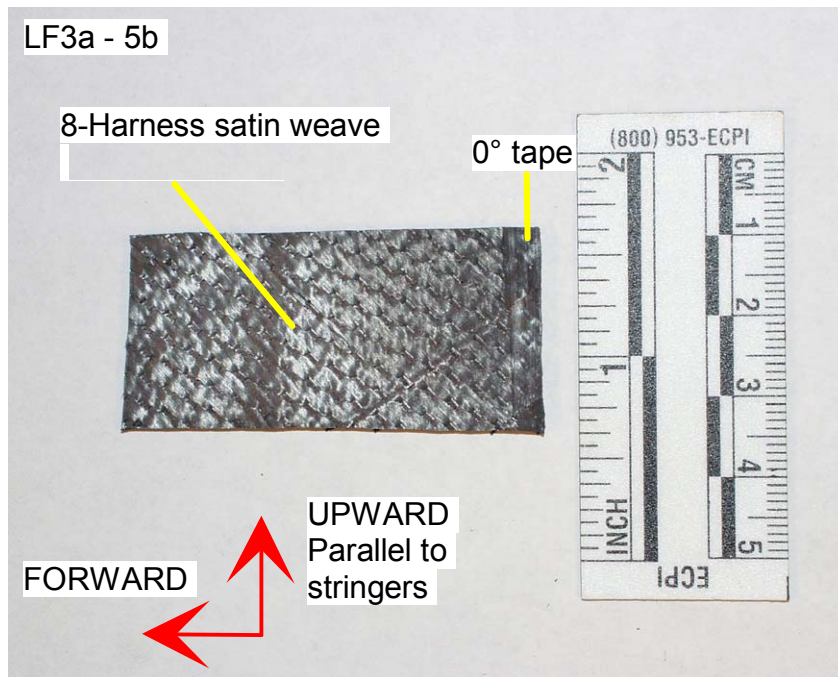
For SEM observation, all of the fracture surfaces were sputter coated with a layer of gold/palladium. All but one of the specimens (specimen LF3a-5b from the main interlaminar fracture on piece LF3a, shown in figure 56) were cleaned in deionized water in an ultrasonic cleaner.

Figure 56. Fracture surface from specimen LF3a-5b.

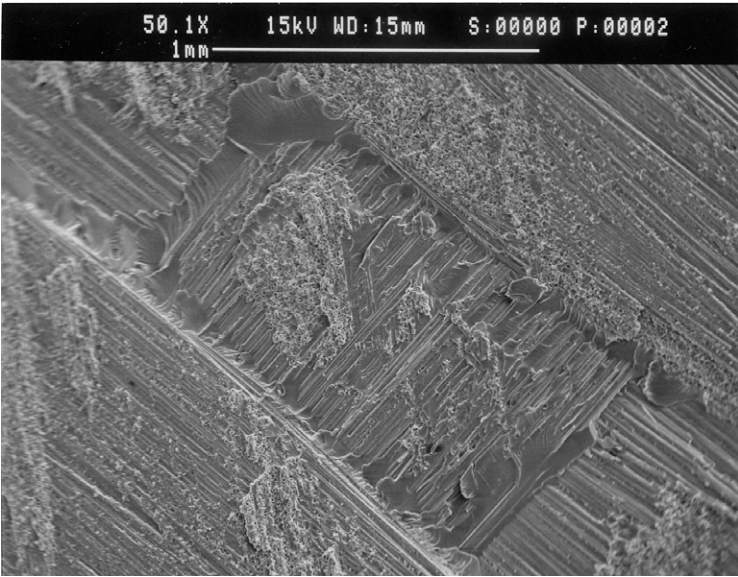
Typical views of the fracture surface on specimens from piece LF3a are shown in figures 57 to 60. Examination of the surface using SEM showed evidence of river marks associated with tension across the fractures surface (Mode I fracture) and hackles associated with shearing deformation at the fracture surface (Mode II or Mode III fracture). The hackle features observed were generally sharp and distinct. The SEM examination did not reveal any microscopic indications of fatigue, such as matrix rollers, widespread abrasion, or striations on exposed fiber surfaces or their imprints. An example photograph from the SEM examination of the specimen LF3a-5b (not cleaned) is shown in figure 57. The figure shows the presence of hackles pointing generally upward and forward between the main fibers in the weave, with river marks (also upward and forward) in the matrix pocket formed where the bundles cross. Also indicated is a region of microscopic matrix porosity, which is common.

Figure 58. A view of the center of specimen LF3a-5c showing a bundle crossing in the woven fabric. Orientation as in figure 56.

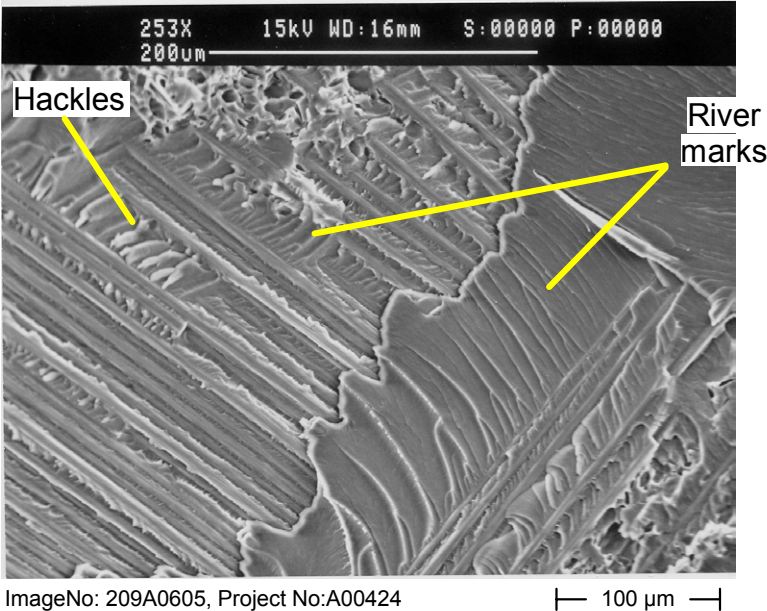
Figure 59. Higher magnification view of the upper left corner of the bundle crossing shown in figure 58. Orientation as in figure 56.

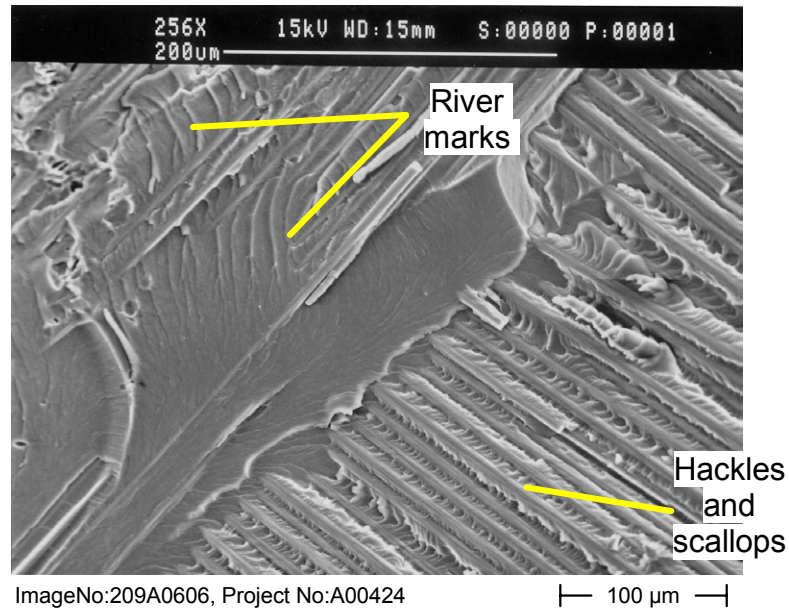
Figure 60. Higher magnification view of the lower right corner of the bundle crossing shown in figure 58. Orientation as in figure 56.
