Report Nr.: TN – MVQ3 – 001/04

Incoming Inspection (NDI) of the LHS Lug Test#1 specimen

Date: 05.08.2004

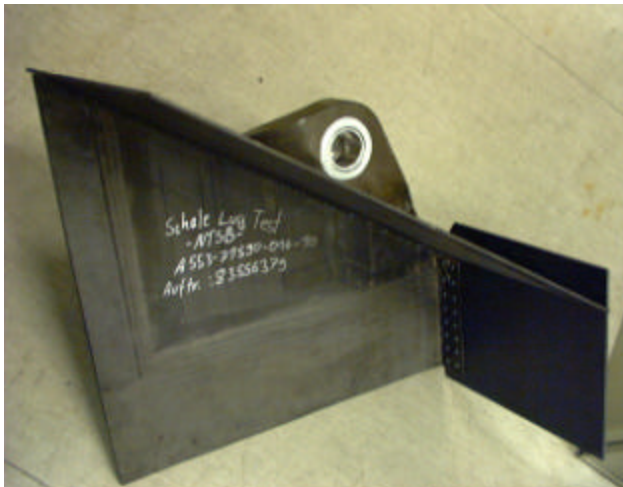
Figure 1.1

The preparation of the Lug Test#1 specimen shown in figure 1.1 and 1.2 was done in accordance to the Test Requirement 32 X 029 K4 804 P34 “AAL 587 Airbus Structure Investigation Test program Rear Main Fitting A300-600R (Lug Test#1)”.
