Report Nr.: TN – ESWNG – 1239/03

Incoming inspection of the rear lug cut out **RH** side shell of the fin box from the aircraft MSN 513 of the American airlines

Date: 19.12.2003

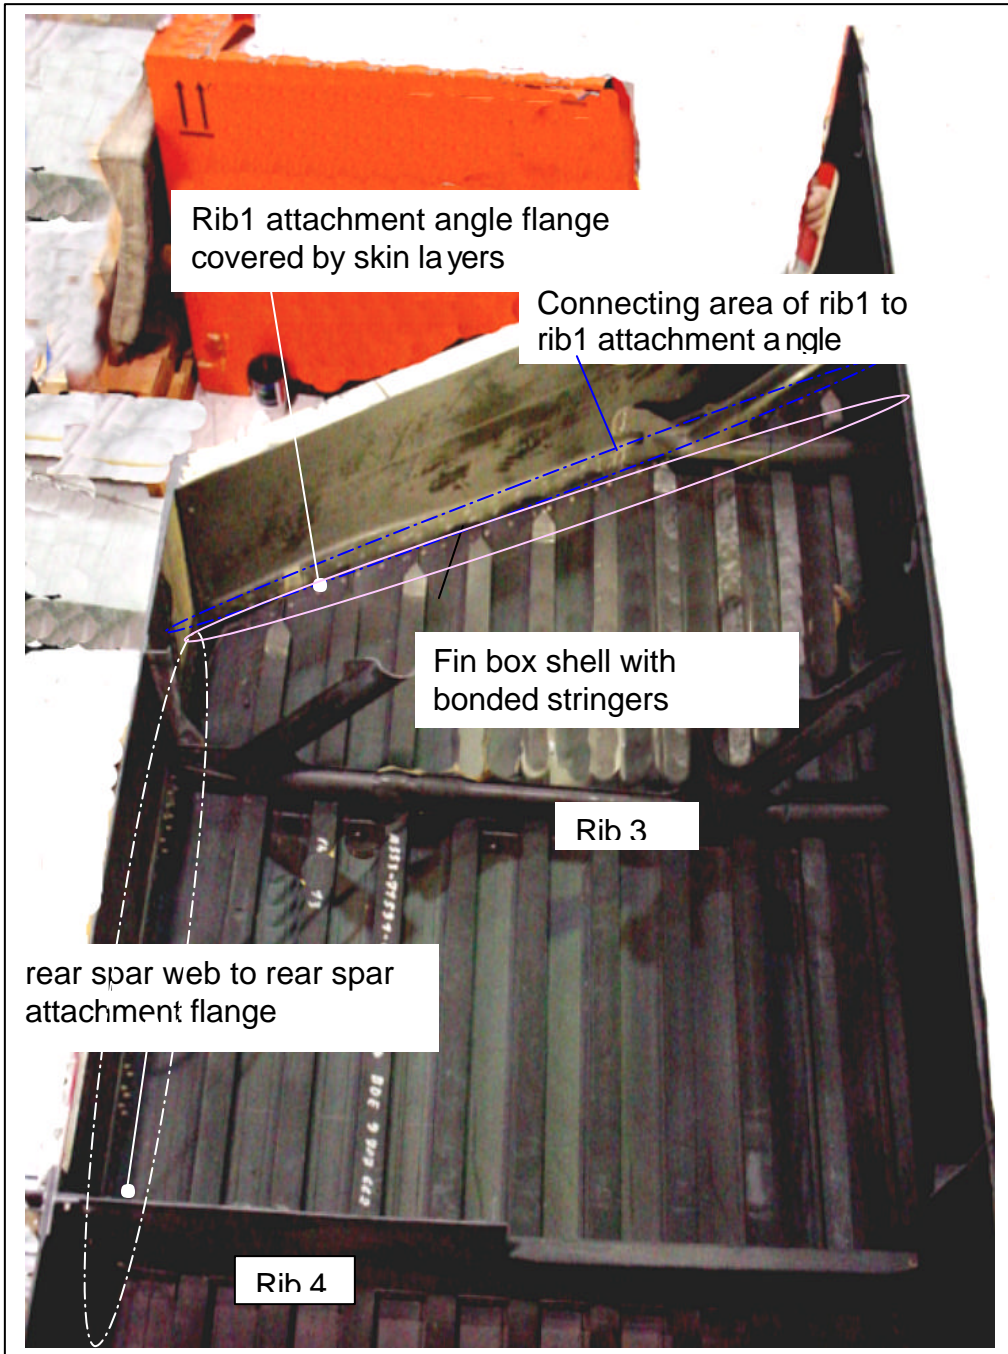
Figure 2: Structure elements of the cut outs (view from the inboard side)
