Report Nr.: TN – ESWOG – 1265/04

AAL587 Investigation

LH side Lug sub-component test #2, Lab investigation

Date: 30.06.2004

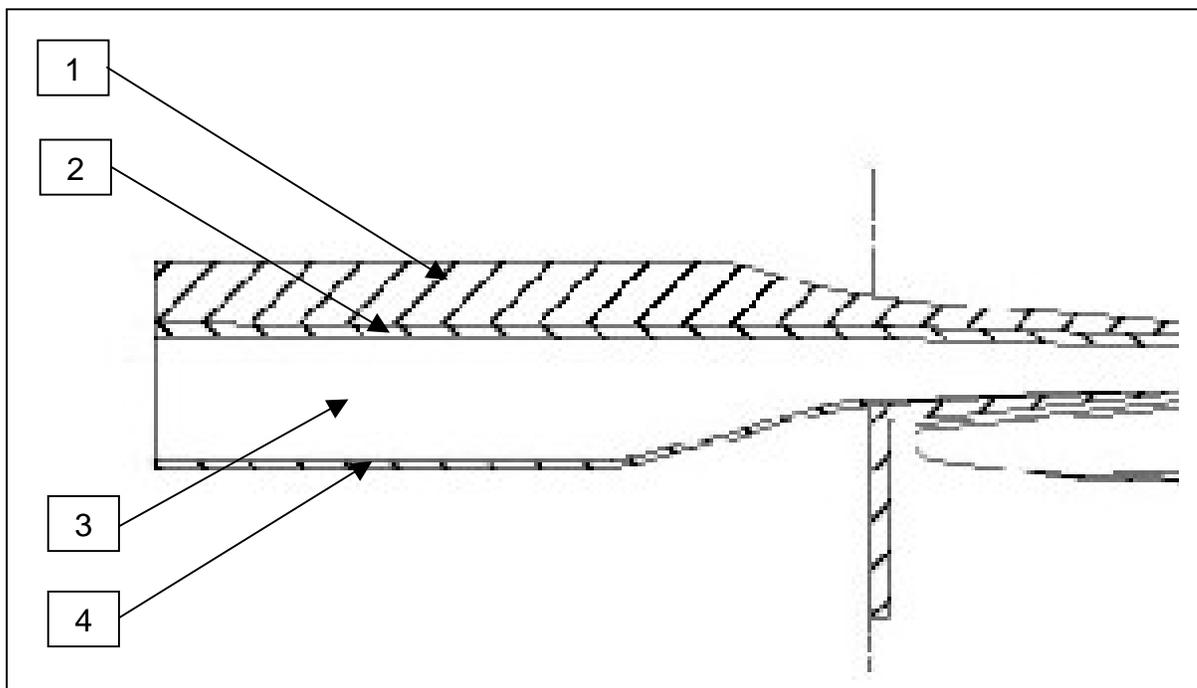
Microsection S3 was also used to confirm that measurement of the thickness of the individual parts were as per documentation.

Part
Outer part (1)
Skin and reinforcement (2)
Inner part (3)
Additional layers (4)
