Technical Note

Report Nr.: TN – ESWOG – 1266/04

AAL587 Investigation

RH side Lug sub-component test #3, Lab investigation

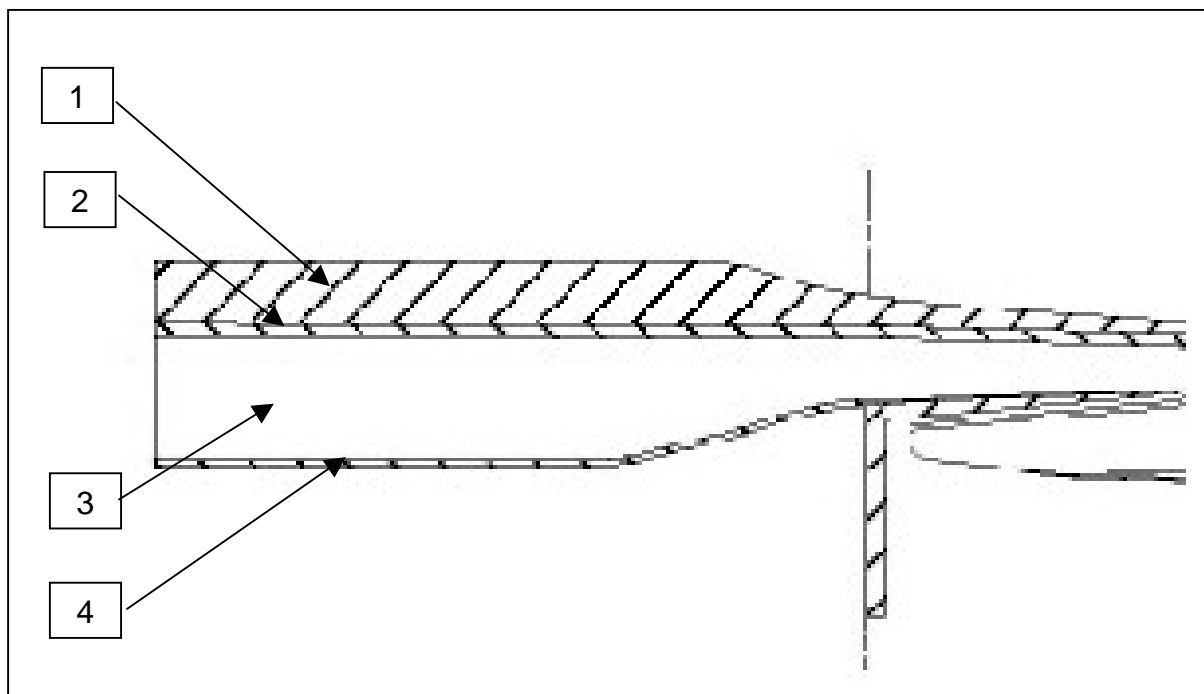
Microsection S3 was also used to confirm that measurement of the thickness of the individual parts were as per documentation.

Part	Thickness
Outer part (1)	11.0 mm
Skin and Reinforcement (2)	6.0 mm
Inner Part (3)	33.0 mm
Additional layers (4)	2.0 mm
