NATIONAL TRANSPORTATION SAFETY BOARD

MATERIALS LABORATORY FACTUAL REPORT

Report No. 00-145

Place : Near Port Hueneme, California
Date : January 31, 2000
Vehicle : Boeing MD-83, N963AS
Operator : Alaska Airlines, Flight 261
NTSB No. : DCA00-M-A023

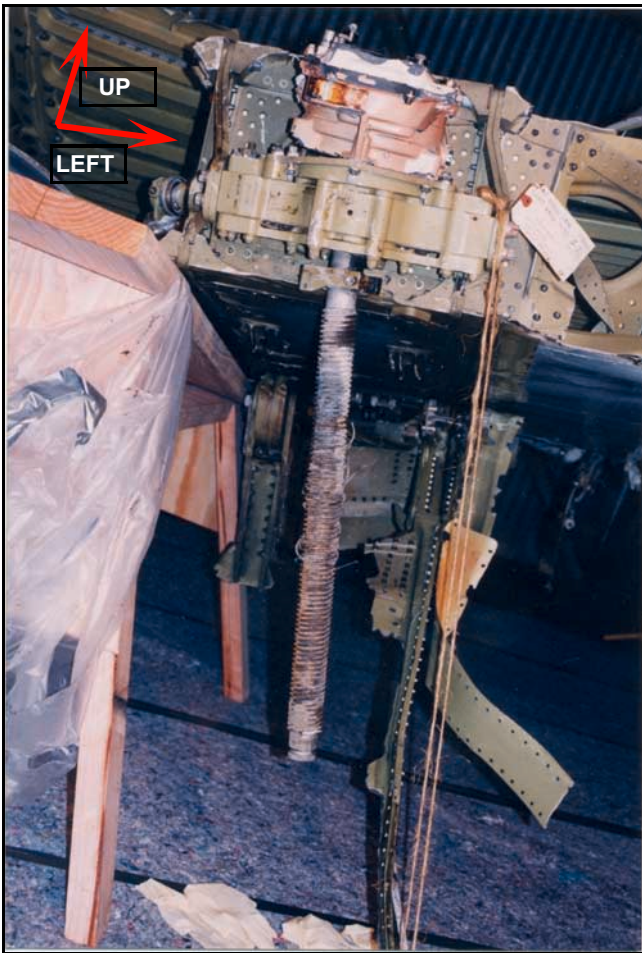
ImageNo:010A0169, Project No:A00095

Figure 1--An overall view of the as-recovered jackscrew assembly mounted on the horizontal stabilizer. One thread remnant has been removed.

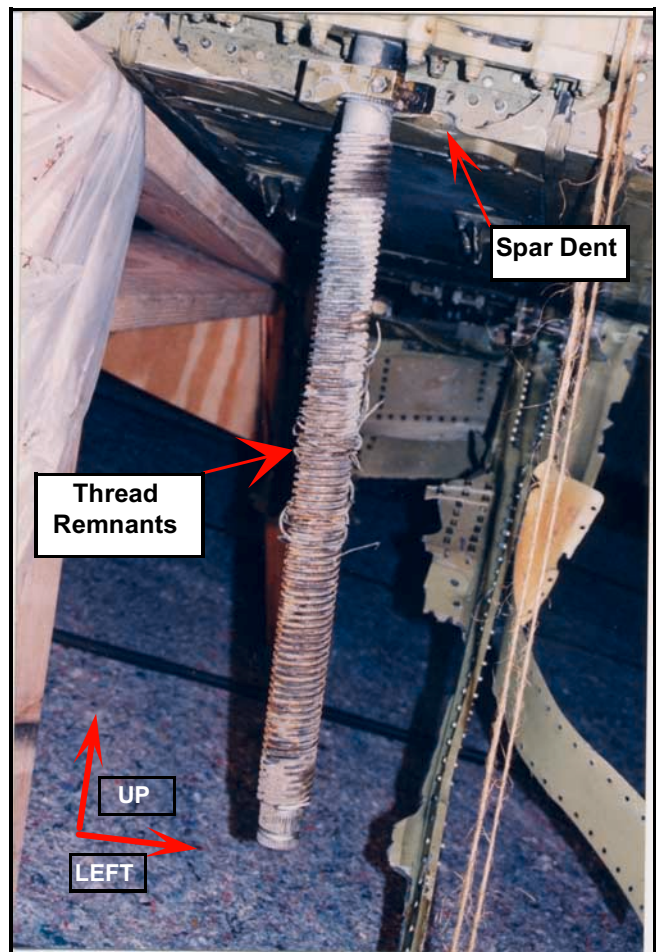
ImageNo: 010A0180, Project No:A00095

Figure 2--A closer view of the Acme screw showing the location of the thread remnants. The relationship between the screw and the dent in the lower edge of the stabilizer spar is also apparent.

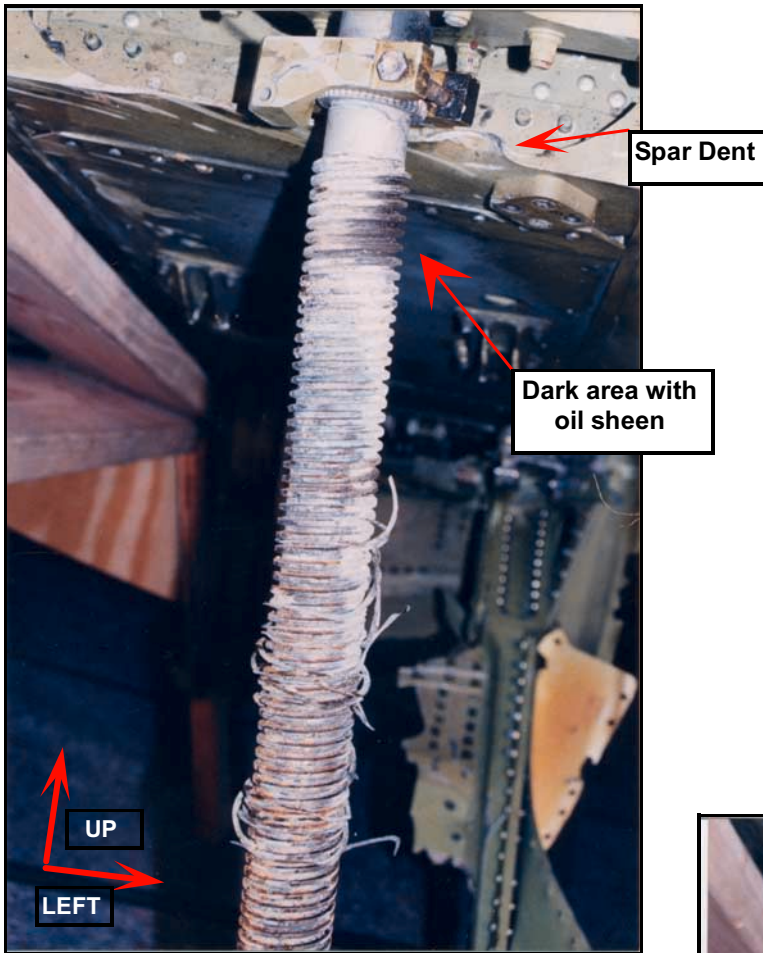
ImageNo:010A0187, Project No:A00095

Figure 3--As recovered jackscrew showing the upper portion of the Acme screw and upper stop. Note dark area on the upper end of the screw.

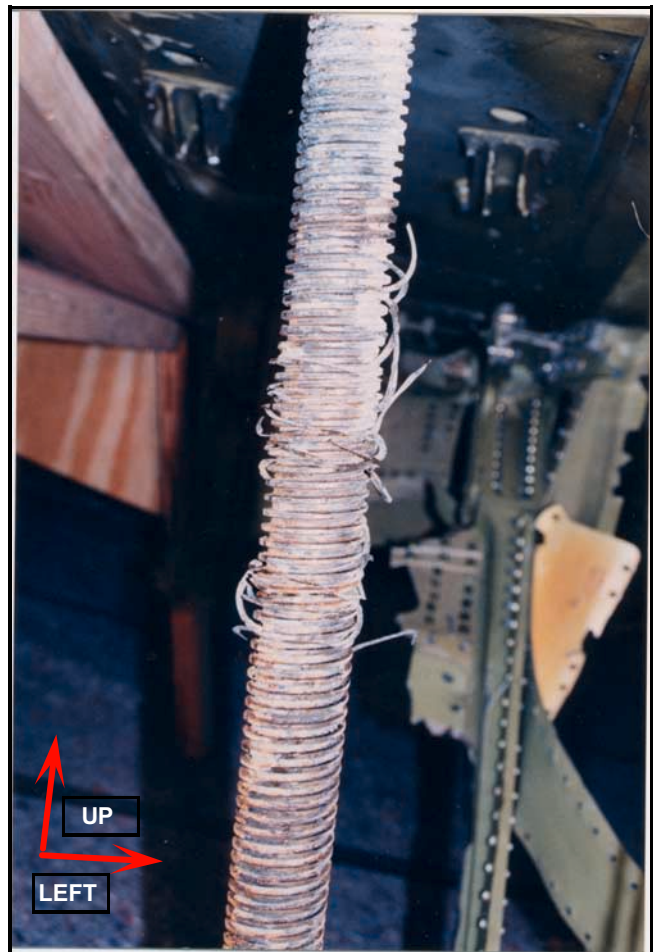
ImageNo: 010A0197, Project No:A00095

Figure 4--Closer view of the thread remnants on the screw. One remnant has been removed.

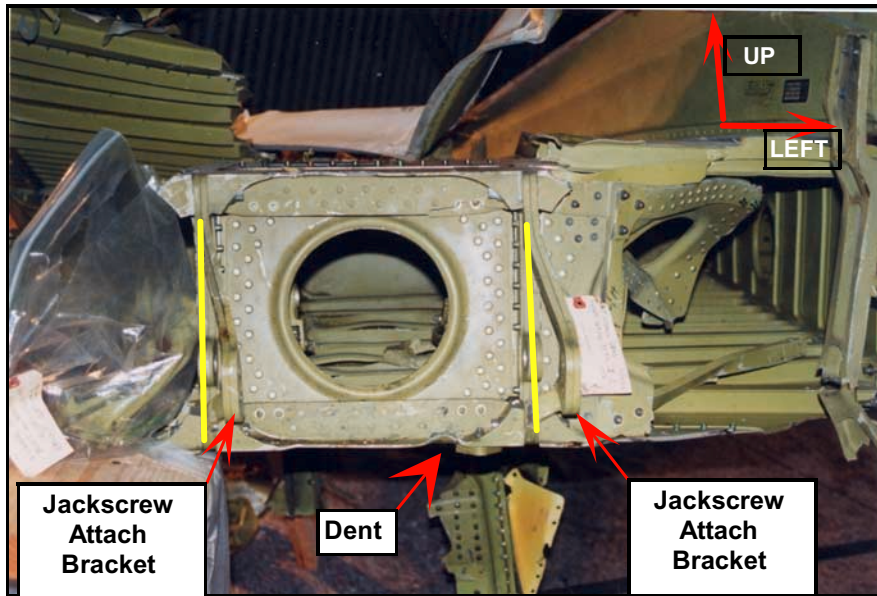
ImageNo:010A0168, Project No:A00095

Figure 9--Looking aft at the horizontal stabilizer showing the left deflection of the jackscrew attach brackets. Vertical lines (yellow) denote the original positions of the brackets. Also note the dent in the forward edge of the of the spar lower flange.

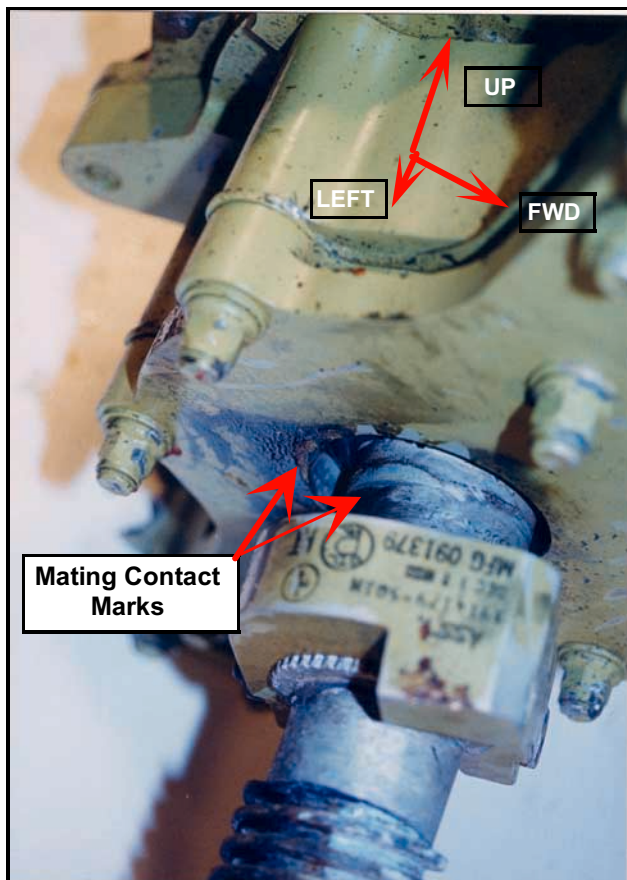
ImageNo: 010A0170, Project No:A00095

Figure 10--Upper end of the Acme screw showing contact mark from the lower gearbox support plate.

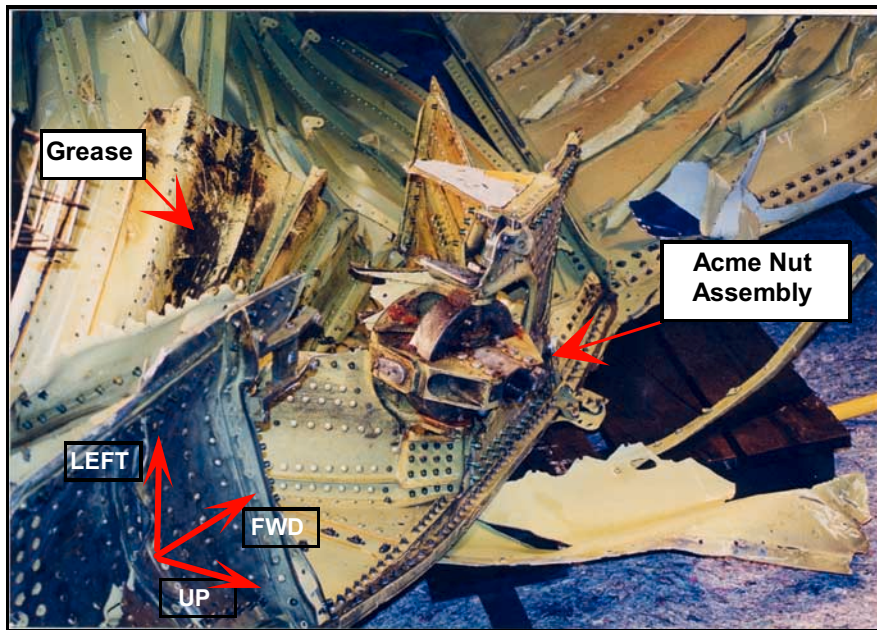
ImageNo:010A0177, Project No:A00095

Figure 17--The as-recovered Acme nut assembly in the structure of the vertical fin.

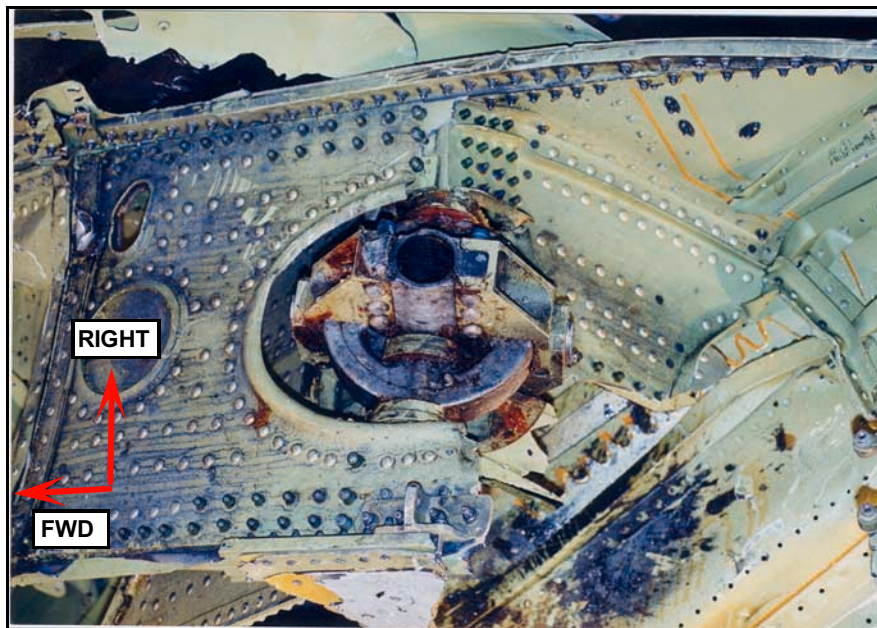
ImageNo: 010A0178, Project No:A00095

Figure 18--A close view of the as-recovered Acme nut assembly looking down and right. Note the visible reddish grease on the exterior of the nut and the black grease on the structure below.

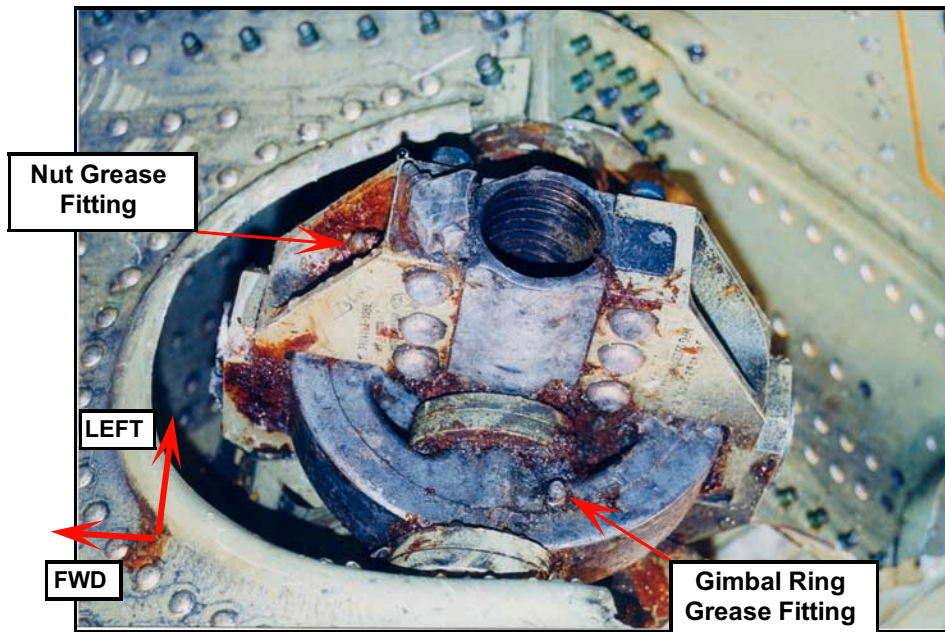
ImageNo:010A0179, Project No:A00095

Figure 19--A closer view of the Acme Nut assembly showing the grease on the exterior surface and the grease fittings. The spiral pattern on the nut interior is also visible.

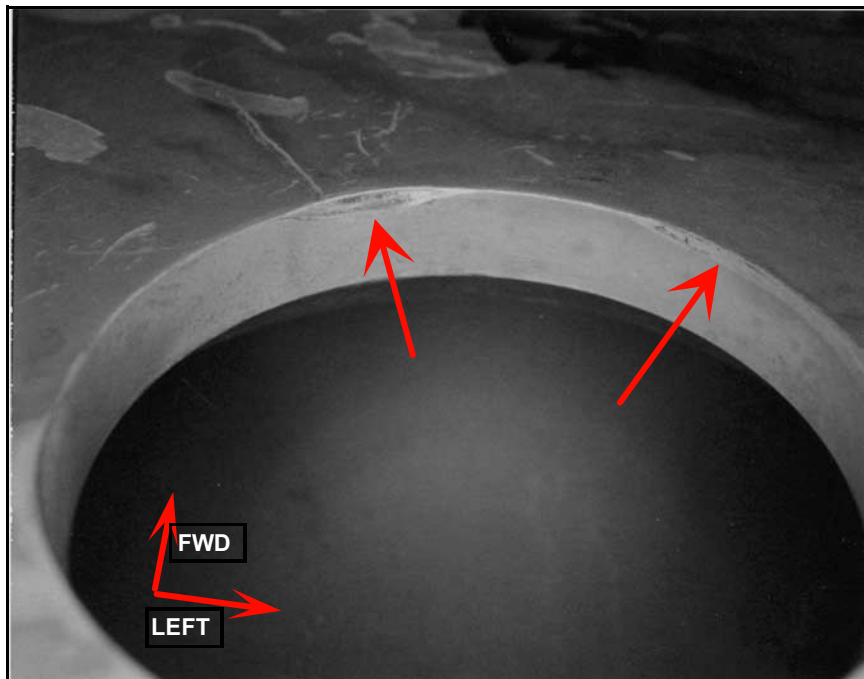
ImageNo: 010A0189, Project No:A00095

Figure 31--A closer view of the pass through hole showing the two minor dents (arrows) in the forward half.

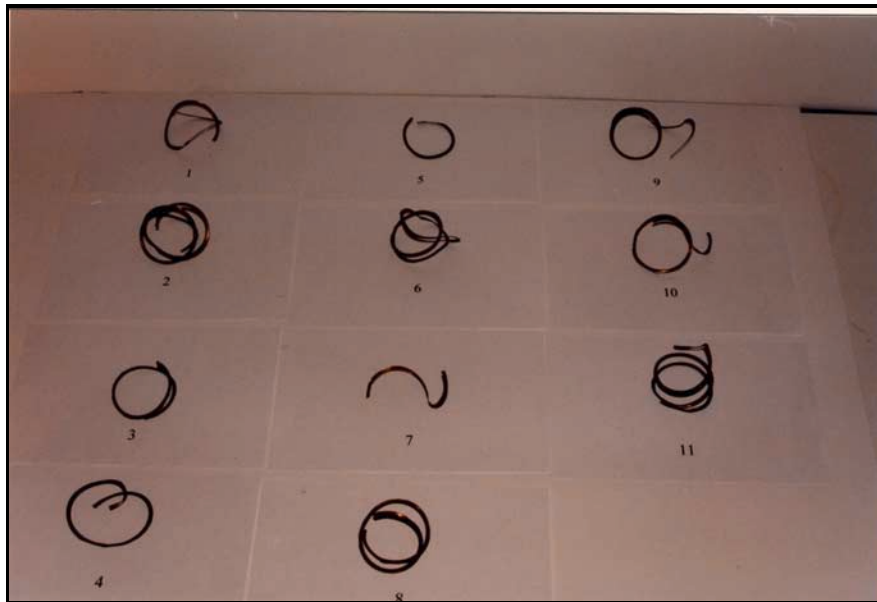
ImageNo:010A0190, Project No:A00095

Figure 34--An overall view of the eleven removed thread remnants, above. Below, remnant #6 showing typical features.

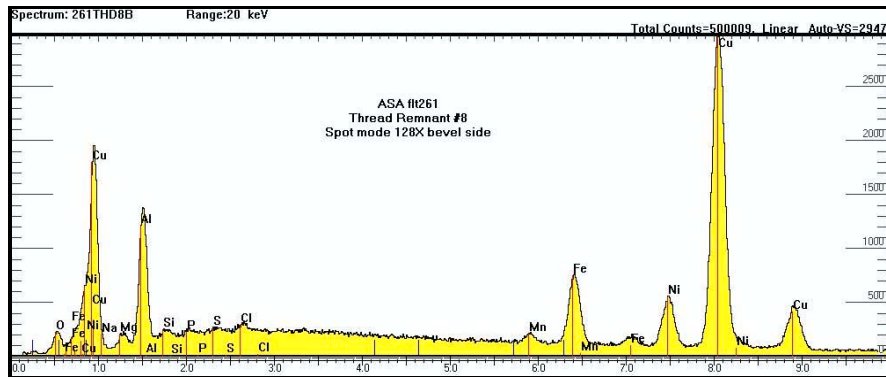
ImageNo:010A0352, Project No:A00095

Figure 35-- EDS of thread remnant #8 showing constituents of nickel aluminum bronze (Cu, Ni, Fe, Al, Mn) along with other contaminants (Cl, S, P, Si, Mg, O).

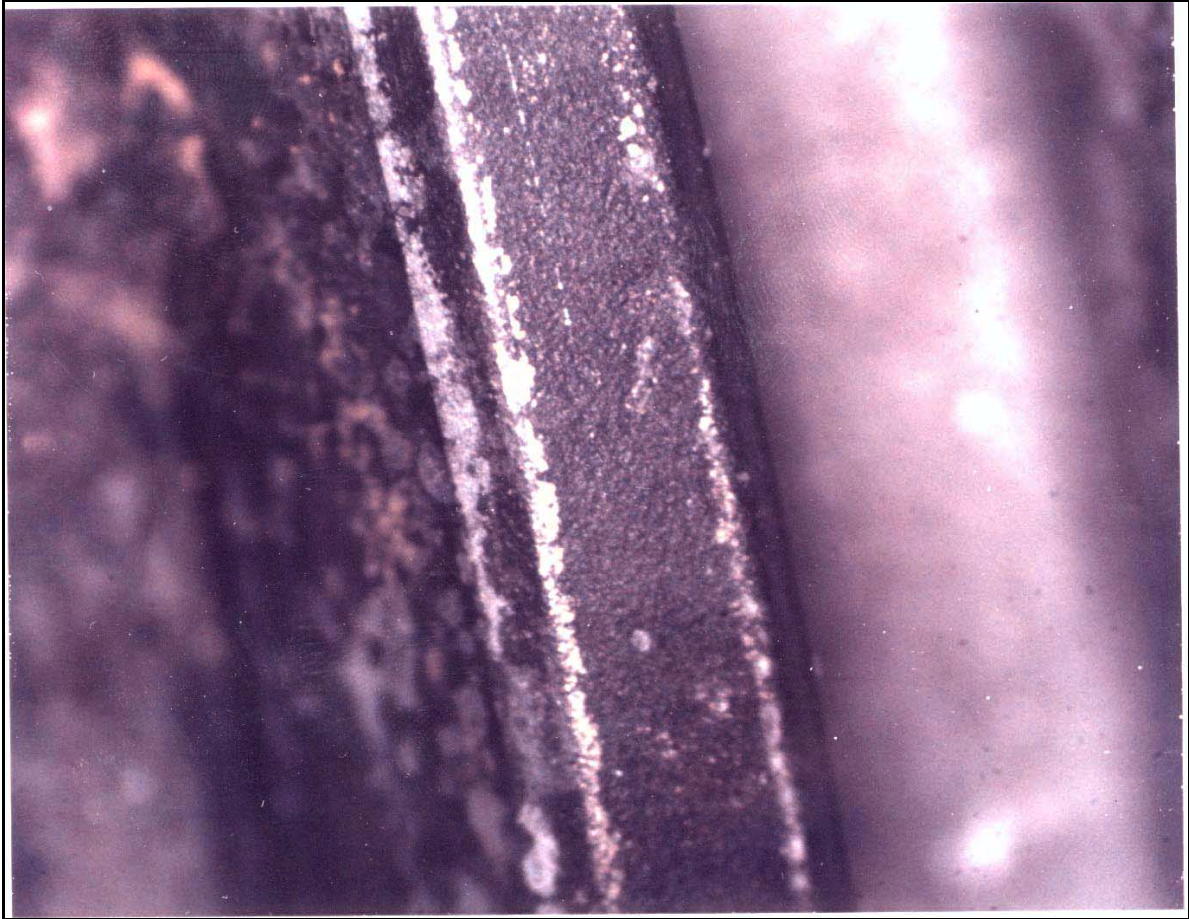
ImageNo:010A0217, Project No:A00095

Figure 45--Typical glass bead surface finish on the threads of the Acme screw.

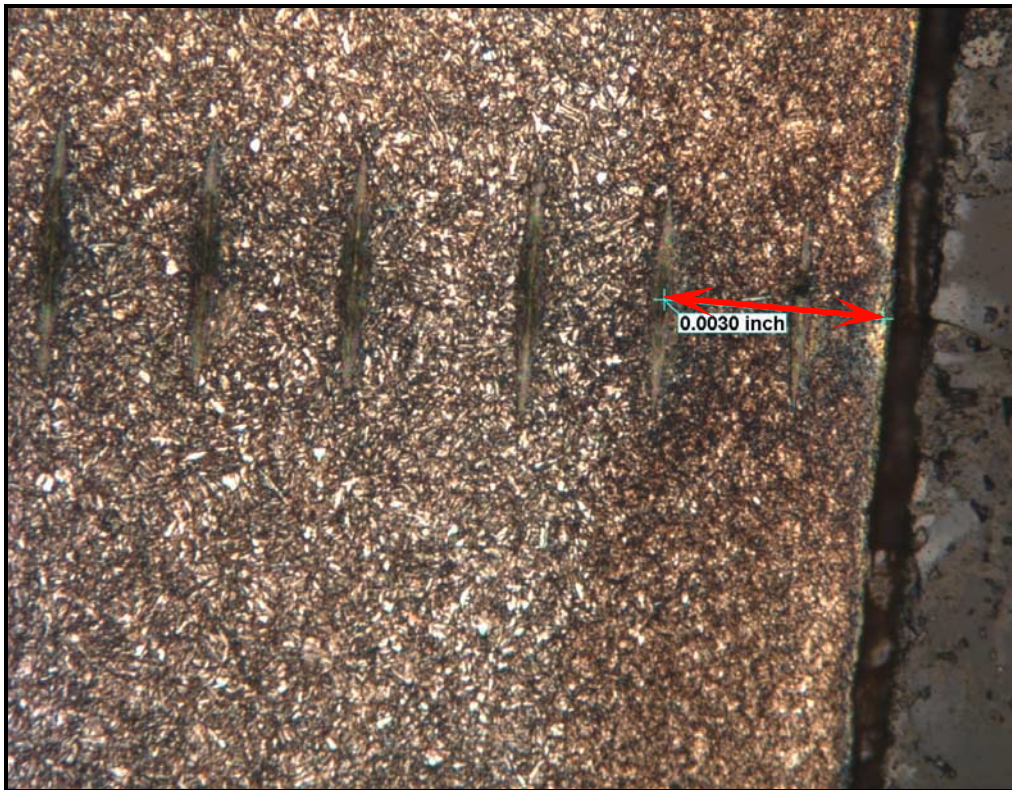
ImageNo:010A0349, Project No:A00095

A longitudinal micro-section was cut through the upper five threads of the Acme screw. The section was mounted, polished and initially examined unetched. Some small longitudinally oriented stringers were visible. The depth of the nitrided case was measured by micro-hardness at the root between two threads and at the flank of a third thread. At the time of manufacture for the accident screw, the case depth requirement was 0.003 to 0.005 inches deep. It has since been increased and the latest revision of the drawing it is 0.003 to 0.010 inches. Douglas Production Specification (DPS) 5.00-3 for nitrided parts defines the case depth as the depth below the surface where the hardness (HK or HV) is 50 points or greater than the average core hardness. Using this criterion and Knoop (HK) measurements at 500 gram load, the measured case depth was 0.004 inches deep at the flank and 0.007 at the root. When etched with 2% Nital²⁰ reagent, the case and core microstructures appeared typical of a nitrided, quenched and tempered steel with no evidence of a white layer, as shown in figure 47. Core hardness measured on the specimen averaged 40 HRC (402 HK). Using a Wilson Chart 70 conversion table, the engineering drawing's requirement for heat treatment to 160,000 psi to 180,000 psi corresponds to an approximate hardness range of 36 to 40 HRC.

Figure 47--Typical nitride case on tooth flank of Acme screw with hardness impression visible. 2% Nital etch. The double arrow represents 0.030 inch.

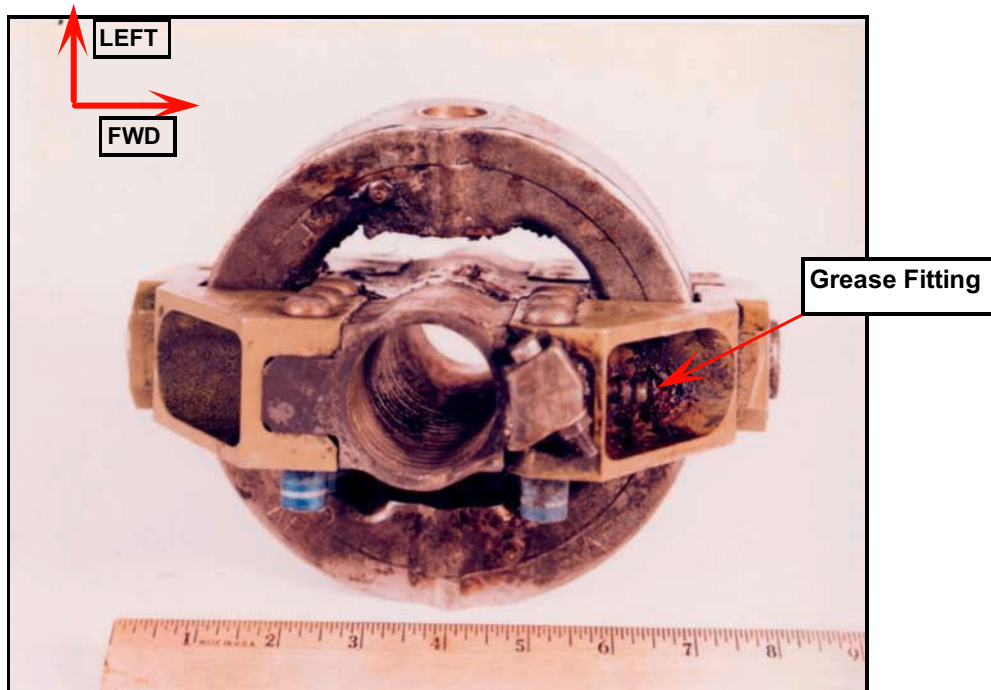
ImageNo:010A0220, Project No:A00095

The as-received Acme nut assembly with gimbal ring is displayed in the two views of figure 48, looking generally downward into the thread bore of the nut. The bore showed only the spiraling traces of the original threads. Two bright spiral lines were visible with dark surfaces in

Figure 48--Above, an overall view of the as-received Acme nut assembly. A closer view into the interior showing the lack of threads is shown below.

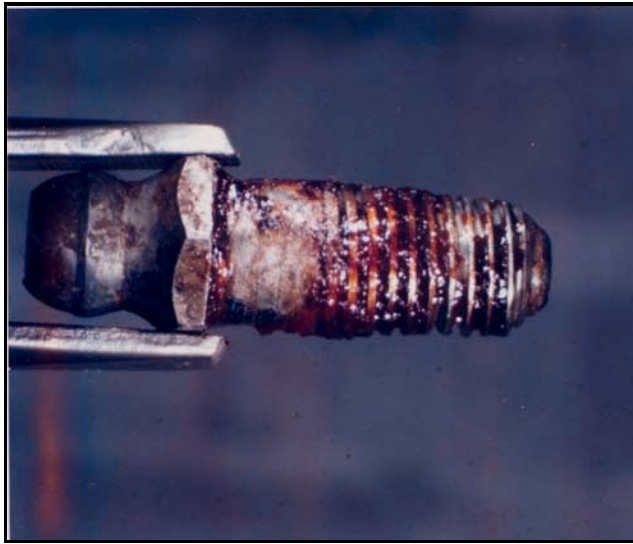
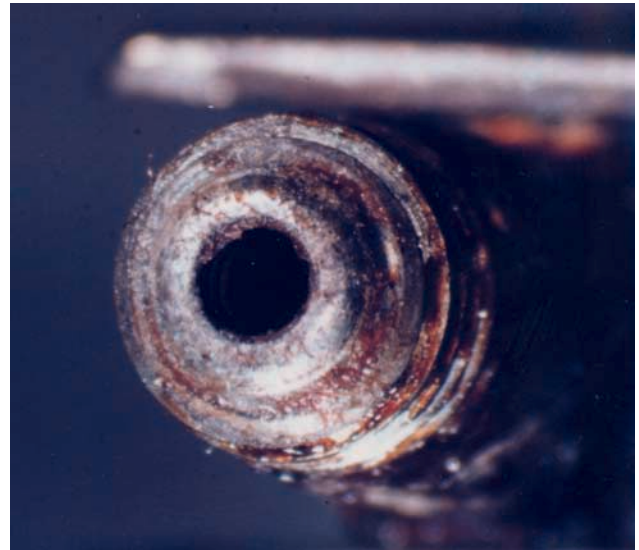
As the grease fitting was removed, translucent reddish grease was present on the threads of the fitting as shown in the left view of figure 49. No grease was apparent in the passageway in the nut or in the bore of the grease fitting, see right view of figure 49. Probing the depth of the grease fitting bore with a slender wire removed a small amount of reddish grease that appeared consistent with the grease on the external threads.

Figure 49--Side view (left) showing the reddish grease on the exterior of the grease fitting removed from the Acme nut. End view (right) looking into the orifice of the grease fitting.

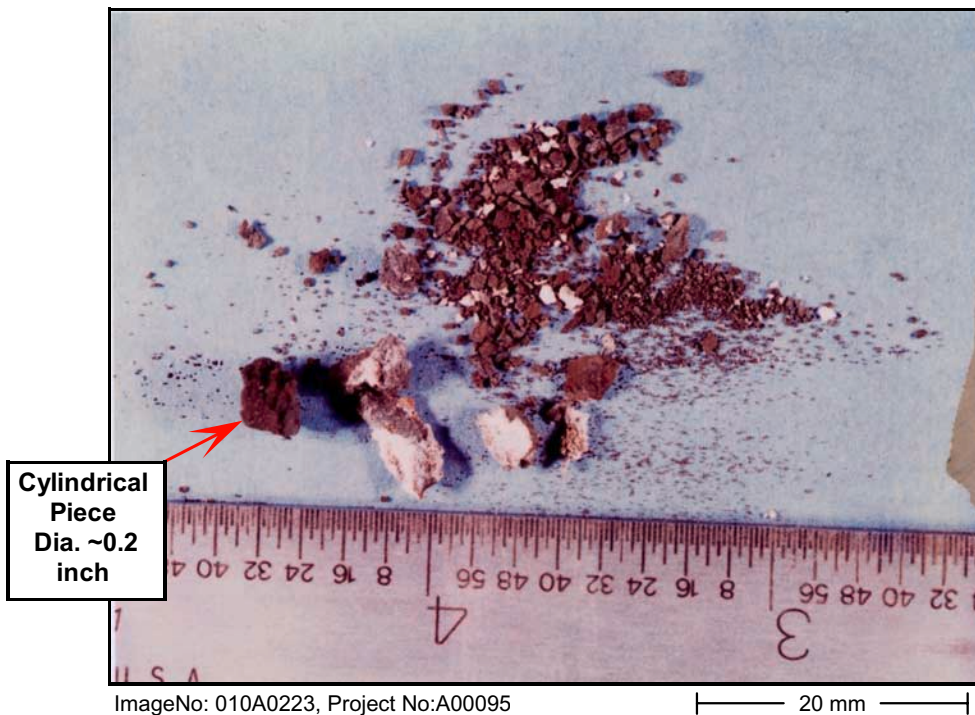
ImageNo: 010A0223, Project No:A00095

A significant amount of material remained in the counter bore of the grease passage in the nut interior. A sharp tipped probe was used to scrape residue from the counter bore. The entire sample, shown in figure 50, was retained for later analysis. One large piece of the removed material retained the cylindrical shape and approximate diameter of the grease passageway before the counterbore.

Figure 50--The residue removed from the Acme nut grease passageway and counterbore. The cylindrical piece has the approximate diameter of the passageway.

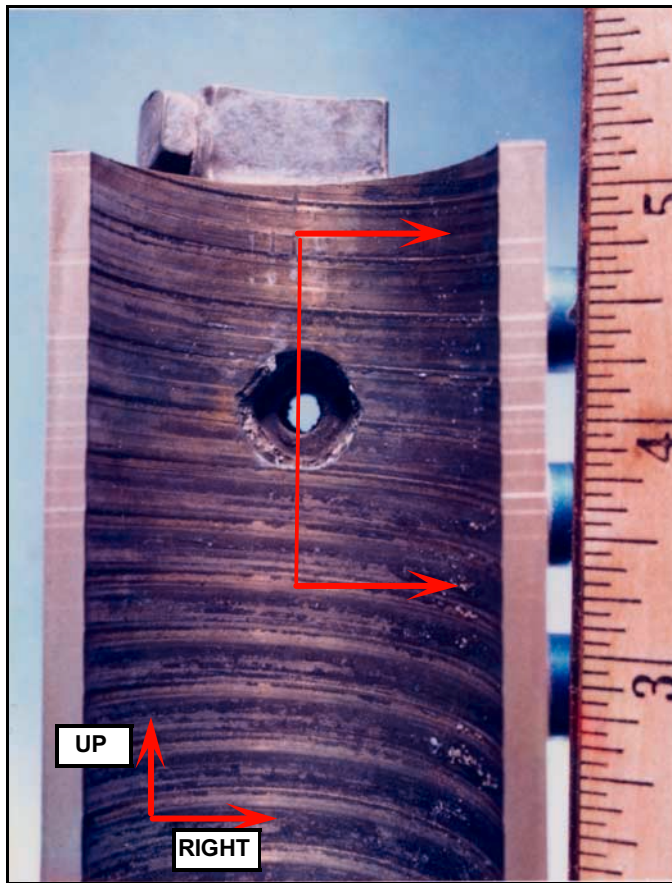
ImageNo:010A0224, Project No:A00095

The upper view in figure 51 shows the exit side of the grease passageway from the grease fitting after the fitting and the sample residue were removed and the nut was cut open. The lower view of figure 51 schematically illustrates the arrangement of the grease fitting,

Figure 51--Upper view is looking forward into the grease passageway and counterbore, after sectioning the nut. The lower view is an illustration of a cross section (at section lines in upper view) through the passageway and grease fitting showing the approximate location and extent of the blockage in the passage. Red areas denote locations where red grease was found. (not to scale)

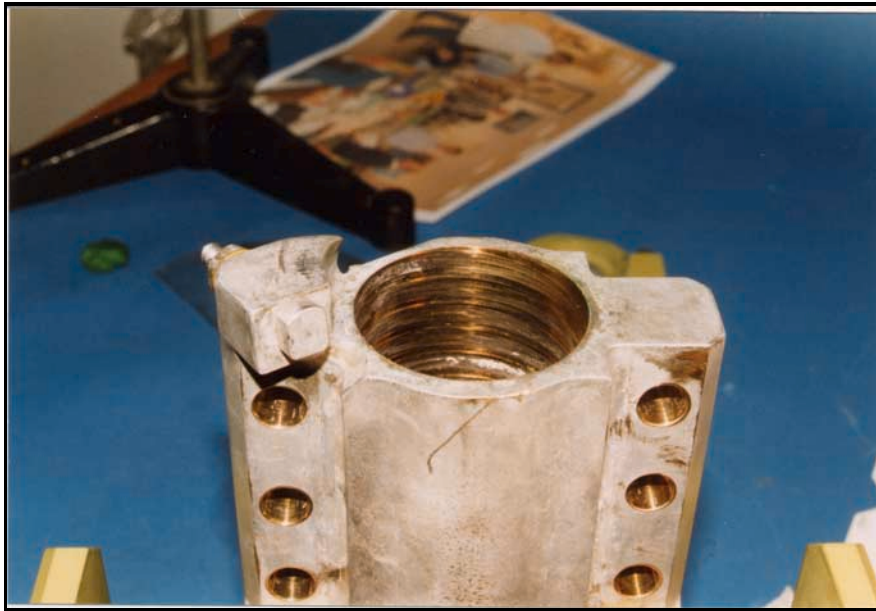
ImageNo:010A0226, Project No:A00095

To disassemble the Acme nut assembly, the gimbal ring was removed by pulling out the pivot pins after unthreading the locking bolts. The pins easily slide out of the nut and the ring. The lower forward and aft support blocks were removed by extracting the three pins in each. These were tight in the assembly and required using a punch to hammer them out. During disassembly the flanges on the lower aft support were slightly dented. Figure 52 shows the lower end of the Acme nut after removal of the lower support blocks.

Figure 52--The lower end of the Acme nut after partial disassembly showing the spiral pattern on the interior.

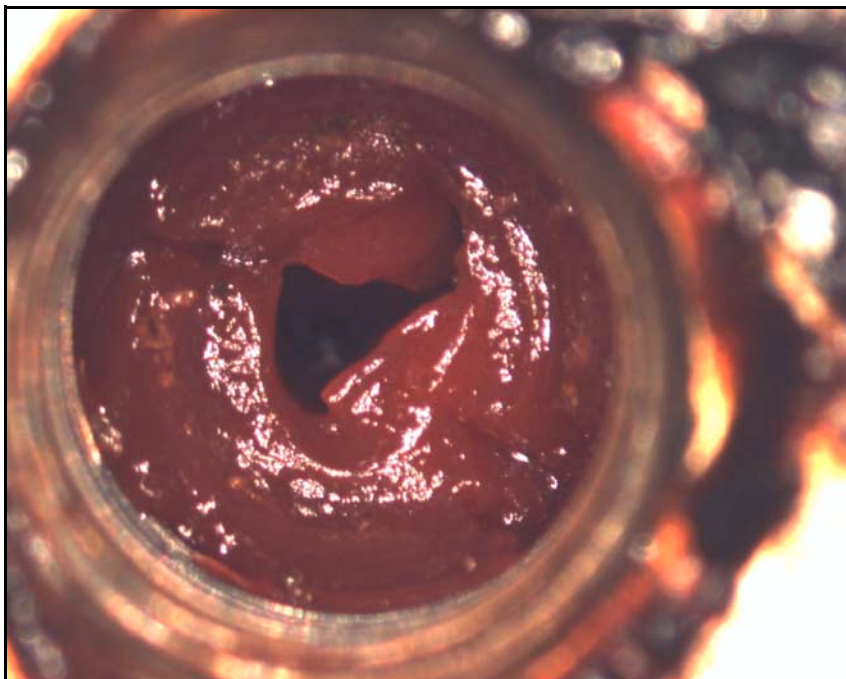
ImageNo: 010A0354, Project No:A00095

Both grease fittings at the pivot points in the undamaged gimbal ring were unthreaded and removed. The fittings were located on the upper surface of the ring, one was on the left side aft of the pivot point and the other was on the right side forward of the pivot point. Clean red translucent grease was visible in both passageways and in the bores of the fittings, see figure 53. Samples were taken from the openings with wooden probes and retained for further analysis. Also, the fittings were retained in the as-removed condition.

Figure 53--Red grease in left grease fitting passageway in the gimbal ring.

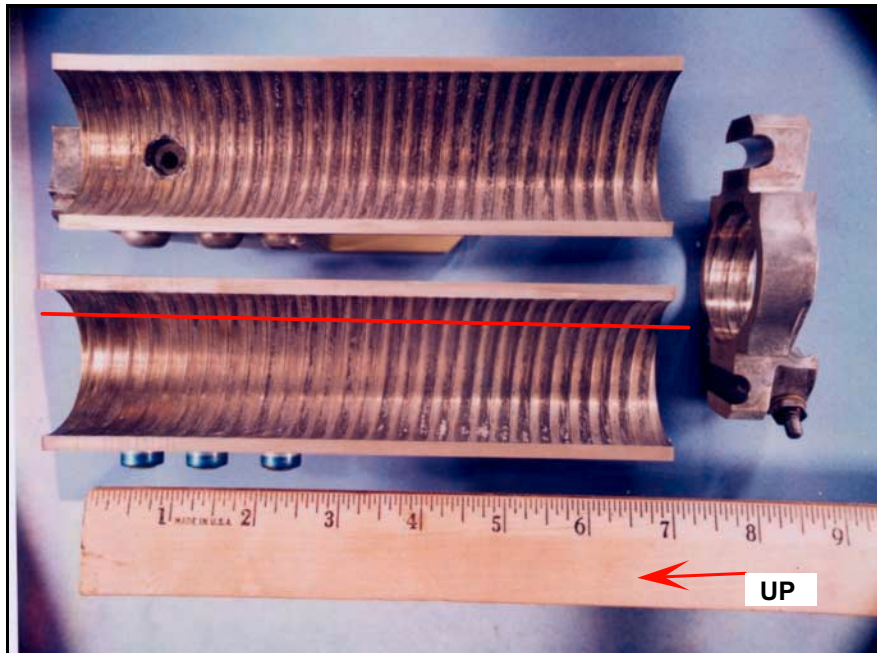
ImageNo:010A0227, Project No:A00095

To section the nut and more closely examine the interior, the lower $\frac{1}{4}$ inch of the nut was first transversely cut off using a wire EDM²⁴. This cut retained the physical relationships between the nut bore and the lower stop lug for further examinations as reported in report 00-045. The remainder of the nut was then longitudinally split into forward and aft halves roughly along the nut centerline. The opened nut is displayed in figure 54. The left side of the aft half was then cut further along the line depicted in figure 54 for metallographic and SEM specimens.

Figure 54--The interior surfaces of the Acme nut after it was cut showing the repeating pattern. The line on the lower half of the nut denotes the location of an additional cut to remove additional nut samples.

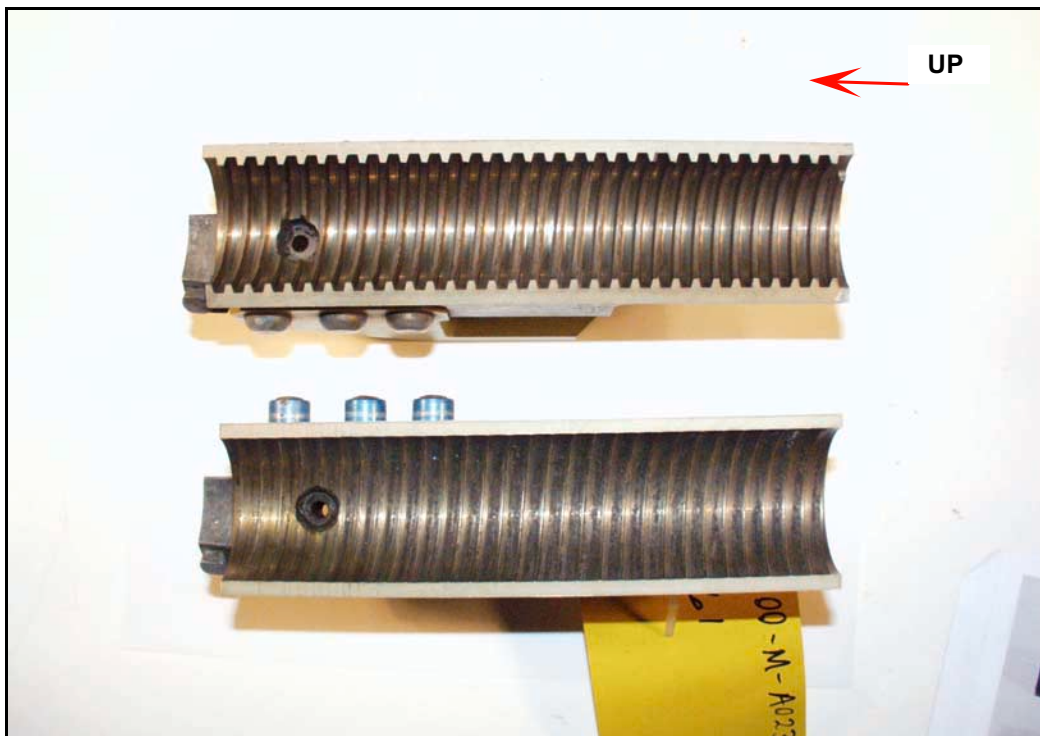
ImageNo: 010A0259, Project No:A00095

Magnified visual inspections of the exposed nut interior found a regular spiraling pattern down the length of the nut having a frequency consistent with the specified pitch of the internal nut threads. For comparison, an exemplar nut²⁵ was cut on the thread centerline and is shown beside the accident nut in figure 55.

Figure 55--Comparison of accident acme nut thread profile (Top) to a similarly sectioned exemplar nut 2264 (below).

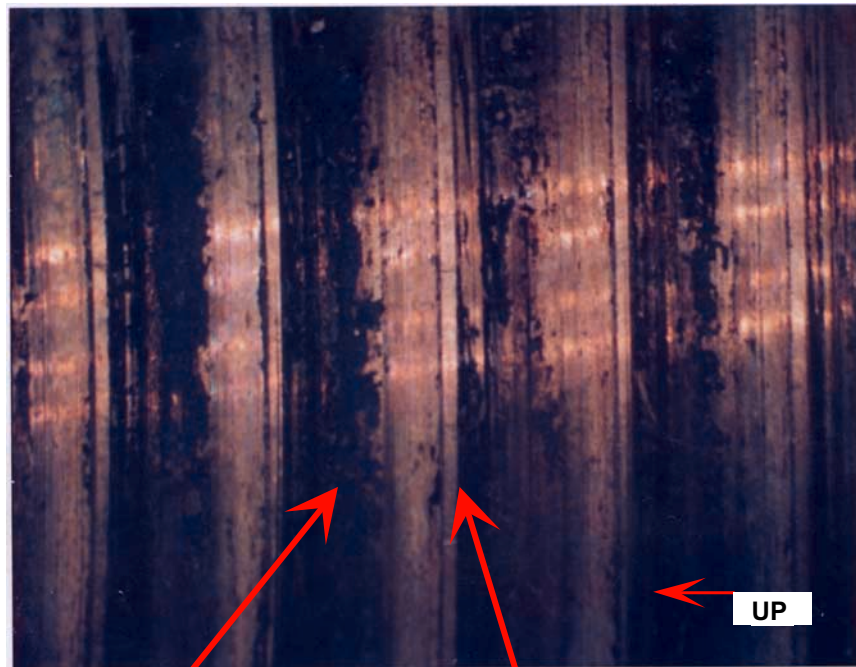
From the bottom up, the pattern generally consisted of a raised ridge followed by a lustrous depression showing spiral machining or wear marks transitioning into a dark band of surface deposits that rose to the next ridge. The features of the pattern on the inner surface are shown in figure 56 and the profile is visible in figure 57 on the longitudinal cut surface of the nut. Under high magnifications, the distinct raised ridges showed mostly a longitudinally smearing but in some area clear shearing fractures were discernable. The smearing and shearing both indicated a relative upward movement of the threads in relation to the nut body. Along most of the ridges material could be seen folded upward and smeared over the adjacent surfaces. The measured widths of typical ridges ranged from about 0.013 to 0.020 inches and appeared to depend on the amount of smearing. The lower view of figure 56 has been annotated to show the approximate original specified thickness of the thread at its base, assuming that the upper edge of the ridge corresponds to the original upper edge of the thread.

Figure 56--Two views of the interior of the nut showing the pattern of damage. Upper view shows several threads with the raised ridges and the black deposits. Lower view is an enlargement of a single thread area with corresponding feature indicated and the approximate original thread width indicated by vertical lines.

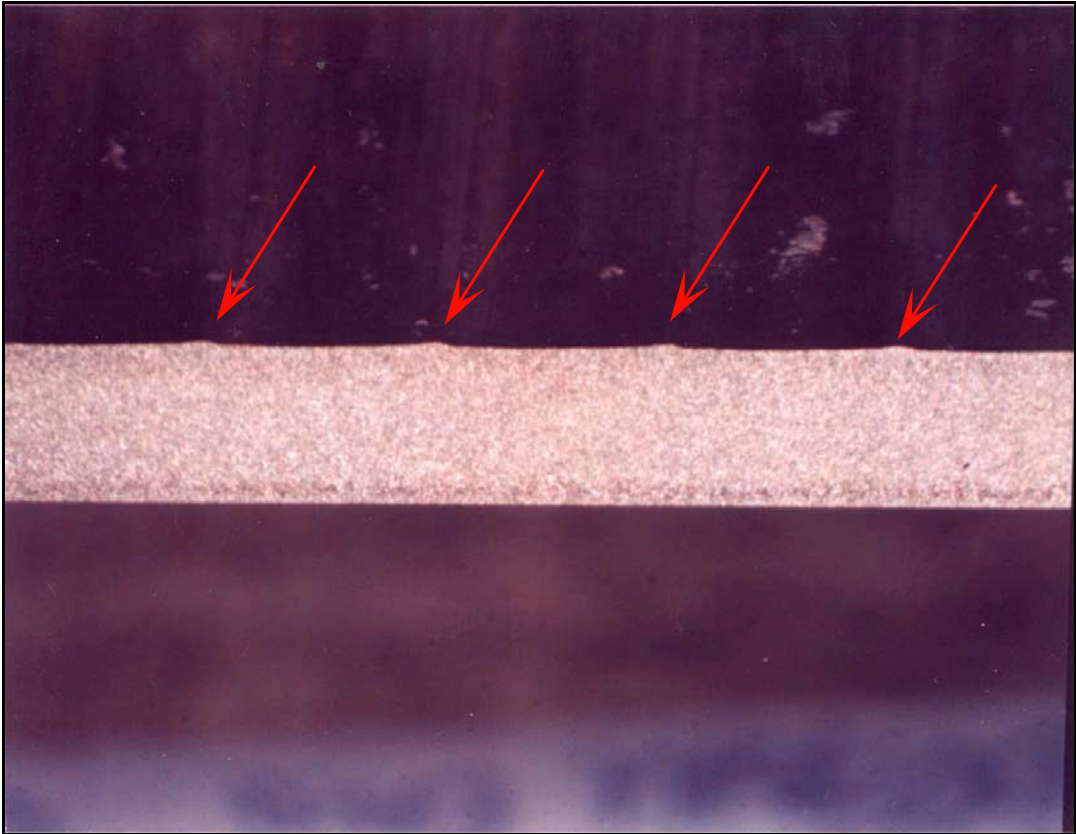
ImageNo:011A0056, Project No:A00095

Figure 57--A cross sectional view of the nut at the longitudinal cut. The raised ridges are indicated by the arrows.

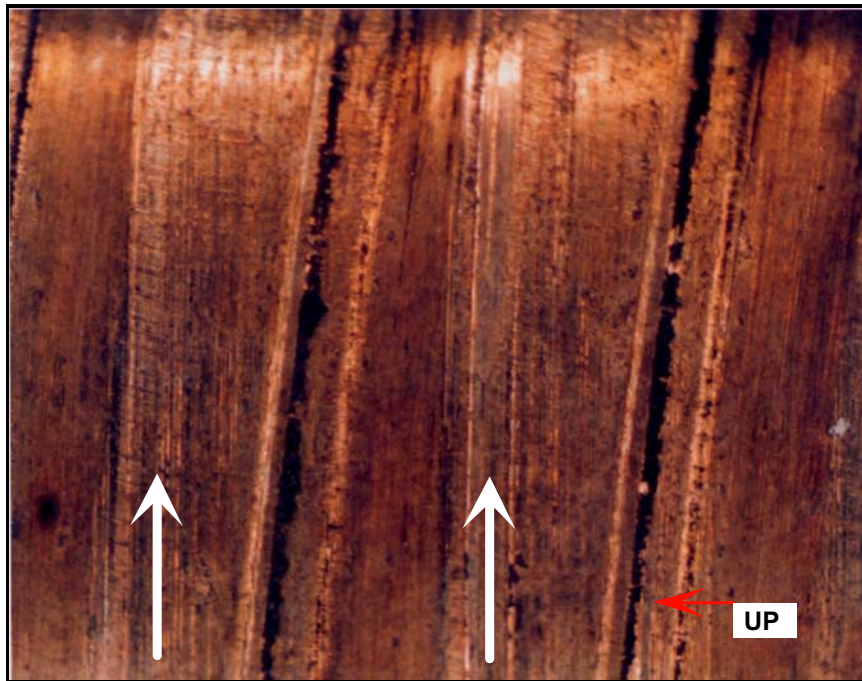
ImageNo:010A0230, Project No:A00095

The vast majority of the markings on the interior nut surface spiraled around the bore. However, some circumferential and longitudinal marks were noted in isolated locations overlaying the spiral marks, such as those shown in figures 58 and 59. At the location of figure 58 on the upper end of the forward side of the nut, two circumferential running bands of scratches were present partially around the inner diameter. In other locations, the black surface deposits were locally removed in circumferential patterns. At the location of figure 59 near the top of the nut, several longitudinal scuff marks were present on the aft side above the grease orifice. The scuff marks appeared to be running upward.

Figure 58--Two circumferential bands of scratches (arrows) overlaying the spiral pattern.

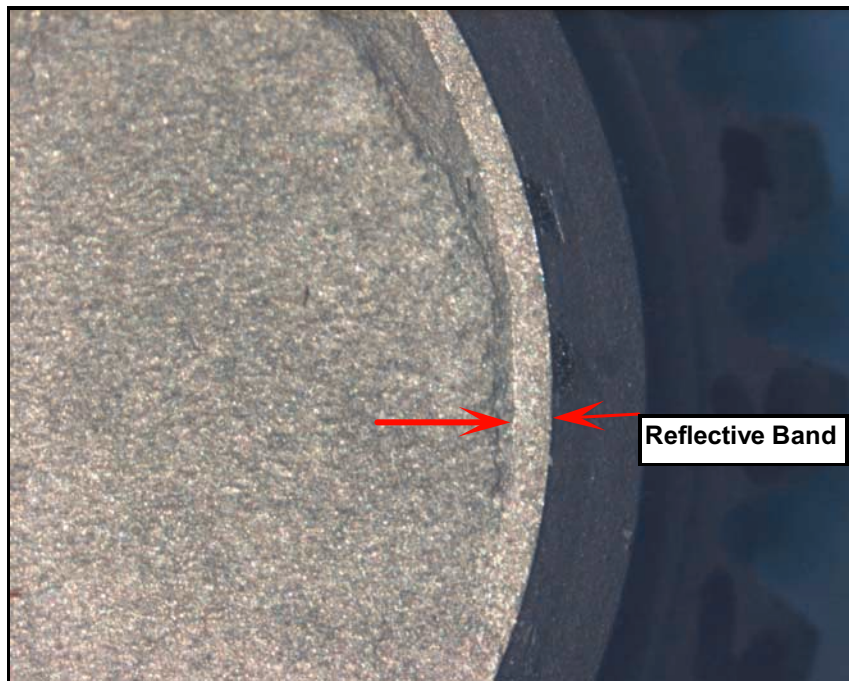
To the right, in the view of figure 68, the band spiraled downward following the thread root below the level of the main fracture plane, as shown in figure 70. In this direction, the width of the band thinned slightly to about 0.019 inches thick when measured 90 degrees from the initiation region, see figure 71. The band extended around the thread root and was visible opposite the initiation region and appeared to eventually undercut the fracture as a crack at the shear edge. To the left, the band raised slightly above the main fracture but became much thinner until it disappeared about 135 degrees from the initiation region, see figure 72. At 90 degrees left of the initiation, the band measured 0.012 inches thick. In total, the band was present for an estimated 330-degrees around the torque tube fracture.

Figure 70--Oblique view of the torque tube fracture showing the thread and fracture. The thread is left-handed and spirals upward to the left in this view.

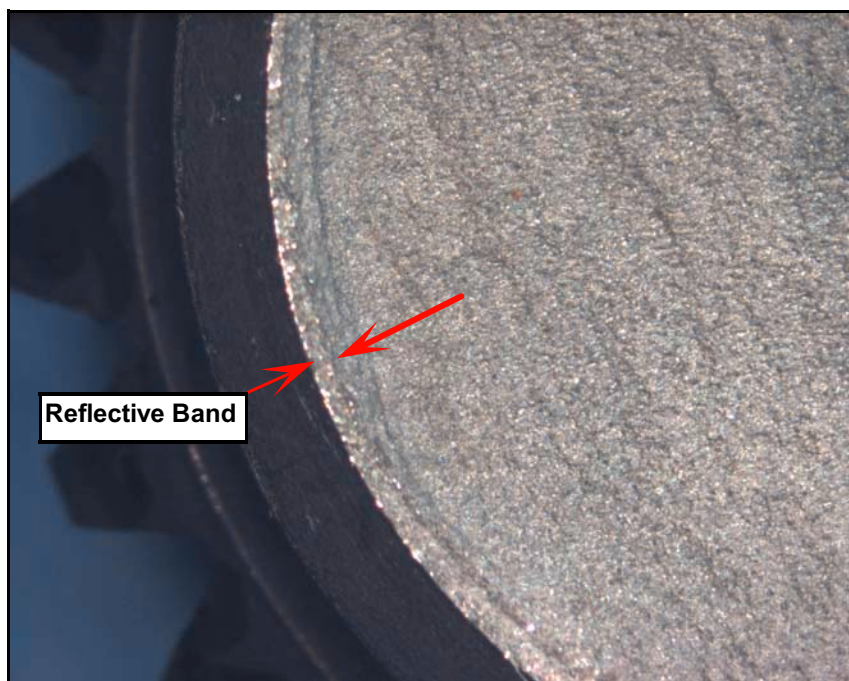
Figure 71--View looking upward onto the torque tube fracture showing the reflective band 90 degrees to the right of the initiation area.

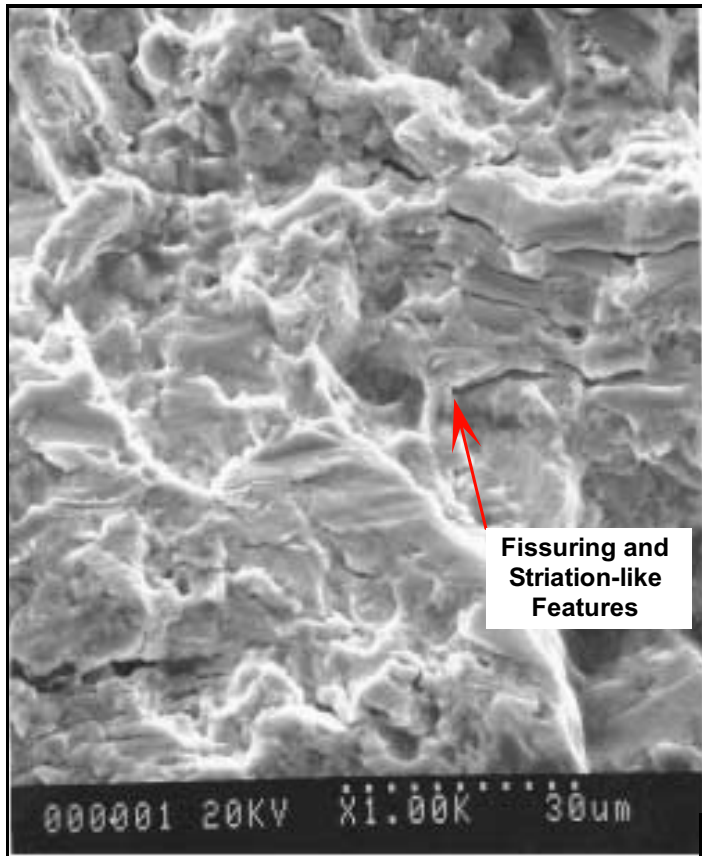
Scanning electron microscope examinations of the fracture surface found ductile dimple fracture features, as shown in figure 73, over the majority of the fracture except in the previously mentioned band. Within the band, the feature consisted of small irregular plateaus with fissuring running generally parallel to the circumference of the tube. Further examination at the Boeing Huntington Beach laboratory uncovered fatigue striation-like features throughout the band, as shown in figure 74.

Figure 73--SEM view showing typical overstress ductile dimples present on the majority of the fracture.

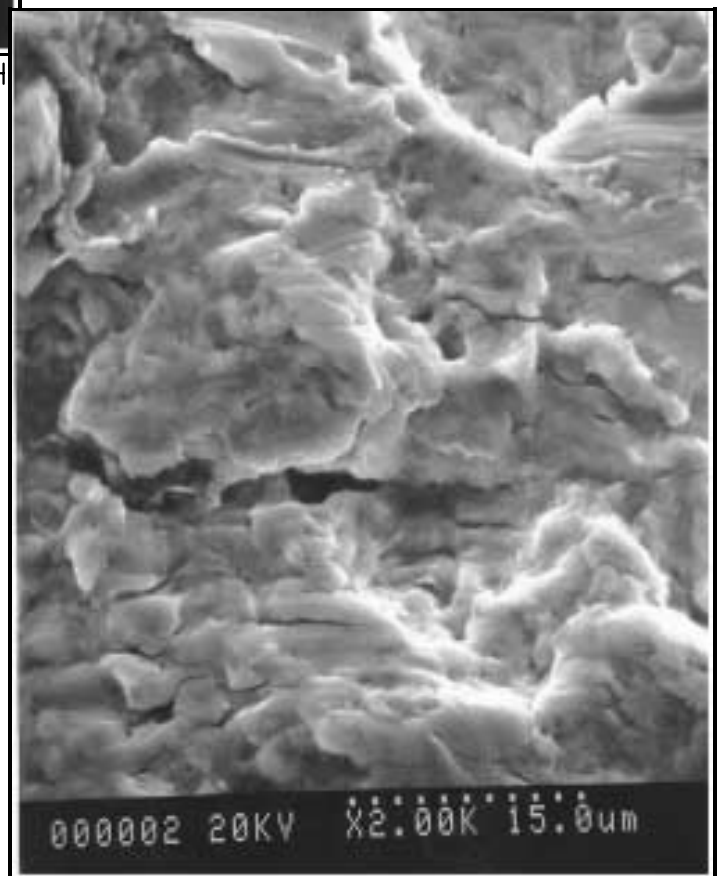
Figure 74--SEM views showing typical fracture features in the reflective band. Note the fissures and striation-like features.
