NATIONAL TRANSPORTATION SAFETY BOARD

MATERIALS LABORATORY FACTUAL REPORT

Report No. 00-145

Place : Near Port Hueneme, California
Date : January 31, 2000
Vehicle : Boeing MD-83, N963AS
Operator : Alaska Airlines, Flight 261
NTSB No. : DCA00-M-A023

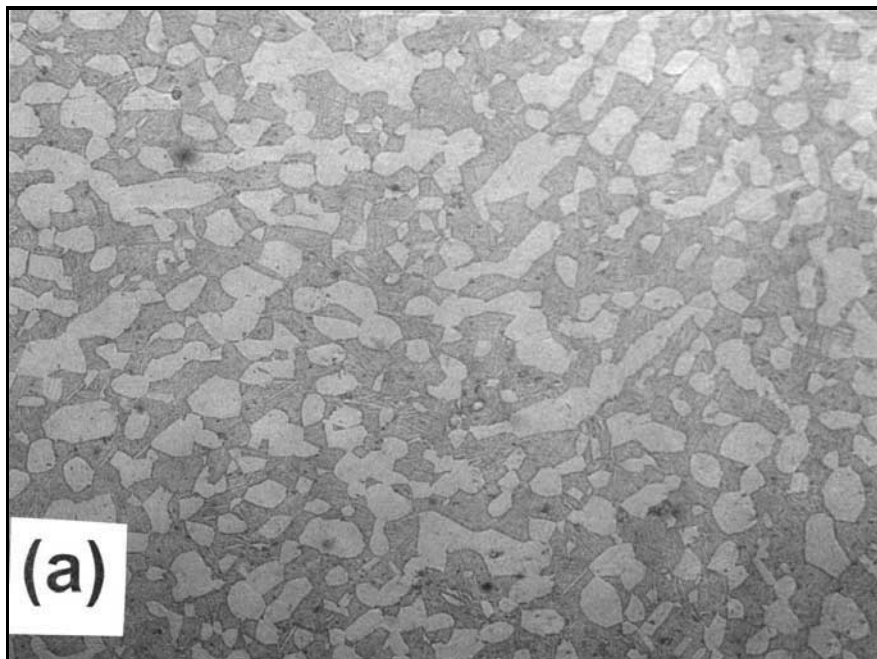
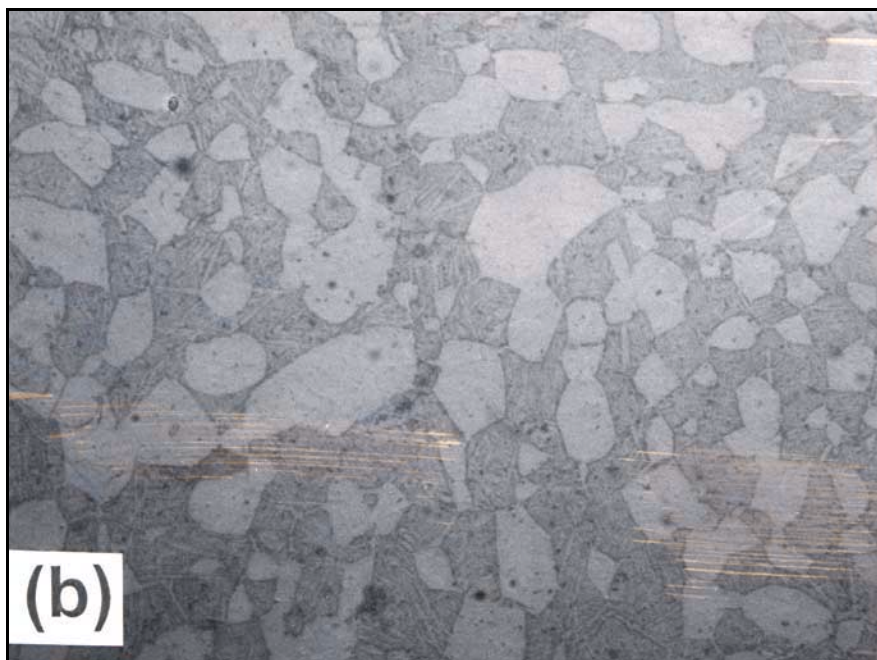
The microstructure of the torque tube was examined on a transverse metallographic specimen made from the previously cut plug at a location about 2 inches above the fracture. The specimen was polished and etched with Kroll's³⁰ reagent to revealed fine alpha islands in an alpha plus beta matrix as displayed in figure 75. No indications of an alpha case were found. The microstructure appeared typical of a properly heat treated Ti-6-4 forging.

Figure 75--The torque tube transverse microstructure showing alpha islands (light etching) in a fine alpha plus beta matrix (darker areas). Upper view at 800X, lower at 1600X original Magnifications. Etchant Kroll's

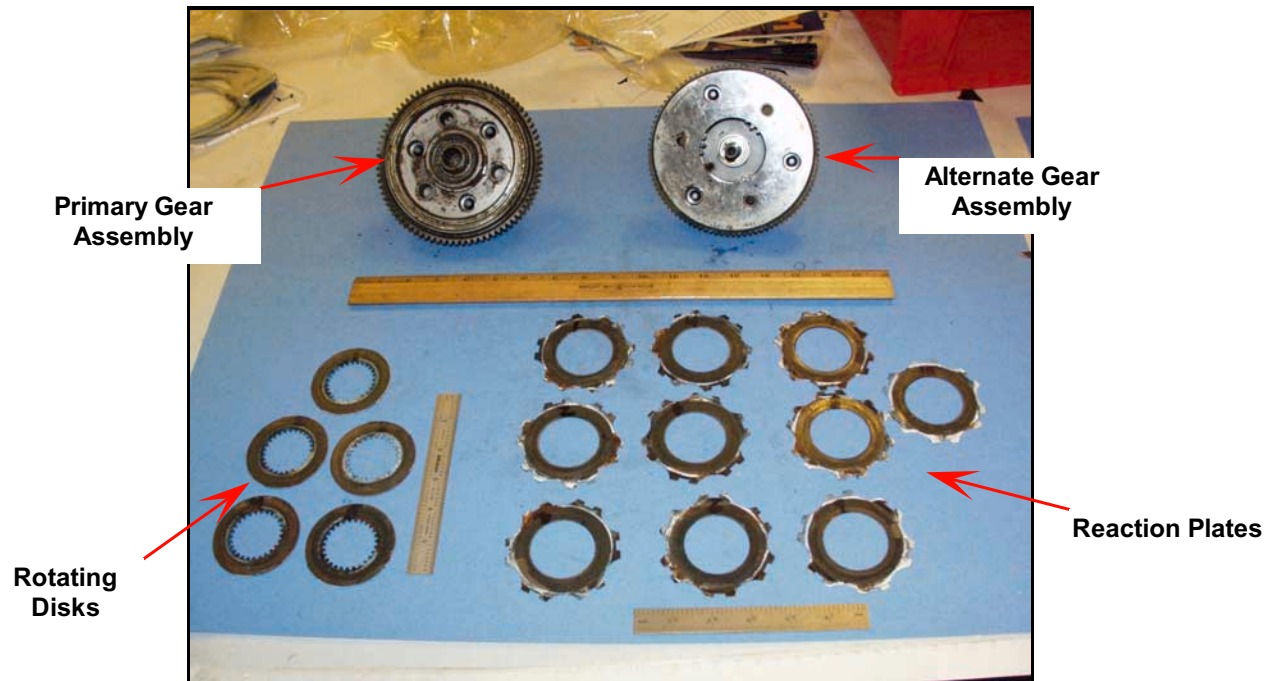
planetary gear assemblies (primary and alternate) from the jackscrew gearbox assembly. The received parts are displayed in figure 76.

Figure 76--An overall view of the gearbox and trim motor components.

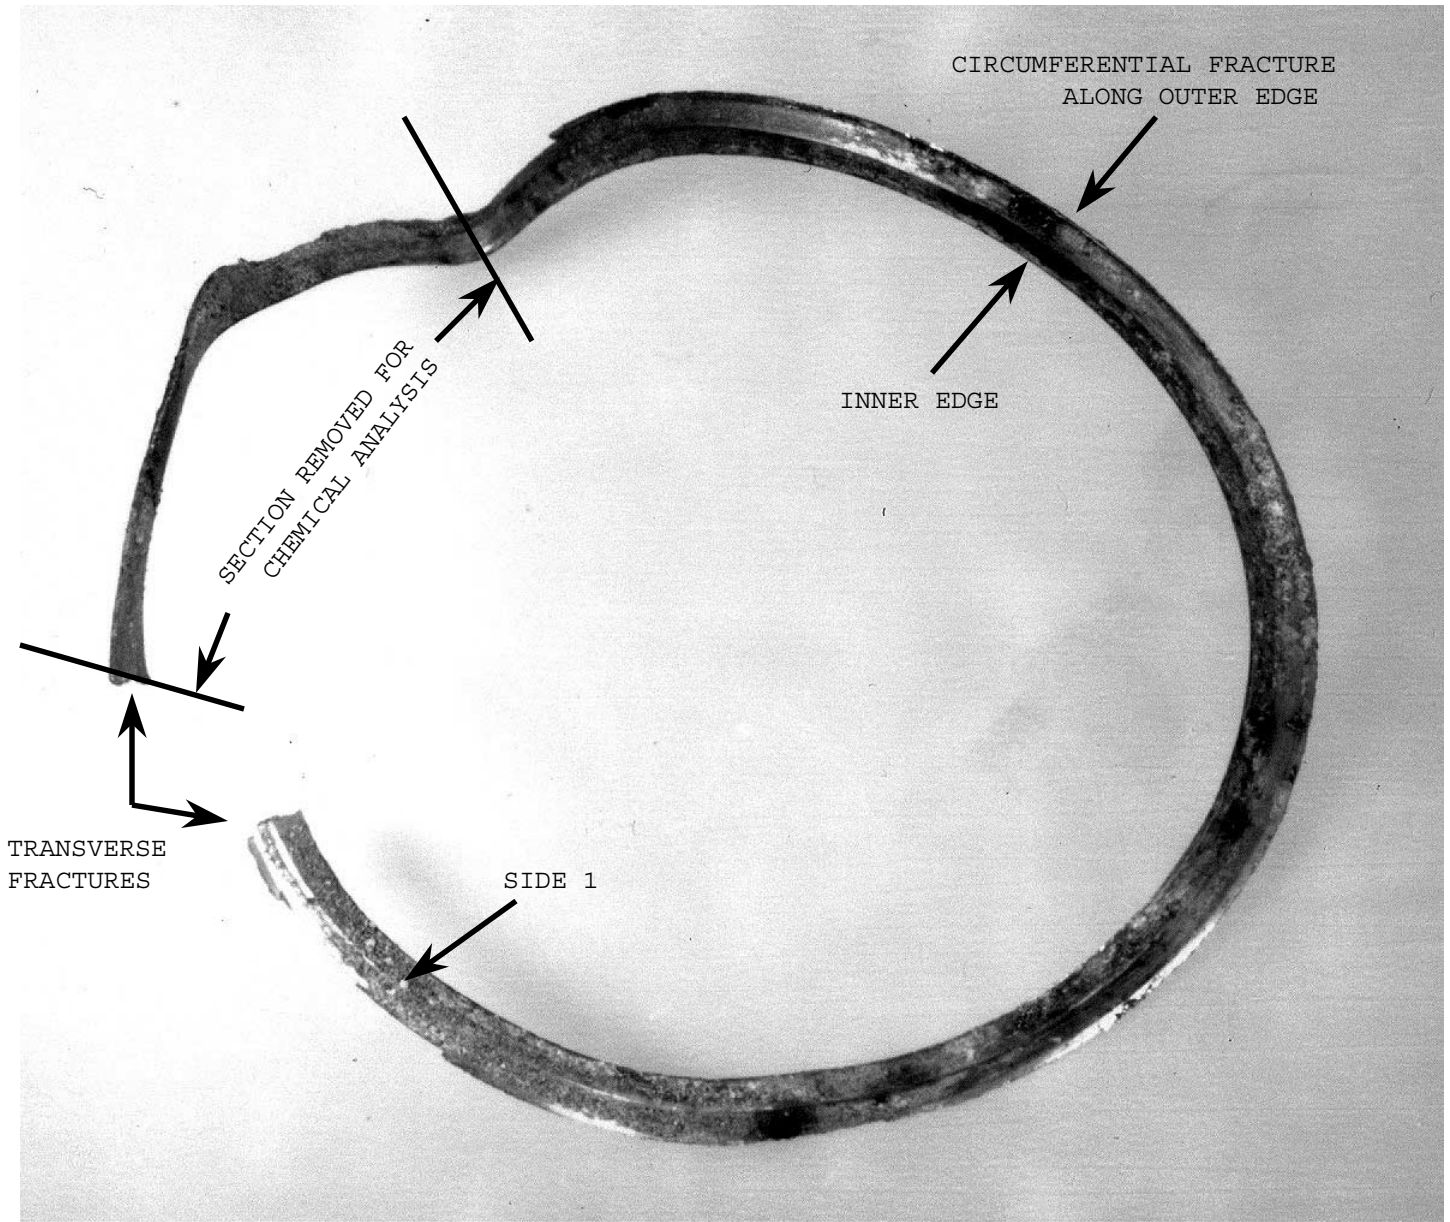
OVERALL OF METAL SHAVING
(NEG: 00-N0069)

A small, metallic shaving/sliver, approximately 6.3 inches in length, was submitted for SEM evaluation (Figure 1). The sliver was measured to be 0.125 inch in width and 0.025 inch thick. The sliver exhibited a light, copper color and was partially masked by bluish-green corrosion byproducts. The sliver was ultrasonically cleaned in acetone, and a small section at one end was excised for chemical analysis of the base material prior to SEM examination. The cleaning technique removed a portion of the corrosion byproducts.

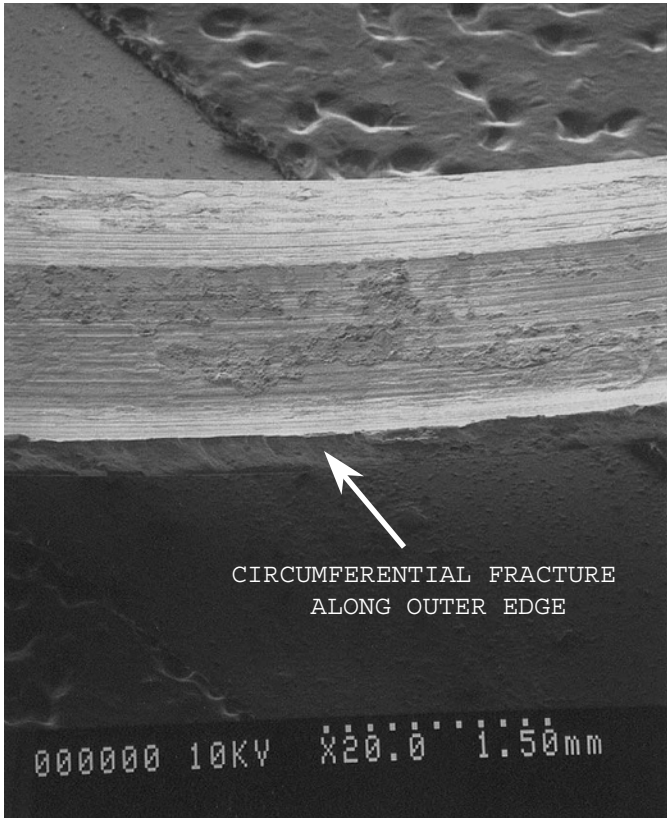
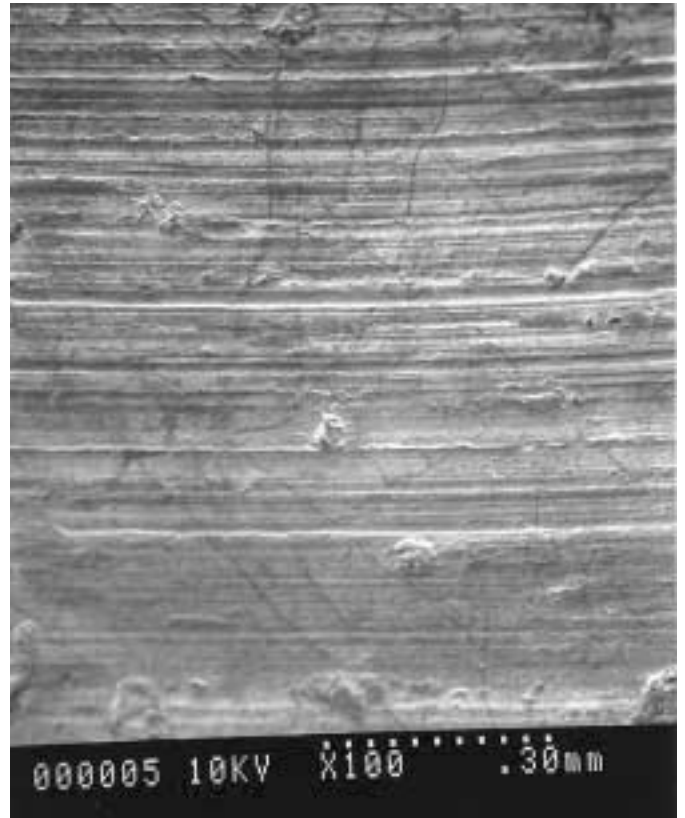
CLOSE-UP OF SIDE 1
(NEG: 00-S0066)

Both sides of the sliver exhibited circumferential grooves (Figures 2 to 5). No evidence of a failure mechanism was observed along either of these two surfaces. The sides were identified as Side 1 and Side 2 in the lab (Figure 1). Side 1 exhibited a bevel. Side 2 was relatively flat. A small circumferential fracture was observed along the outer edge of the sliver (Figure 6). The fracture surface appeared smooth and smeared, typical of shear overload. The direction of smearing appeared to extend from Side 2 towards Side 1. SEM analysis of this fracture surface revealed a predominant dimple mode of rupture, indicative of ductile overload (Figure 8). The sliver also exhibited two transverse fractures (Figure 1). One was excised with the section that was sent out for chemical analysis. The other fracture exhibited a smooth, smeared topography, similar to the circumferential fracture (Figure 7). SEM analysis of this transverse fracture also revealed a predominant dimple mode of rupture.
