NATIONAL TRANSPORTATION SAFETY BOARD

FIRE INVESTIGATION FACTUAL REPORT

Report No. 09-003

Place : San Francisco, California
Date : 6/28/2008
Vehicle : Boeing 767-200 Freighter
NTSB No. : DCA08MA076
Investigator : Lorenda Ward

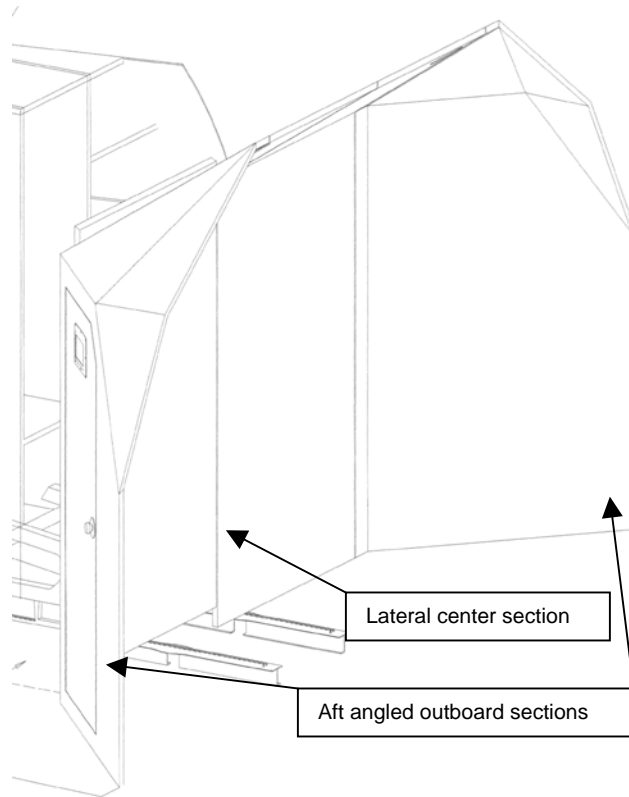
Figure 10: Diagram depicting the original shape of the smoke barrier wall

The smoke barrier wall separating the main deck cargo compartment from the supernumerary area was constructed of a fiberglass-faced honeycomb-core composite panel material. The wall was constructed with a lateral center section and aft angled outboard sections (figure 10). The aft fiberglass face, of the smoke barrier wall, was mostly intact and the decorative finish was burned along the upper areas but was mostly present on the lower areas. The top edge of the vertical wall was no longer connected to upper aft angled section and the remains of the wall had fallen aft into the area between the 9G cargo net and the original location of the wall. The lower edge was still mostly connected to floor structure. When

the fallen center section was raised back into the upright position (figure 11), it extended to a height of 77 inches above the cabin floor. The forward facing fiberglass face of the center section of the wall was charred from floor to ceiling and detached and/or missing in most places. The honeycomb inner section of the center section of the wall was either missing or charred in most locations. An 18 inch wide by 18 inch high section on the lower edge of the middle of the lateral wall was burned away. The left and right lateral wall sections were not connected. An aluminum strip normally connects the two sections but was melted away on the accident airplane. There is normally an upper section of the center wall that extends up and aft to connect to the ceiling of the cargo compartment near the top of the 9G cargo net. Some sections of this material were observed partially attached to parts of the center wall and partially attached to some sections of cargo liner ceiling material that had also collapsed from its normal position.

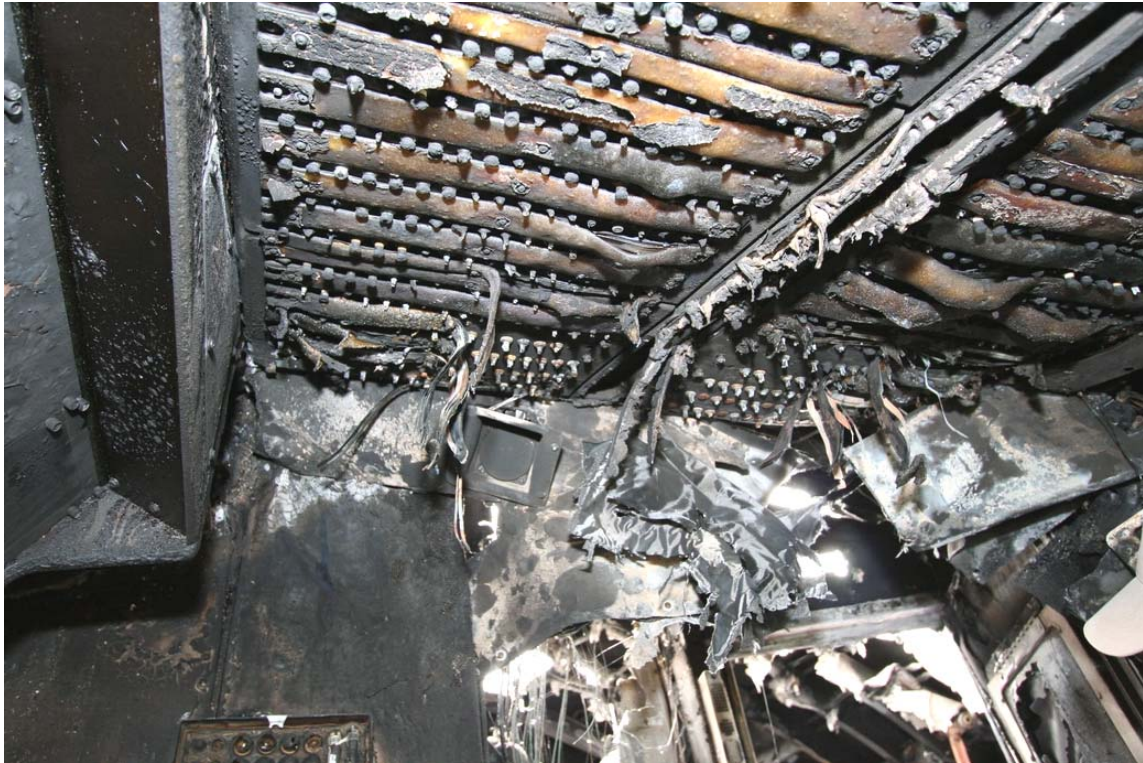
Figure 17: Circuit breaker panel on flight deck ceiling

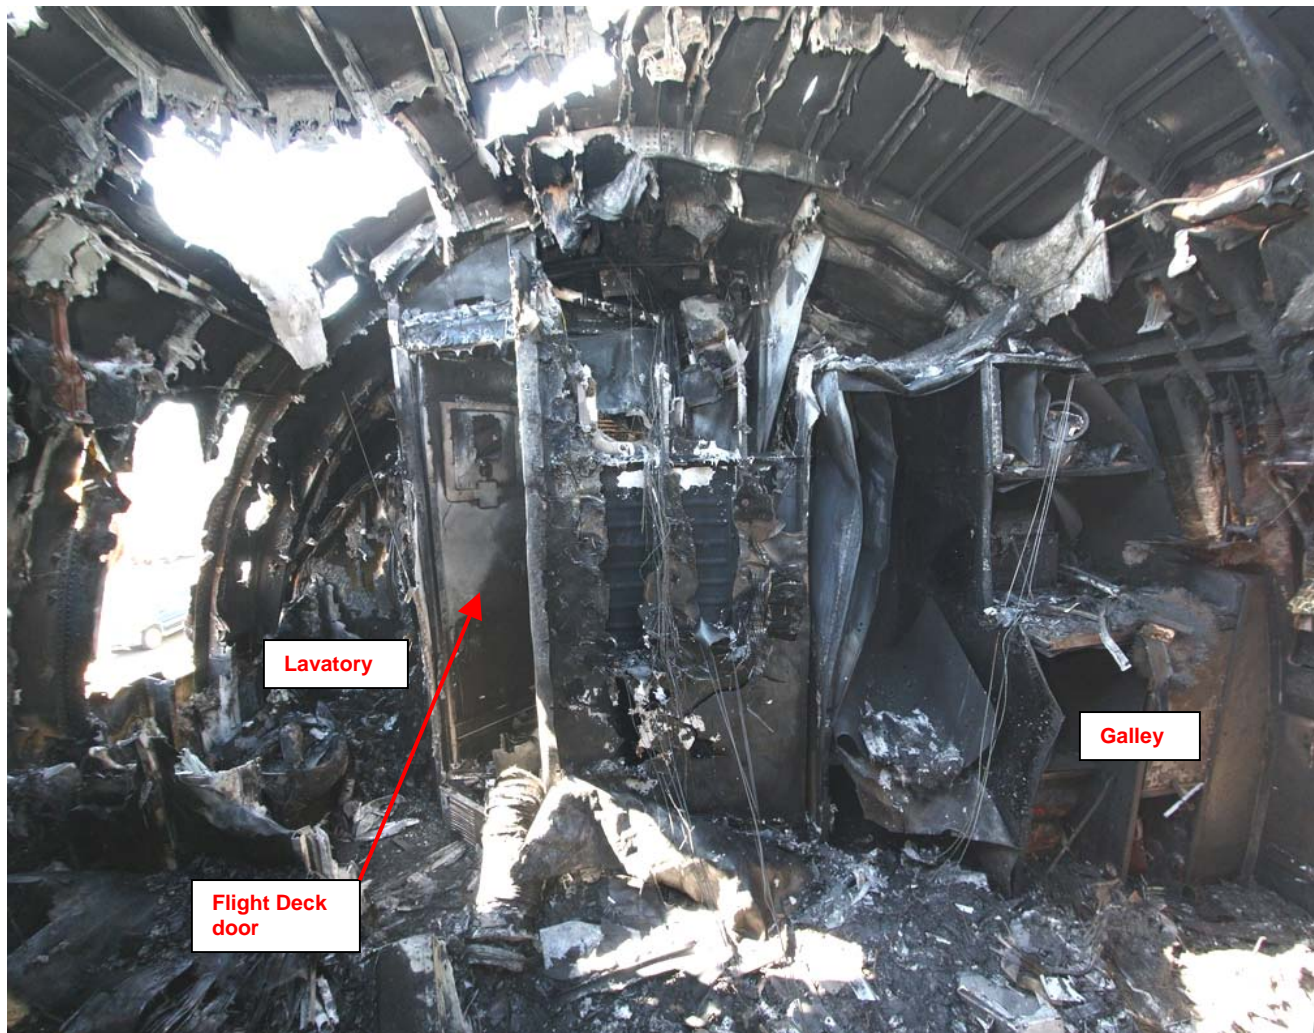
Figure 19: From inside the supernumerary compartment looking forward

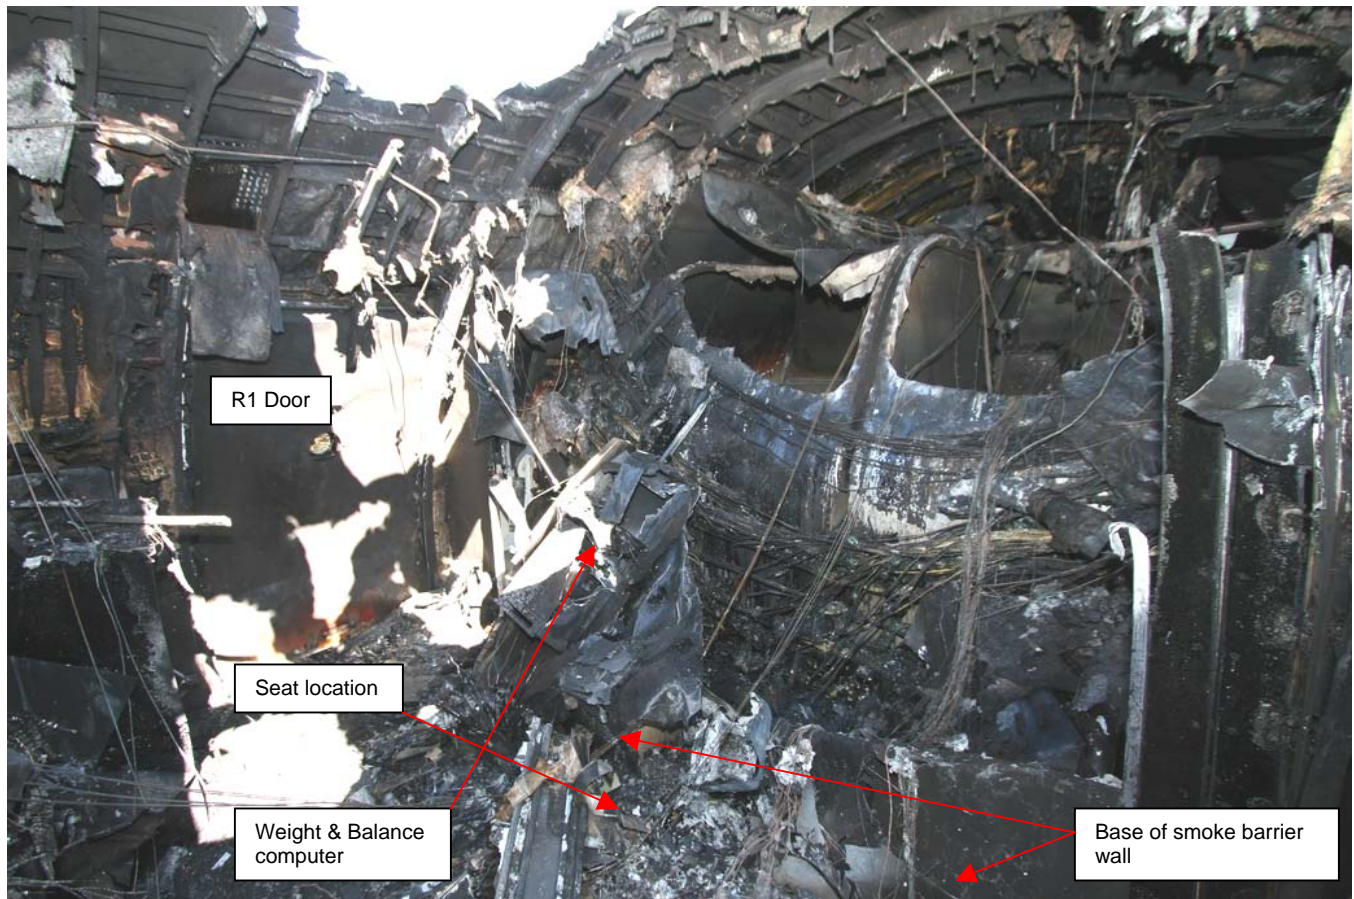
Figure 20: From inside the supernumerary compartment looking aft

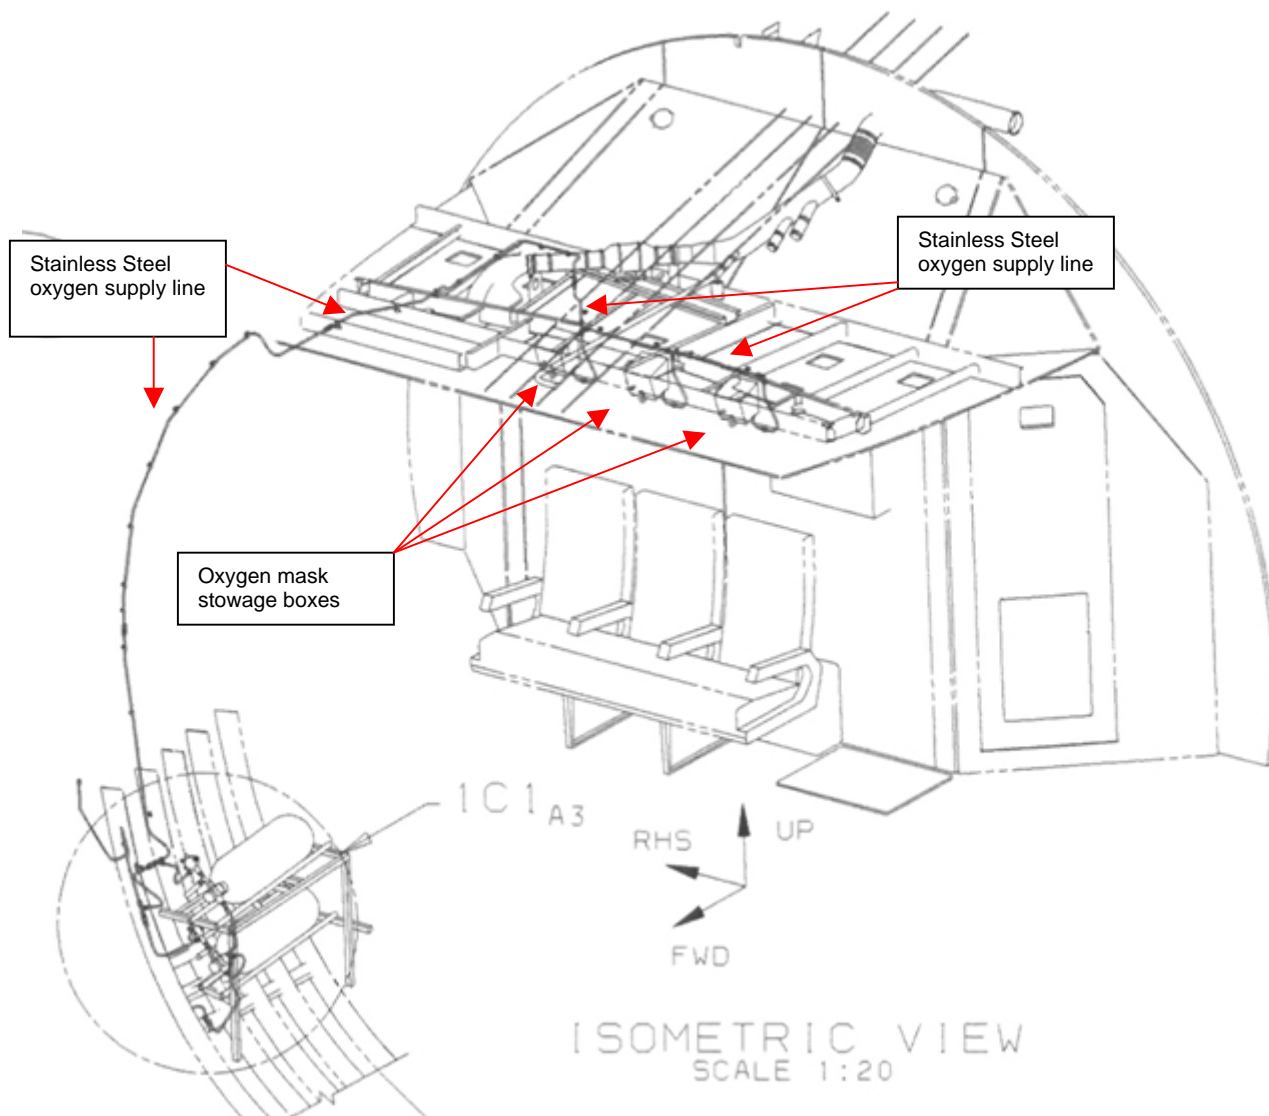
Figure 24: Drawing of supernumerary oxygen system supply line routing

The emergency oxygen system for the supernumerary compartment would have provided for the use of three oxygen masks. A high-pressure oxygen cylinder that was located below deck, forward of the E&E compartment, supplied the oxygen to the system (figure 24). A regulator reduced the pressure of the oxygen to 70 psig as it was transferred to the supernumerary compartment via stainless steel tubing. The stainless steel tubing would run vertically upward from below deck to above ceiling height on the main deck in the area forward and outboard of the galley. The tubing then would have crossed the overhead area above the ceiling panels and then dropped down into the bulkhead containing the oxygen mask stowage boxes (figure 25).

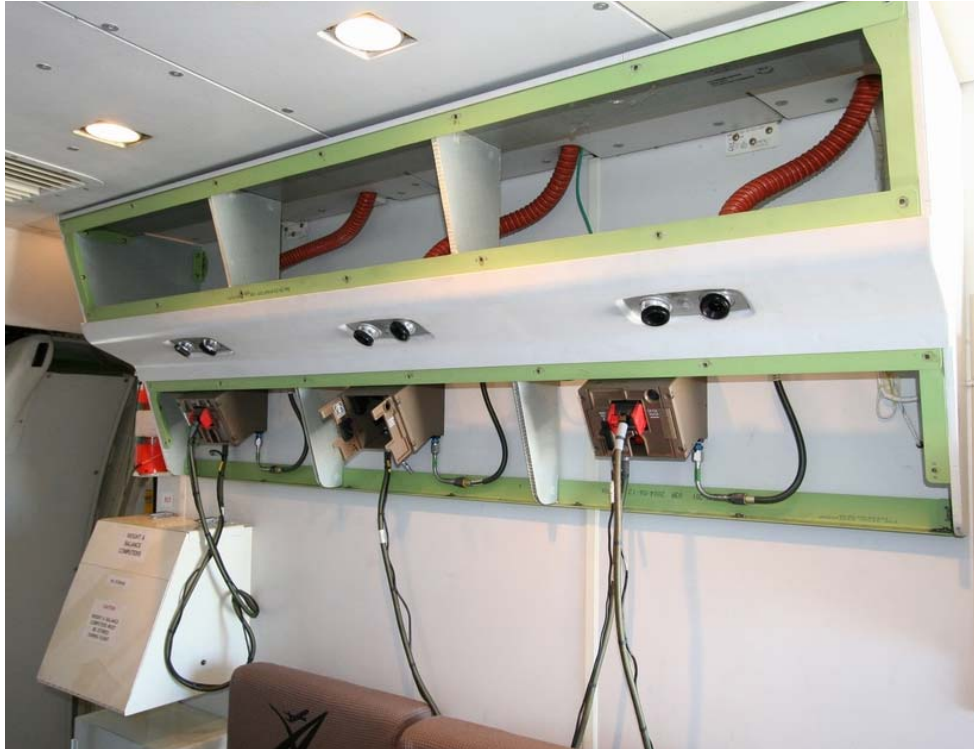
Figure 25: Exemplar bulkhead containing oxygen mask stowage boxes, lights and vents. Face panels of bulkhead have been removed in photograph.

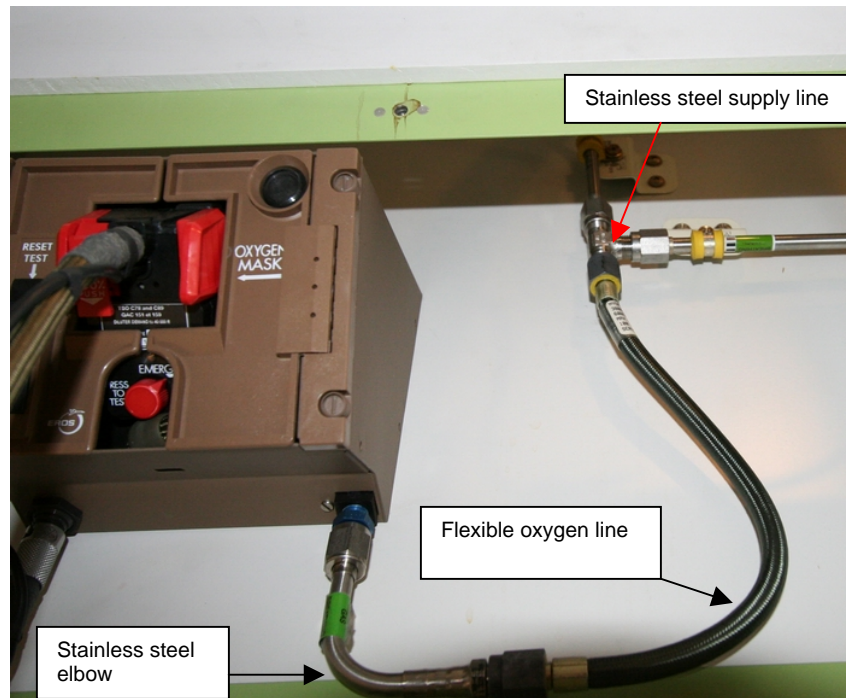
The bulkhead containing the oxygen mask stowage boxes would have been secured to the center portion of the smoke barrier wall, just above the three-person seat. The bulkhead would have been constructed from composite panel and aluminum frame sections. The stainless steel tubing, having dropped down into the bulkhead, would have connected to the oxygen mask stowage boxes by flexible oxygen lines (figure 26). The flexible oxygen lines would have connected to the stainless steel supply line on one end and connected on the other end to a stainless steel tube formed into a 90° bend. The stainless steel 90° tube would have fittings on the ends for attaching the flexible oxygen line to the oxygen mask stowage box (figure 26)

Figure 26: A flexible oxygen line connects the stowage box to the supply line
