NATIONAL TRANSPORTATION SAFETY BOARD

MATERIALS LABORATORY FACTUAL REPORT

Report No. 08-121

Place : Weaverville, California
Date : August 5, 2008
Vehicle : Sikorsky S-61N, N612AZ
NTSB No. : LAX08PA259
Investigator : Mike Hauf (AS-40)

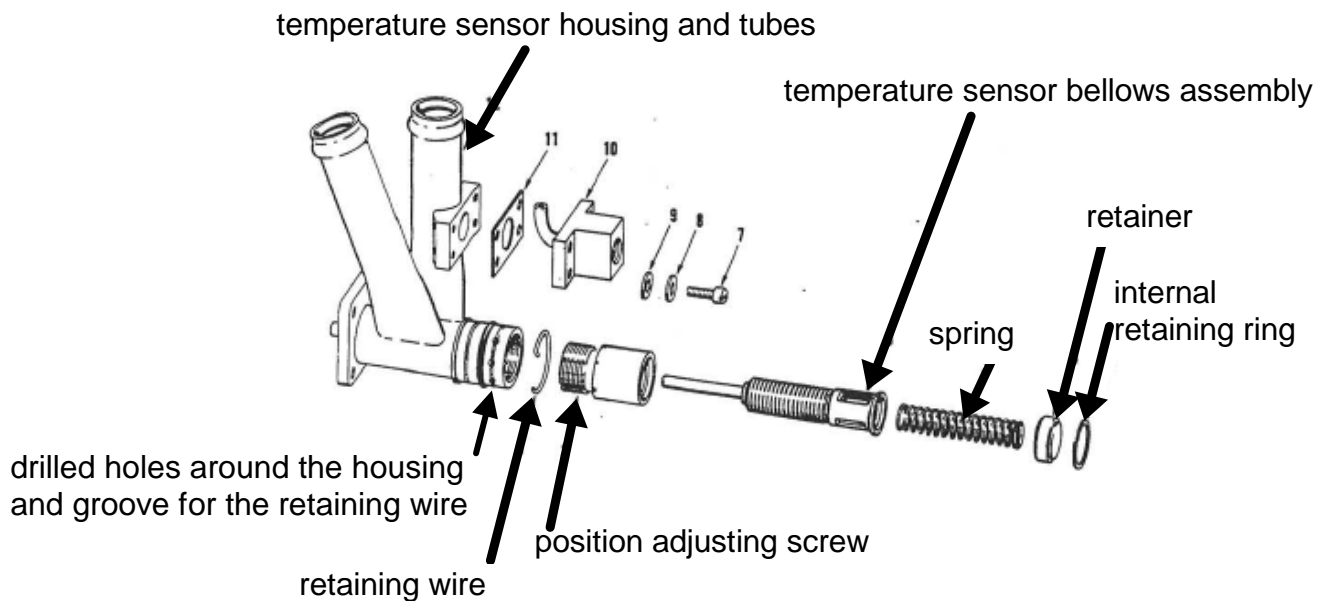
Schematics of the aspirator assembly are shown in figures 2 and 3. The position adjusting screw portion is manufactured from tube stock. The position adjusting screw at one end contained an external thread and the other end contained a circumferential internal square groove. The external thread portion is to be attached to the mating internal threads on the temperature sensor housing. The position adjusting screw and housing were manufactured with several drilled holes to accommodate a retaining wire. A position adjusting screw is attached to the temperature housing and the ends of the retaining wire are inserted into the alignment holes of the adjusting screw and housing. The retaining wire locks the position of the position adjusting screw relative to the housing. The temperature sensor bellows assembly is inserted into the end of the position adjusting screw that contains the circumferential internal square groove. A spring is inserted into the temperature sensor bellows assembly, and a retainer is inserted into the bore of the position adjusting screw until the retainer is positioned slightly deeper than the circumferential internal square groove. An internal retaining ring is inserted into the circumferential internal square groove. In the installed condition, the spring applies pressure to the retainer. The internal retaining ring prevents the retainer from sliding out of the position adjusting screw.

Figure 3. Diagram of the aspirator assembly showing greater detail than shown in figure 1.

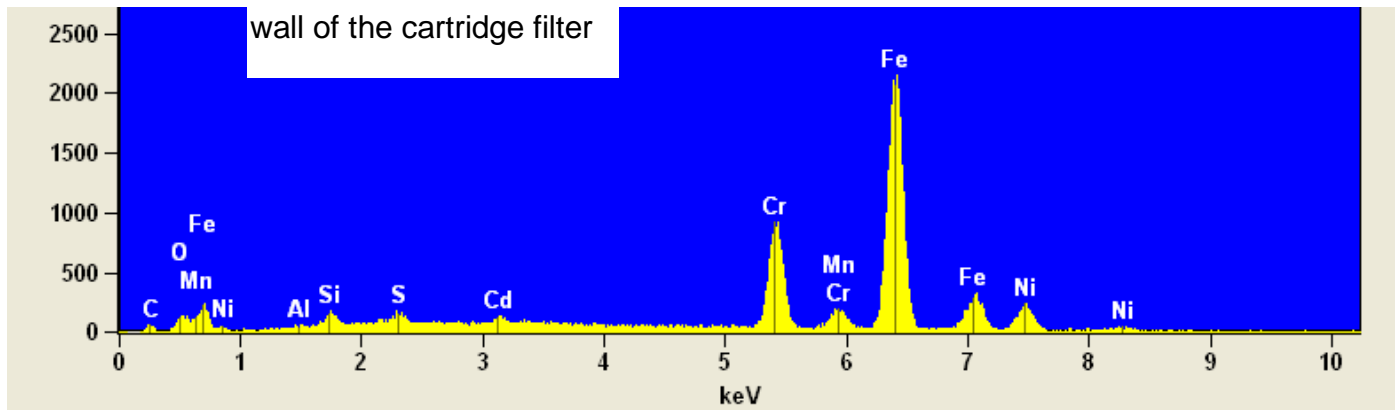
EDS spectrum of the wall from the removable-cartridge filter contained major elemental peaks of iron, chromium, and nickel, and minor elemental peaks of carbon, oxygen, aluminum, silicon, sulfur, and cadmium.

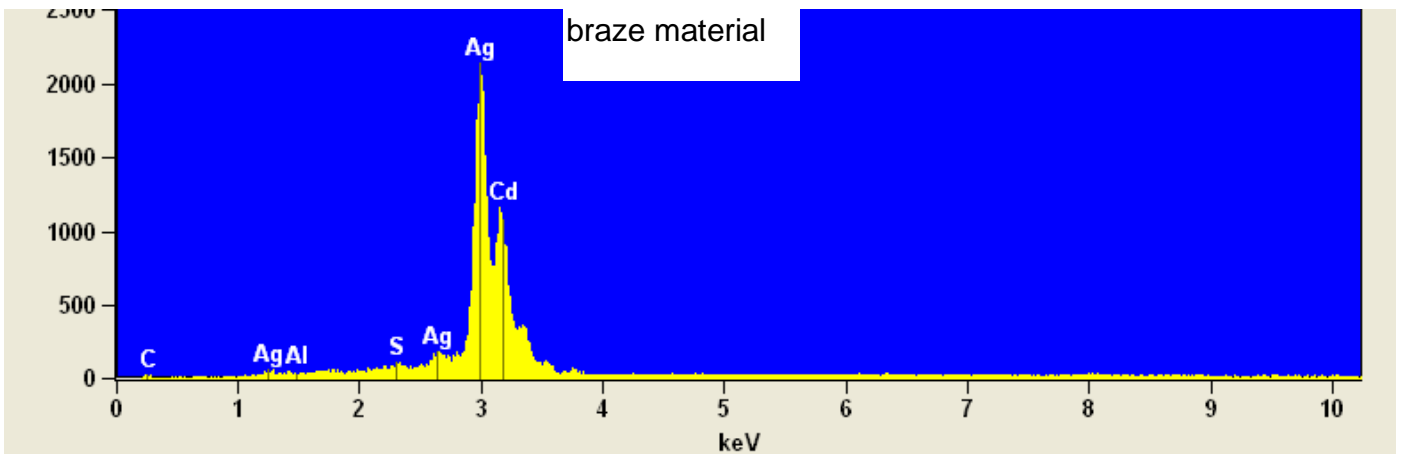
EDS spectrum of the wall of the braze material between the casting and screens contained major elemental peaks of silver and cadmium, and minor peaks of carbon and sulfur.

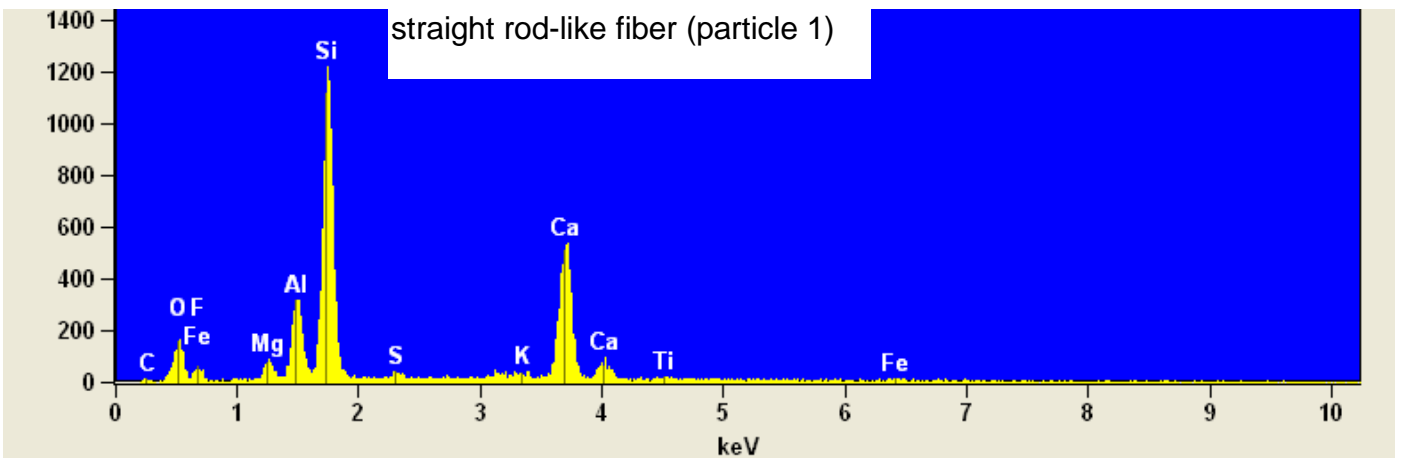
EDS spectrum of the straight rod-like fiber (particle 1 in figure 7) contained major elemental peaks of silicon, aluminum and calcium with minor elemental peaks of magnesium, carbon, and oxygen, consistent with a silicate glass fiber such as E-glass.

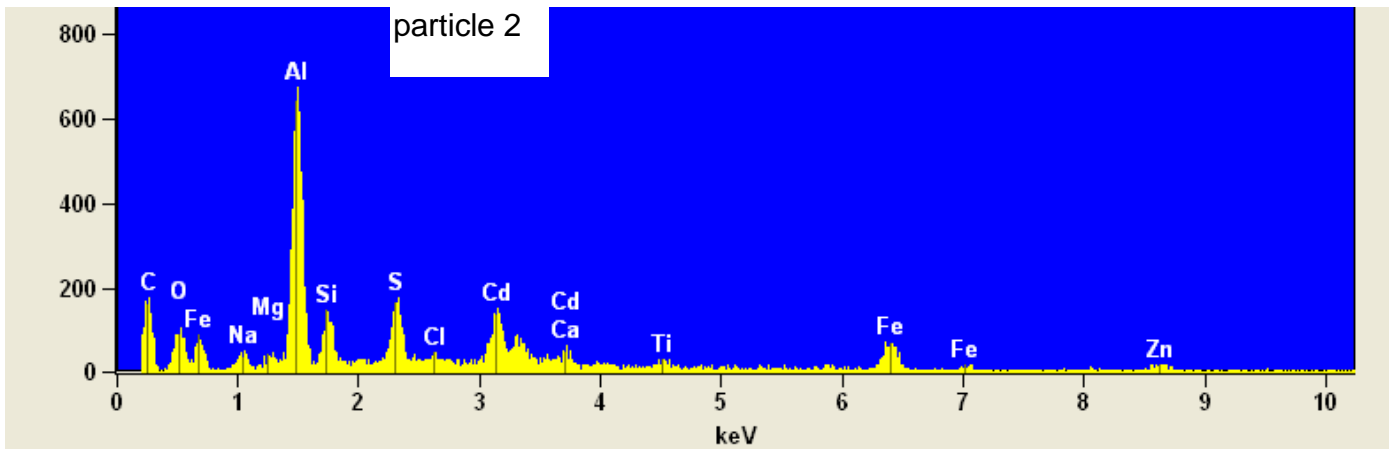
EDS spectrum of particle 2 in figure 7 contained a major peak of aluminum and minor peaks of carbon, oxygen, iron, sodium, magnesium, silicon, sulfur, chlorine, cadmium, titanium, iron, and zinc.

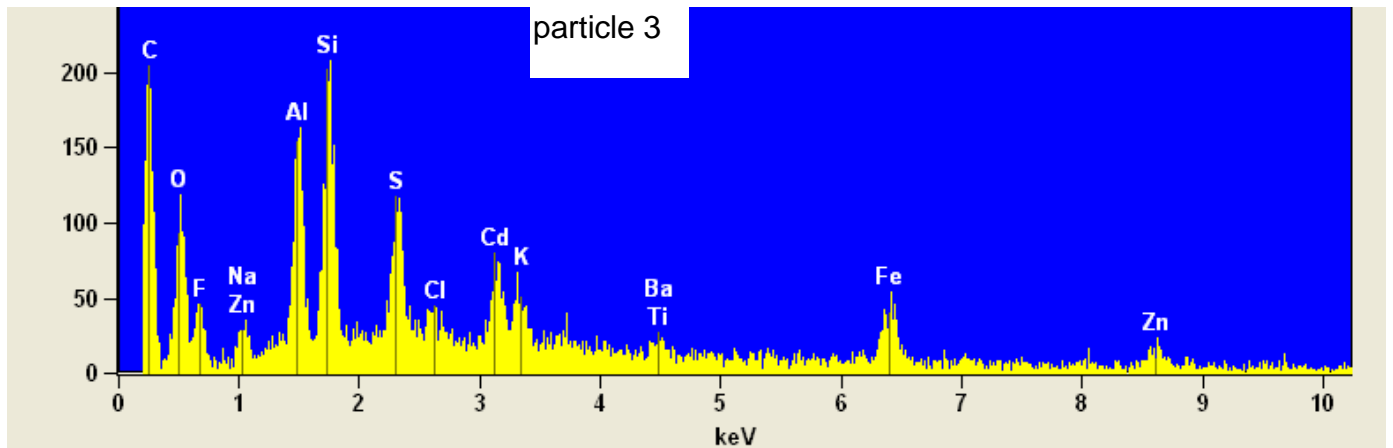
EDS spectrum of particle 3 in figure 7 contained major elemental peaks of silicon, aluminum, and carbon, and minor peaks of fluorine, sodium, zinc, sulfur, chlorine, cadmium, potassium, titanium, iron and zinc.

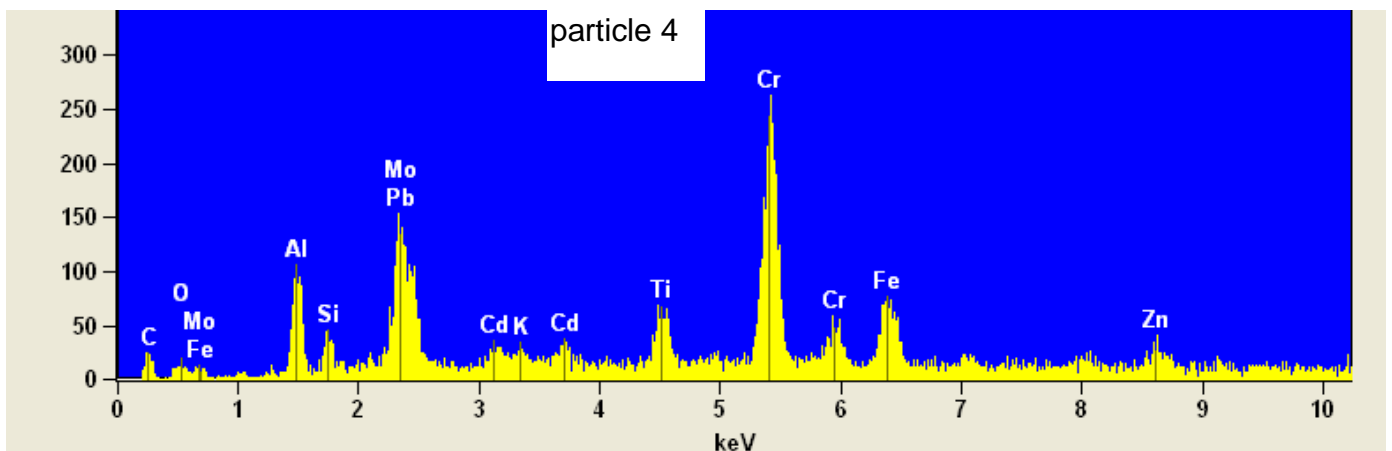
EDS spectrum of particle 4 in figure 7 contained element peaks of iron, nickel, chromium (present in the body of the filter assembly), and elemental peaks of lead, aluminum, silicon, zinc, titanium, carbon, cadmium, and potassium.

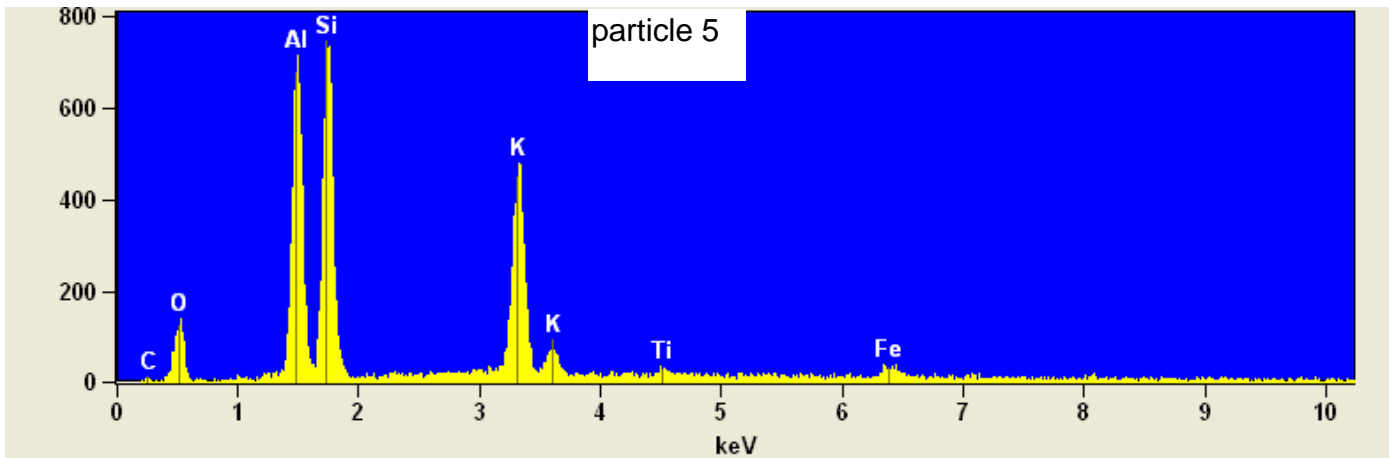
EDS spectrum of particle 5 in figure 7 contained major elemental peaks of silicon, aluminum, and potassium (consistent with Feldspar) and minor elemental peaks of iron, carbon, and oxygen.

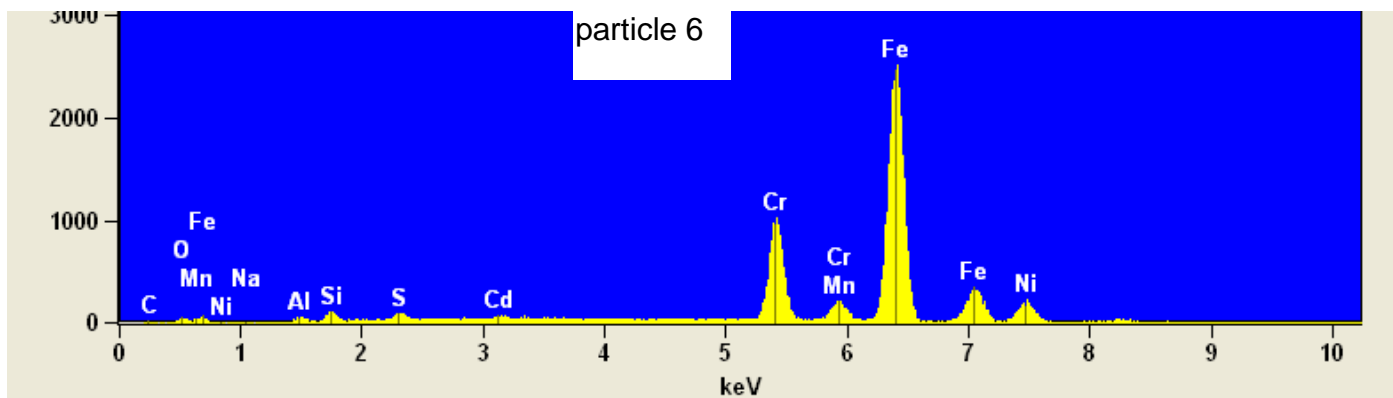
EDS spectrum of particle 6 in figure 7 contained major elemental peaks of iron, chromium, and nickel consistent with stainless steel, and minor elements of oxygen, aluminum, silicon, sulfur, and cadmium.

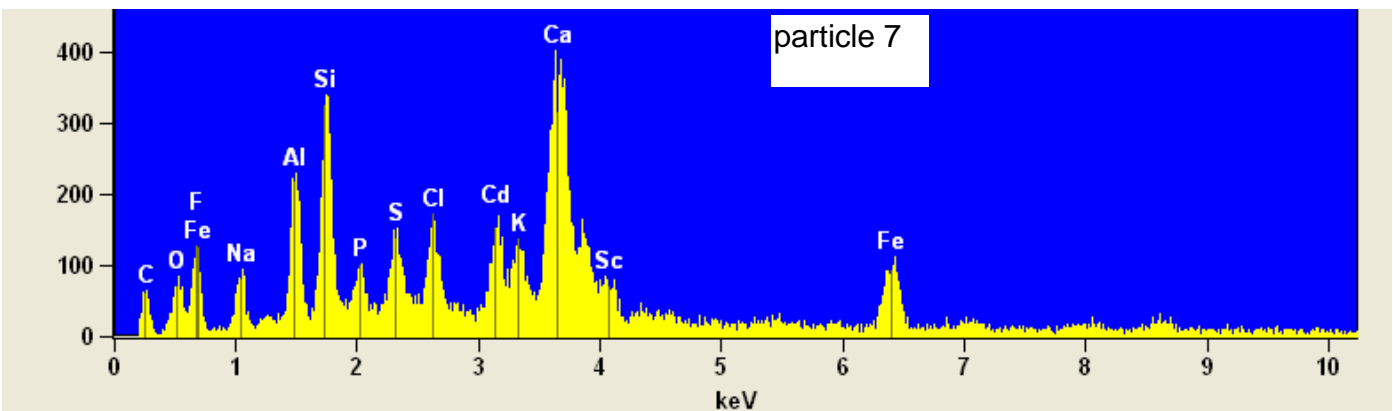
EDS spectrum of particle 7 in figure 7 contained the same elemental peaks as in particle 3 with the exception that the major elemental peaks in this particle were calcium, silicon, and aluminum.

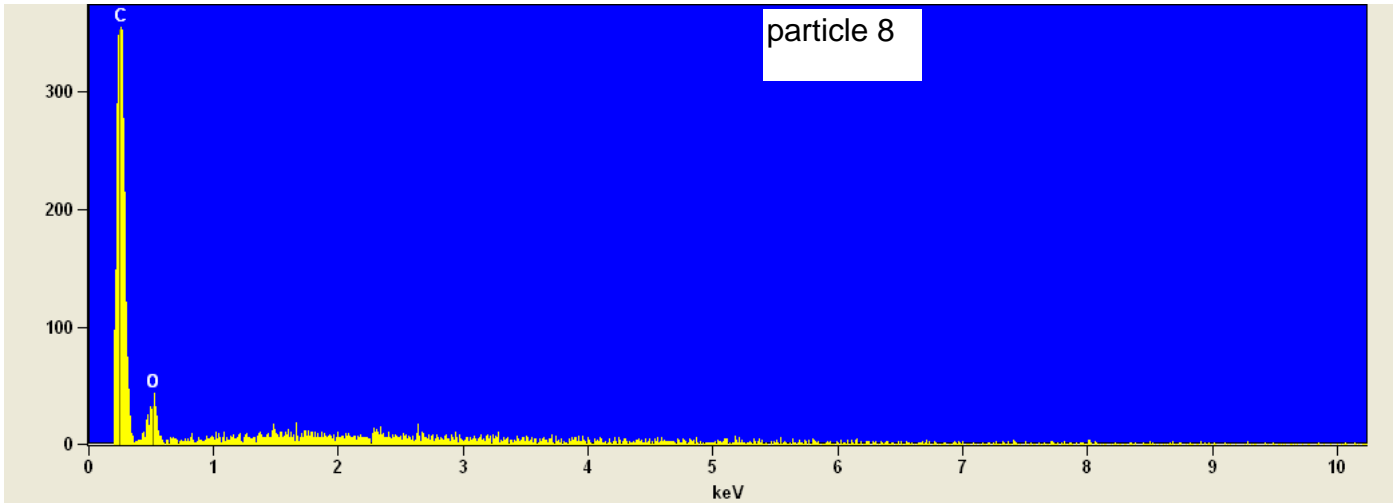
EDS spectrum of particle 8 (curled fiber) in figure 7 contained a major elemental peak of carbon and a minor peak of oxygen.

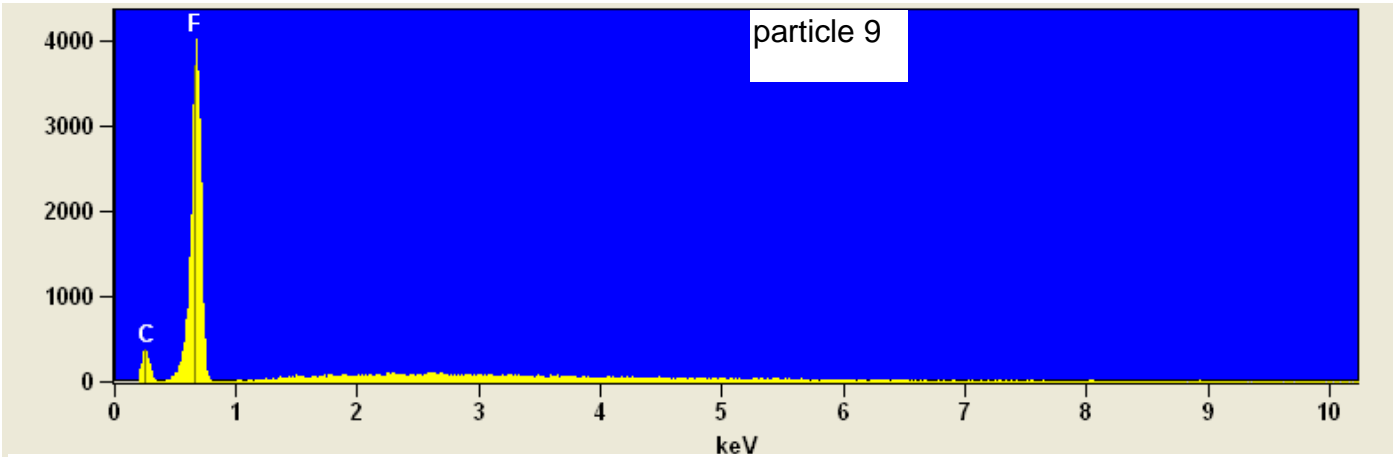
EDS spectrum of particle 9 in figure 7 contained a major elemental peak of fluorine and minor peak of carbon.

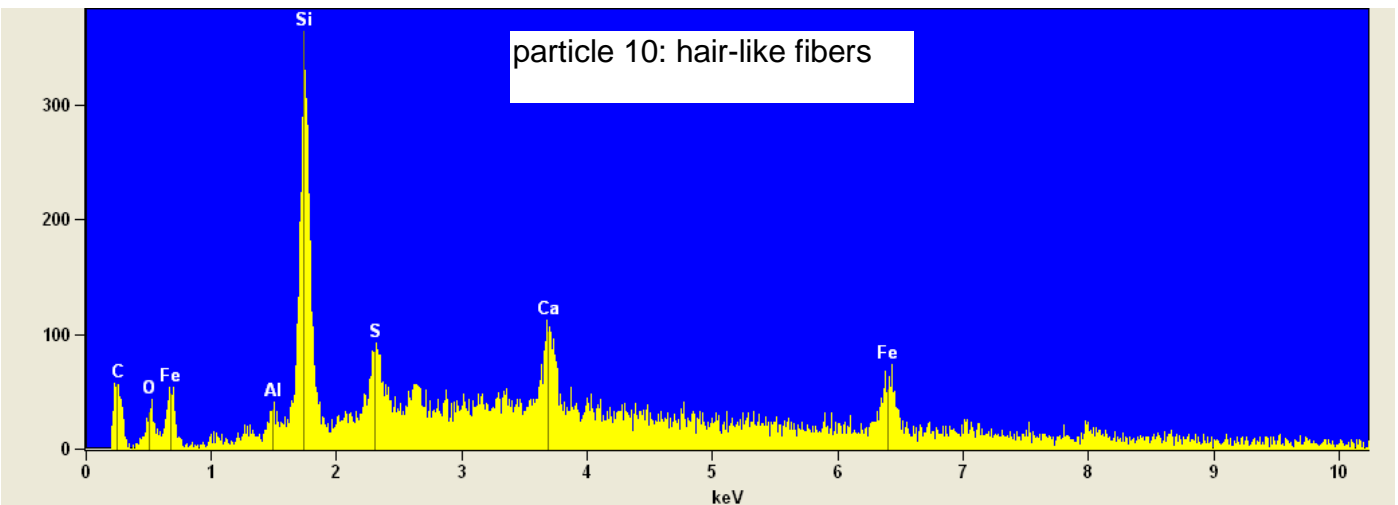
EDS spectrum of particle 10 in figure 7 in the area that contained hair-like fibers showed a major elemental peak of silicon and minor peaks of carbon, oxygen, aluminum, sulfur, calcium and iron.

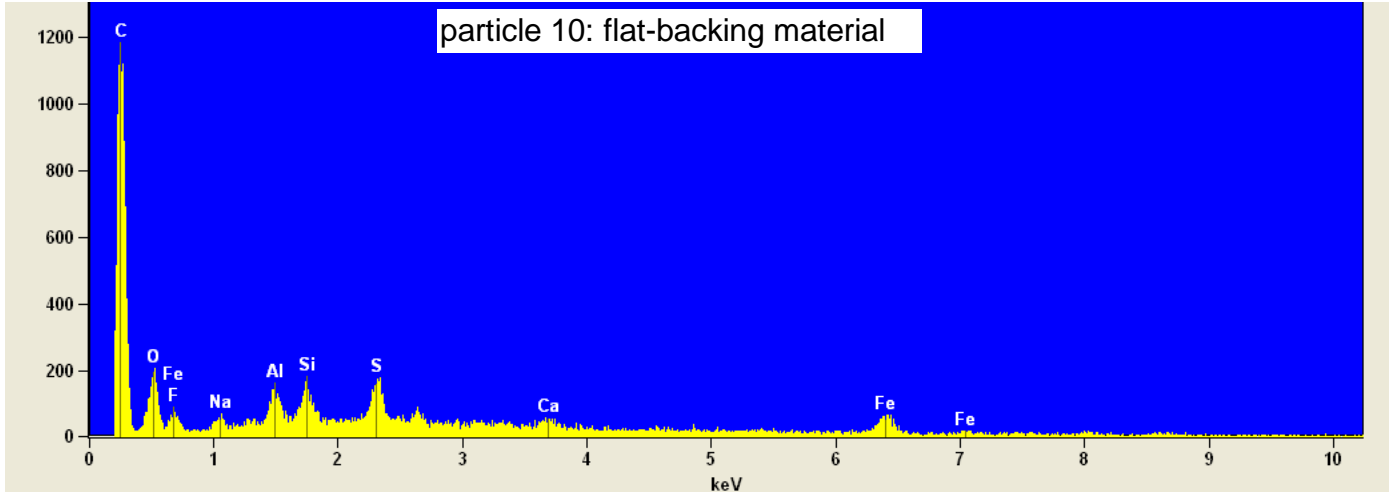
EDS spectrum of particle 10 in figure 7 in the area that contained a flat wall showed a major elemental peak of carbon and minor peaks of oxygen, fluorine, sodium, aluminum, silicon, sulfur, calcium, and iron.

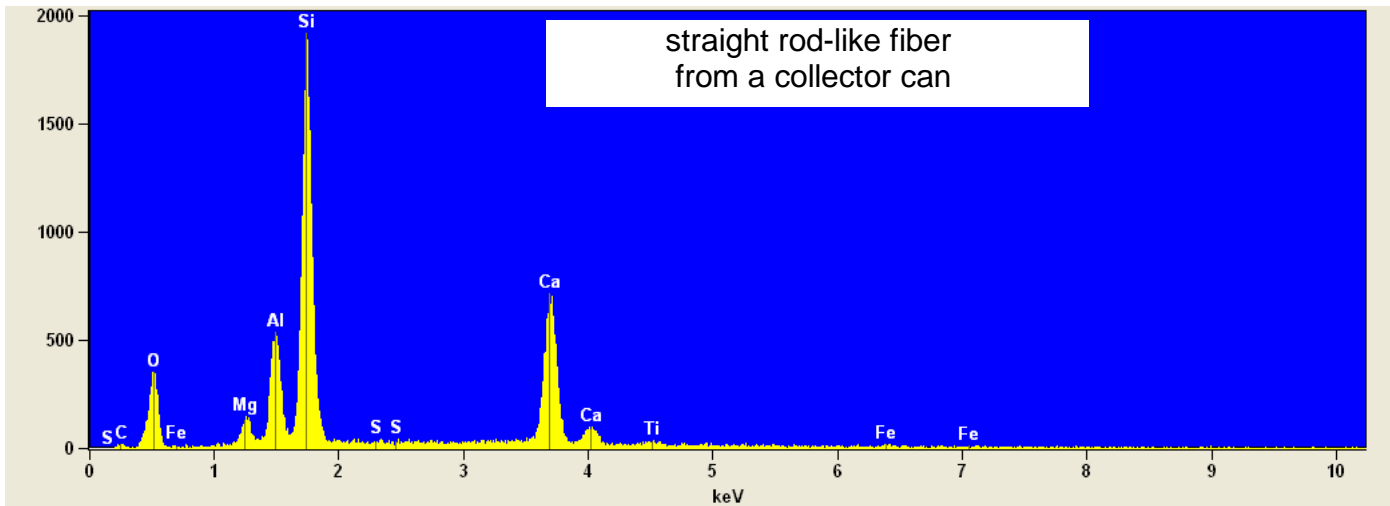
EDS spectrum of a straight rod fiber from a collector can submitted by Carson Helicopter Services Incorporated showing major elemental peaks of silicon, aluminum, and calcium, and minor elemental peaks of magnesium, oxygen, and carbon.
