NATIONAL TRANSPORTATION SAFETY BOARD

MATERIALS LABORATORY FACTUAL REPORT

Report No. 10-101

Place : Borrego Springs, California
Date : April 8, 2010
Vehicle : Snow Rocket F1 (N28VS)
NTSB No. : WPR10LA195
Investigator : Joshua Cawthra

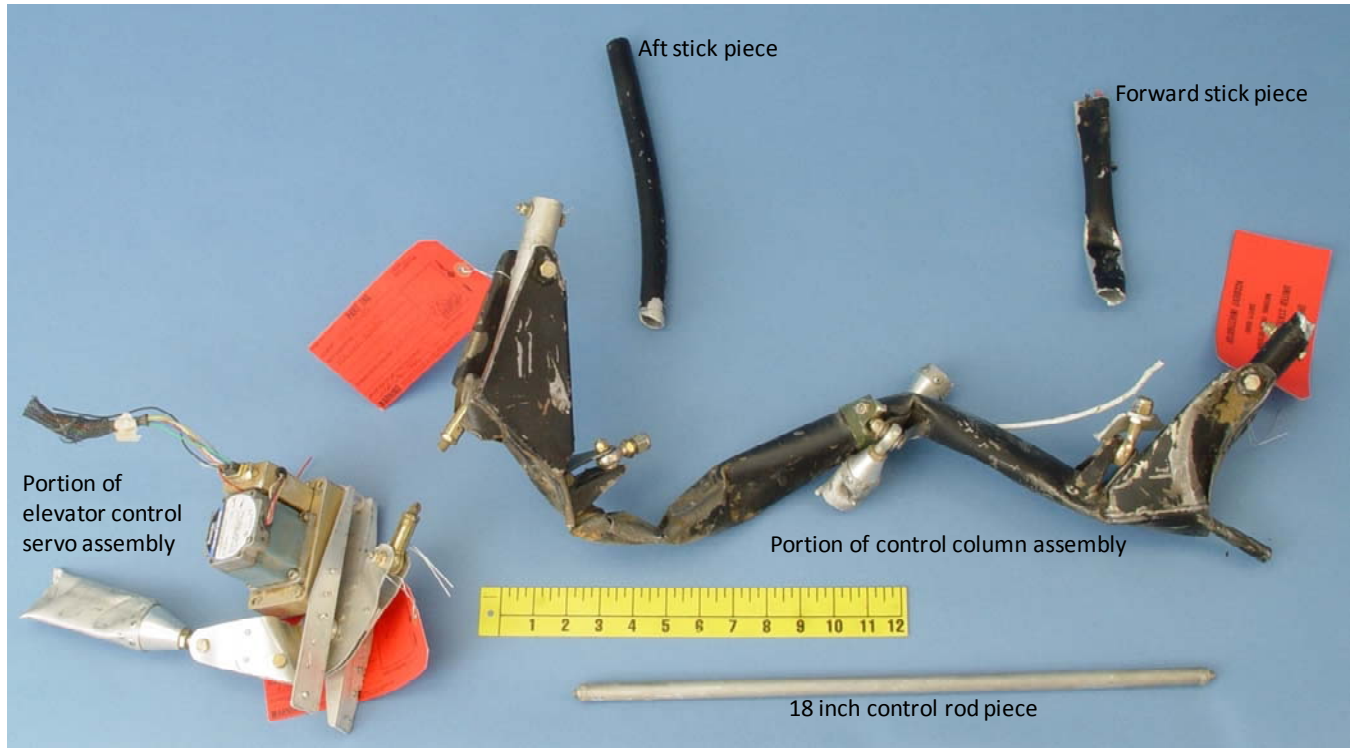
The purpose of this report is to document the fracture mode for each failed linkage component. The as-received components are shown in Figure 1.

Figure 1 The as-received accident components.
