**MATERIALS LABORATORY
FACTUAL REPORT 13-069**

**Bridge Collapse
Mount Vernon, WA; 05/23/2013**

HWY13MH012

MATERIALS LABORATORY FACTUAL REPORT

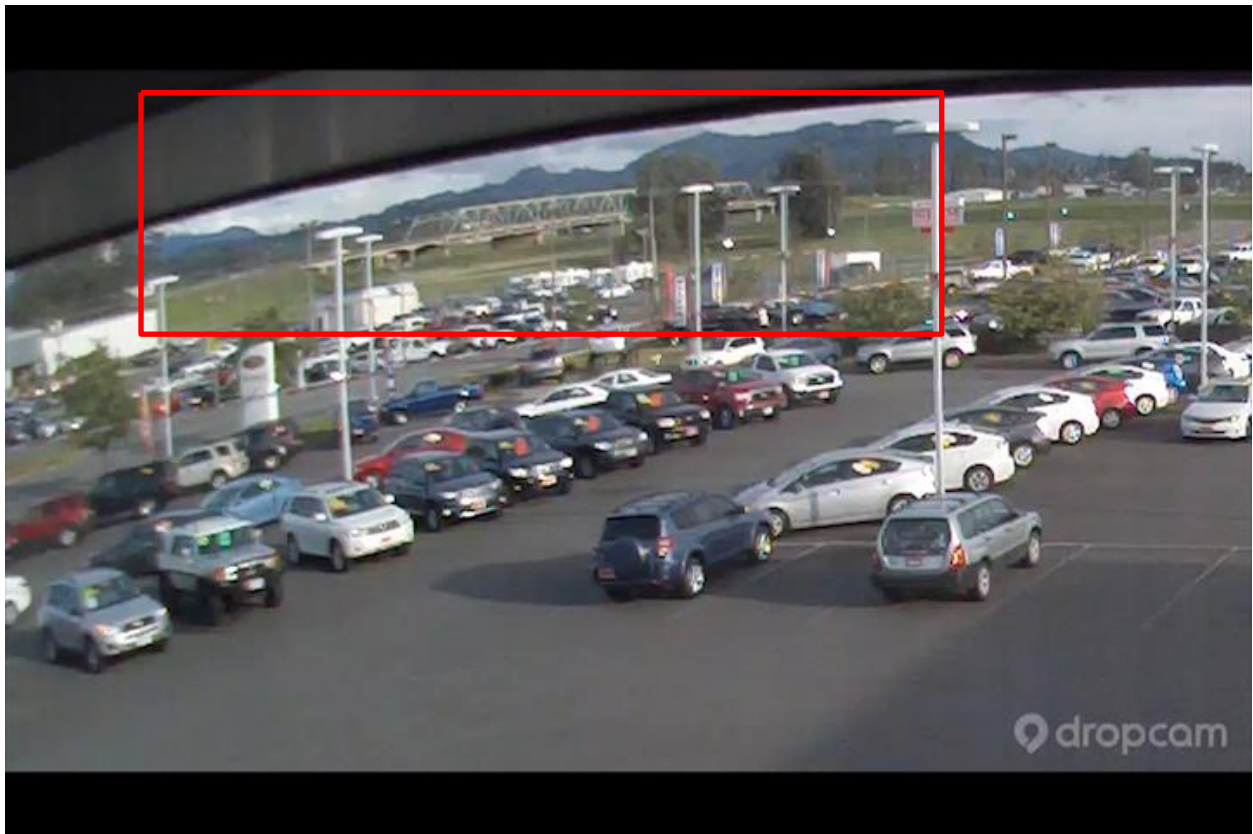
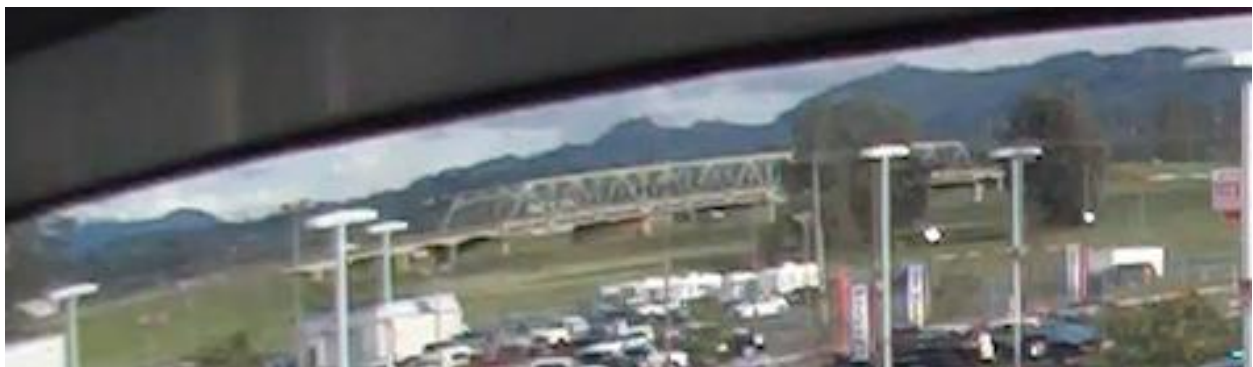
Figure 1. Upper view displays a typical video from with the red box denoting the area of the bridge cropped from each image for analysis. Lower view shows the cropped portion. View looking approximately south southeast.

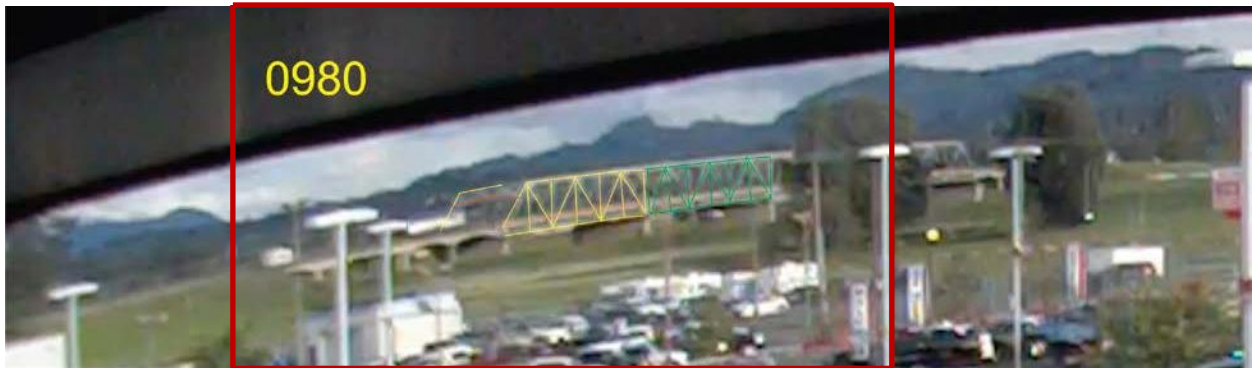
On spans 7 and 8, individual members of the west truss were identified along with the lower chord of the north portal and the identifiable portions of the east truss of span 8. The members were overlaid by thin lines (yellow for span 8 and green for span 7) in the approximate middle of the identified member. The western concrete traffic barrier of the southbound lanes was also identified and delineated. This was performed on frames well before the collapse and the member locations checked on several frames. An example of the cropped and lined image is displayed as figure 2.

Figure 2. The cropped image from figure 1 with the visible members of span 8 trusses denoted in yellow. The red line indicates the north portal. Identified members of span 7 are highlighted in green. Red box indicates the additional cropping used for display in this report (see below).
