**MATERIALS LABORATORY  
FACTUAL REPORT 13-070**

**Bridge Collapse  
Mount Vernon, WA; 05/23/2013**

**HWY13MH012**

MATERIALS LABORATORY FACTUAL REPORT

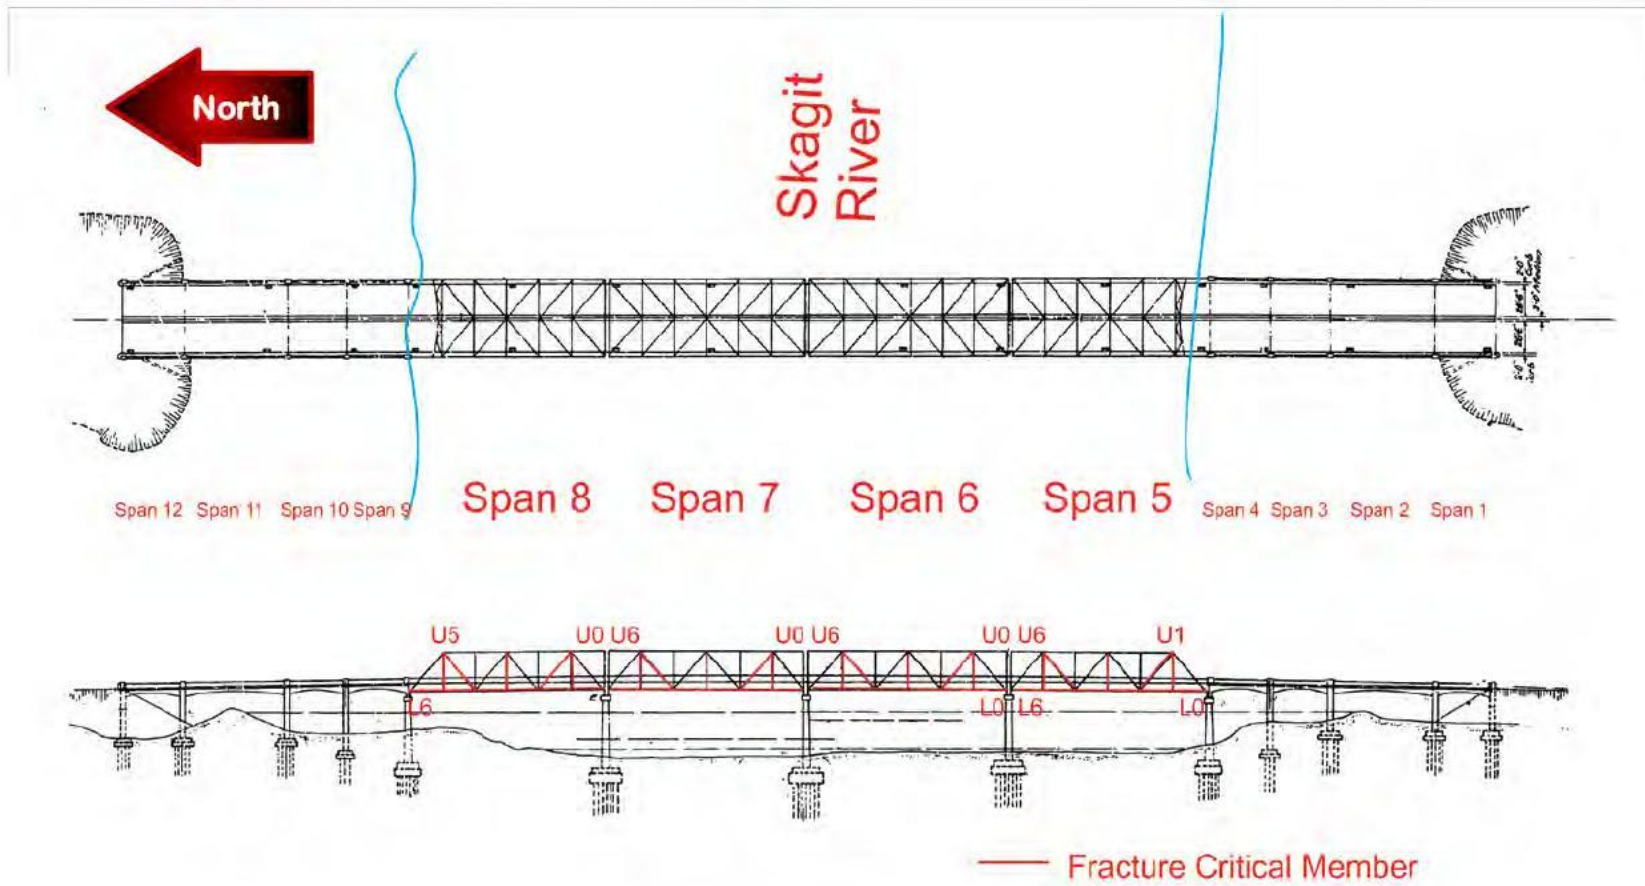
The I-5 bridge was classified as "Fracture Critical". All of the lower chord members along with several diagonals and verticals in each span were designated as fracture critical members. Fracture critical members for a typical span are shown in red in figure 1.

Figure 1. Schematic of the I-5 bridge over the Skagit River. Fracture critical members are shown in red.

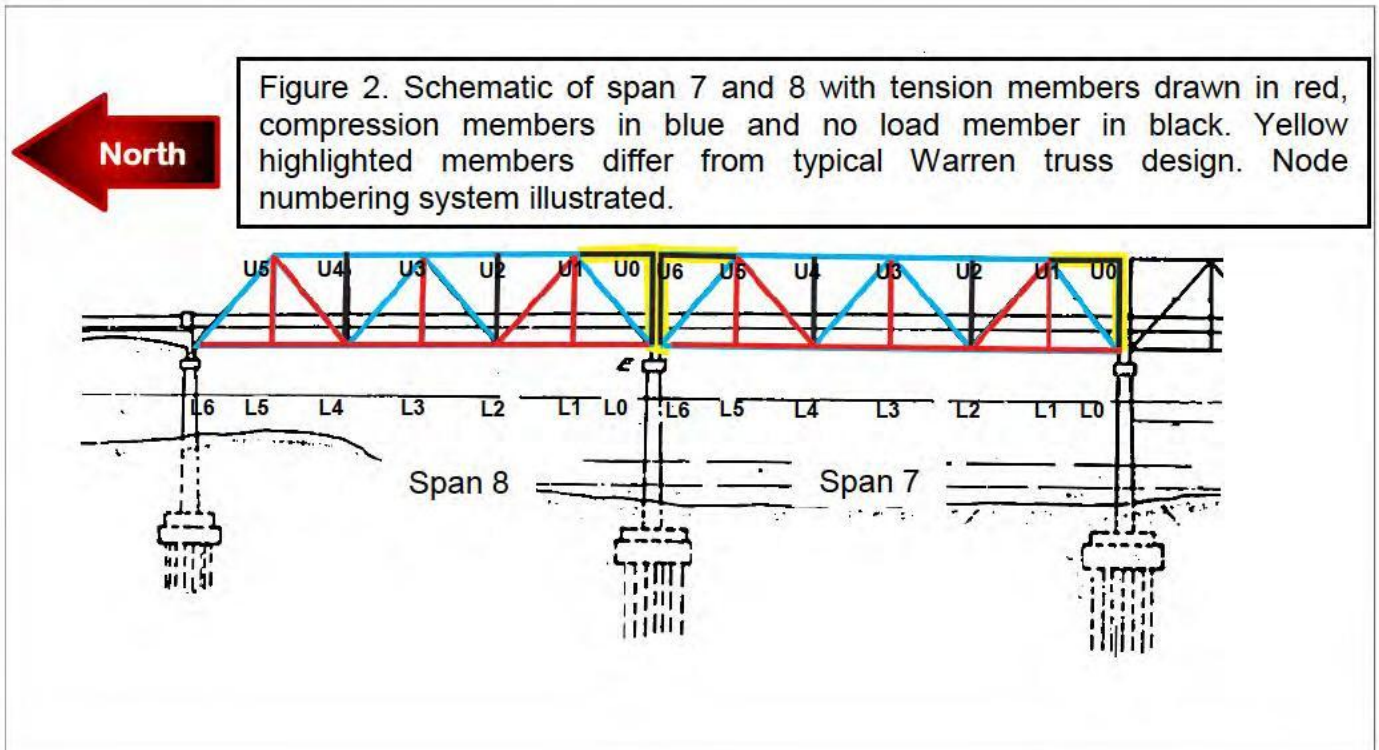
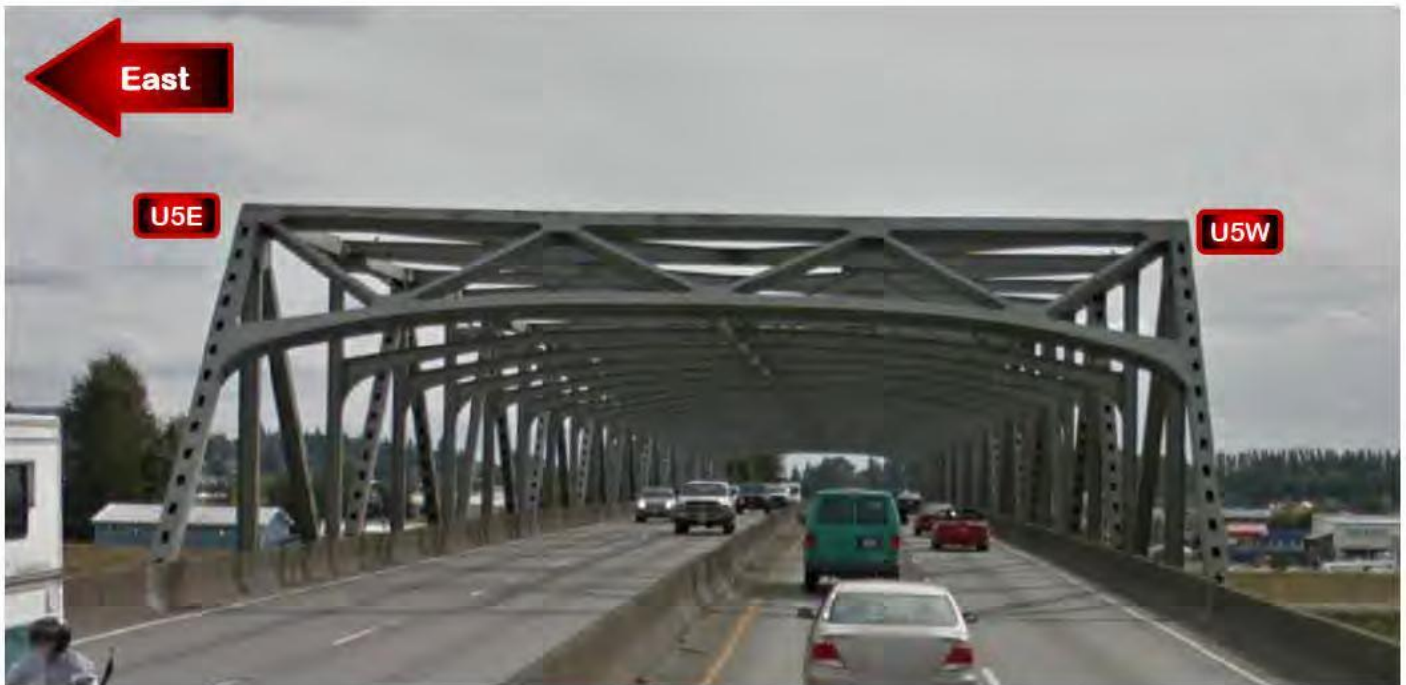
The north end of span 8 and the south end of span 5 are referred to as the north and south portals of the truss spans, respectively. The angled members of the east and west truss are connected by a heavily constructed portal frame of visually similar curvature to the lower chord of the sway frames. See Figure 3.

Figure 3. View looking south at the north portal prior to the collapse.
