# NATIONAL TRANSPORTATION SAFETY BOARD

MATERIALS LABORATORY FACTUAL REPORT

Report No. 15-131

Place : Las Vegas, Nevada  
Date : September 8, 2015  
Vehicle : Boeing 777-200, G-VIIO  
NTSB No. : DCA15FA185  
Investigator : Lorenda Ward, AS-10

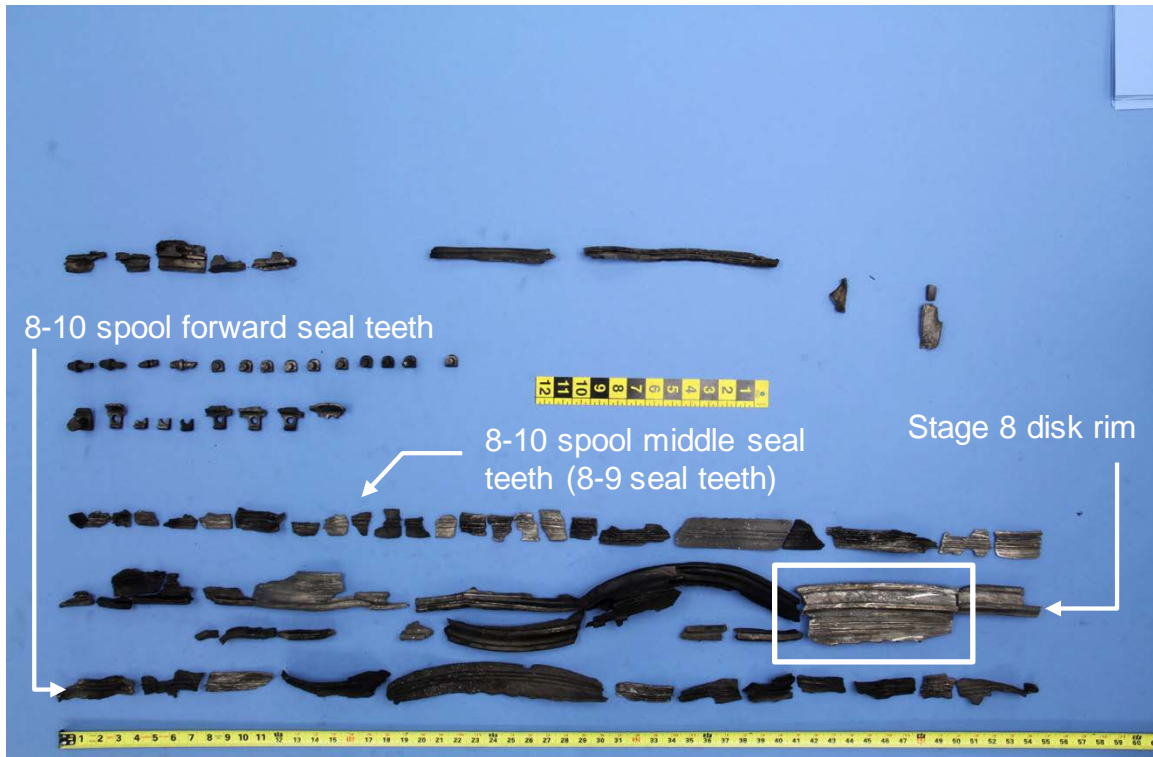
The fracture surfaces of the fragments were examined to determine where the failure initiated. A feature of interest was located in the web of one of the stage 8 disk rim pieces, indicated by a white rectangle in figure 2 and shown in figures 3a through 3c. The feature was located approximately 0.9 inch inboard of the blade slot bottom at the thinnest part of the web (approximately 0.118 inch), as nominally indicated by the red pen mark on the cross section in figure 3c (not an exact marking). Examination of the fractured web revealed the presence of a tinted/discolored hemi-elliptical shaped flat-fracture region, as shown in figures 4a and 4b, that was approximately 0.63 inch in width and extended from the aft face of the web to within 0.004 inch of the forward face of the web. The orientation of the hemi-elliptical region was consistent with the fracture initiating on the aft face of the web and the tinted appearance was consistent with high temperature oxidation of the fracture surface. The flat fracture region transitioned smoothly to a 45°-inclined tinted/discolored region that was consistent with cyclic tensile loading. The cyclic tensile loading region extended circumferentially from both sides of the flat fracture region over a total length of approximately 1.7 inch after which point the appearance of the fracture surface was consistent with tensile overstress.

**Figure 2:** Image of the engine pieces brought to the NTSB Materials Laboratory. Pieces that could be identified as belonging to either the forward seal teeth, stage 8 disk rim, or 8-10 spool middle seal teeth have been lined up from left to right. Approximately 4 ft of the disk rim was recovered.

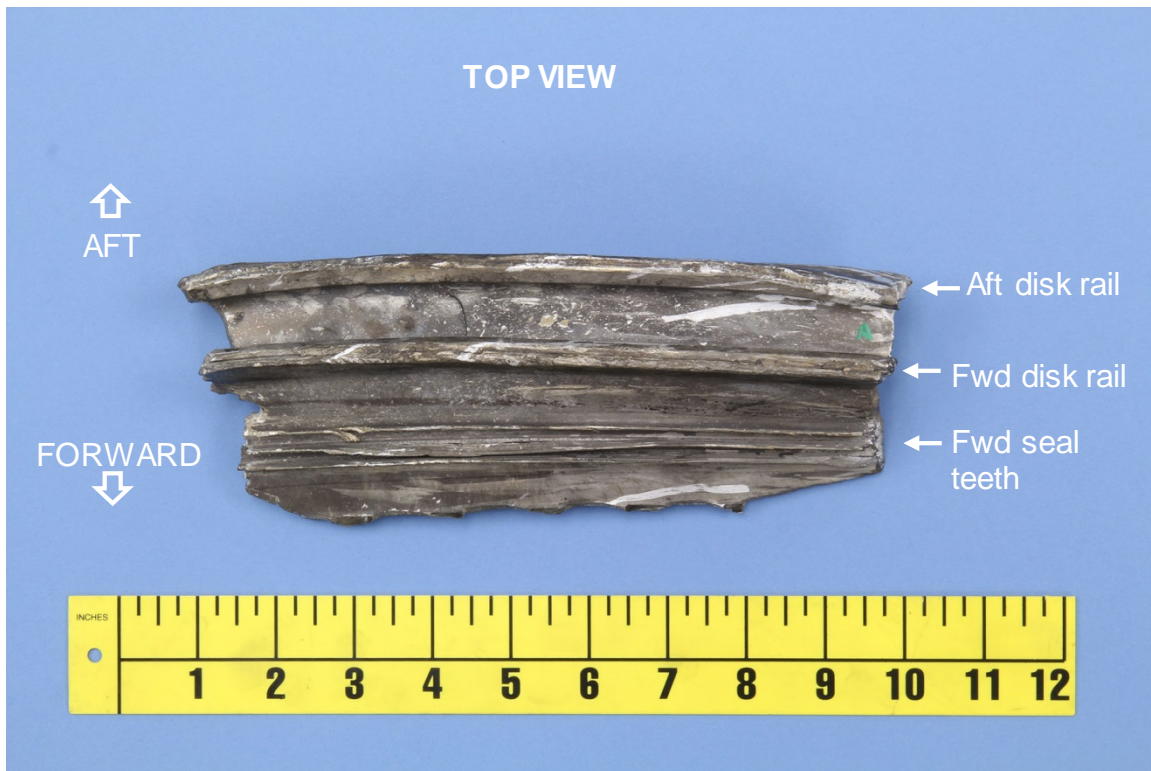
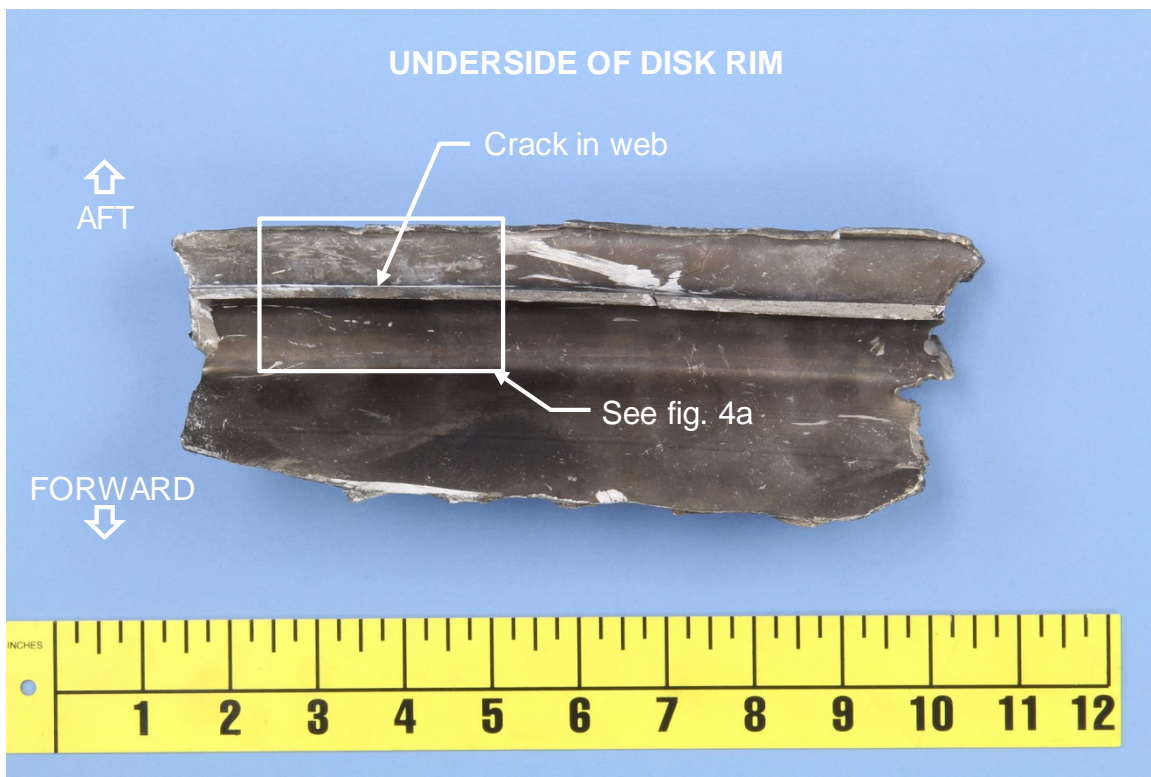
**Figure 3:** Images of the piece of disk rim where the feature of interest was observed in the disk web, a) top view showing the disk rim; b) view of the underside showing the fracture web;

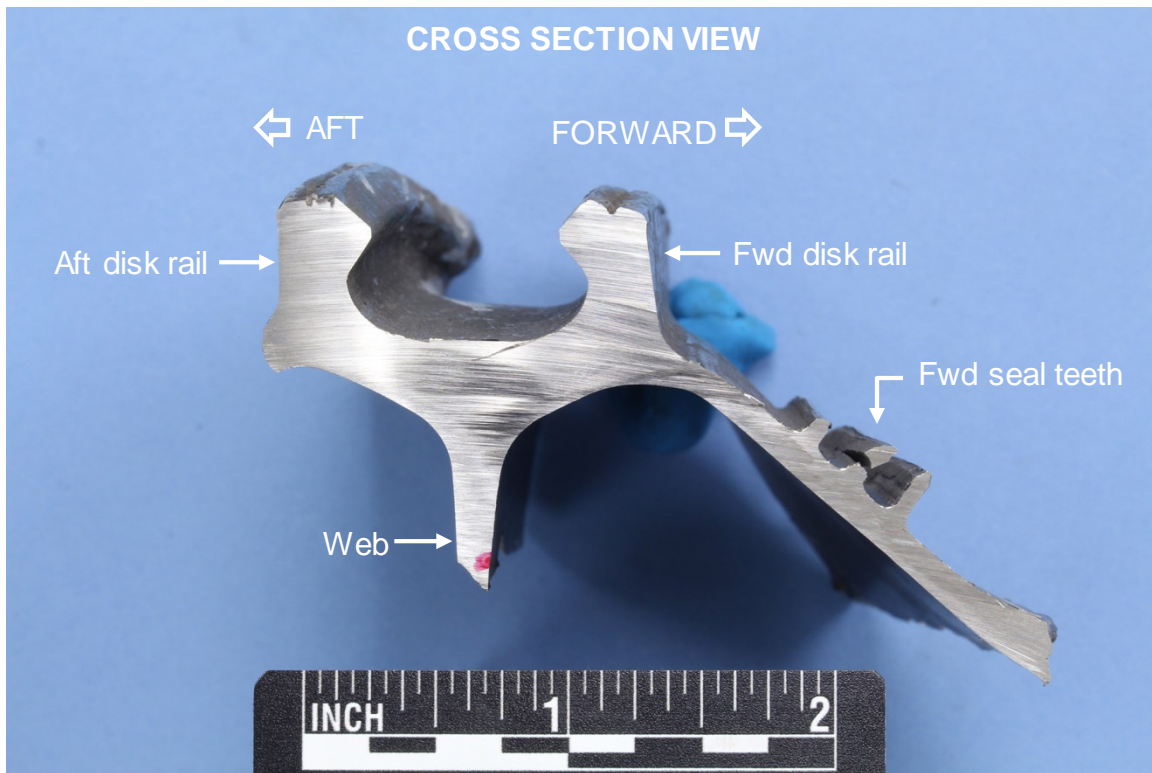
**Figure 3 (cont.):** c) cross section view showing the web and the approximate location of the crack relative to the slot bottom (red pen mark).

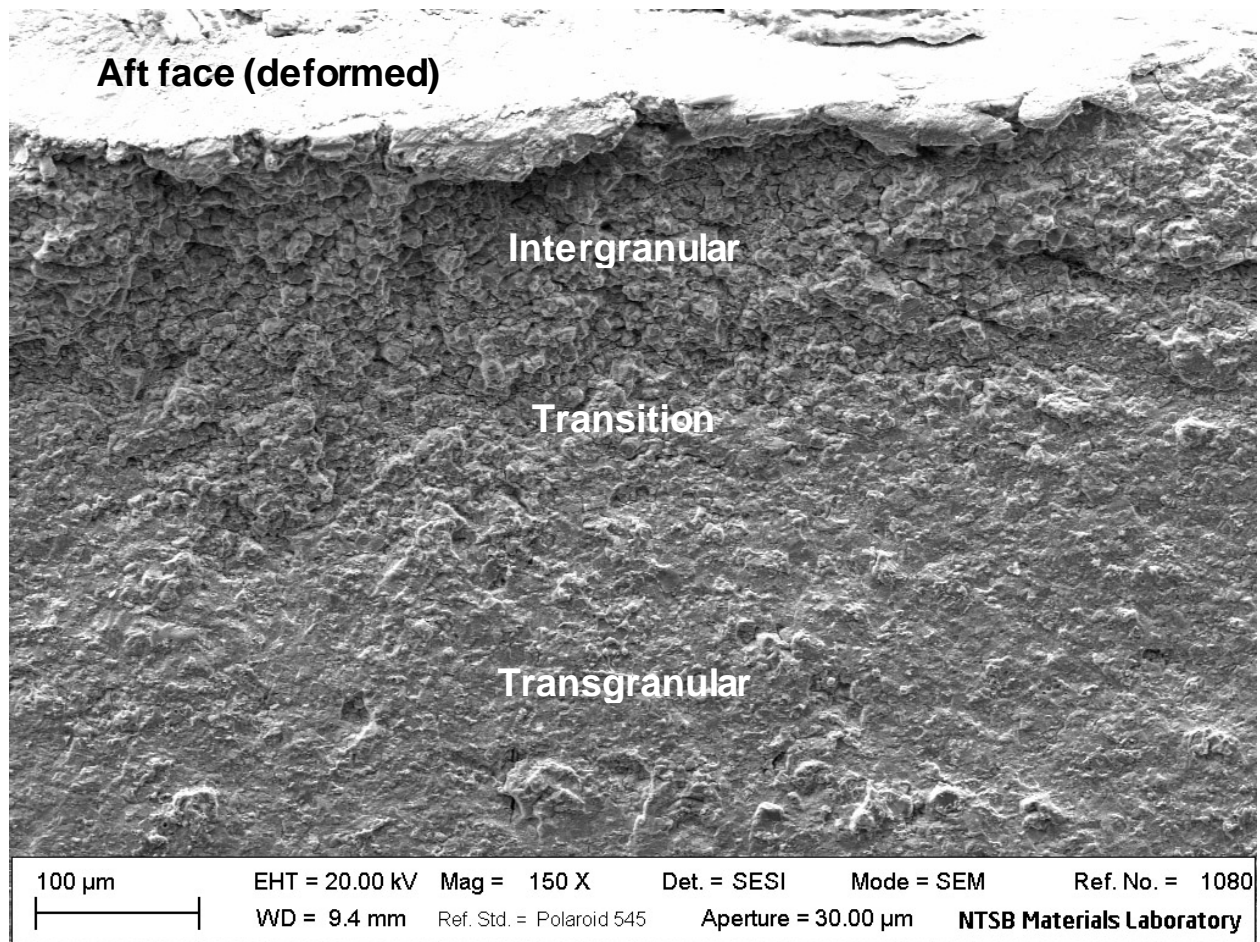
figure 5.<sup>1</sup> Representative higher magnification views of the intergranular and transgranular regions are shown in figures 6a and 6b, respectively. At this magnification the transgranular regions exhibited fatigue striations consistent with high alternating stress low-cycle fatigue crack growth. Detailed characterization and determination of crack propagation mode of the intergranular region was carried out at a later date.<sup>2</sup>

The fracture surface was deformed where it met the aft face pushing material out of the original plane of fracture (see figure 5). To examine this in greater detail the aft face of the web was examined in the SEM where it met the fracture, as shown in figure 7a. Smeared material, which was also visually apparent, was observed on the aft face in the vicinity of the fracture. The composition of the smeared material was examined using energy dispersive X-ray spectroscopy (EDS), as shown in figure 7b, and consisted primarily of aluminum (Al).

**Figure 5:** SEM image of the fracture surface at the aft face of the web where the crack initiated. The fracture surface exhibited an intergranular morphology near the aft face which transitioned to transgranular at approximately 0.007 inch.

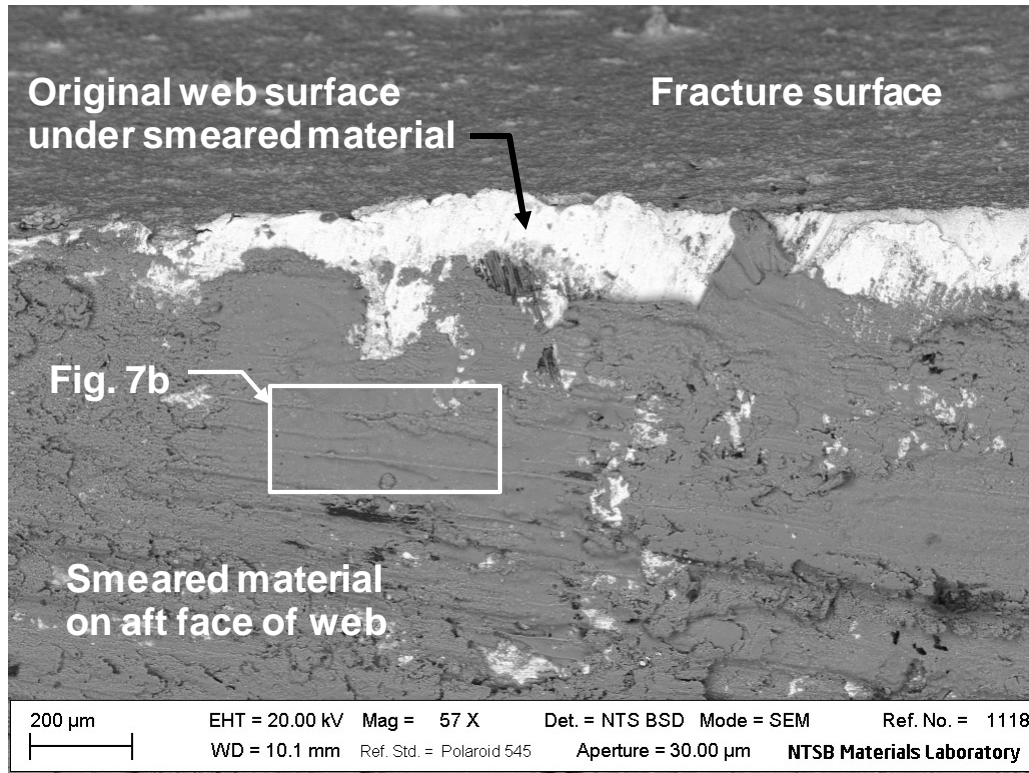
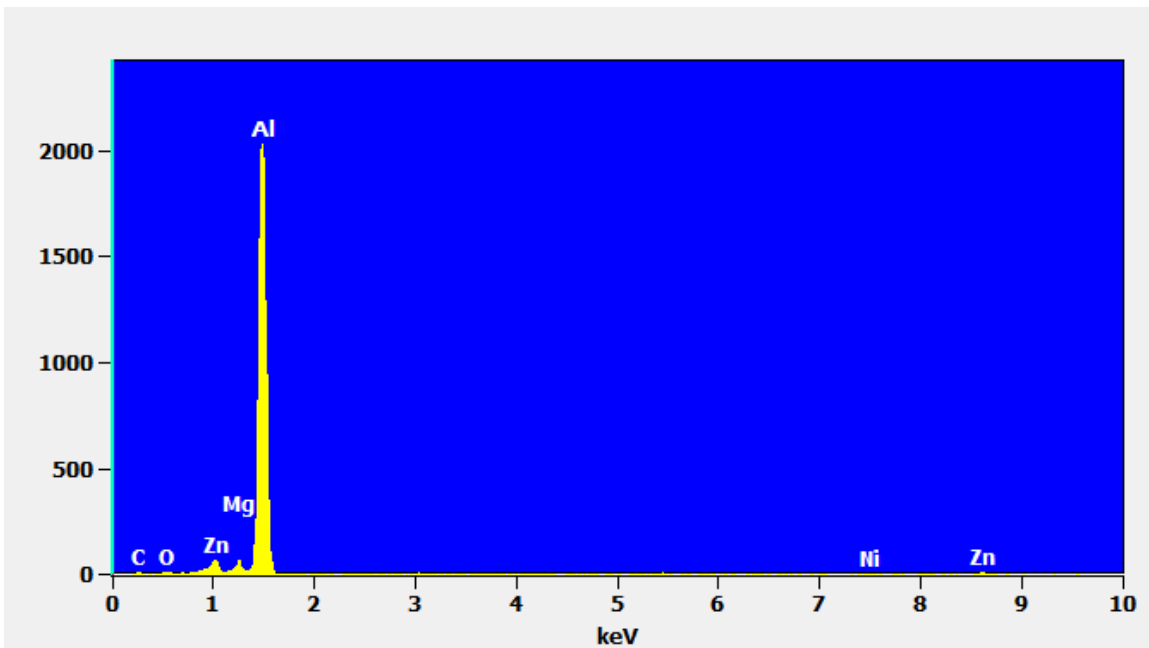
**Figure 7:** a) SEM image of the aft face of the web where it met the fracture surface. Smeared material was observed on the aft face; b) EDS of the smeared material exhibiting primarily aluminum (Al).

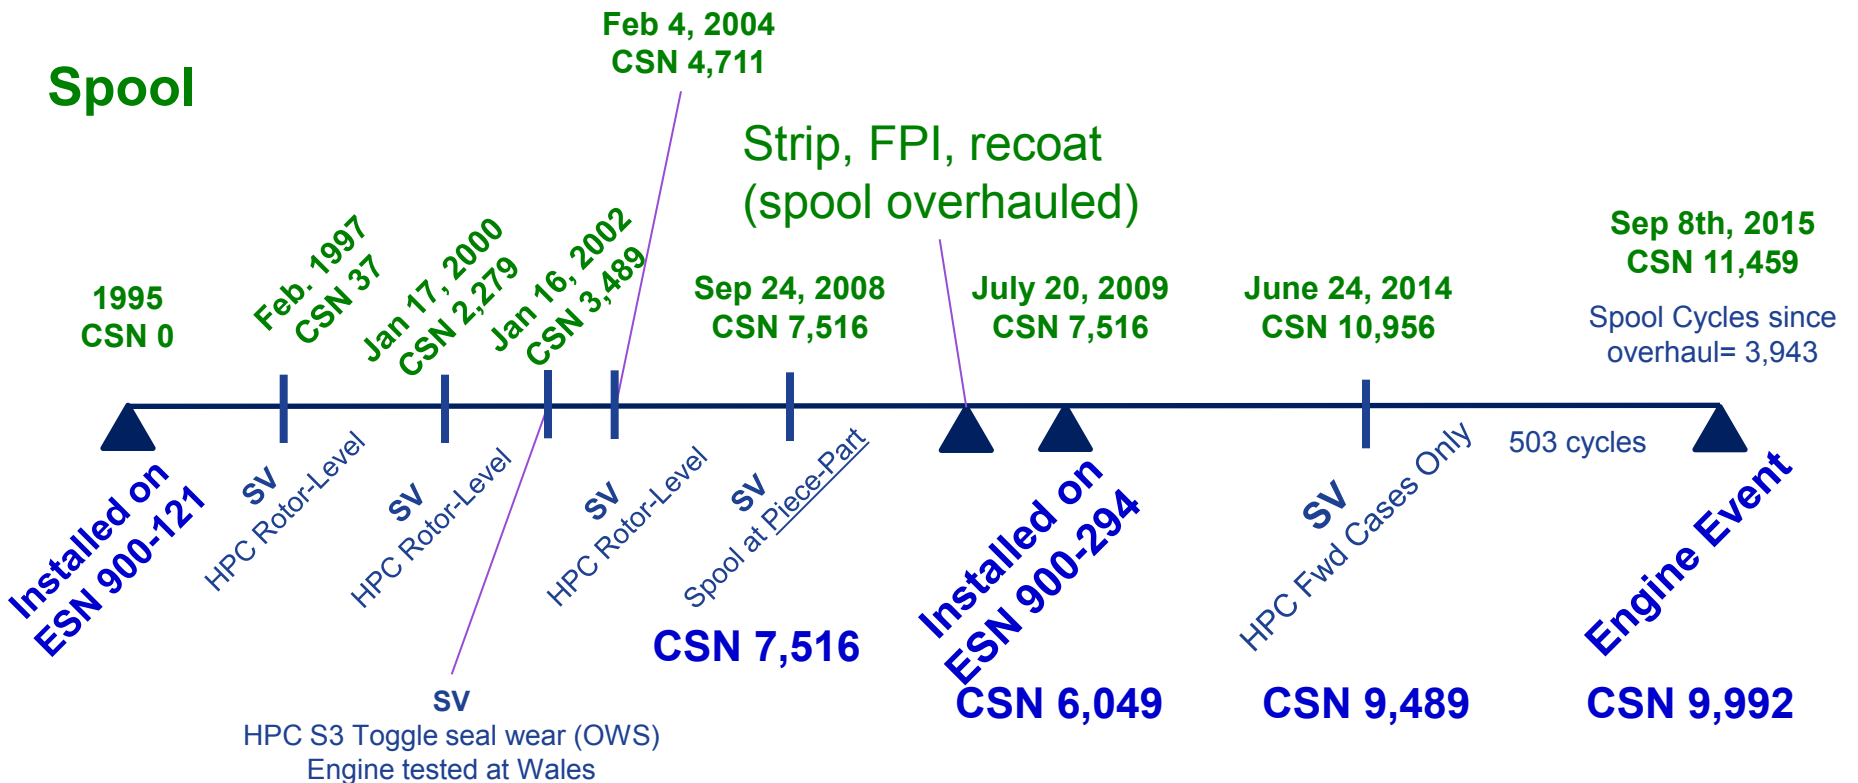
- The engine accumulated a total of 66,801 hours since new (TSN) and 9,992 cycles since (CSN), while the part accumulated **74,170 TSN / 11,459 CSN**. The part was inspected at piece-part level at the last overhaul **26,671 hours / 3,943 cycles** prior, which included alkaline cleaning, stripping and re-coating of the seal teeth, fluorescent penetrant inspection (FPI), and eddy current inspection of the inertia weld. Prior to the overhaul the part was installed on ESN 900-121 with the same operator. A graphical depiction of the part history timeline can be seen in Figure 1.

**Figure 1:** Description of the significant timeline events on the 8-10 spool being investigated. It had 11,459 cycles since new and was inspected at piece-part level 3,943 cycles prior.

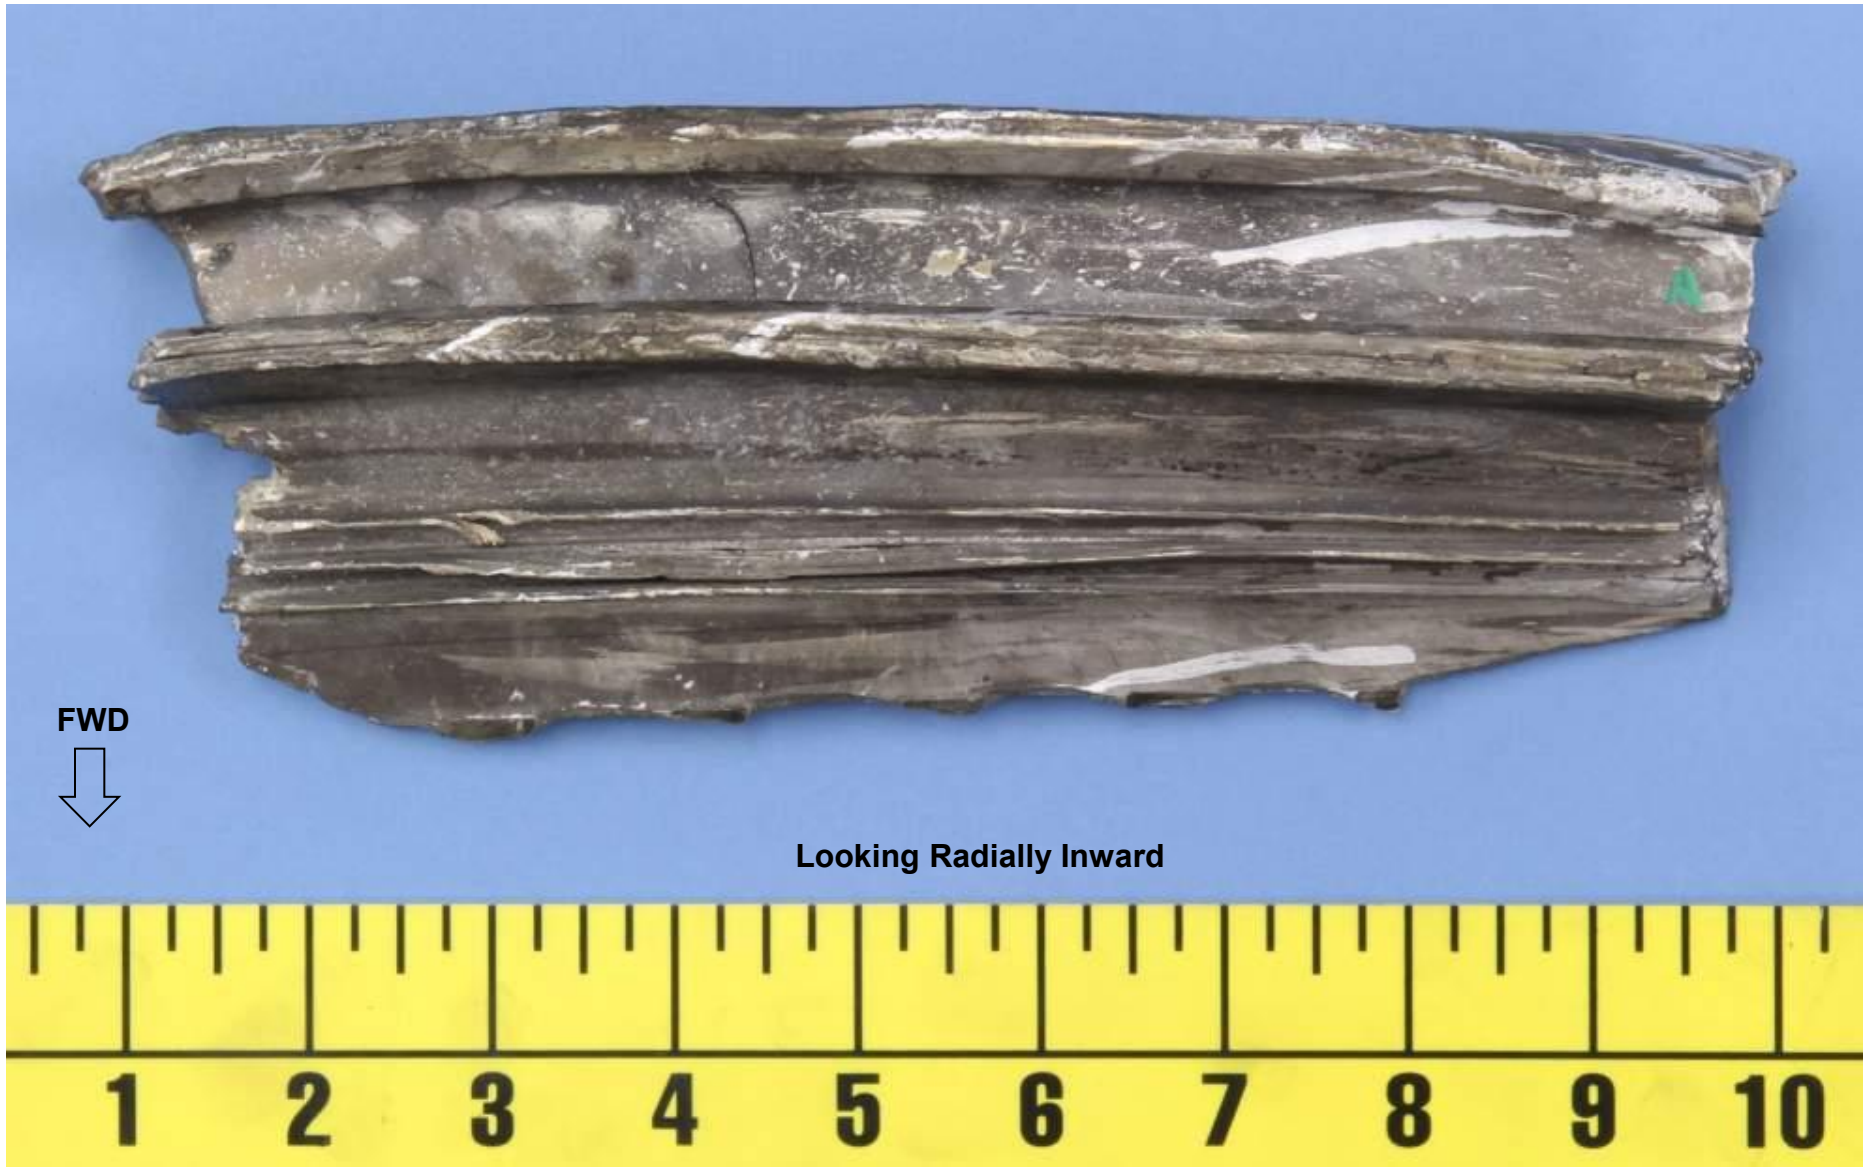
**Figure 5:** Optical view of the portion of the liberated stage 8 rim piece containing the fatigue fracture in the web (not visible).

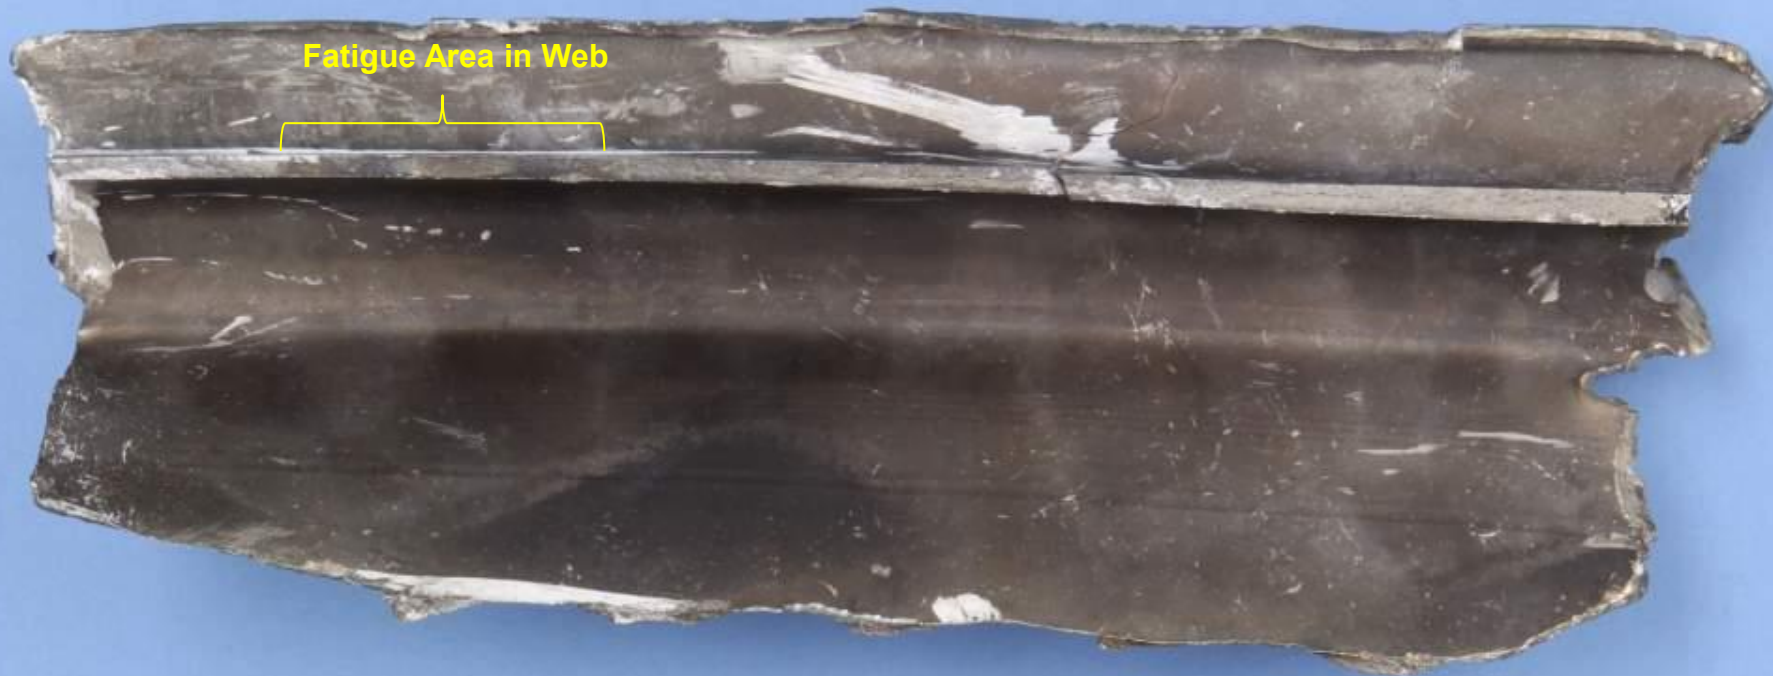
- The fatigue region extended in a circumferential/axial plane and was initially planar for approximately **0.62 inch** long then extended at a slant angle for a total combined length of approximately **1.72 inches**, prior to transitioning to overstress fracture (Figures 6-8, 10-11).

Figure 6: Optical view of the portion of the liberated stage 8 rim piece containing the fatigue fracture in the web (tinted area).

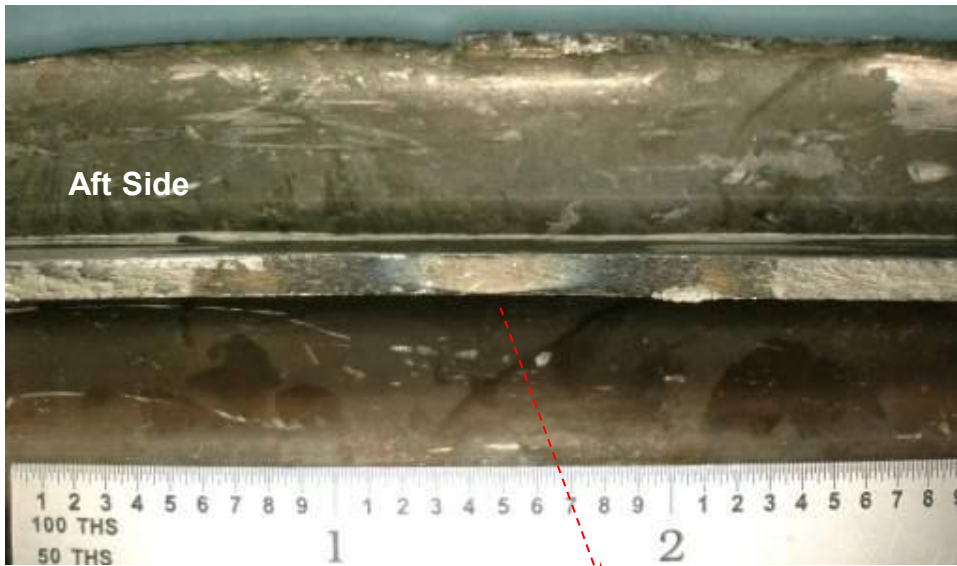
- Cross-sections of the GE90 HPC showing the part geometry and location of the fatigue crack can be seen in Figures 2 and 3.
- Optical examination of the fracture surfaces revealed a single heat-tinted, thumbnail-shaped fracture extending into the web outer rim transition region with features consistent with **fatigue** (Figures 4-10, 23, 24, 26-28). No fatigue cracks were found in the seal teeth or inertia weld.

**Figure 10:** Optical views at varying magnification of the web fracture showing a thumbnail-shaped region normal to the surface with varying tinting, consistent with fatigue, initiating from the aft web face.

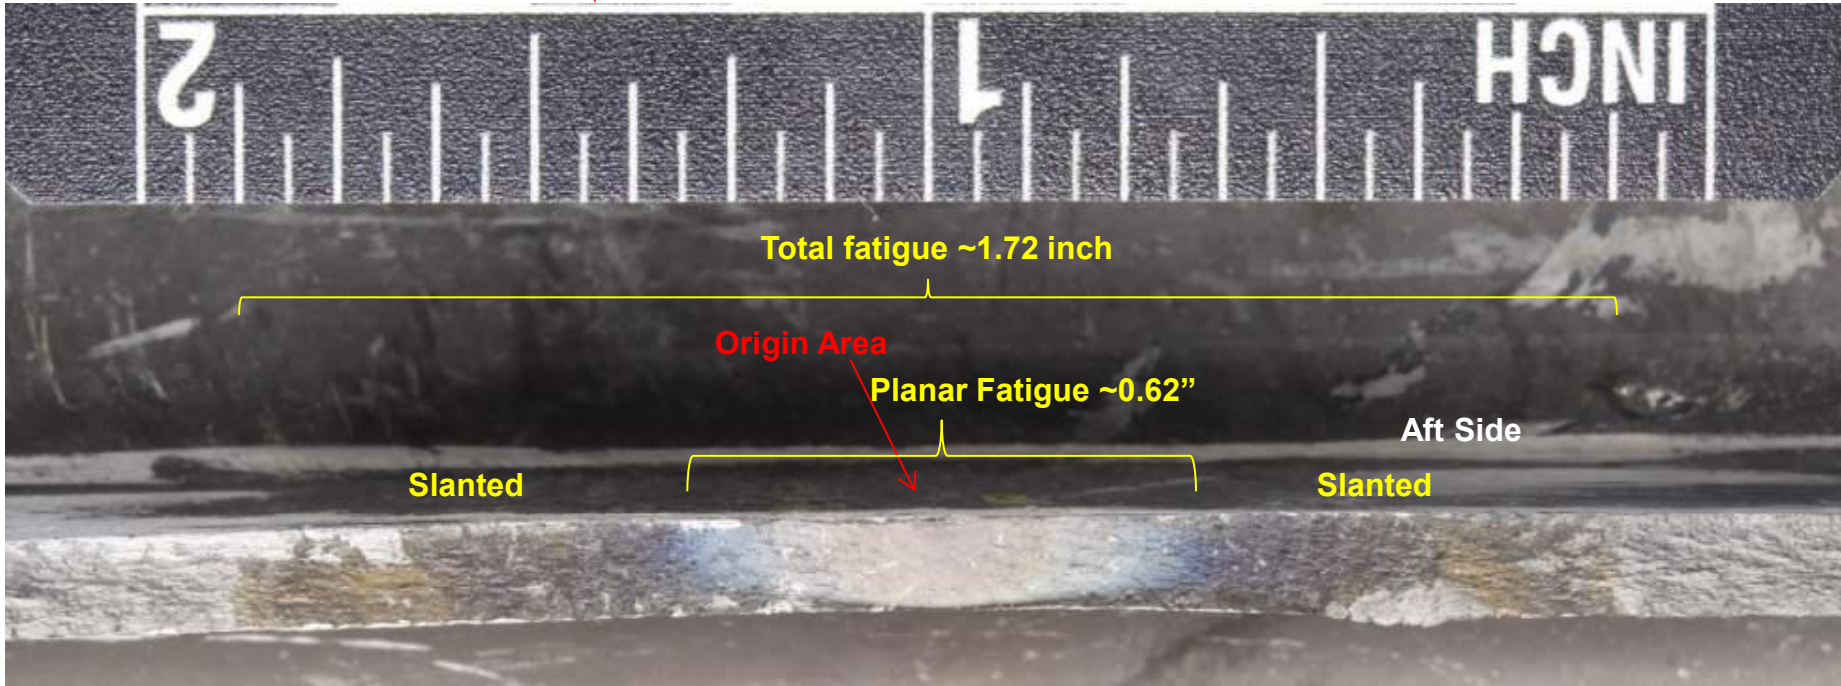
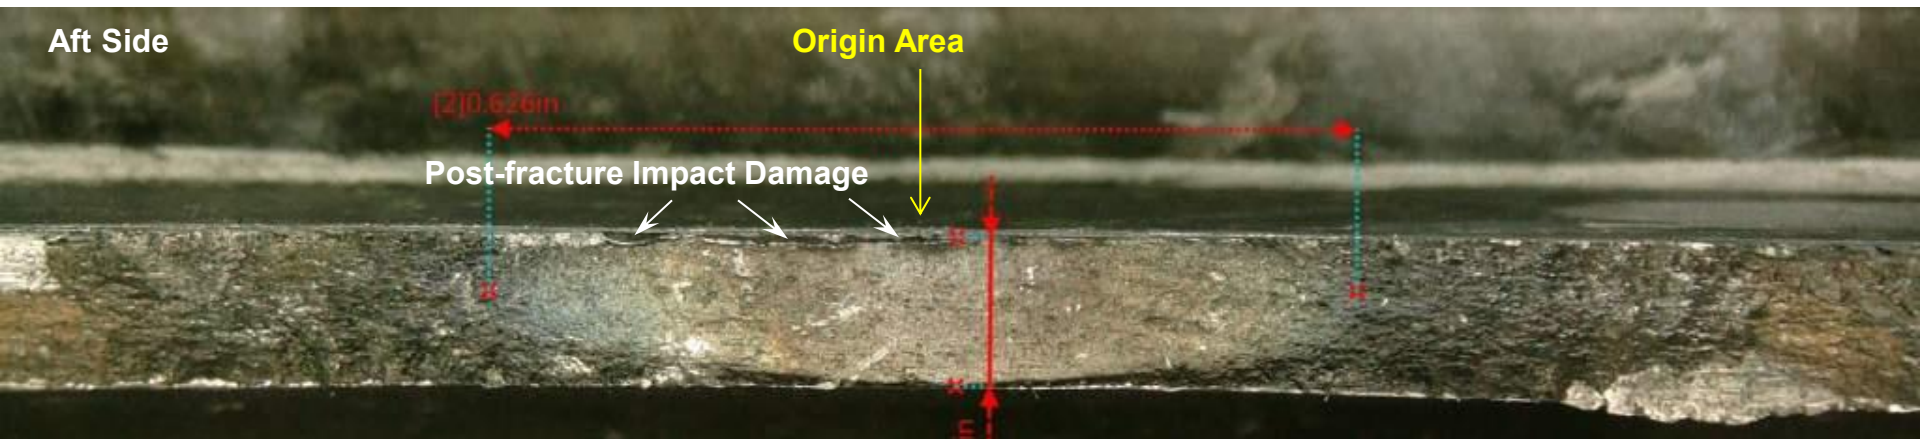
- The fatigue crack initiated from the **aft face** of the web and both the inboard and outboard faces were damaged by post-fracture impact damage (Figures 11, 12, 27-29).

**Figure 11:** Higher magnification optical view showing the variation in tinting and changes in morphology on the fracture. The initial 0.62 inch portion of fatigue was planar until it progressed through the wall thickness. The fracture then continued with a rougher morphology at a slant angle, consistent with a cyclic tensile region.

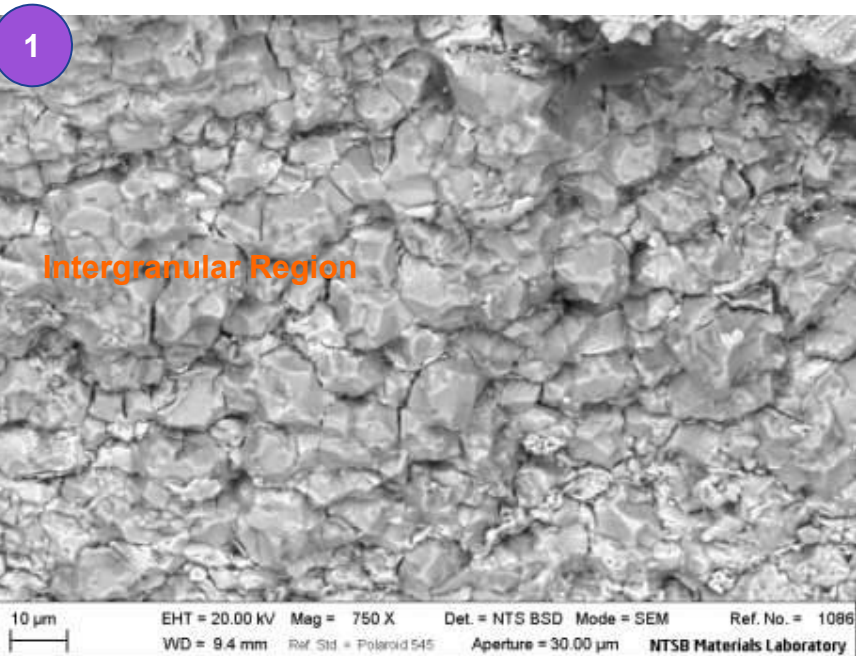
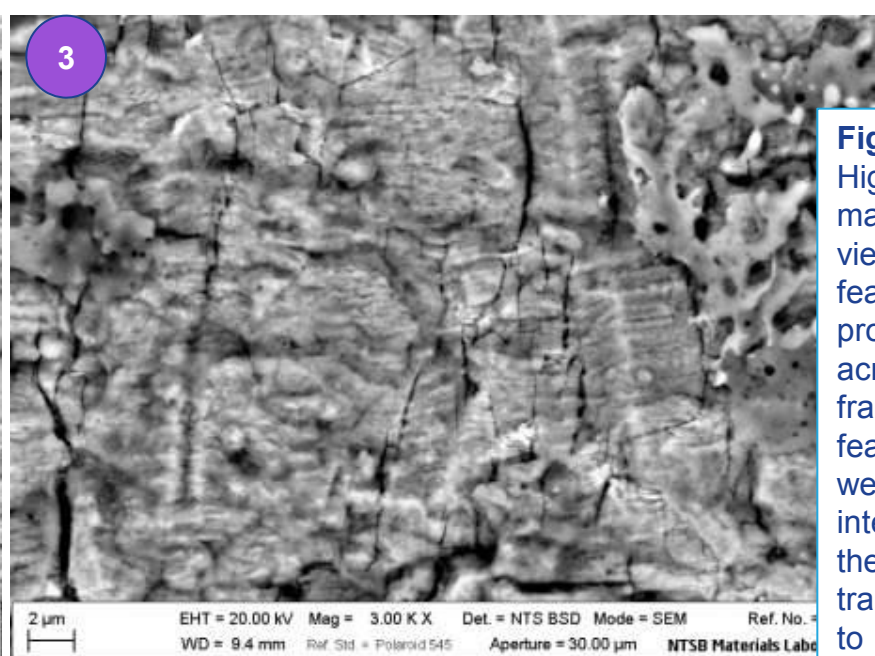
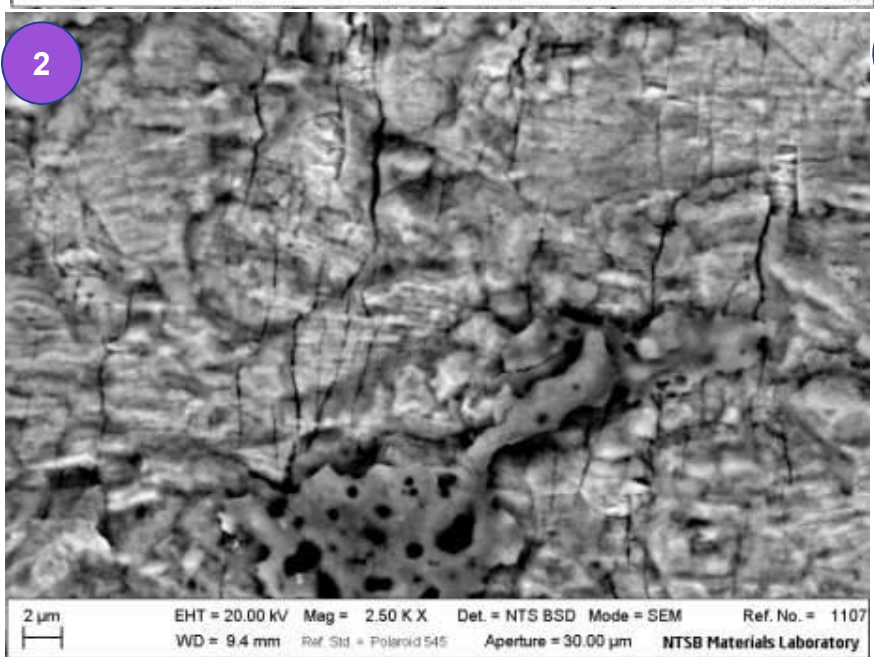
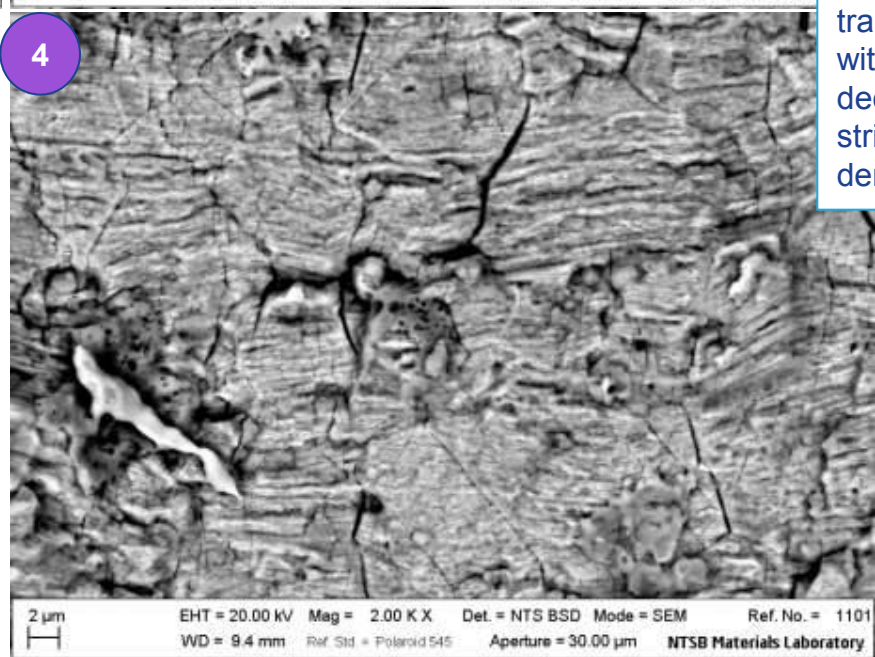
- Scanning electron microscope (SEM) examination of both mating fracture surfaces revealed that the primary fracture **initially propagated** with **intergranular** features to a depth of approximately **7-10 mils** (with local variation), consistent with **hold-time fatigue** (Figures 13-18 and 30-34). The very aft surface/origin area of the outboard fracture had approximately 3 mils of surface damage and the inboard fracture approximately 1 mil of damage, consistent with post-fracture, event-related impact damage (Figure 29). The crack then transitioned to **transgranular, striated** areas that decreased in density progressing through the thickness, consistent with **LCF** (Figures 17-19, with views of the transition area also shown in in Figures 32-36).

**Figure 18:** Higher magnification views of the features progressing across the fracture. The features were initially intergranular, then transitioned to transgranular with decreasing striation densities.

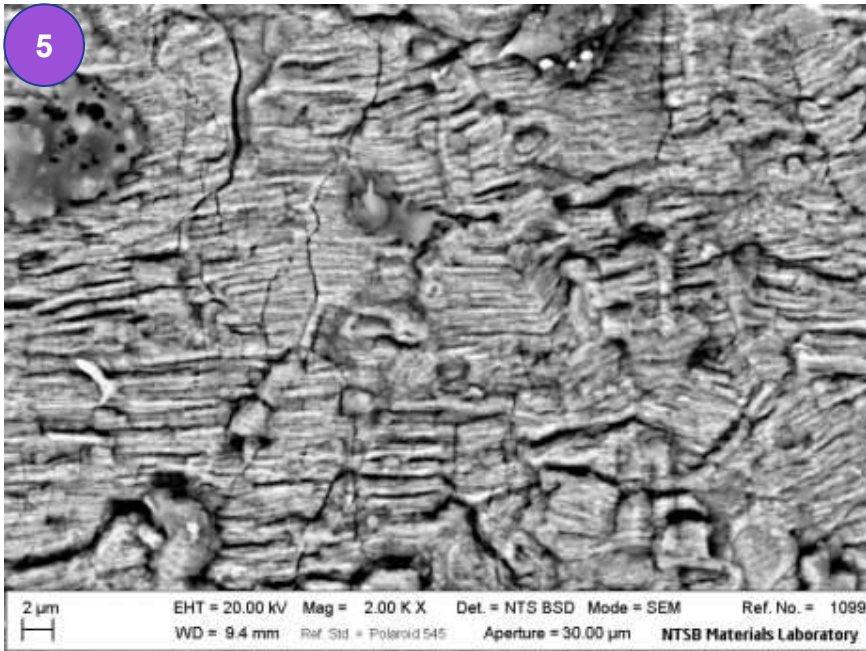
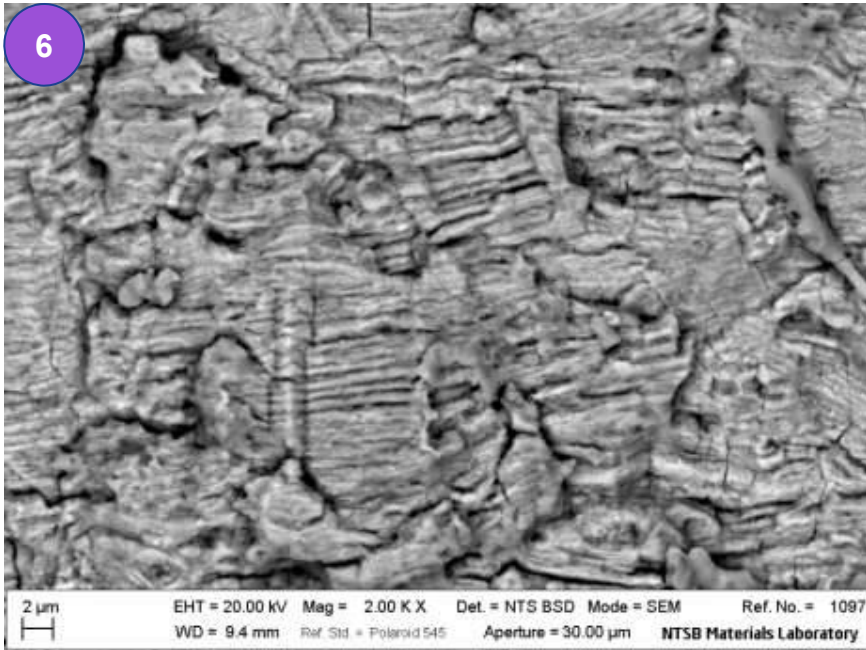
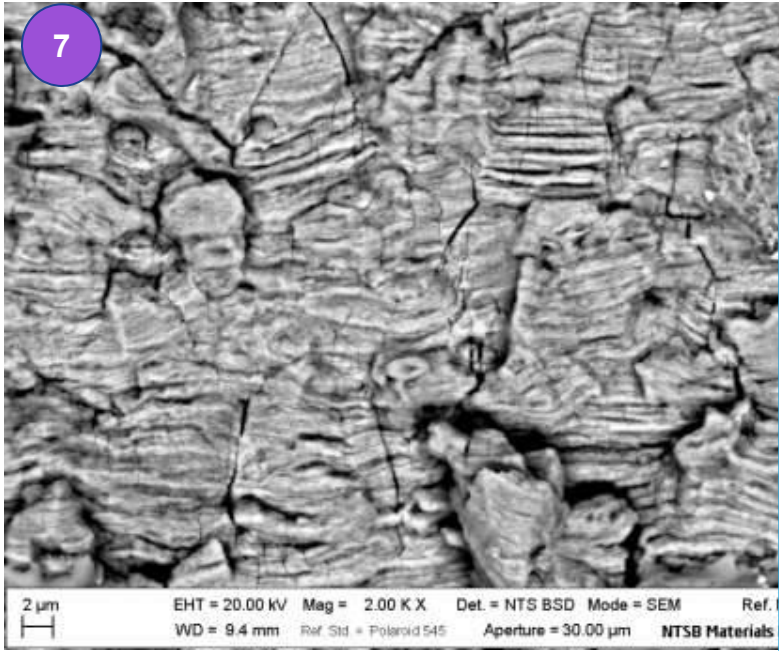
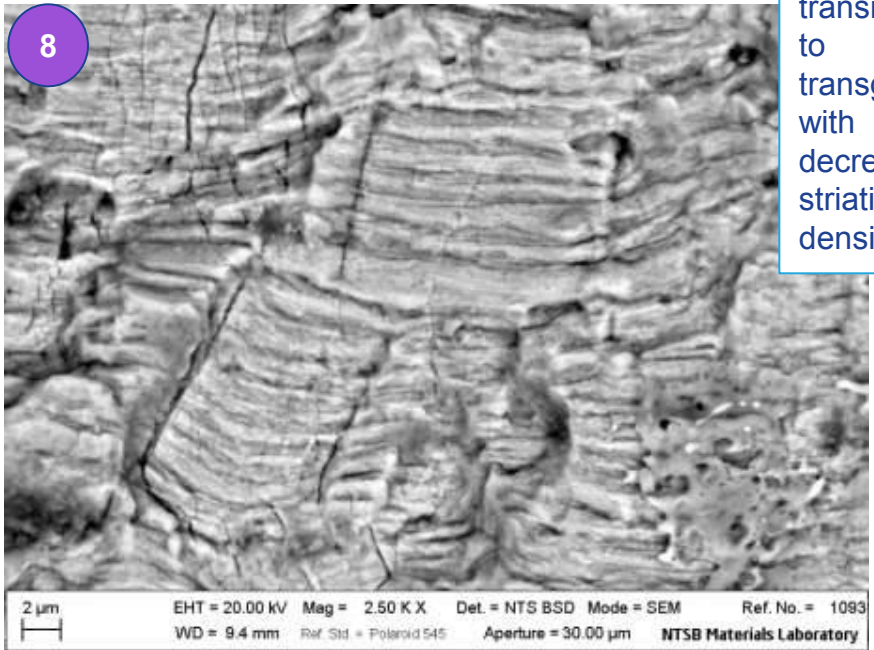
**Figure 19:** Higher magnification views of the fracture features progressing across the web thickness. The features were initially intergranular, then transitioned to transgranular with decreasing striation densities.

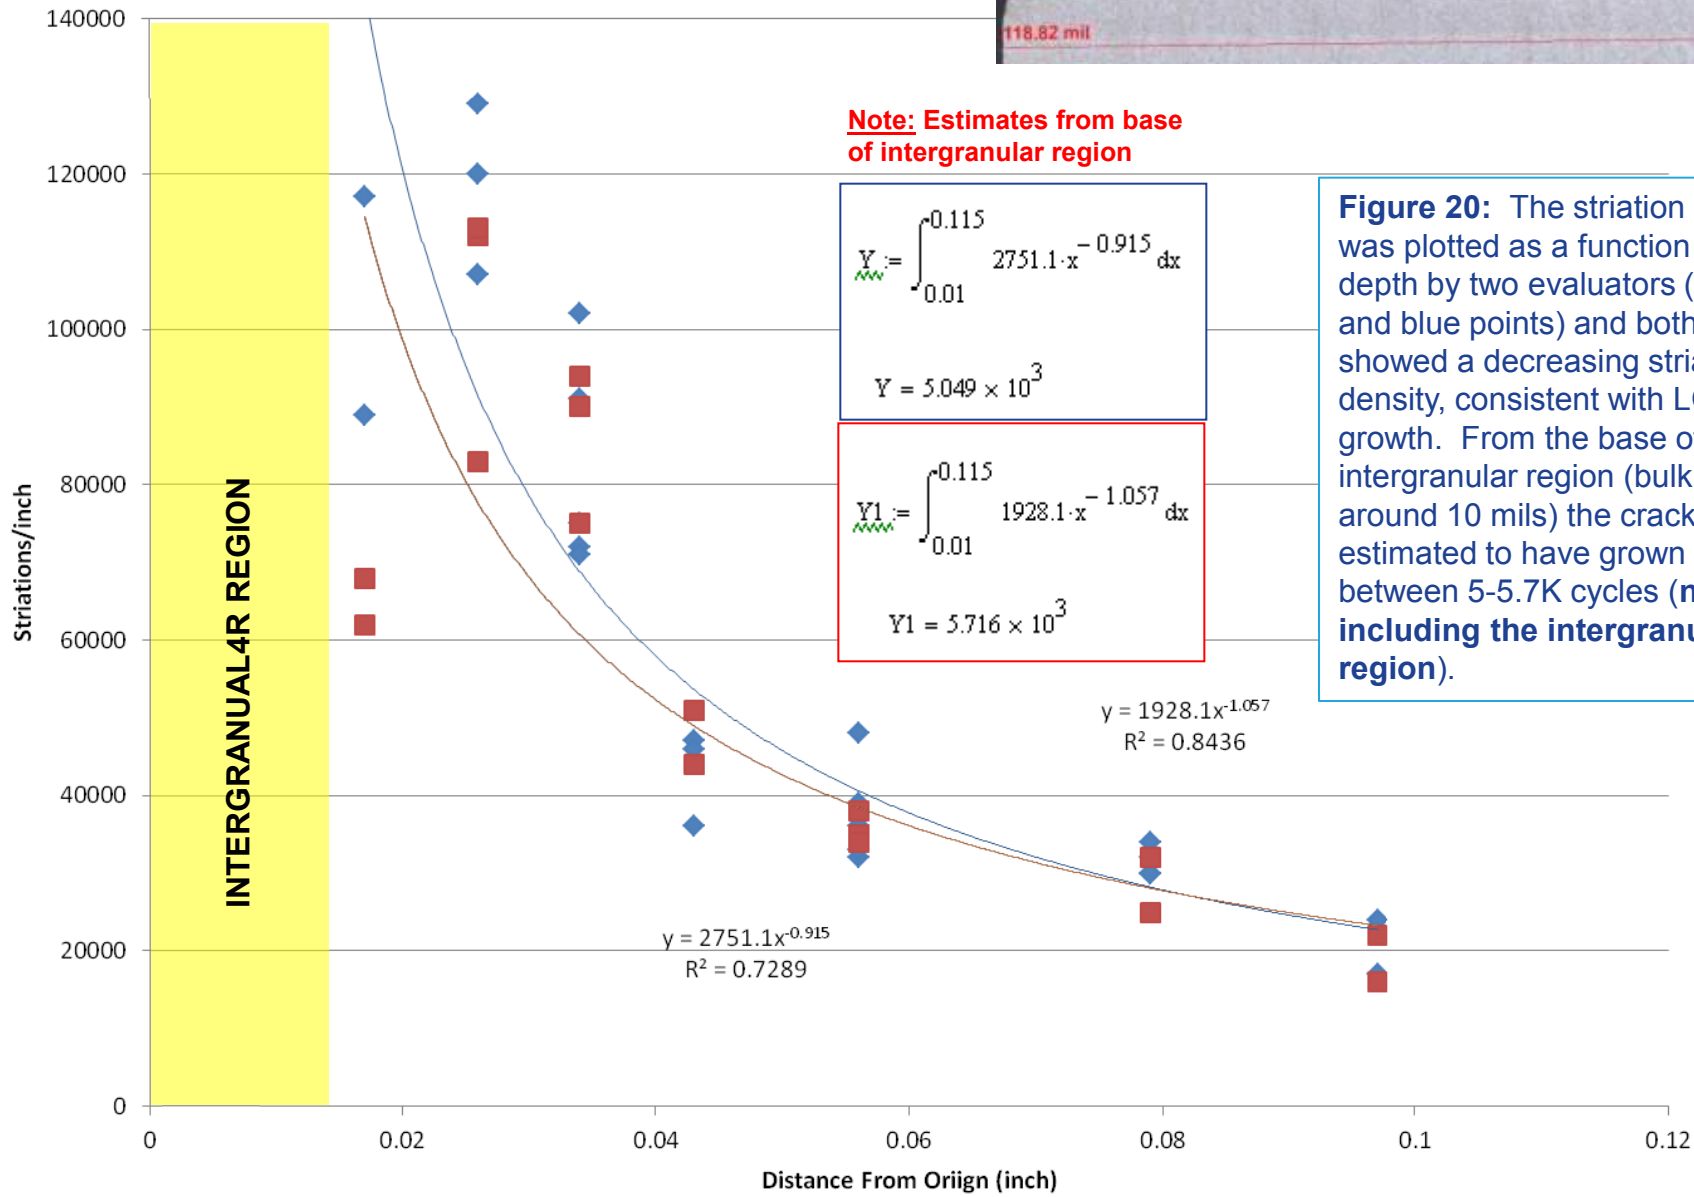
- Based on interpretable striations the fatigue fracture is estimated to have grown from the base of the intergranular region to the end of the striated region (10-105 mils) in **over 5,000 cycles** by multiple estimates (does not include the initial intergranular region)- Figure 20.

**Figure 20:** The striation data was plotted as a function of depth by two evaluators (red and blue points) and both showed a decreasing striation density, consistent with LCF growth. From the base of the intergranular region (bulk around 10 mils) the crack was estimated to have grown between 5-5.7K cycles (**not including the intergranular region**).
