# NATIONAL TRANSPORTATION SAFETY BOARD

MATERIALS LABORATORY FACTUAL REPORT

Report No. 15-131

Place : Las Vegas, Nevada  
Date : September 8, 2015  
Vehicle : Boeing 777-200, G-VIIO  
NTSB No. : DCA15FA185  
Investigator : Lorenda Ward, AS-10

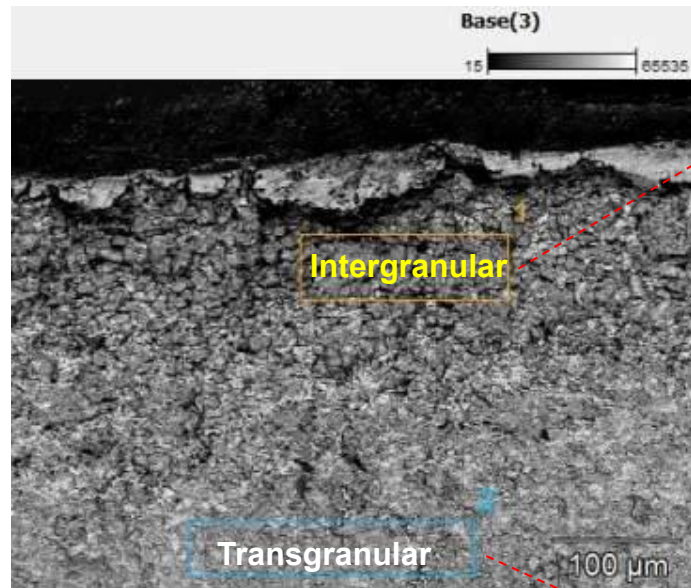
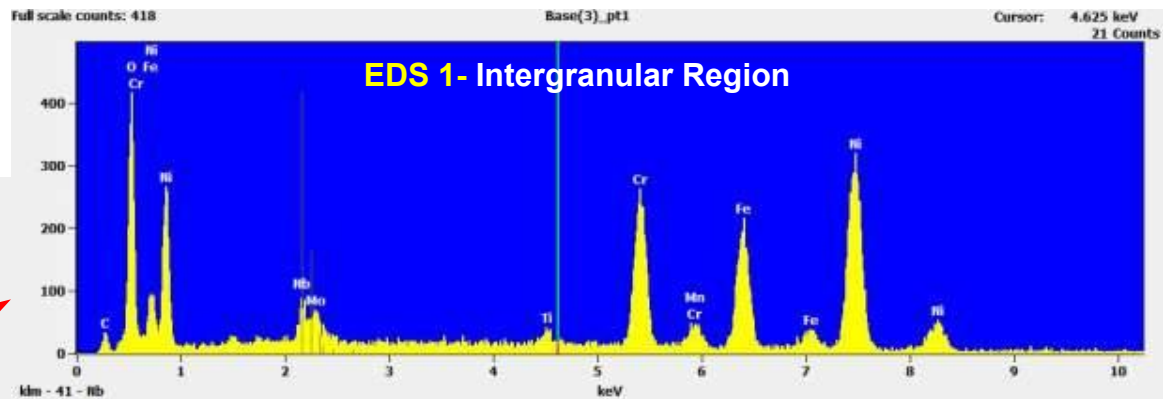
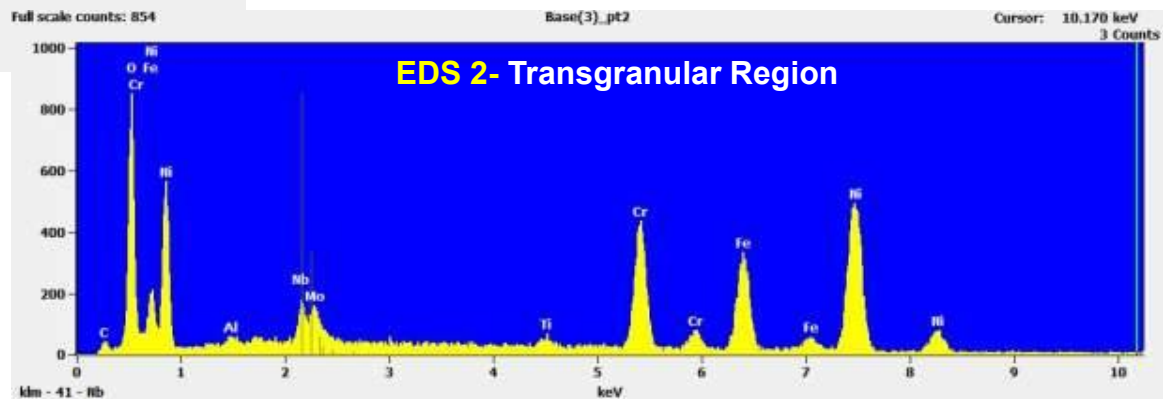
- Energy dispersive spectroscopy (EDS) analysis of the fracture only showed elements consistent with oxidized **alloy 718** (EDS 1 and 2- Figure 21; EDS 5- Figure 29). On the outboard fracture origin area the **secondary impact** damage was consistent with an **Al-base alloy** containing Zn and Mg (EDS 4- Figure 22), with smeared base metal nearby (EDS 3). By comparison the impact on the inboard side fracture was consistent with a **Ni-based** alloy, but the peak heights were not an exact match for DA718 (EDS 6- Figure 29).

**Figure 21:** Energy dispersive spectroscopy analysis showed that in both the intergranular and transgranular areas spectra consistent with the requirement of alloy 718 were observed (per C50TF81), with the addition of oxygen. No detrimental species were found.

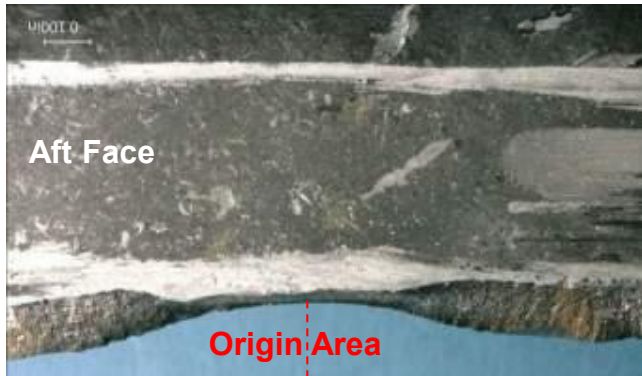
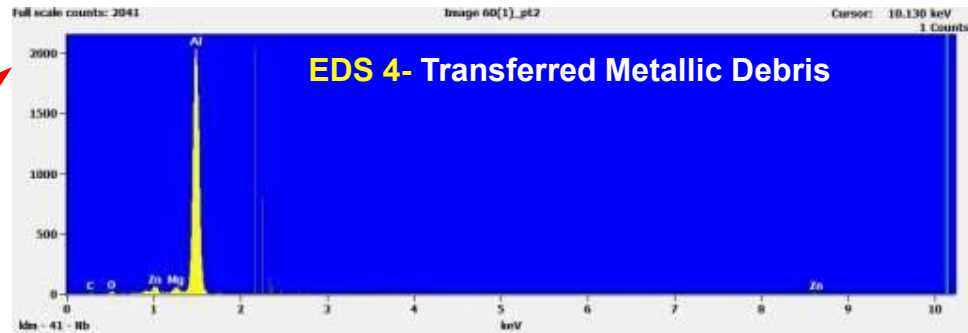
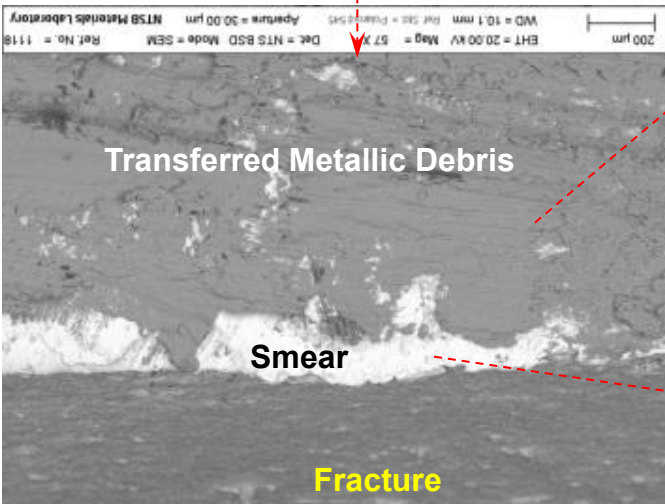
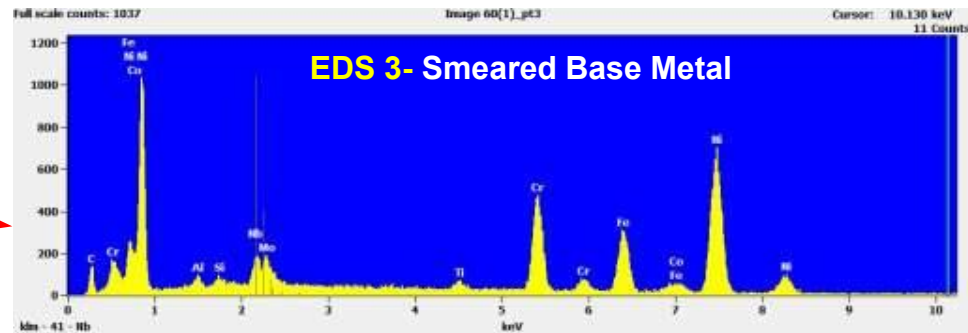
**Figure 22:** EDS analysis of debris on the aft outer web surface showed that in the smeared area adjacent to the fracture alloy 718 base metal elements were observed (EDS 3), with superimposed aluminum-rich transferred material containing small peaks of Zn and Mg (EDS 4).

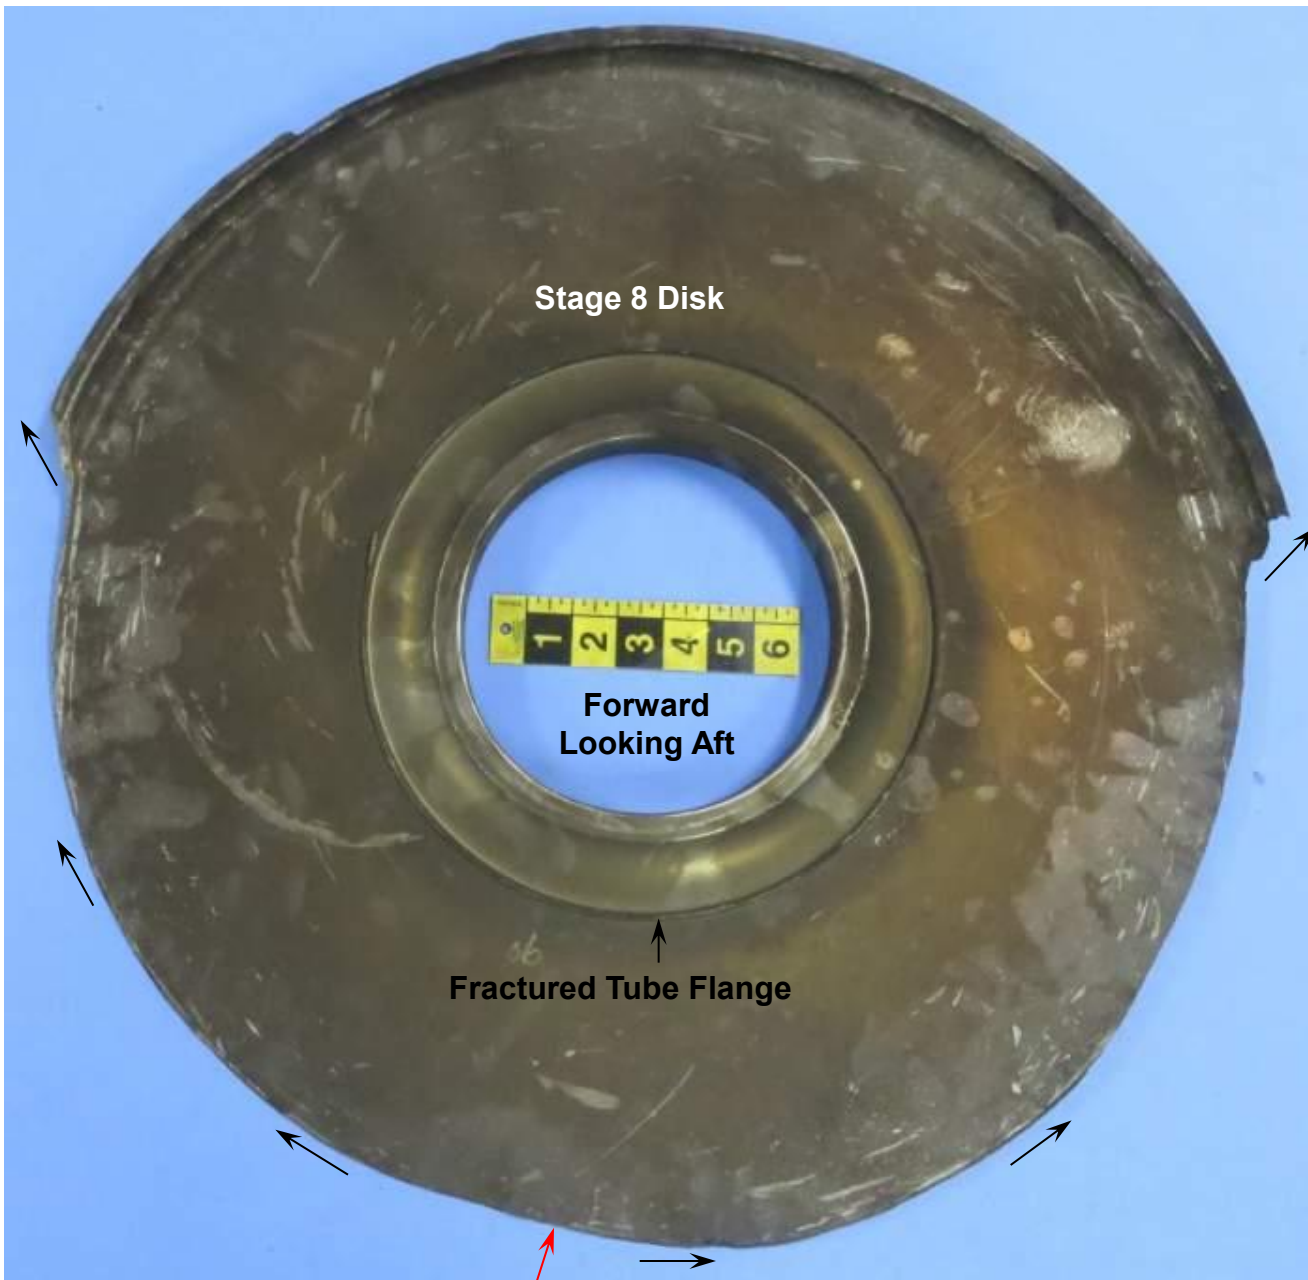
**Figure 23:** Optical view of the fractured stage 8 disk from the 8-10 spool after removal from the engine. The disk liberated approximately 60 percent of the rim and a single fatigue area was found near the center of the liberated region. All other areas of the fracture were consistent with overstress, including the forward tube flange near the bore.

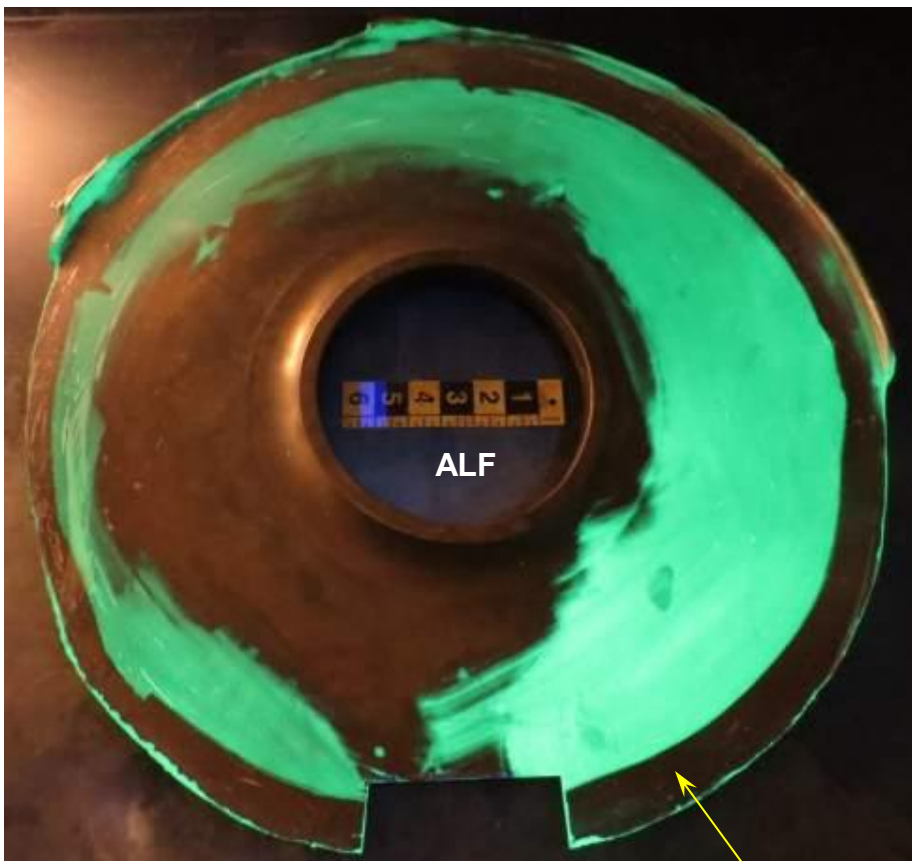
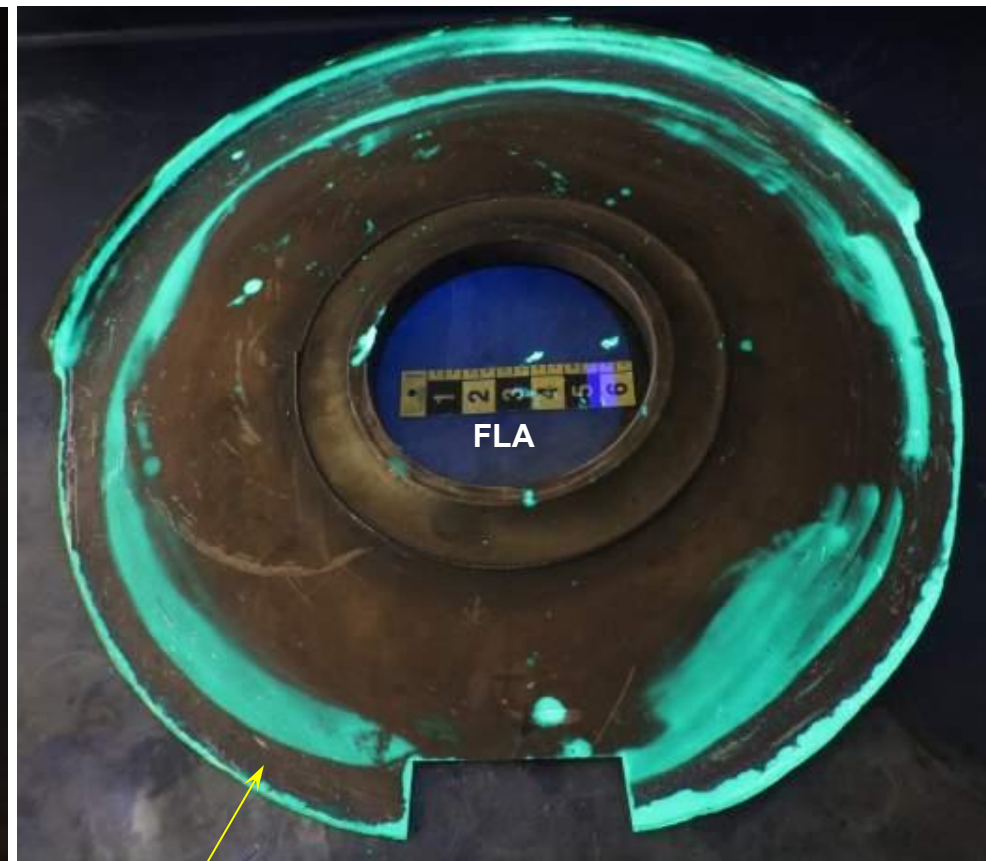
**Figure 25:** A local FPI inspection of a 1.5 inch band around the part adjacent to the fracture plane did not reveal any additional interpretable linear indications/cracks.

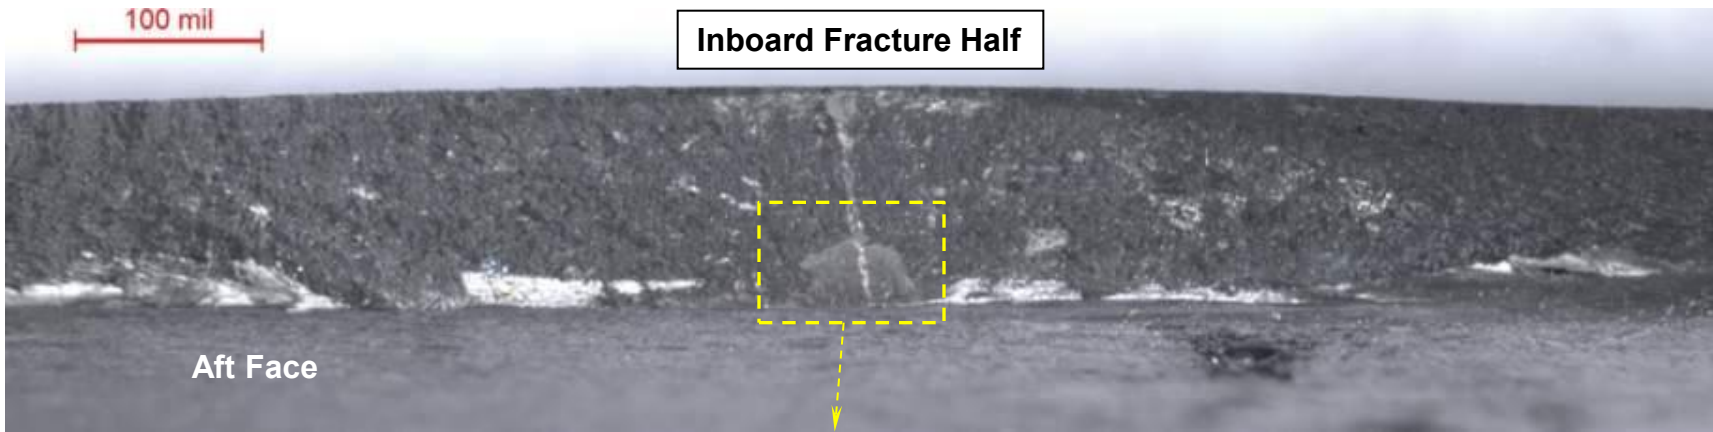
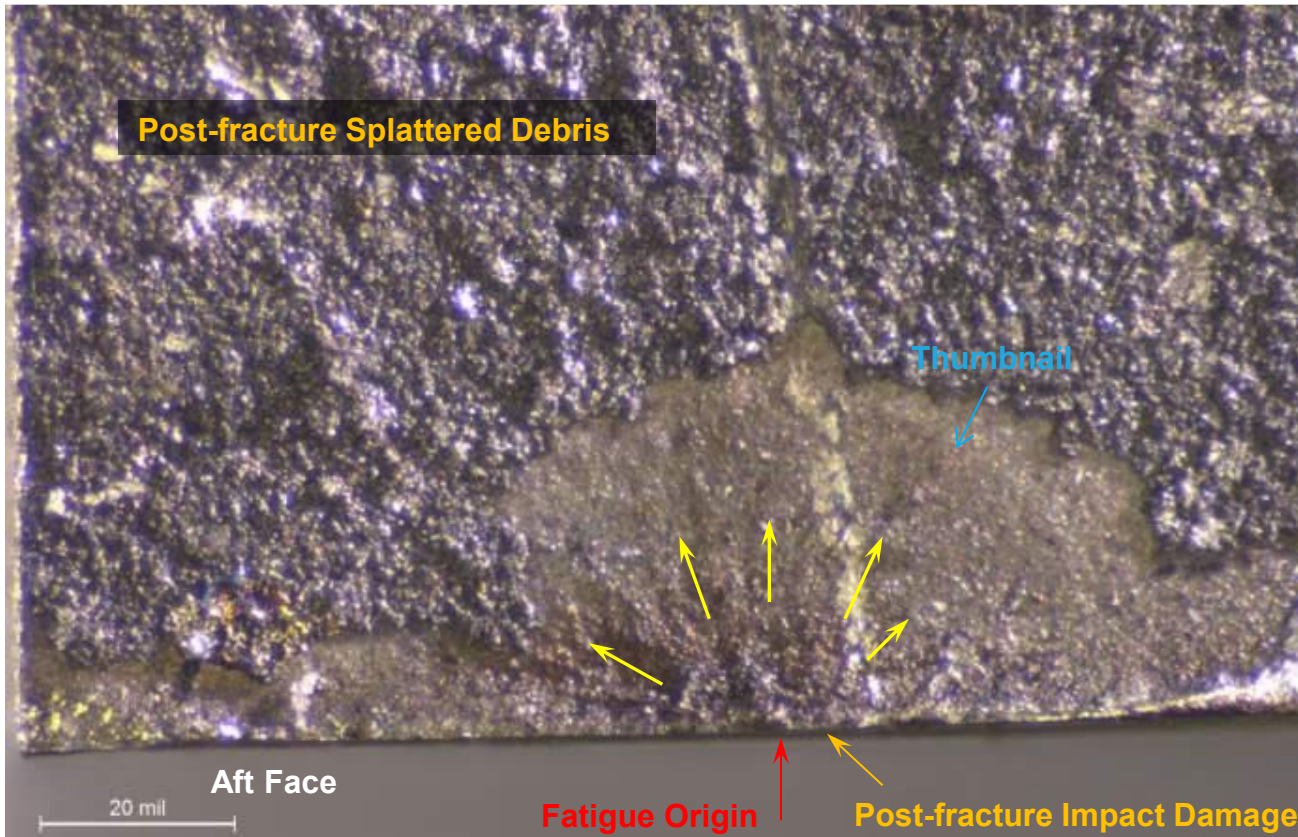
**Figure 28:** Close-up optical view of the inboard fatigue fracture showing that most of it was covered in post-fracture splattered debris, except for the origin area that had a thumbnail pattern and tinting. The aft surface at the origin area was damaged by post-fracture smearing, but had less damage than the outboard side (see next page).

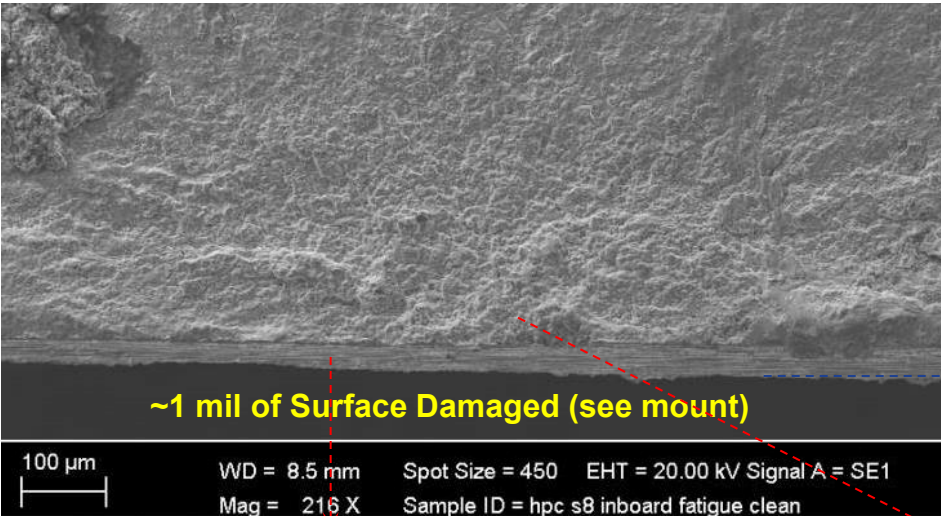
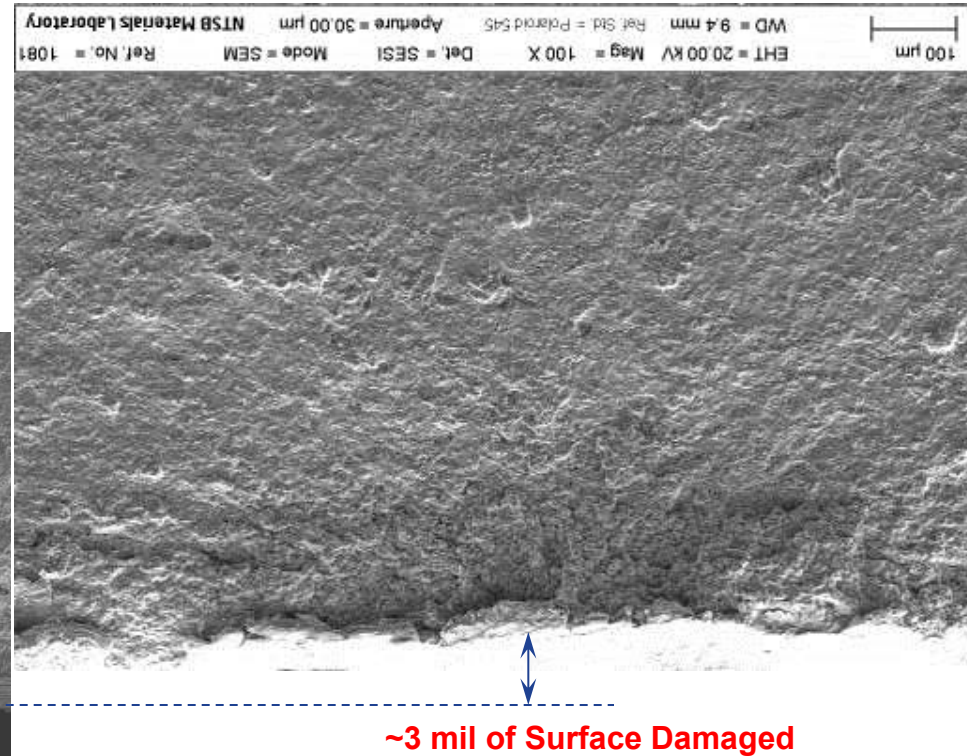
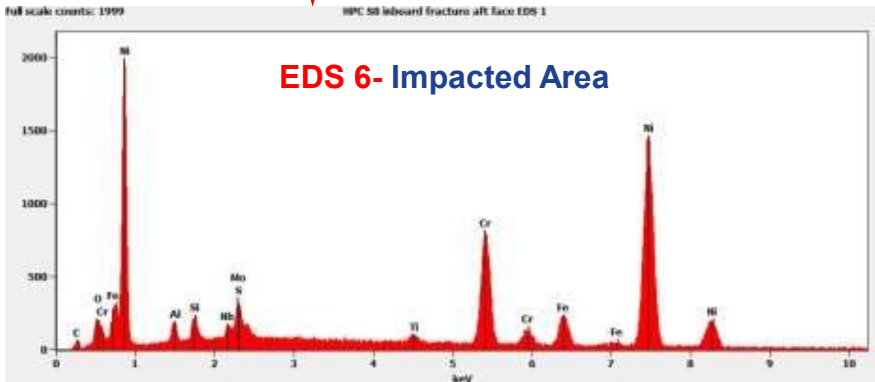
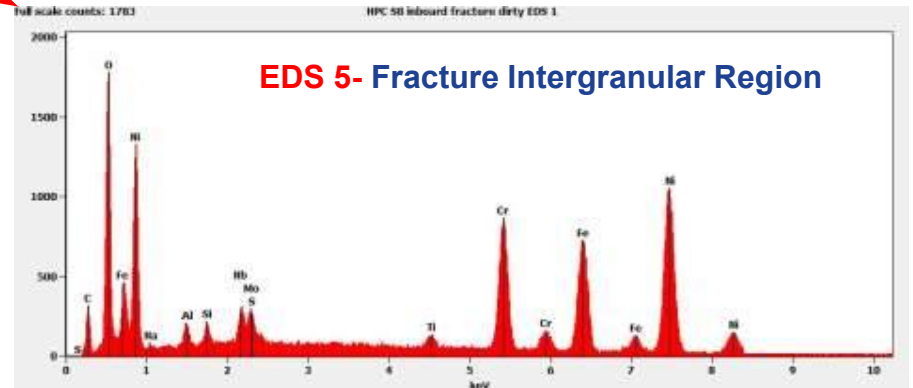
**Figure 29:** Side-by-side SEM views at similar magnifications of the mating fracture surface origin areas showing that the outboard half had approximately 3 mils of damage at the surface compared to approximately 1 mil of damage on the inboard half. EDS spectra showed that the fracture surface intergranular region was consistent with oxidized 718 (EDS 5), while on the inboard post-fracture impacted area a Ni-based alloy with similar elements was observed (EDS 6).

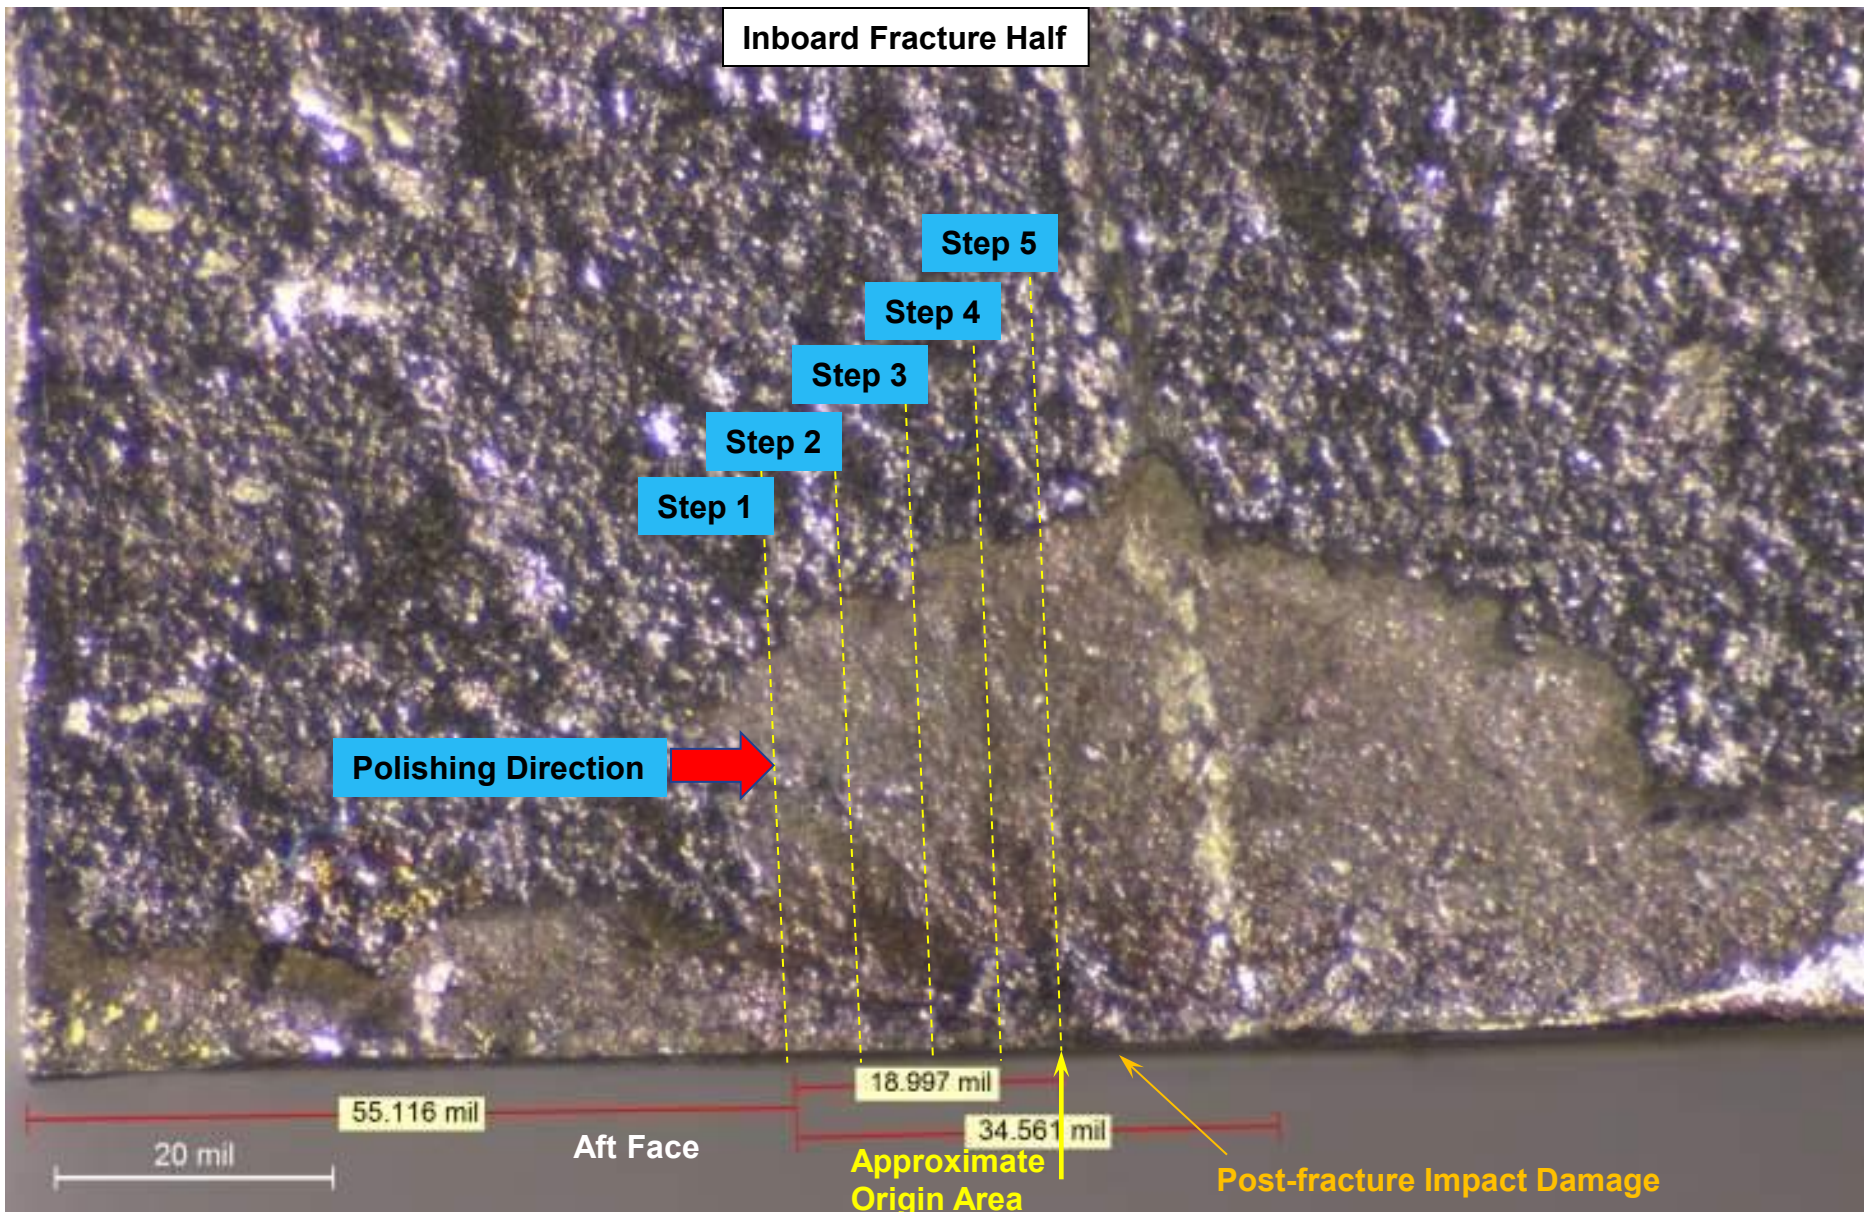
**Figure 37:** Map showing where a series of step polishes were made across the inboard fracture half metallographic mount. The 5<sup>th</sup> step was approximately in the plane of the origin area.

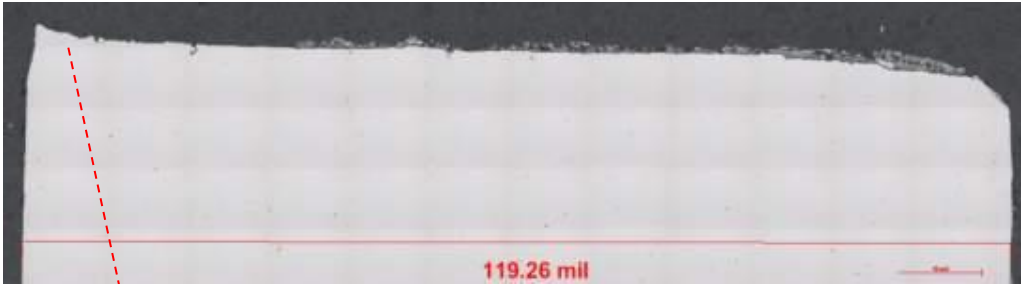
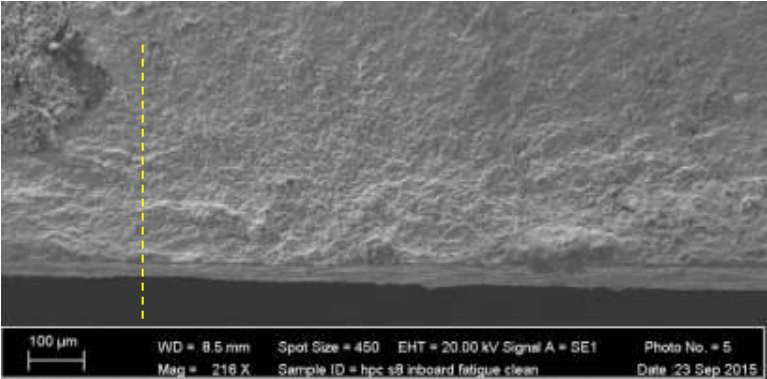
Figure 38: As-polished 1<sup>st</sup> step view of the inboard fracture showing initial intergranular growth that transitioned to transgranular growth with no material anomalies noted. The first 1 mil of the aft face was damaged by post-fracture smearing.

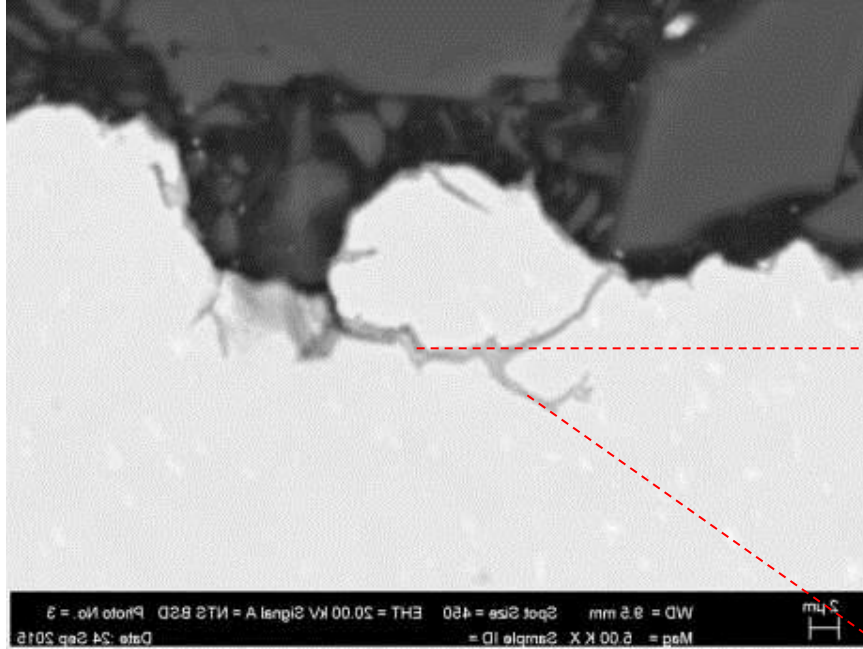
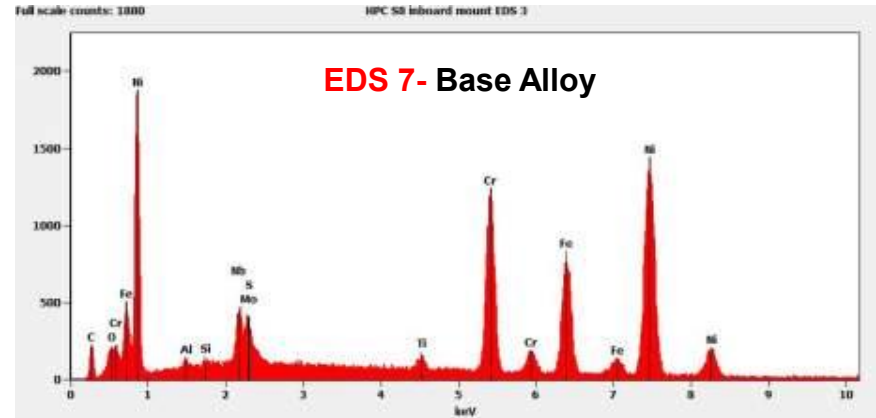
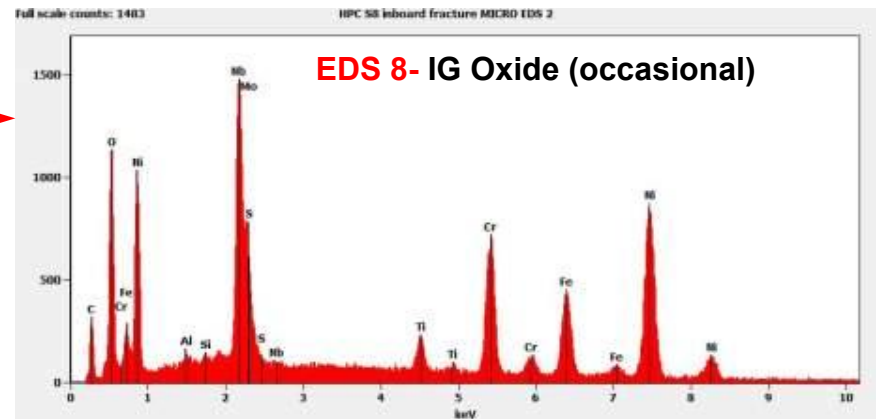
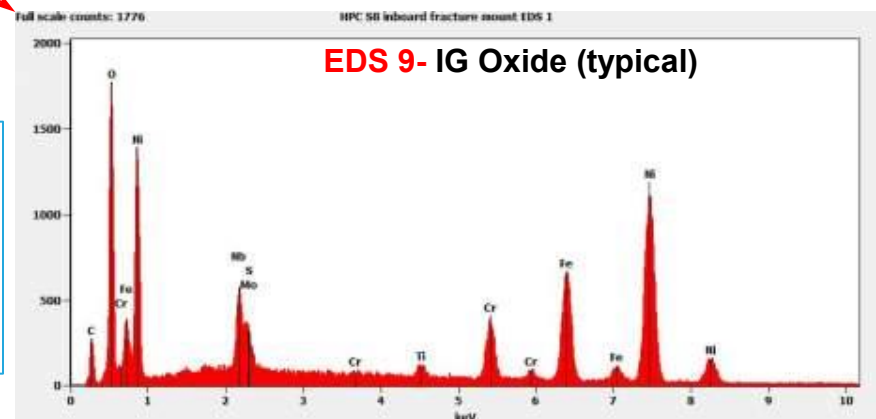
- EDS, microprobe, Auger, high-resolution SEM, and transmission electron microscopy (TEM) examination of the intergranular region did not identify any foreign detrimental species, only **oxidized base material** (Figs. 39. 43. 67-93).

**Figure 39:** SEM/EDS examination of the intergranular surface oxides. The base material was consistent with the requirement of alloy 718 (EDS 7), while at the grain boundaries only elements consistent with oxidized base material were observed (EDS 9), with occasional areas richer in Nb, consistent with local delta phase oxidation (EDS 8).

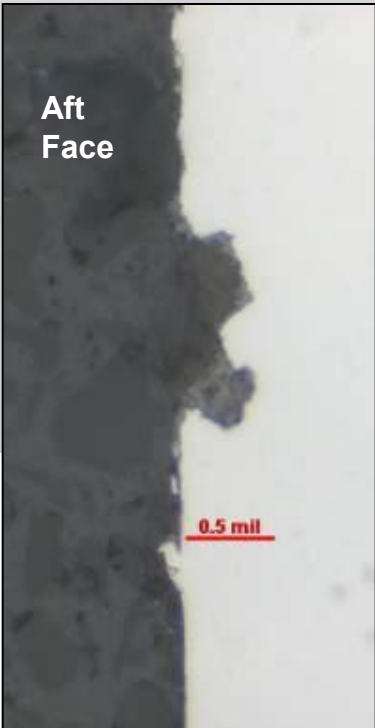
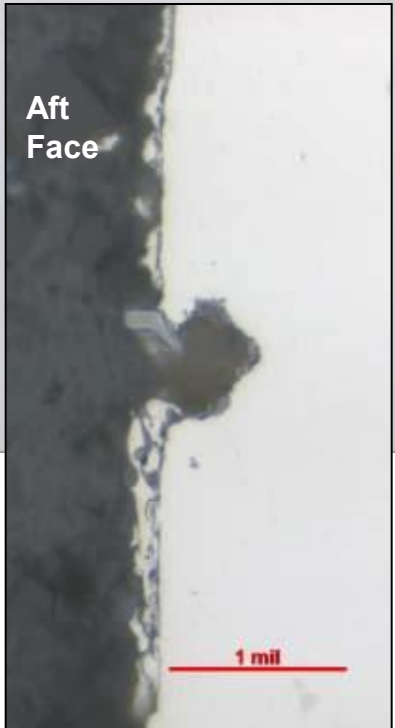
- No metallurgical anomalies were found in the base material in the as-polished condition and a typical distribution of carbides was observed, which often intersected the surface. In those areas the carbides were often oxidized and partially removed, leaving depressions/pits up to **0.5 mil deep** (Figures 41 and 42).

**Figure 41:** As-polished 3<sup>rd</sup> step view of the inboard fracture showing initial intergranular growth that transitioned to transgranular growth with no material anomalies noted. The first 1 mil of the aft face was damaged by post-fracture smearing. Inboard of the fracture along the face were surface-connected carbides that were etched/oxidized up to approximately 0.5 mil deep locally.

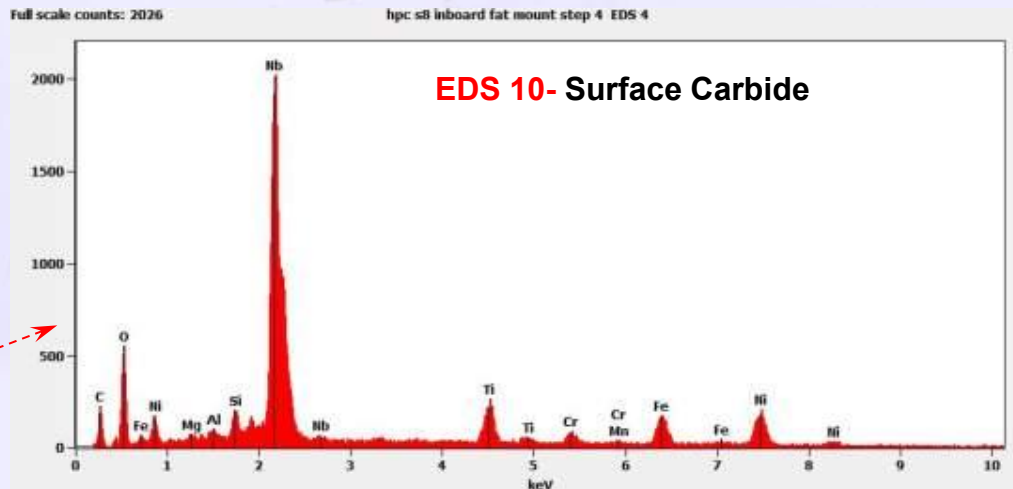
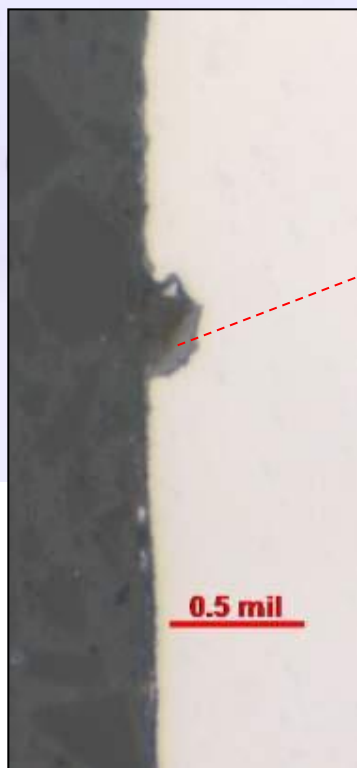
**Figure 42:** As-polished 4<sup>th</sup> step view of the inboard fracture showing initial intergranular growth that transitioned to transgranular growth with no material anomalies noted. The first 1 mil of the aft face was damaged by post-fracture smearing. Inboard of the fracture along the face were surface-connected carbides that were etched/oxidized up to approximately 0.2 mil deep locally. EDS analysis confirmed the surface “pit” was consistent with oxidized Nb-rich carbides (EDS 10).

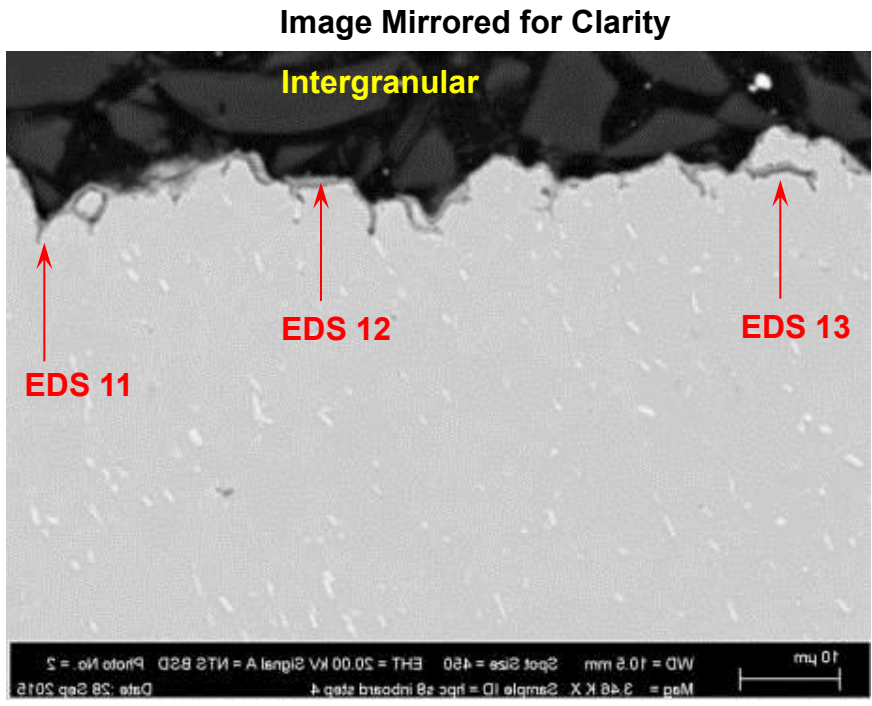
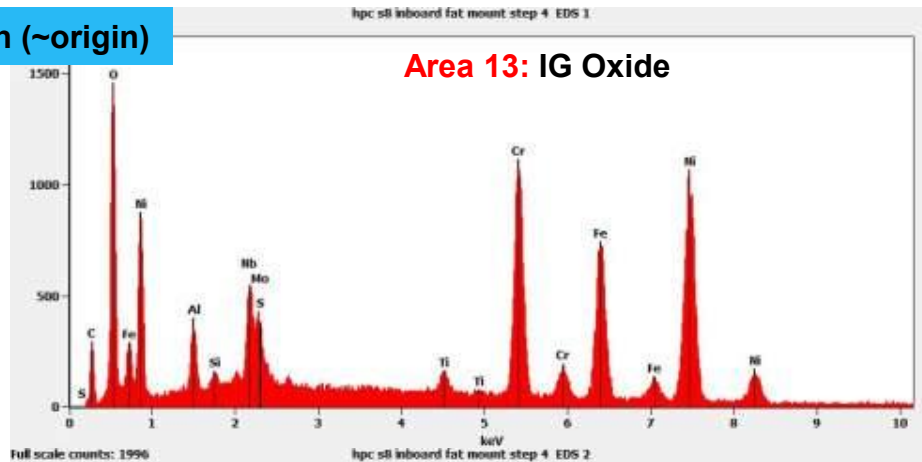
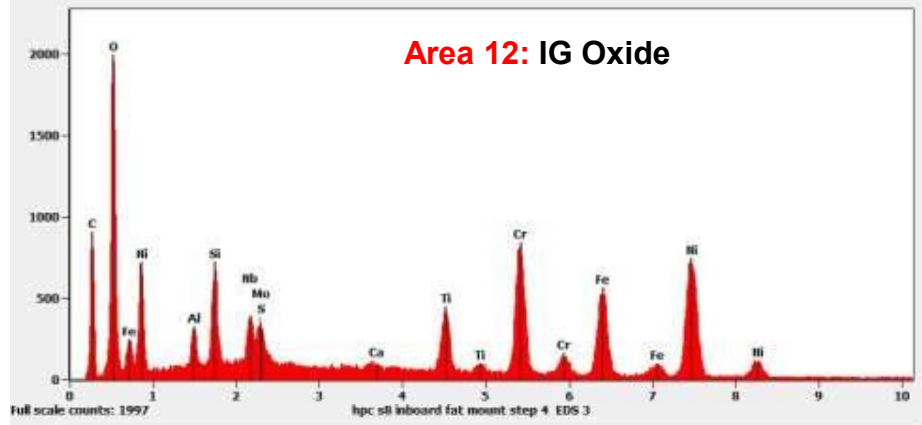
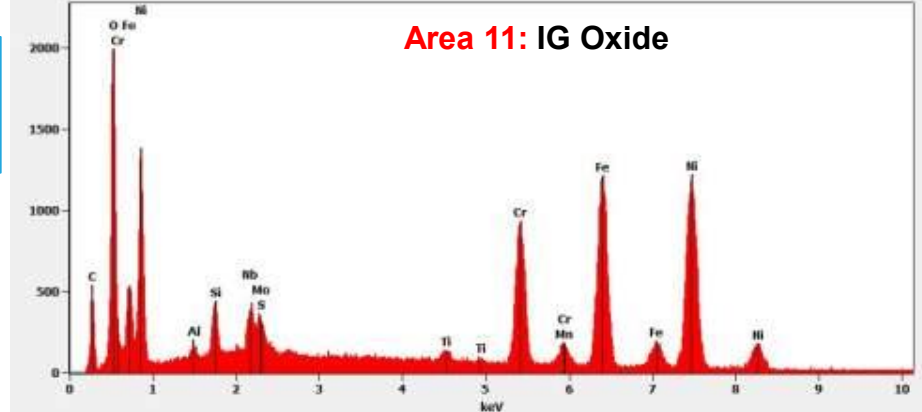
**Figure 43:** EDS analysis of the fracture in the intergranular region only showed elements consistent with base metal material oxides with no detrimental species found (EDS 11-13).

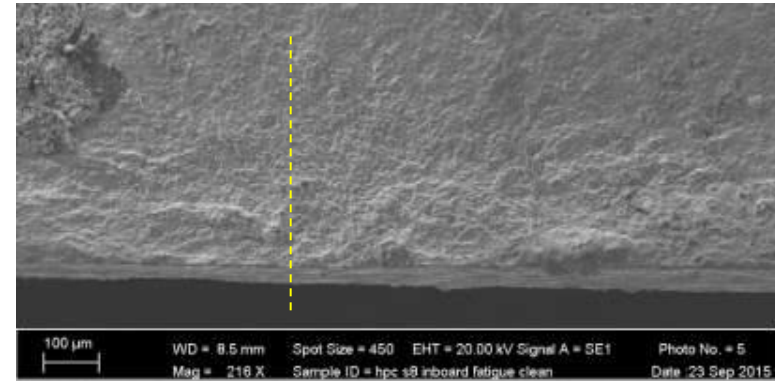
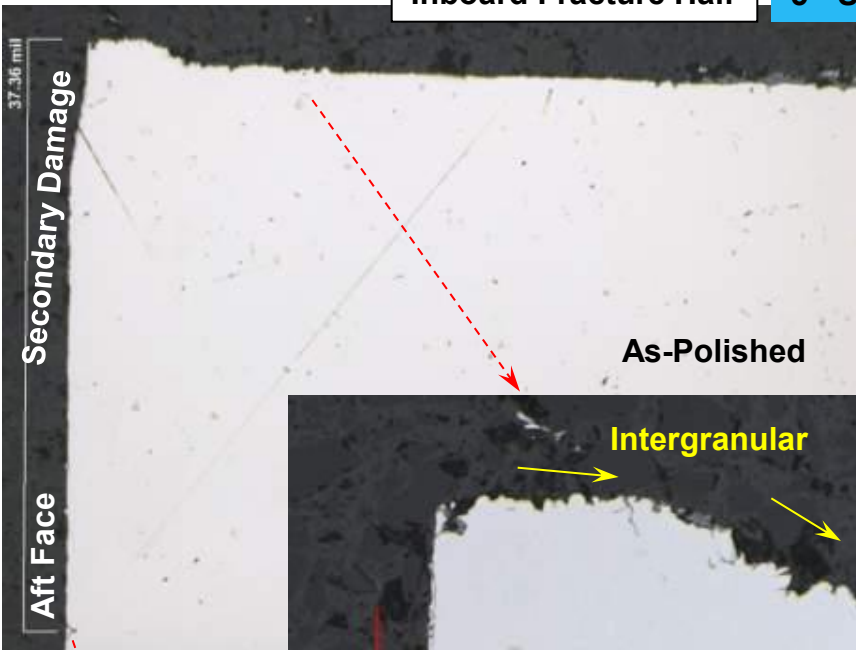
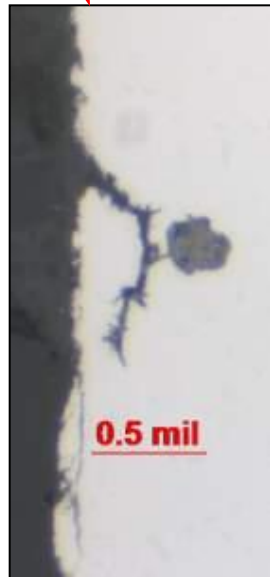
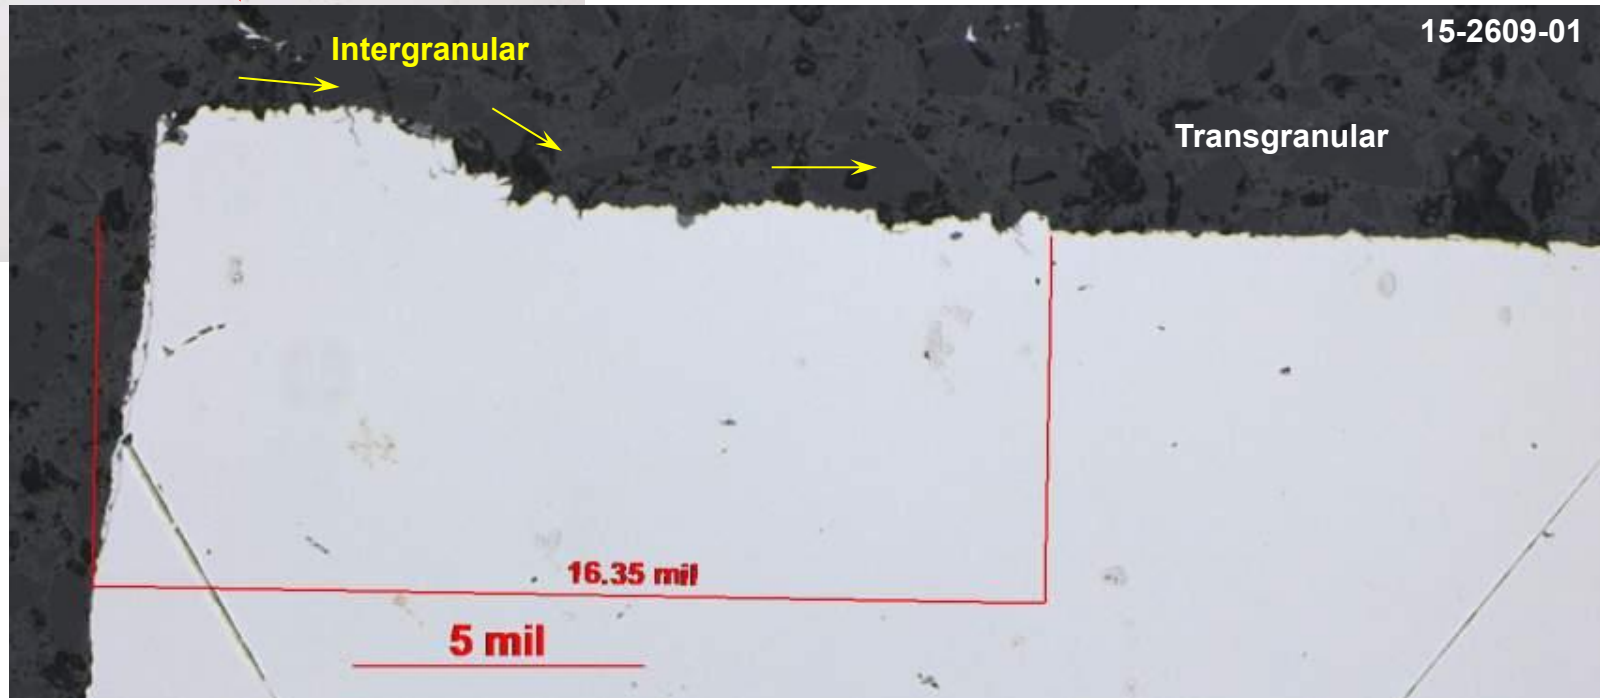
**Figure 44:** As-polished 5<sup>th</sup> step view of the inboard fracture through the approximate origin area showing initial intergranular growth that transitioned to transgranular growth with no material anomalies noted. The first 1 mil of the aft face was damaged by post-fracture smearing. In the current plane of polish the predominantly intergranular region was up to 16 mils deep.
