# NATIONAL TRANSPORTATION SAFETY BOARD

MATERIALS LABORATORY FACTUAL REPORT

Report No. 15-131

Place : Las Vegas, Nevada  
Date : September 8, 2015  
Vehicle : Boeing 777-200, G-VIIO  
NTSB No. : DCA15FA185  
Investigator : Lorenda Ward, AS-10

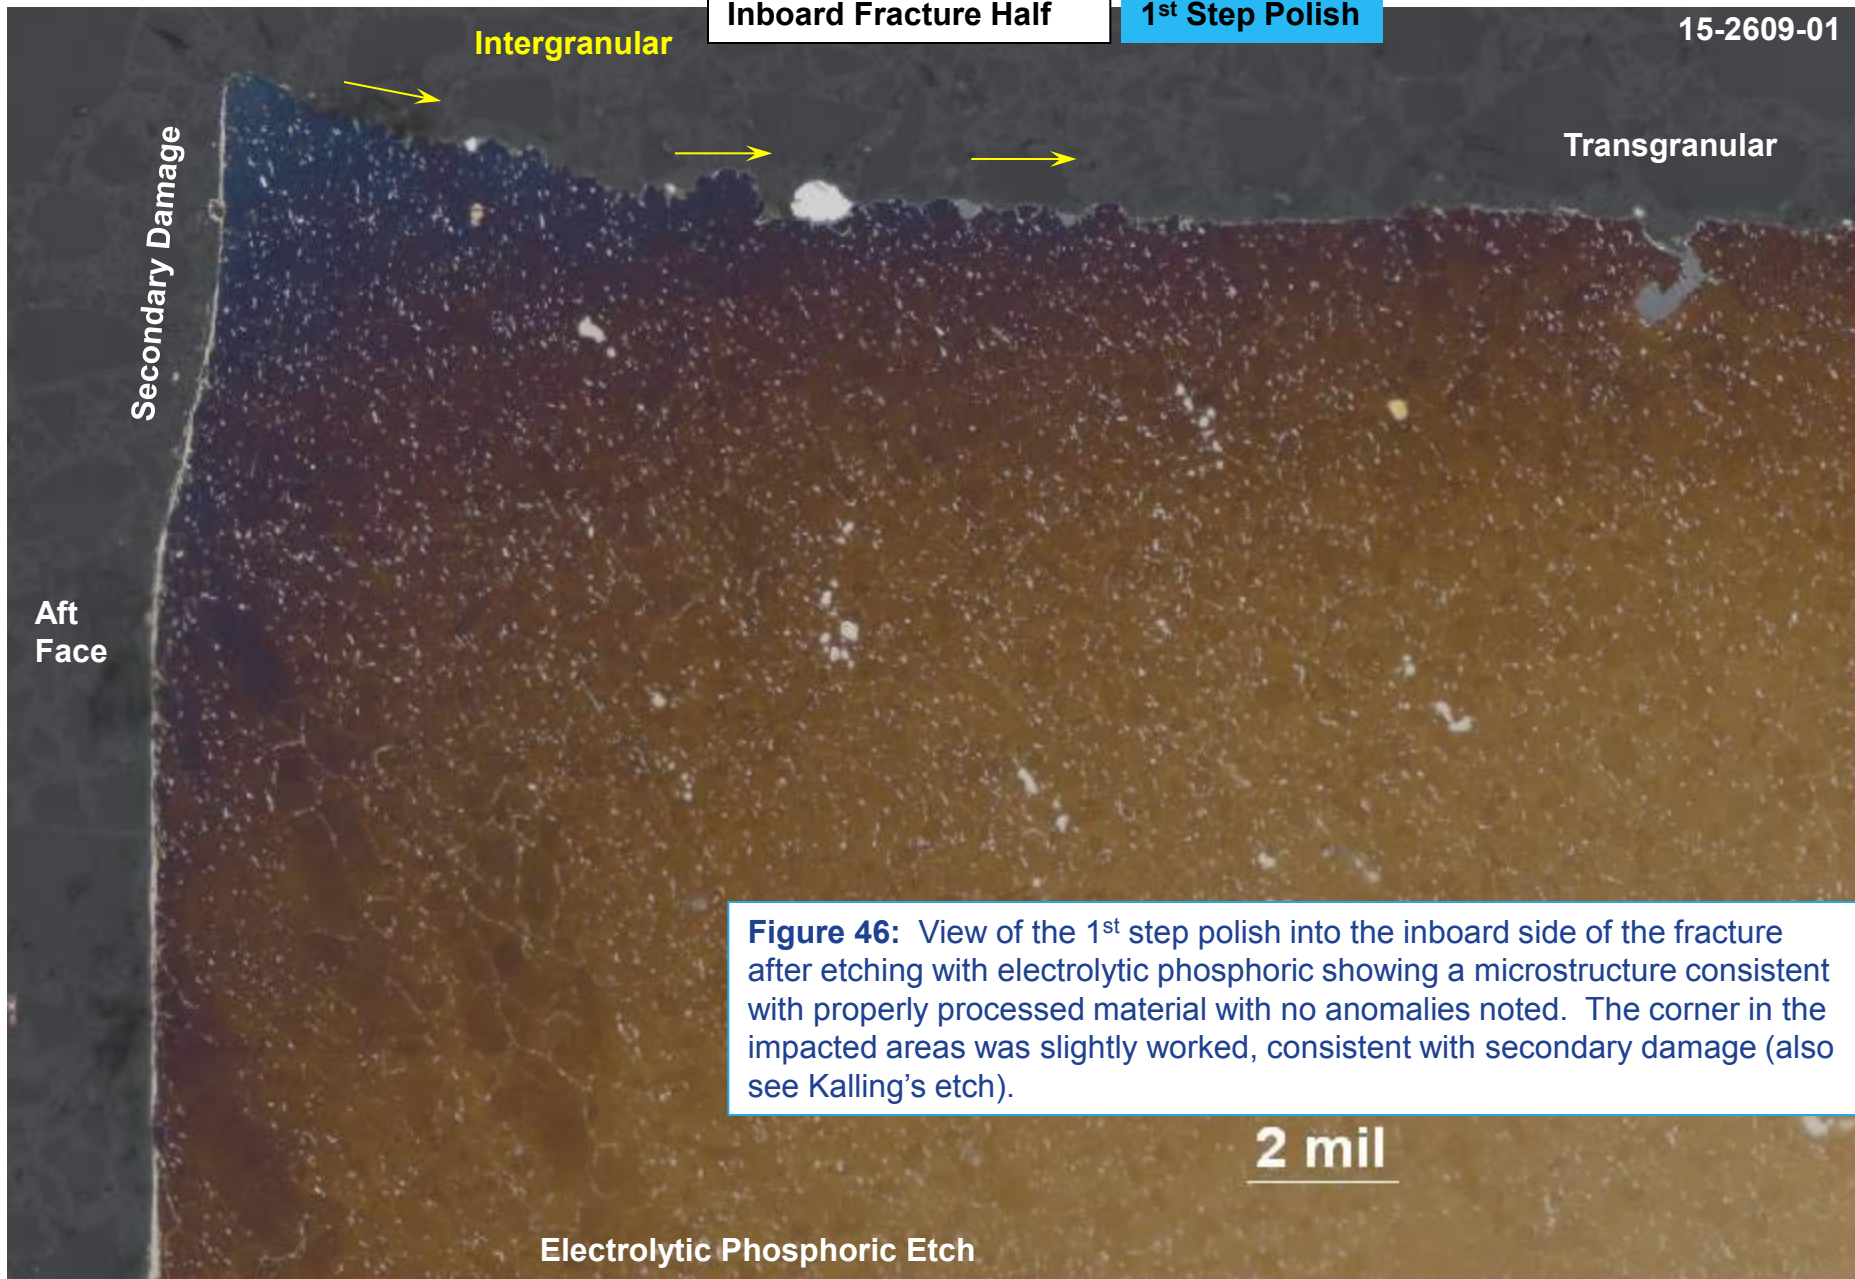
**Figure 46:** View of the 1<sup>st</sup> step polish into the inboard side of the fracture after etching with electrolytic phosphoric showing a microstructure consistent with properly processed material with no anomalies noted. The corner in the impacted areas was slightly worked, consistent with secondary damage (also see Kalling's etch).

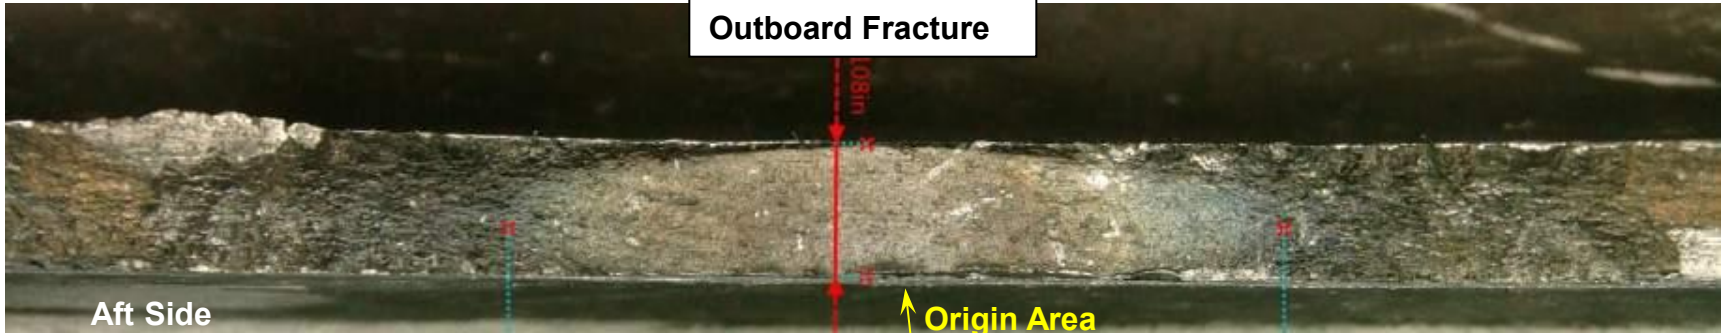
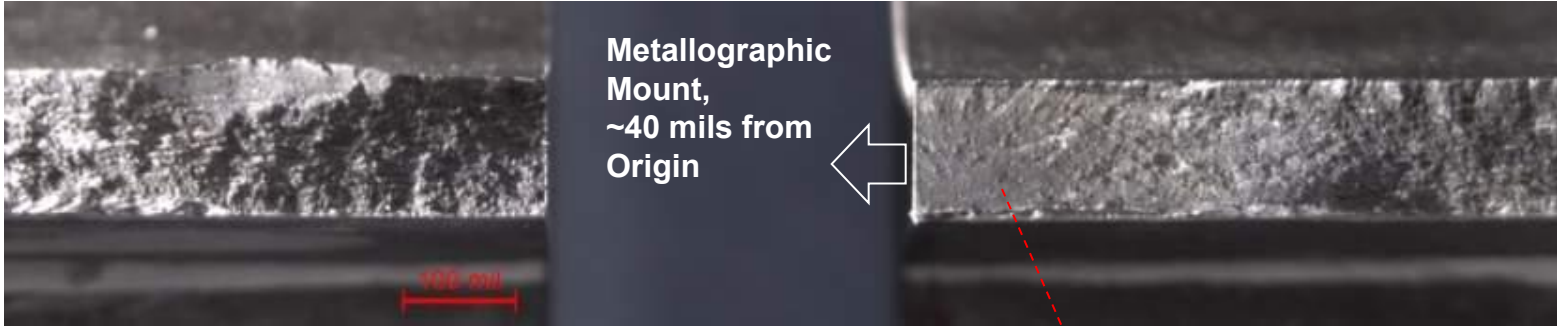
**Figure 56:** A metallographic mount was made in a plane approximately 40 mils away from the origin area (see next page).

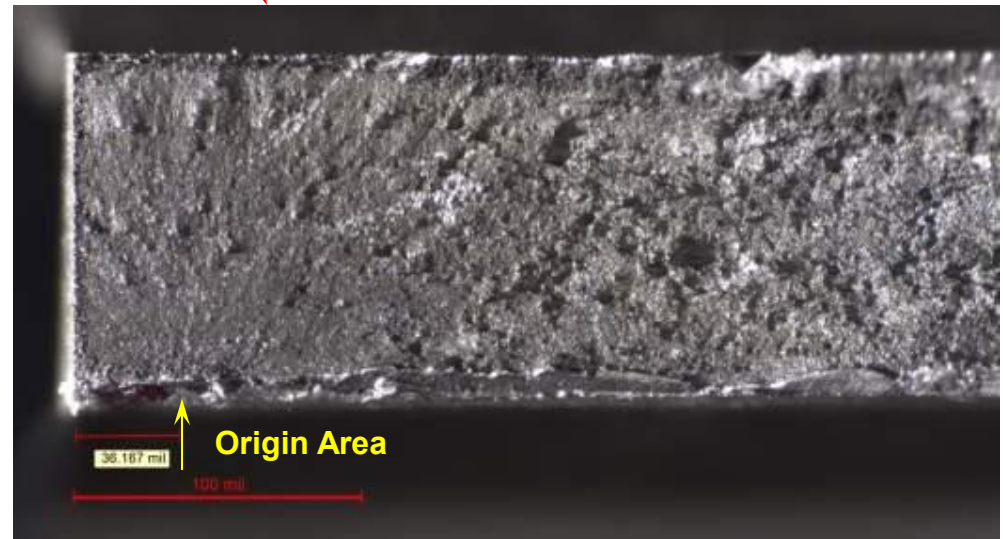
**Figure 57:** A metallographic made into the outboard fracture showed that it extended from the aft side of the web approximately 0.950 inch from the slot bottom at the web transition area where the wall thickness was reduced to approximately 0.118 inch. Secondary cracks were found within 16 mils of the main fatigue fracture further inboard.

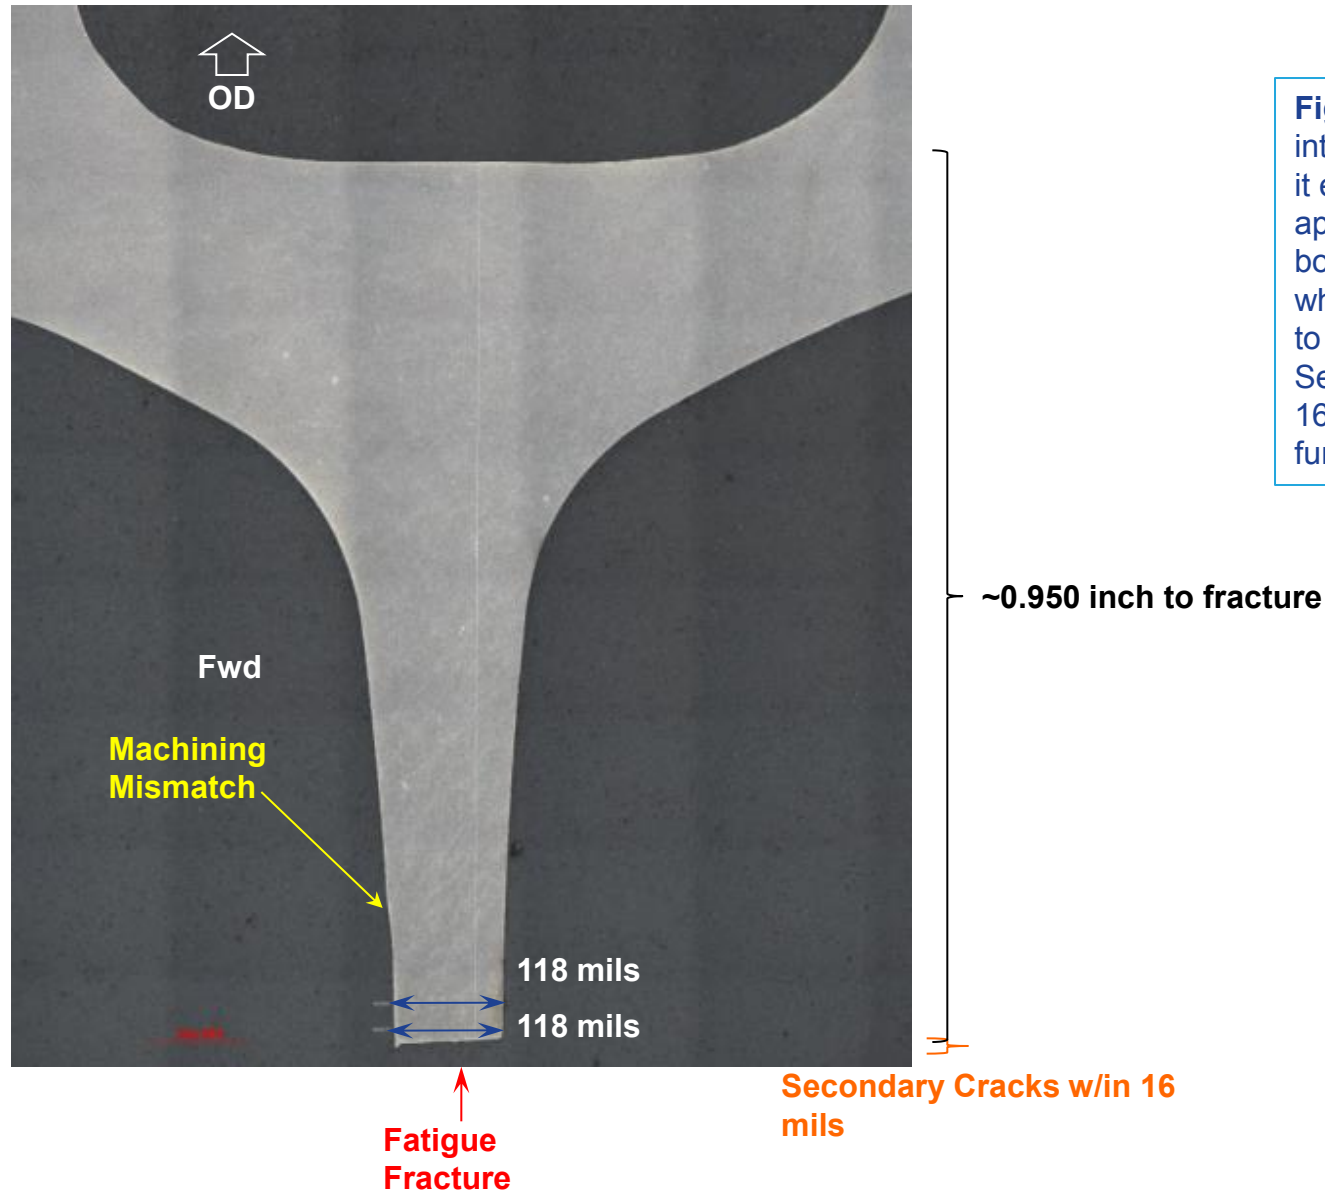
**Figure 58:** The as-polished metallographic mount into the outboard fracture showed that there were no material anomalies in the base structure. The aft corner/origin area fracture was more damaged than the inboard side, but the underlying base structure had less damage/work (see etched mount).

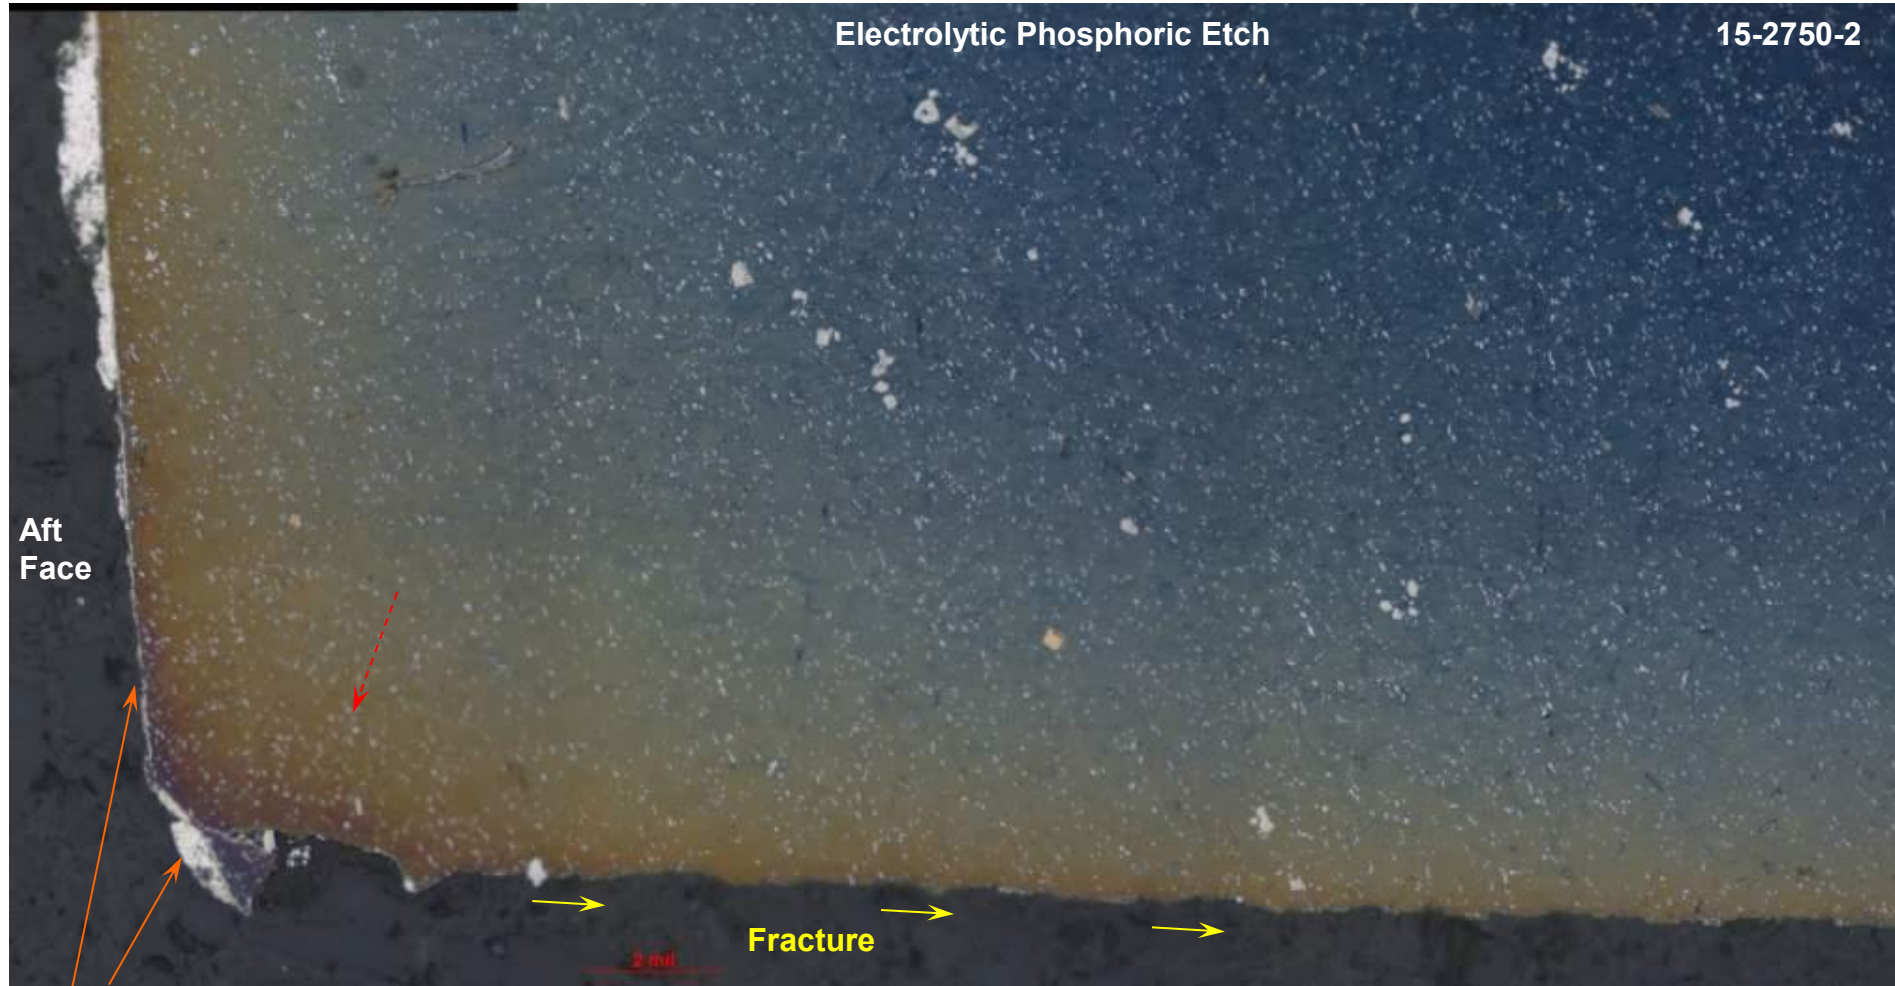
**Figure 59:** The etched metallographic mount into the outboard fracture showed that there were no material anomalies in the base structure. The aft corner/origin area fracture was more damaged than the inboard side, but the underlying base structure had less damage/work (see Kalling's etch)

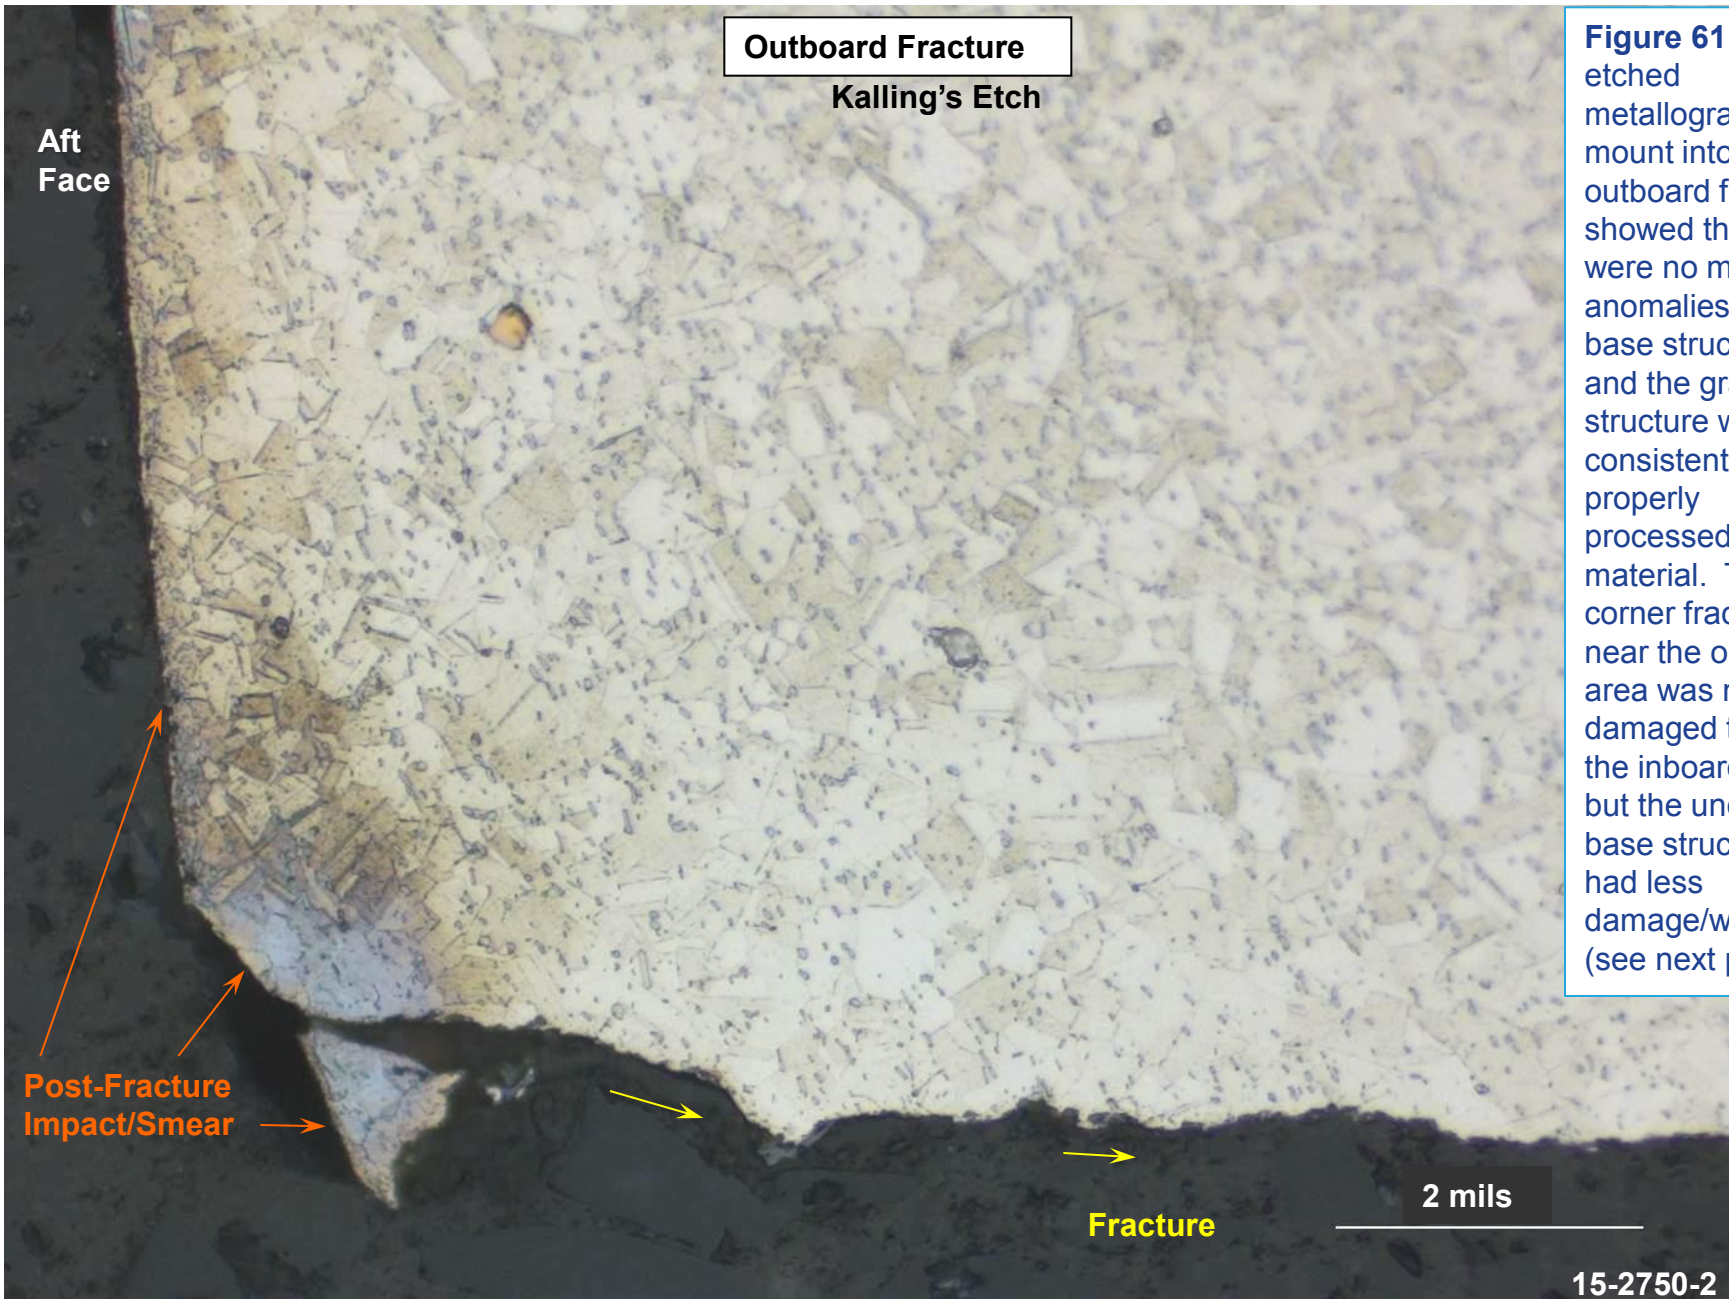
**Figure 61:** The etched metallographic mount into the outboard fracture showed that there were no material anomalies in the base structure and the grain structure was consistent with properly processed material. The aft corner fracture near the origin area was more damaged than the inboard side, but the underlying base structure had less damage/work (see next page).

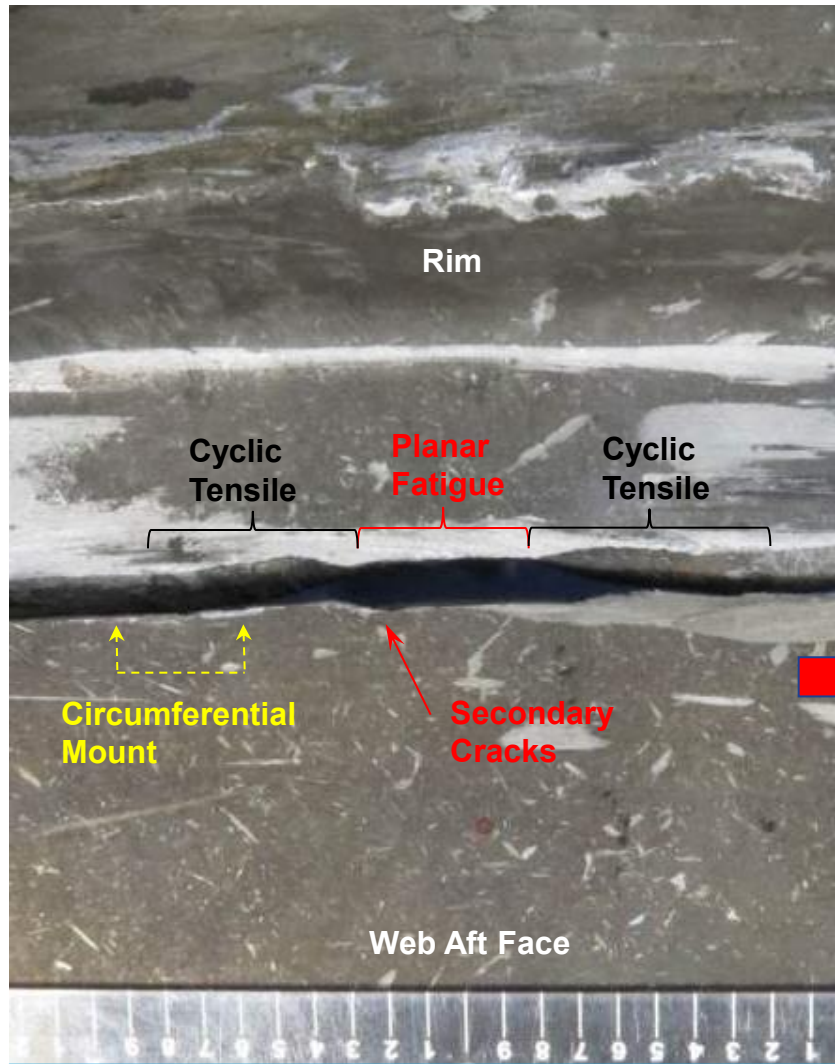
**Figure 65:** Optical views of the aft face of the web showing where a circumferential mount was made to assess the machined surfaces. The right image shows that approximately 11 turning lines were observed within 0.1 inch.

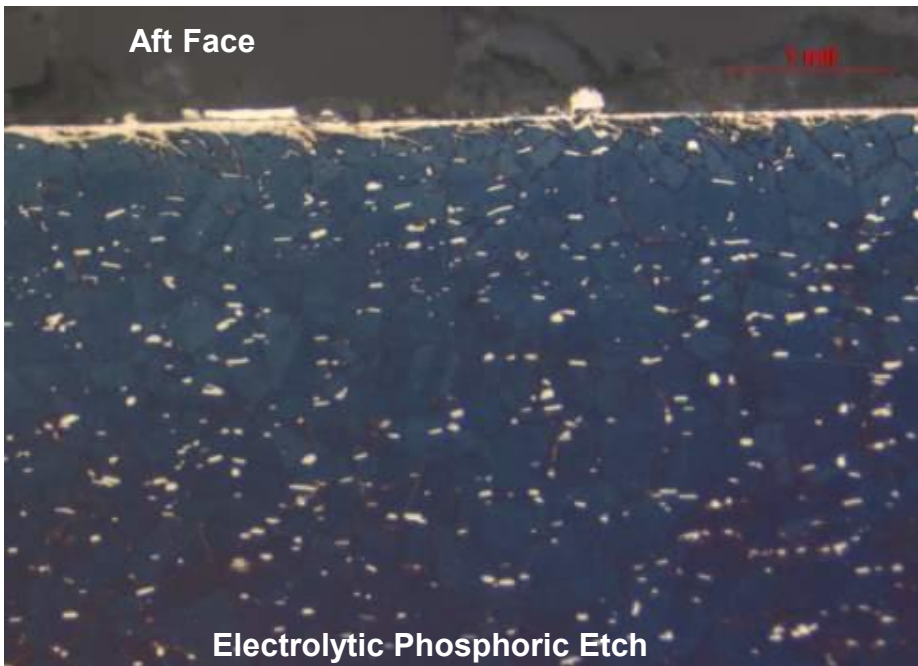
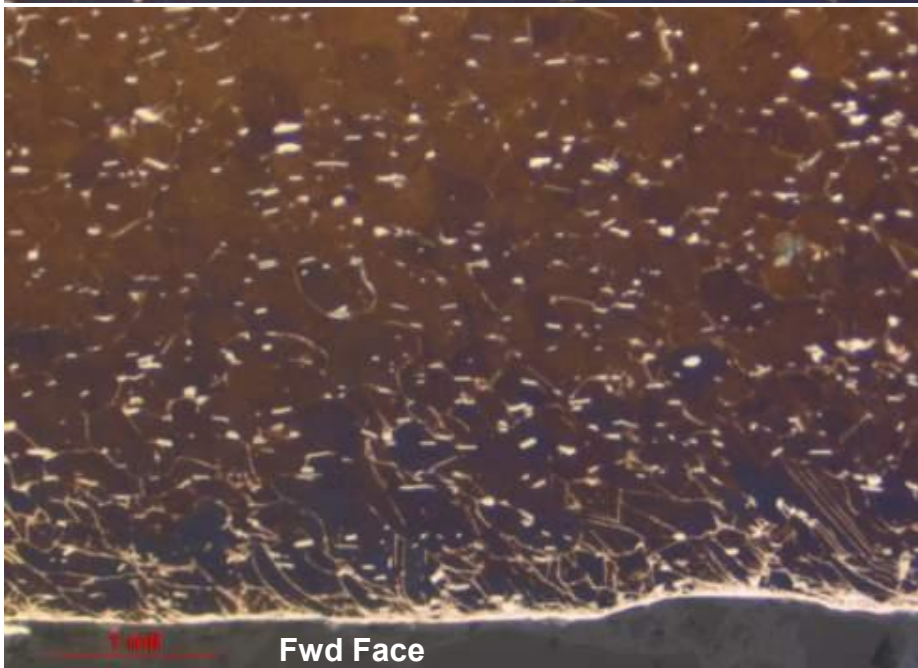
- A circumferential mount made near the fatigue region showed distorted surface grain structure in a single direction on both the forward and aft faces of the web, consistent with a turning operation. From optical examination on the forward side the surface grains were locally distorted by approximately **0.5 mil**, whereas on the aft side by approximately **0.2 mil** (Figures 65 and 66). Follow-on electron backscatter diffraction (EBSD) examination showed that the worked grains were approximately **4.1 mils** deep on the forward face and **1.6-2.0 mils** deep on the aft face (described later). On the aft face approximately 11 turning lines were measured in 0.1 inch, consistent with acceptable machining parameters.

**Figure 66:** A circumferential mount made in the vicinity of the fatigue region showed that on the aft side distorted grains from turning were visible to a depth of approximately 0.2 mil, compared to approximately 0.5 mil on the forward face (the worked structure was shown to be deeper by EBSD- see Appendix E).

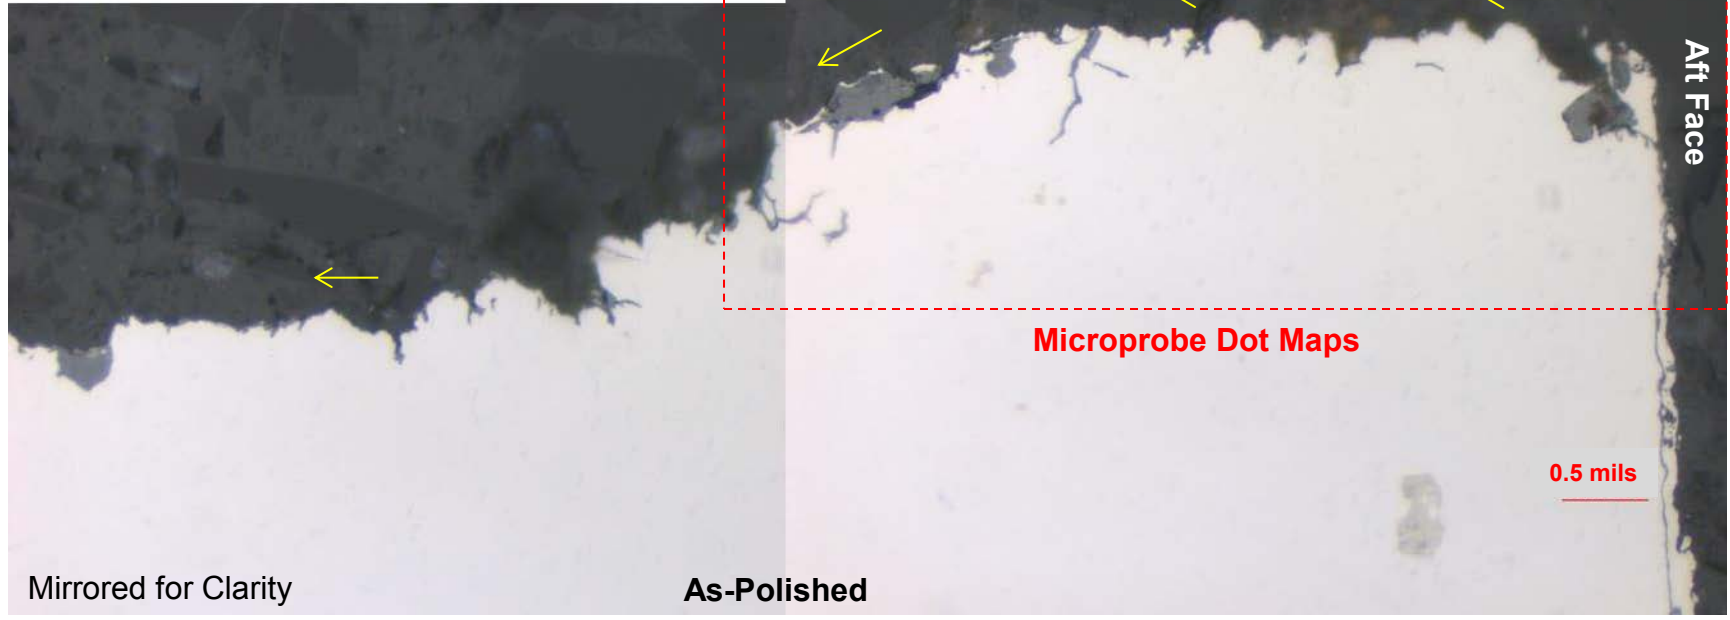
**Figure 67:** Two dot maps regions were generated with by microprobe analysis. The first one was a higher resolution scan of the origin area near the aft face (area shown above) and a second was a slightly larger area of the fracture (see Figure 70).

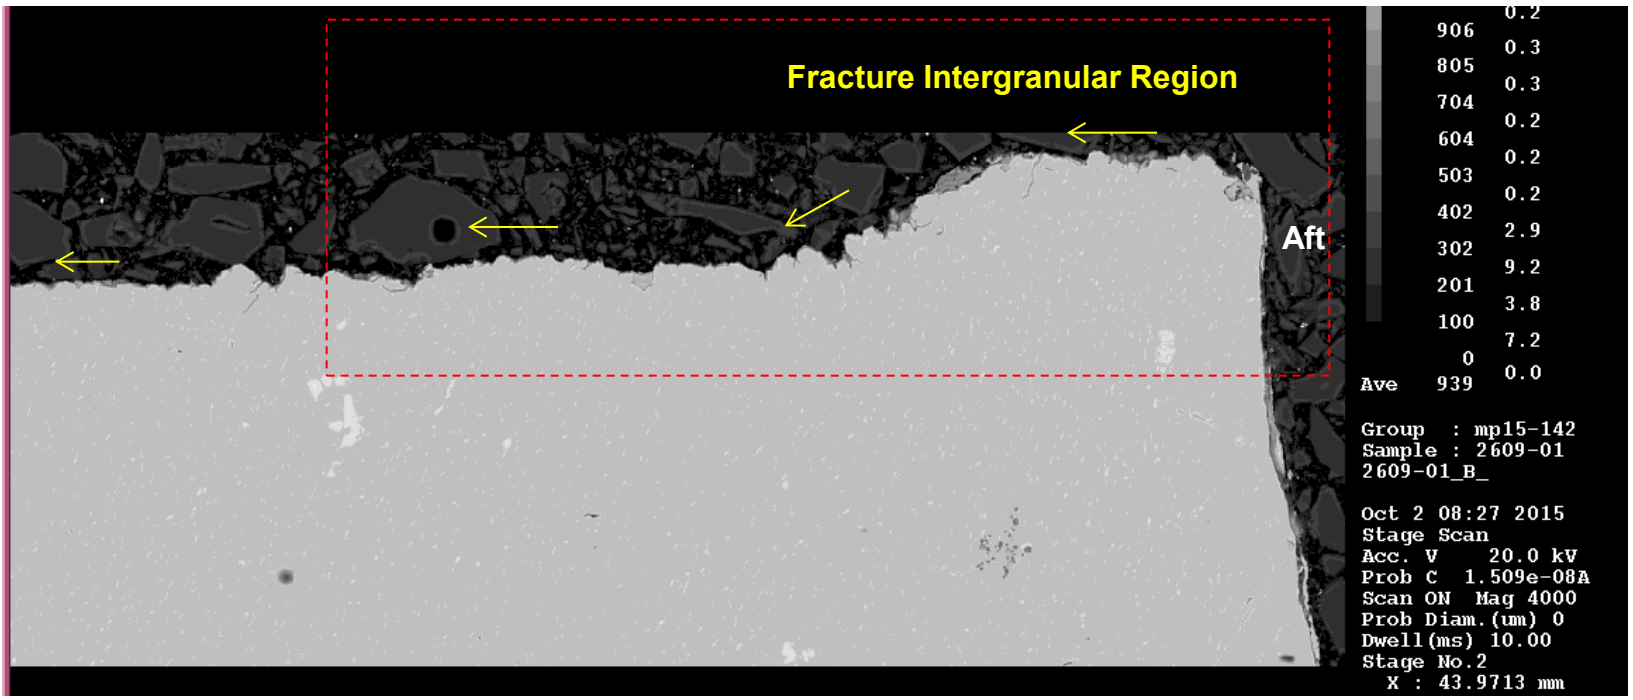
**Figure 70:** SEM image showing the location of the second microprobe dot map, which included a slightly larger area of the intergranular portion of the fracture.

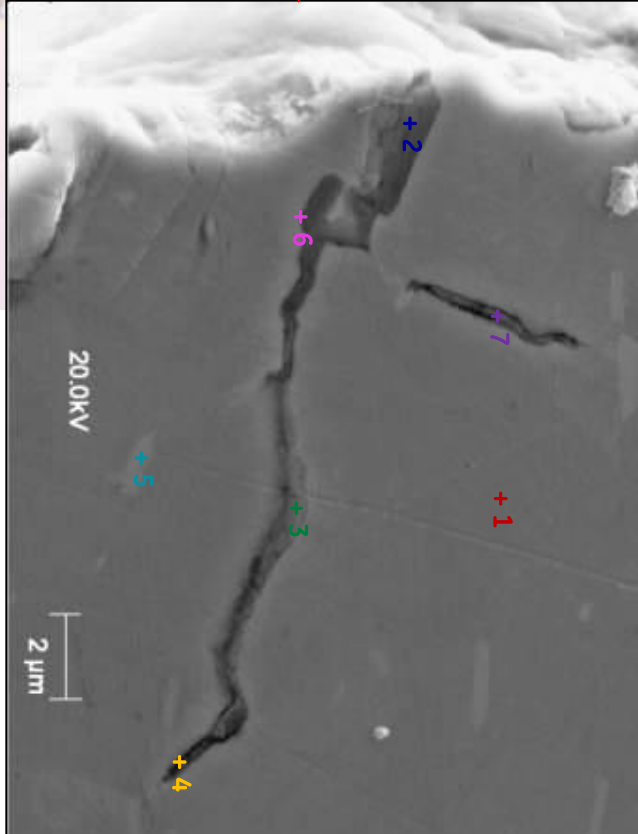
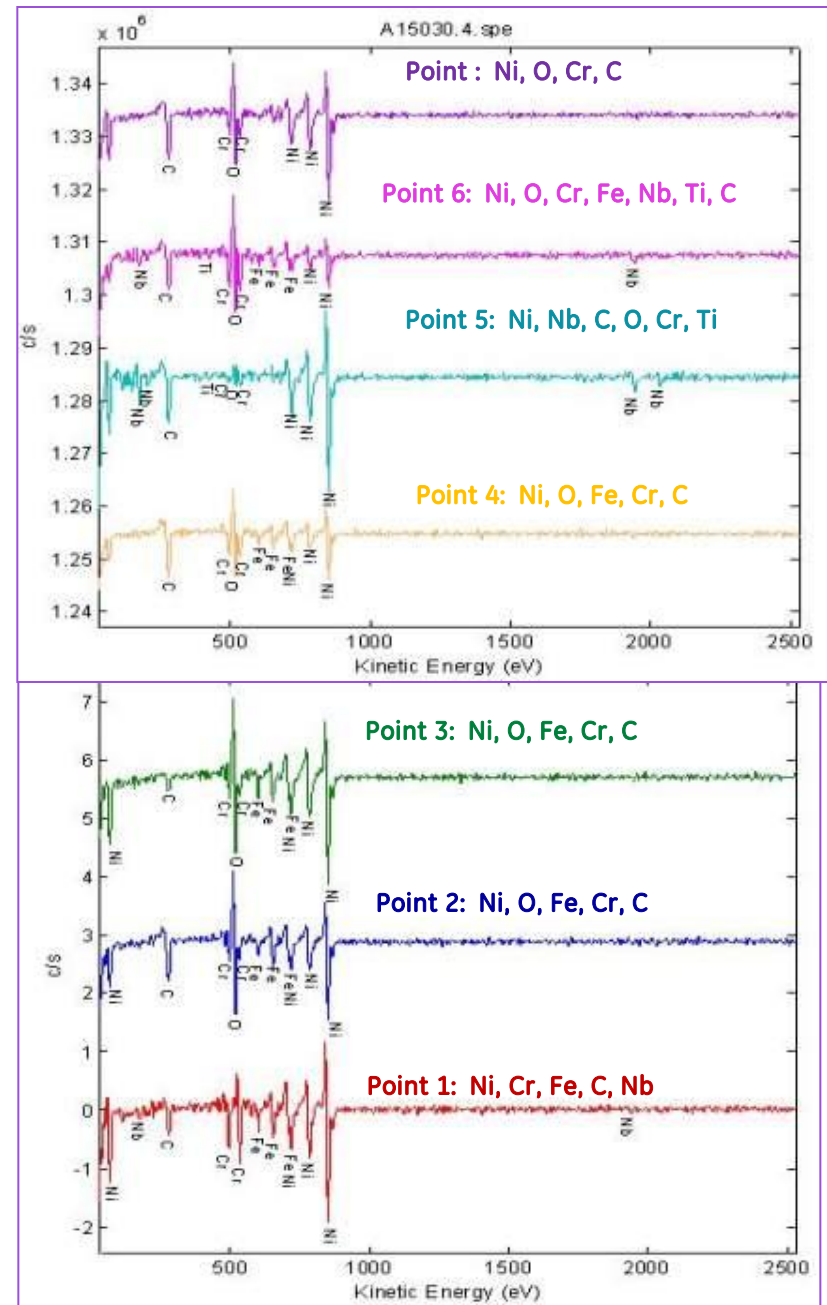
**Figure 74:** Seven areas of the fracture surface intergranular branch spike were analyzed by Auger and only base metal oxides were found with no detrimental species.

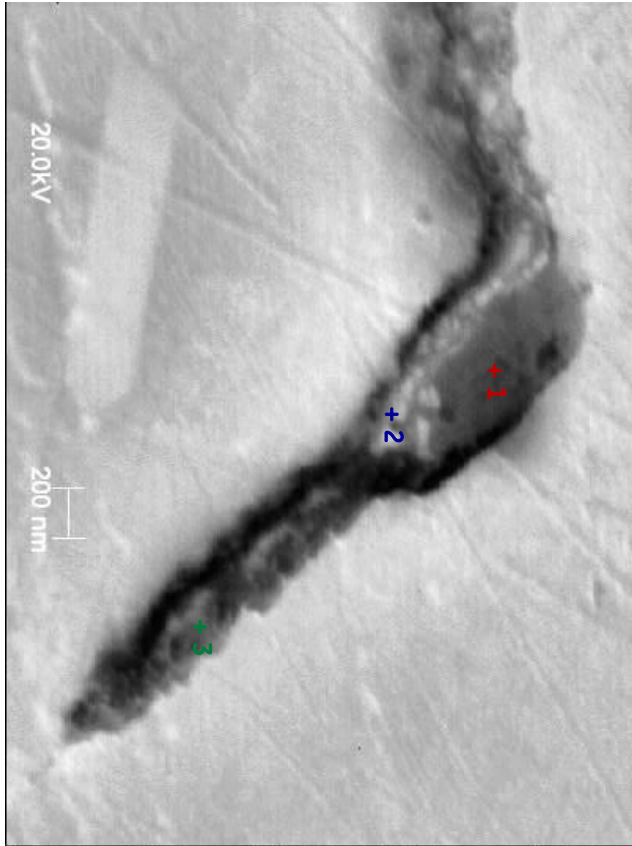
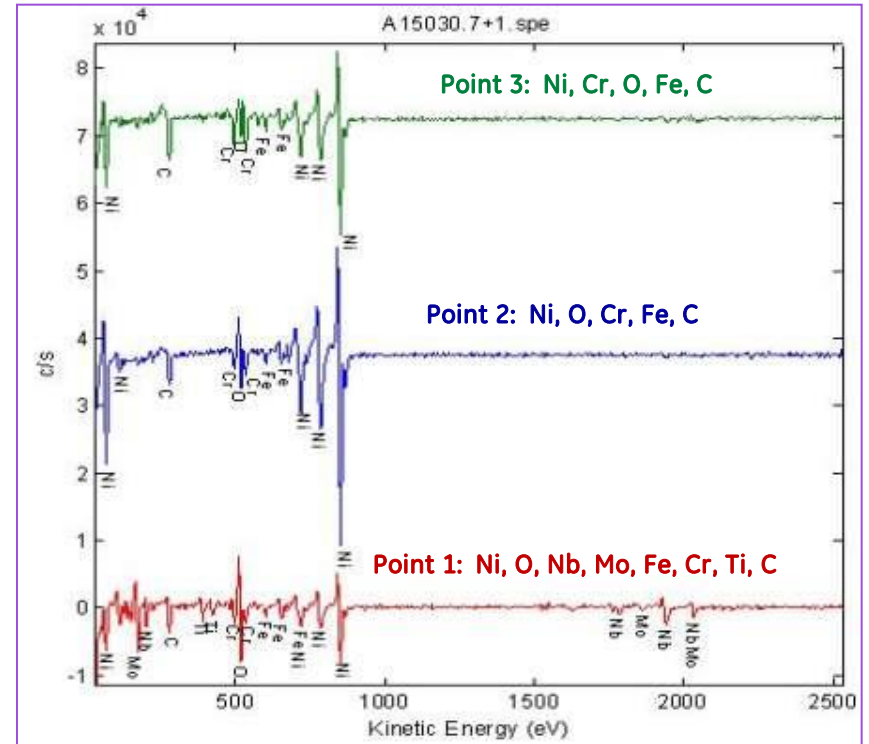
**Figure 75:** Additional examination of the branched crack only showed base metal oxides with no detrimental species.

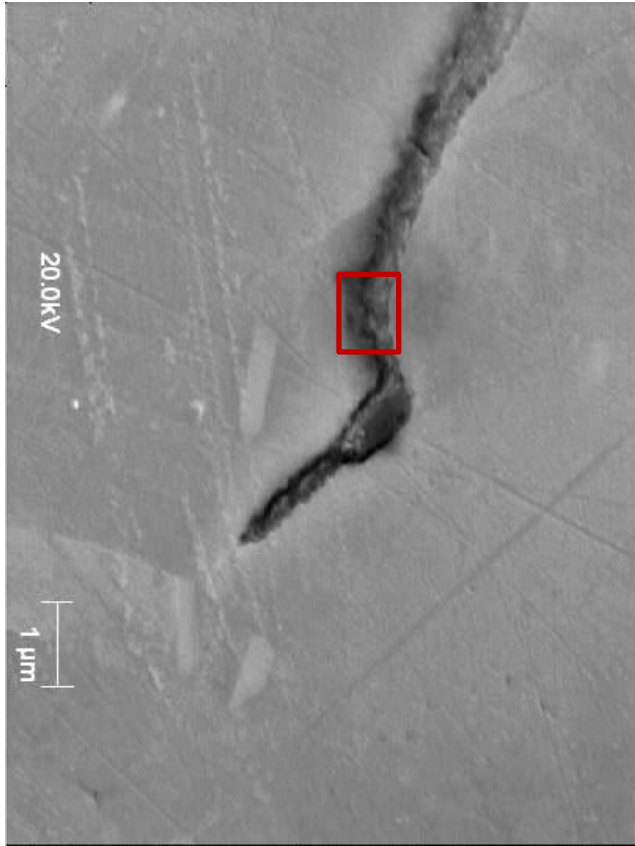
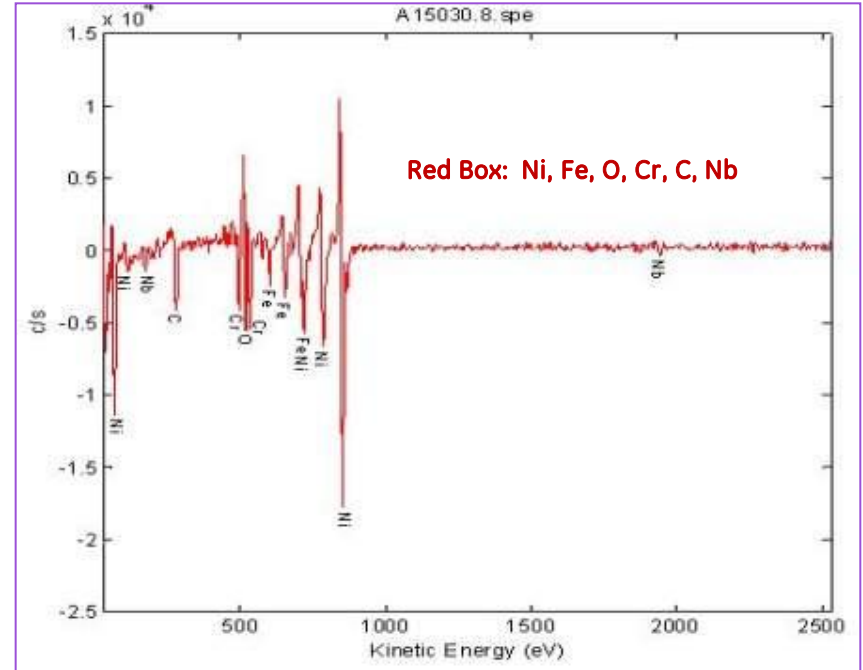
**Figure 76:** Additional examination of the branched crack only showed base metal oxides with no detrimental species.

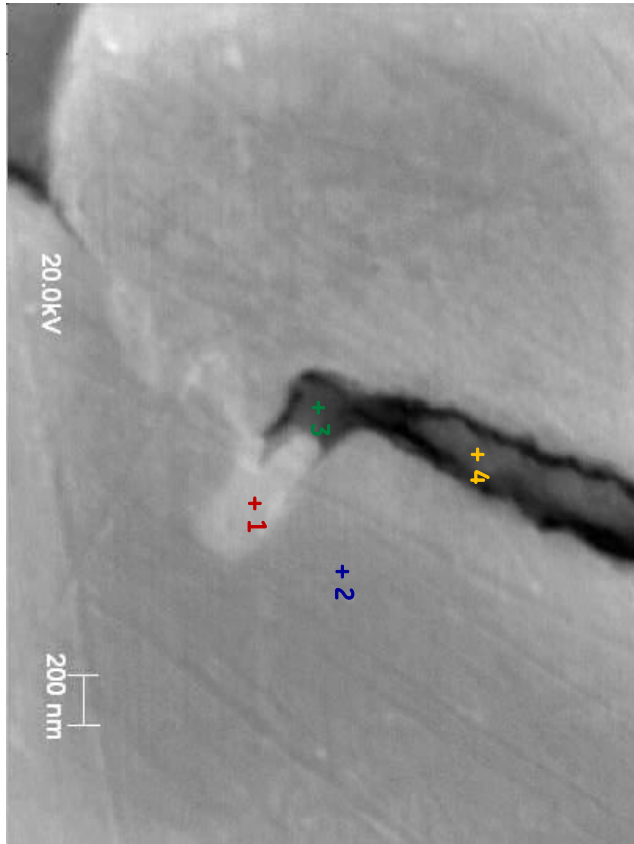
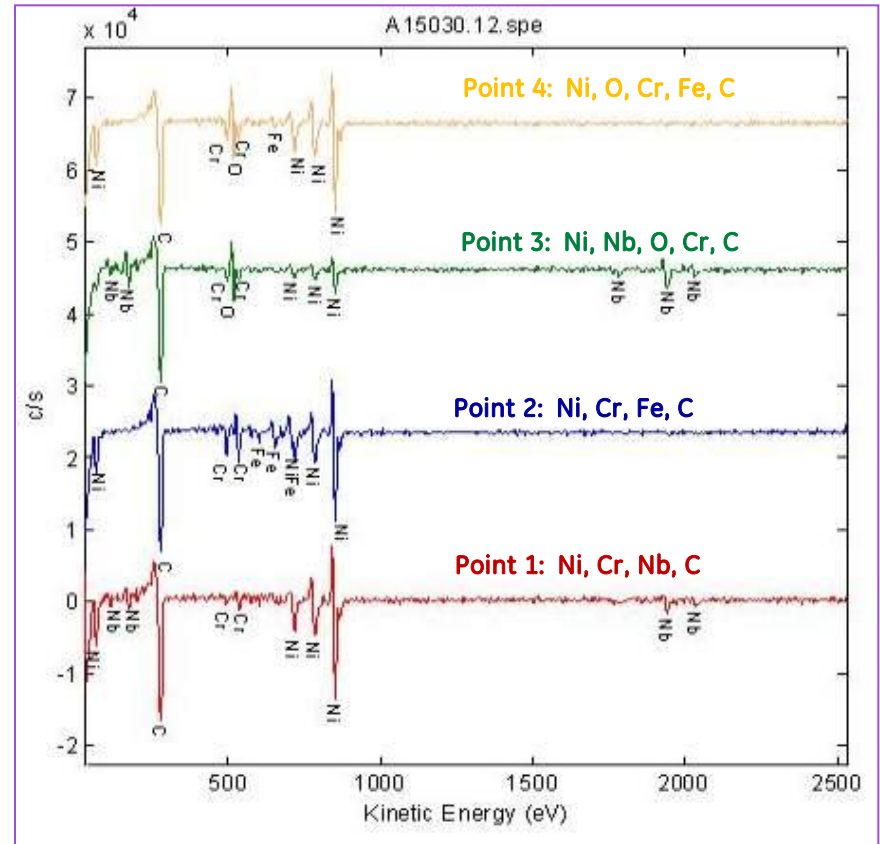
**Figure 77:** Additional examination of the branched crack only showed base metal oxides with no detrimental species.

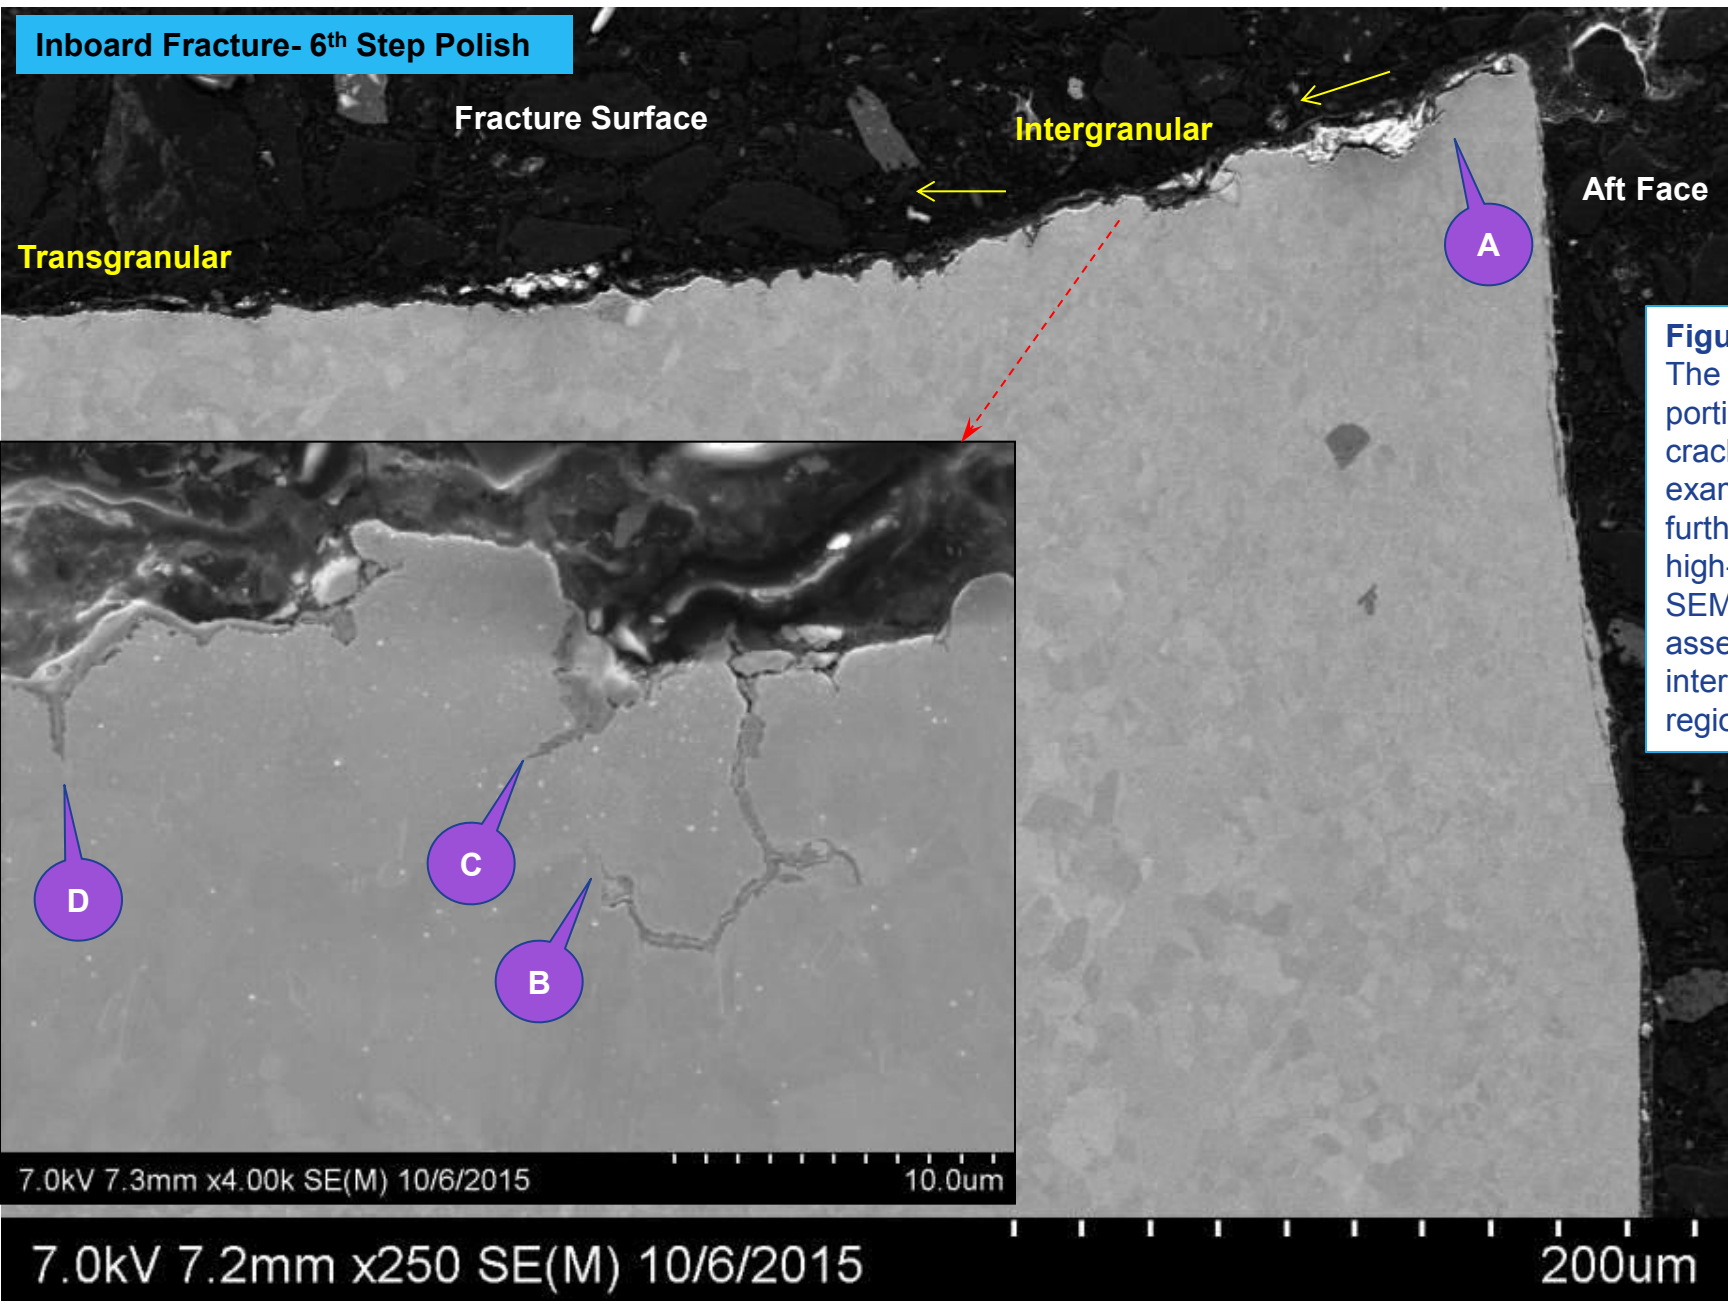
**Figure 78:** The initial portion of the crack was examined further with high-resolution SEM to further assess the intergranular region.
