# NATIONAL TRANSPORTATION SAFETY BOARD

MATERIALS LABORATORY FACTUAL REPORT

Report No. 15-131

Place : Las Vegas, Nevada  
Date : September 8, 2015  
Vehicle : Boeing 777-200, G-VIIO  
NTSB No. : DCA15FA185  
Investigator : Lorenda Ward, AS-10

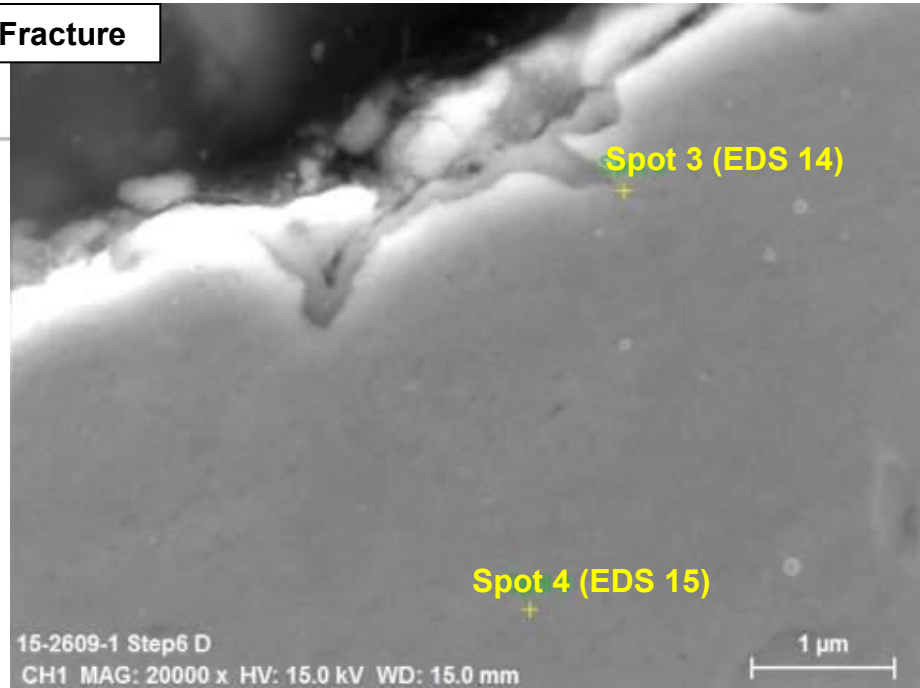
**Figure 80:** Superimposed EDS spectra of the baseline (spot 4- EDS 15) and region ahead of the crack-tip (spot 3- EDS 14), showed that the latter was depleted in Fe and Cr, and richer in Ni.

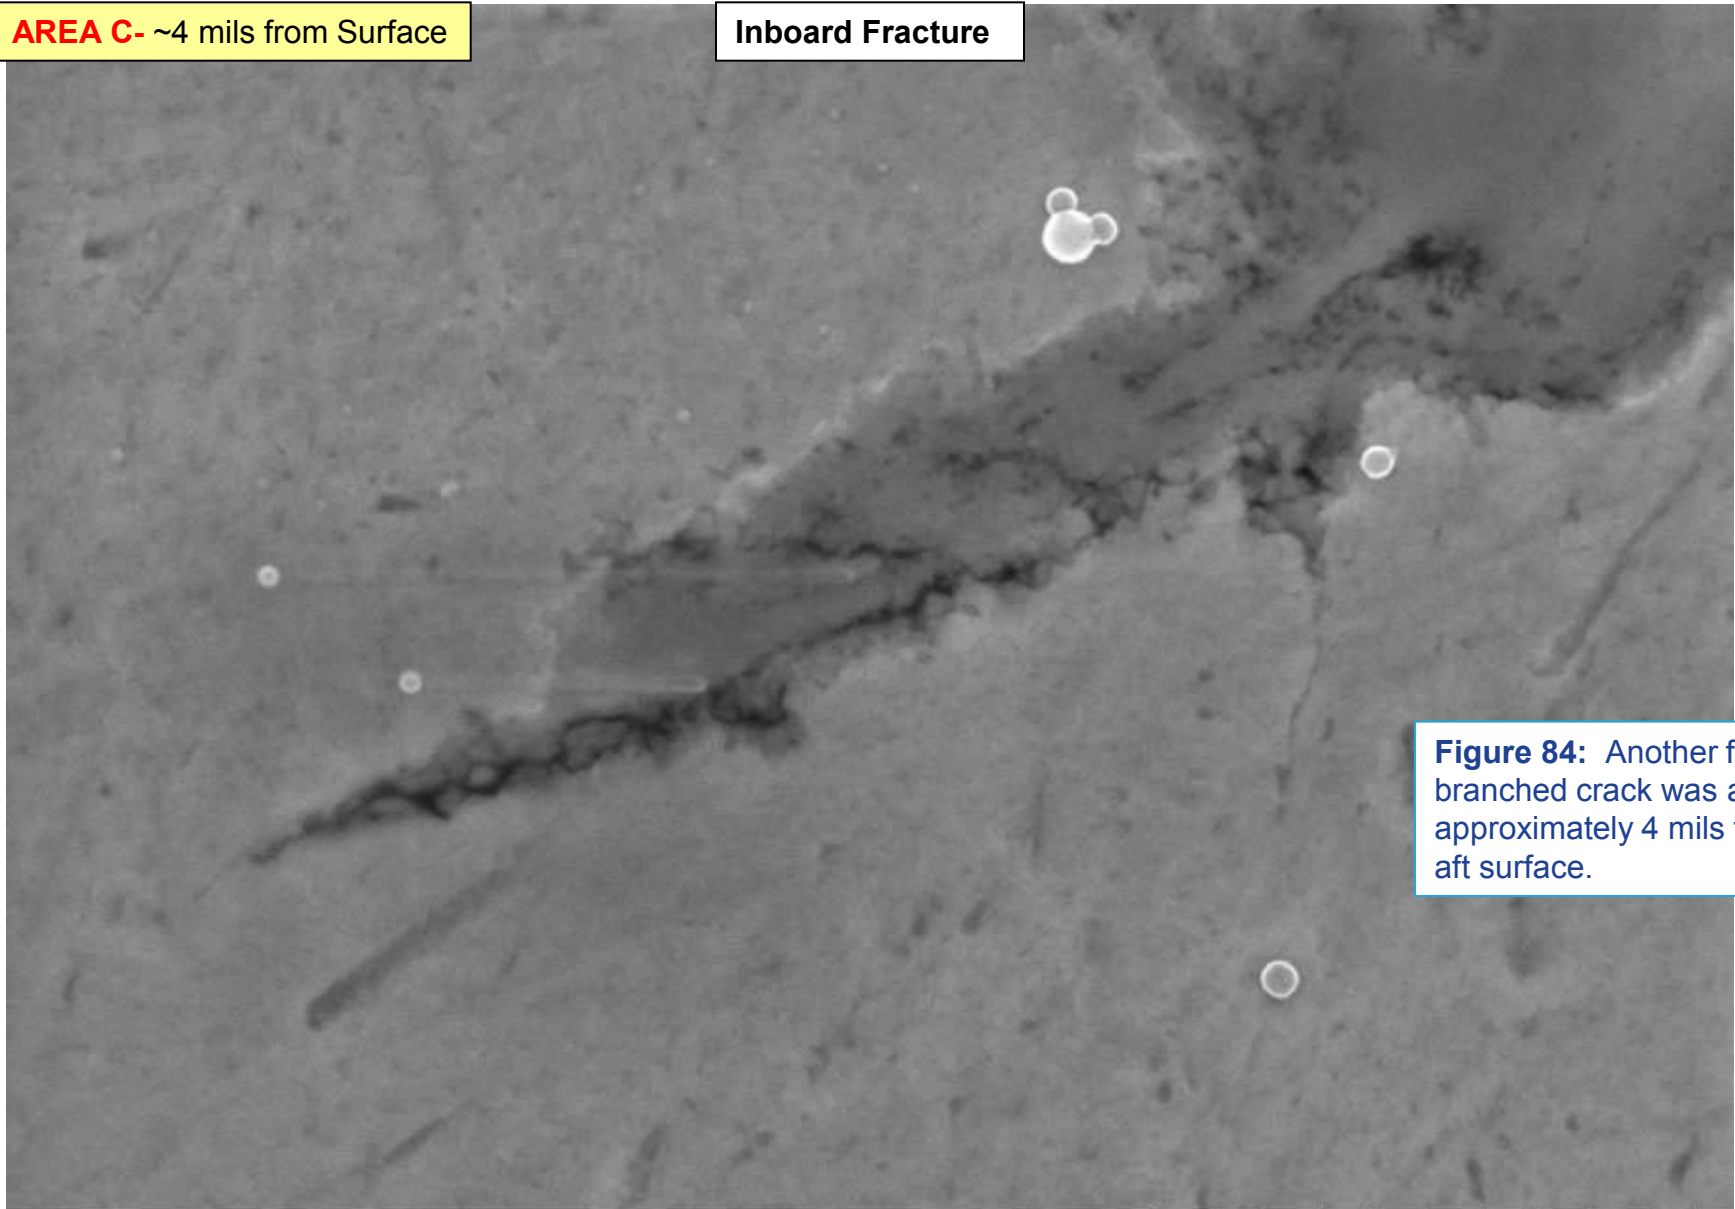
AREA C- ~4 mils from Surface

**Figure 84:** Another fracture branched crack was analyzed approximately 4 mils from the aft surface.

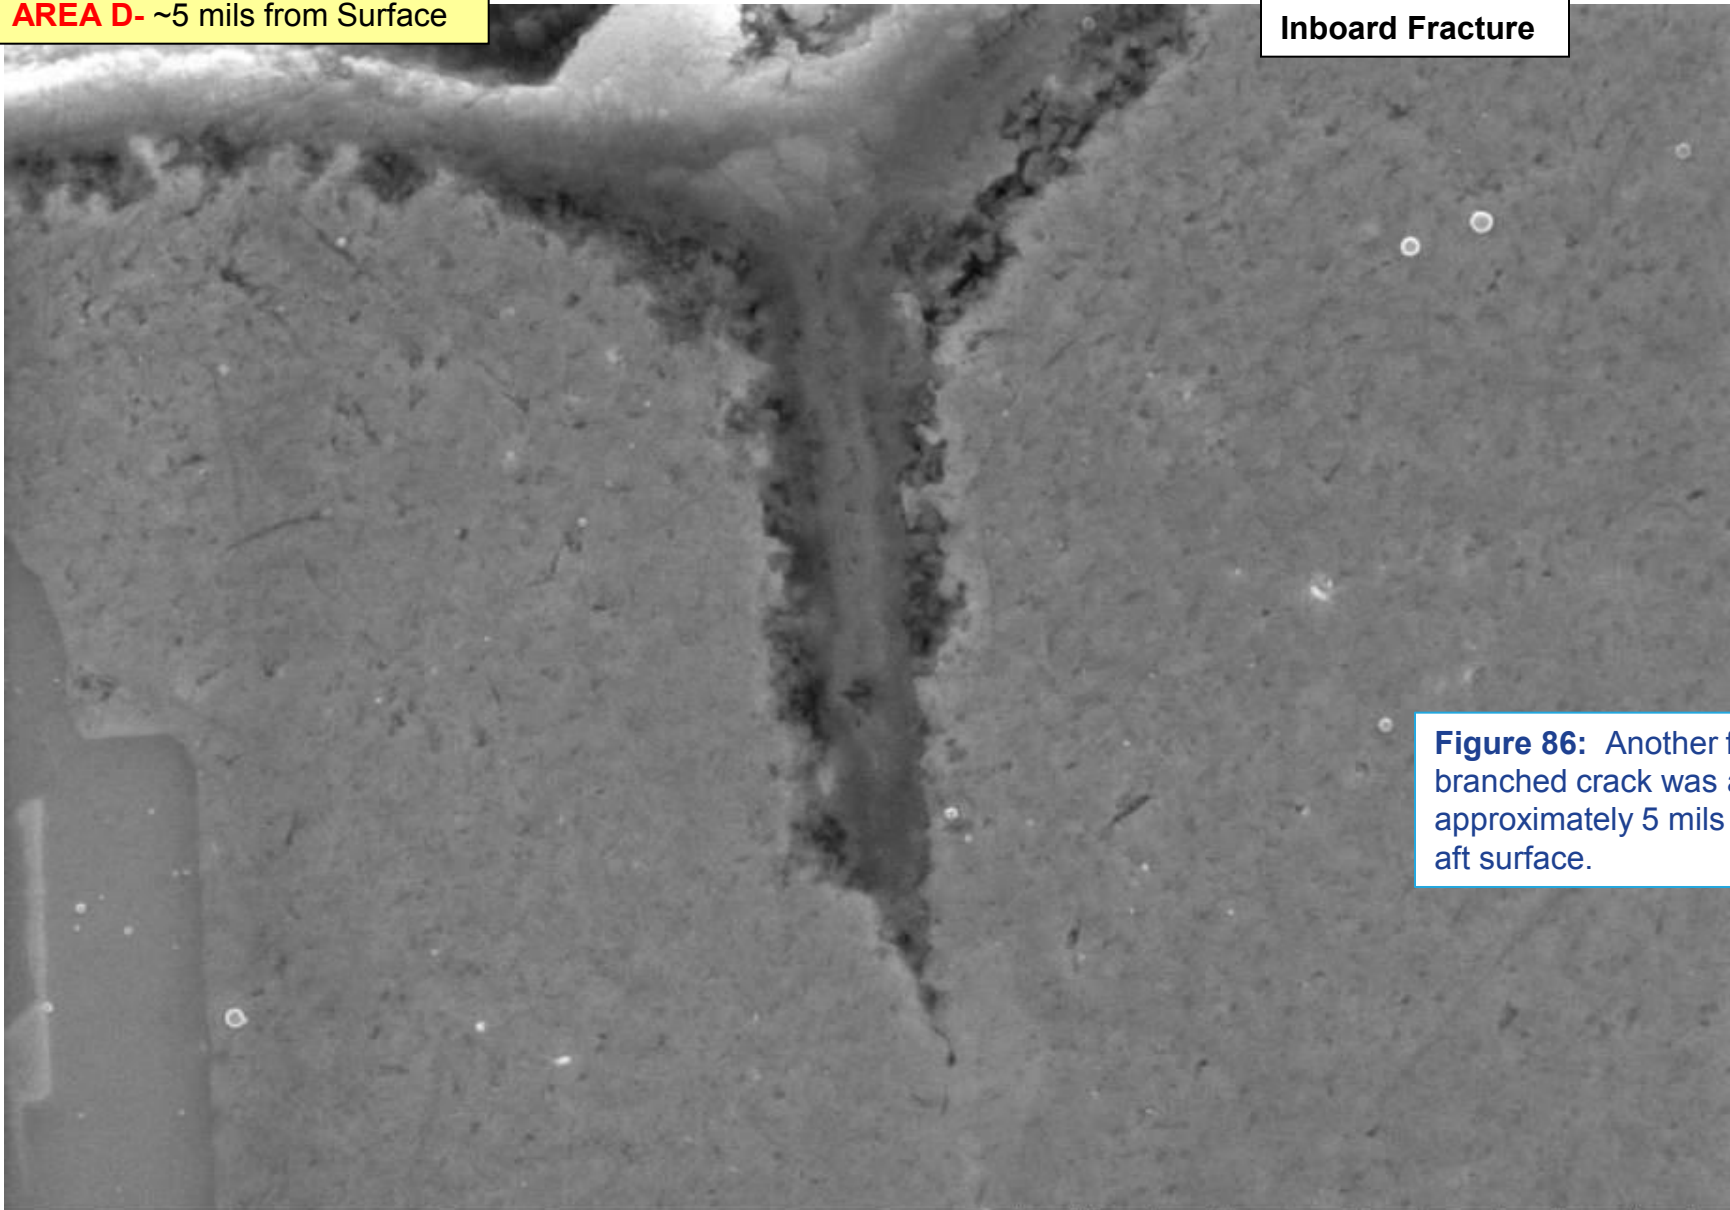
AREA D- ~5 mils from Surface

**Figure 86:** Another fracture branched crack was analyzed approximately 5 mils from the aft surface.

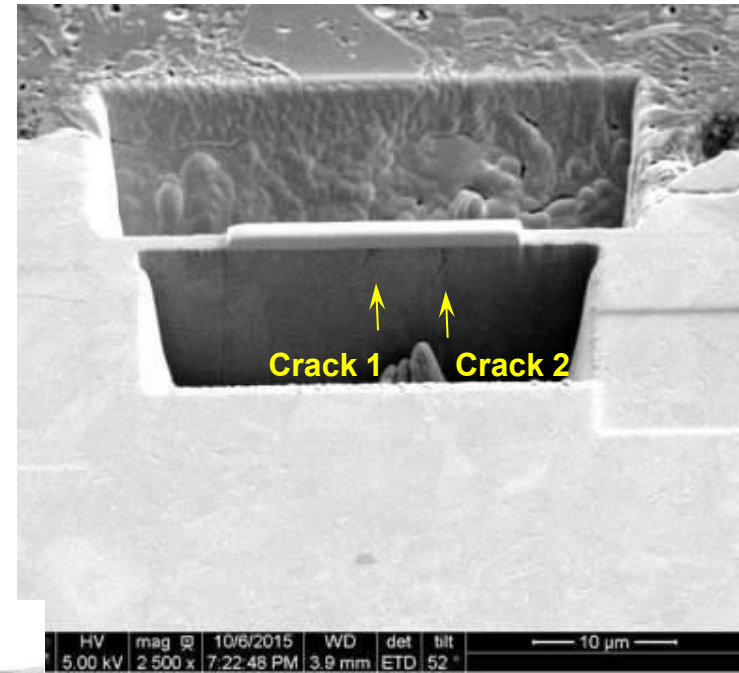
**Figure 88:** Views of the FIB section removed for TEM analysis that included 2 cracks from the intergranular fracture.

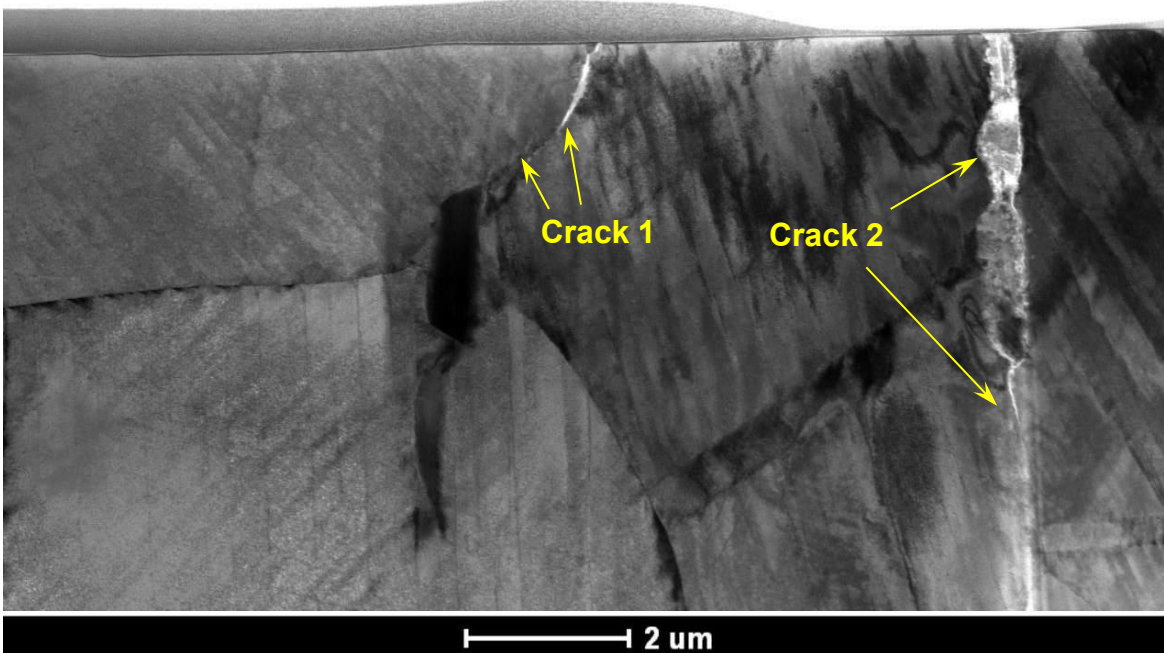
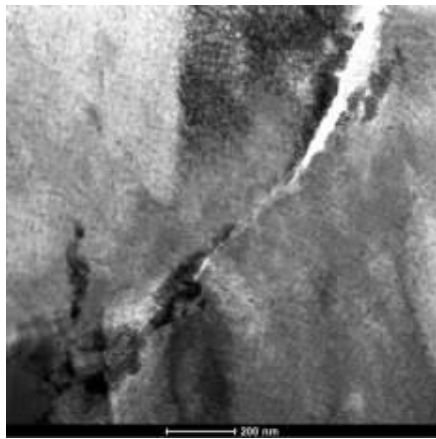
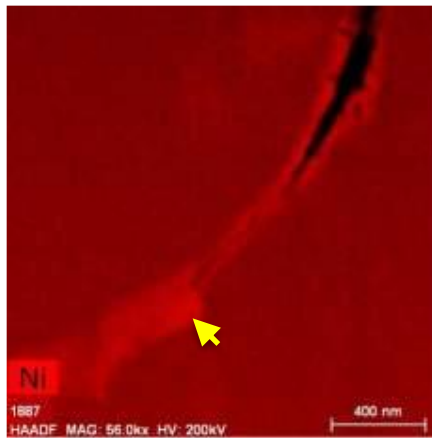
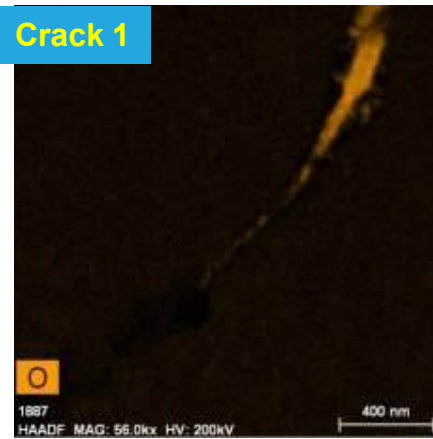
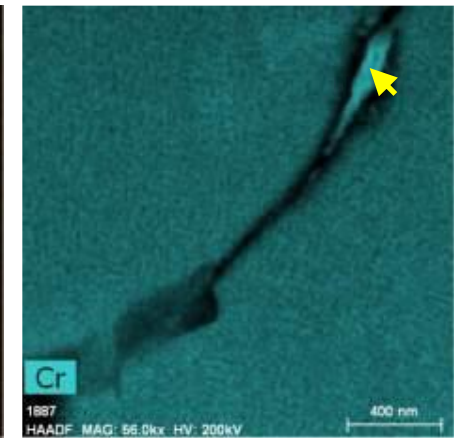
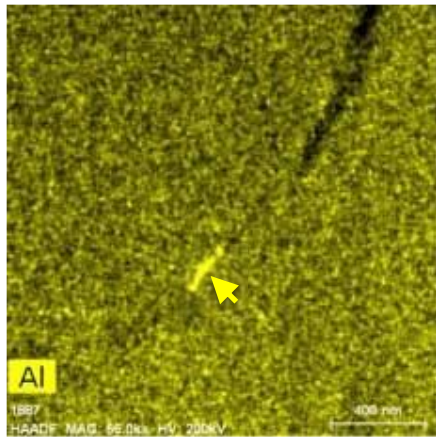
### Crack 1

1. Oxidation ahead of crack tip: preferential formation of Al and Ti oxides ahead of Fe-Cr rich spinel oxide structure (with lowering of pO<sub>2</sub>, oxidation preference changes from Ni/Fe → Cr → Ti → Al).
2. Consistent with hold time fatigue crack growth under low oxygen partial pressure.
3. Formation of  $\gamma$  phase ahead/adjacent to crack tip.

**Figure 89:** TEM analysis of Crack 1 in the intergranular fracture region.

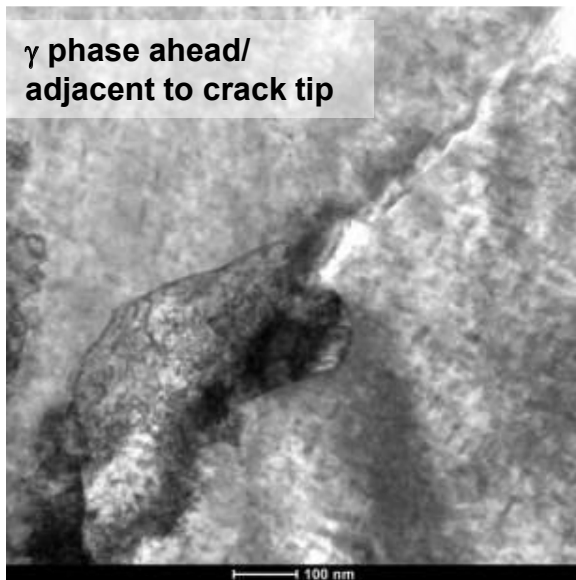
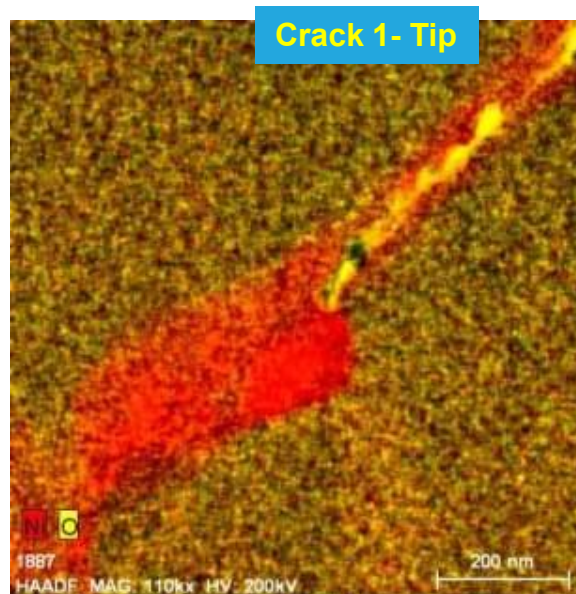
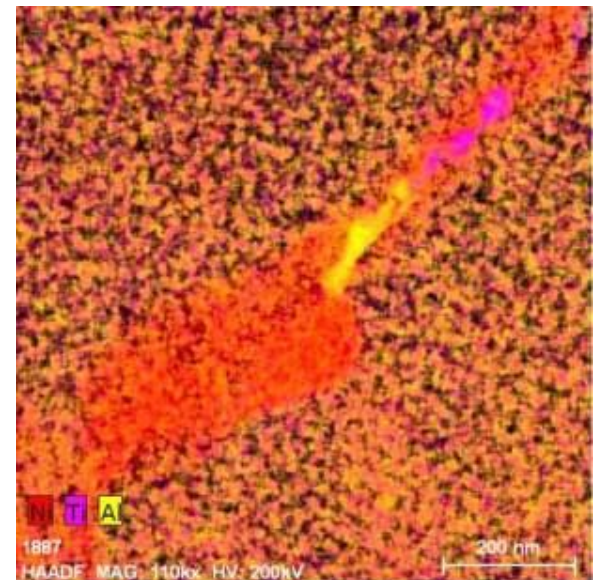
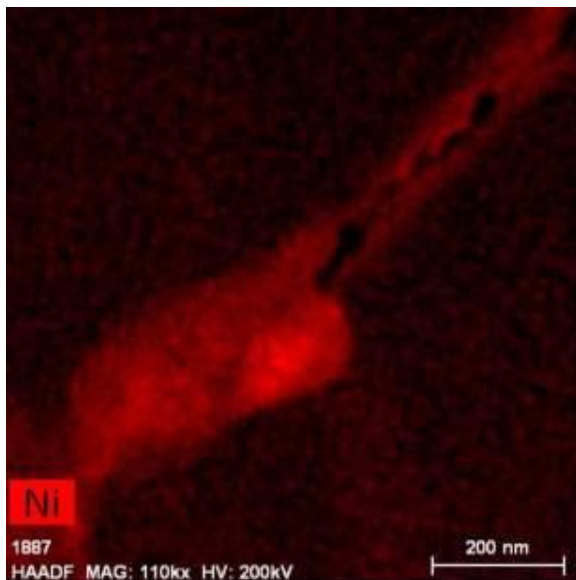
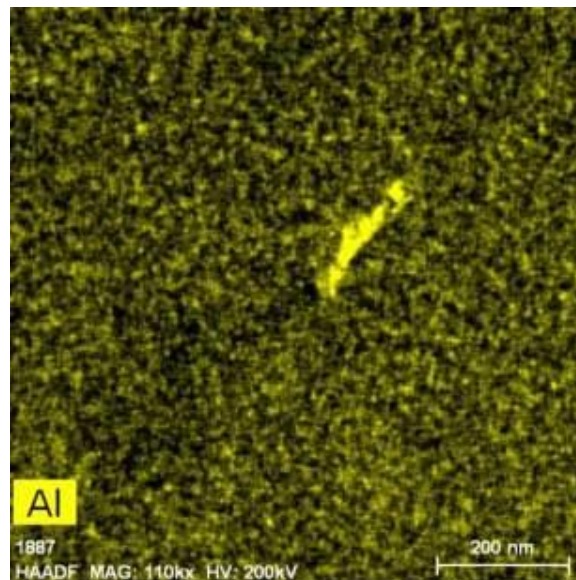
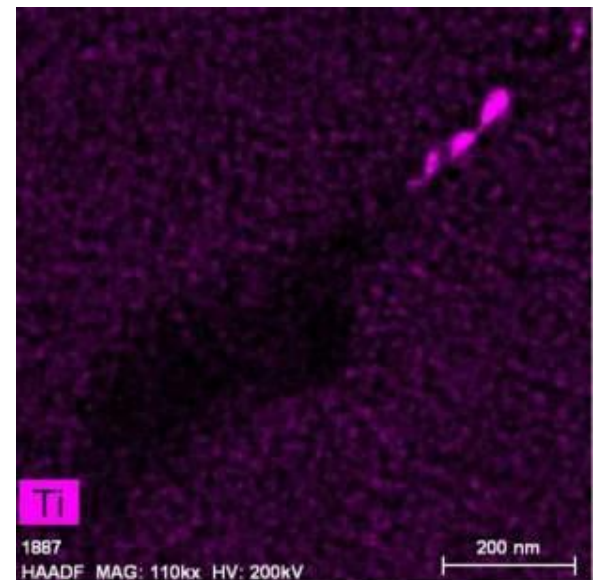
**Figure 90:** More detailed examination of the tip of crack 1 showing the  $\gamma$  phase ahead/adjacent to crack tip and initial oxides formed.

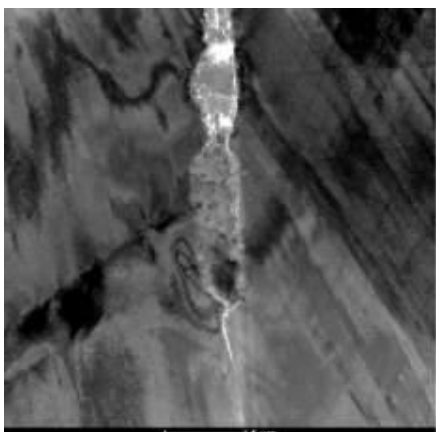
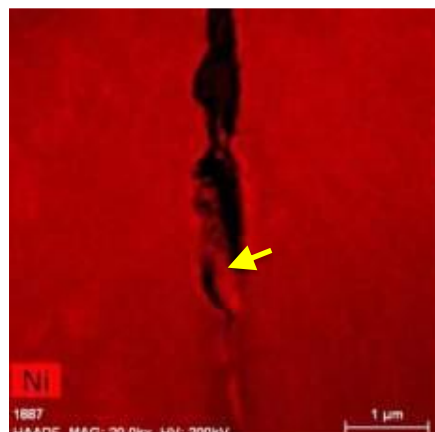
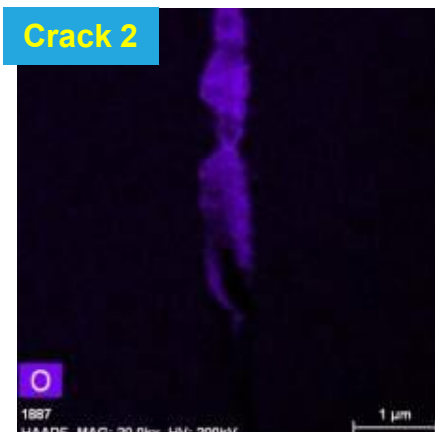
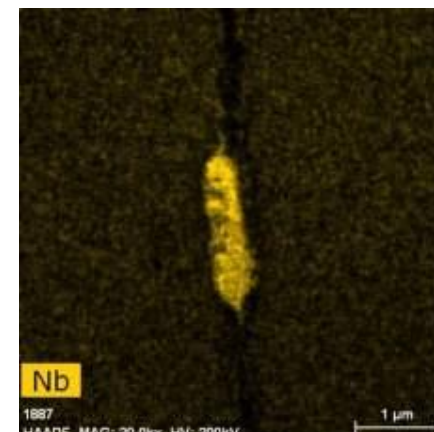
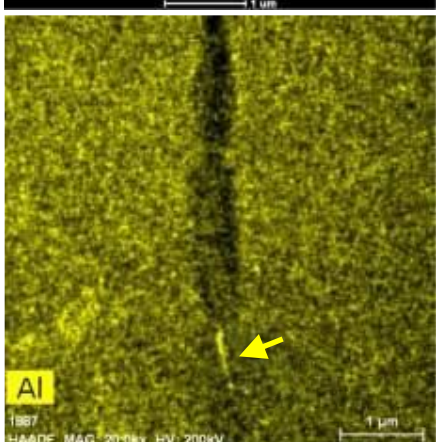
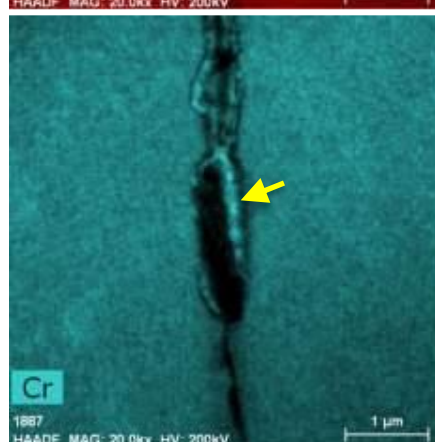
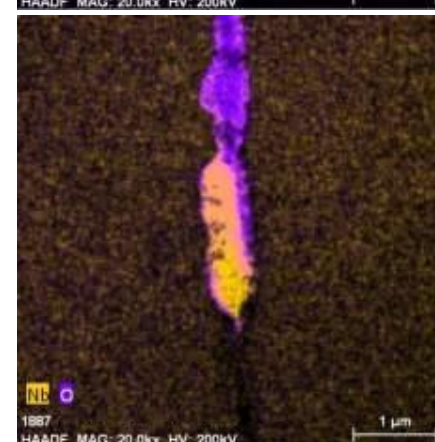
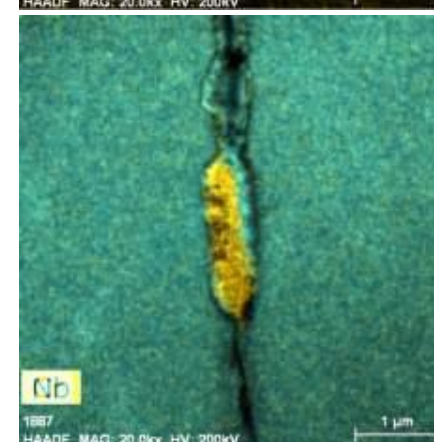
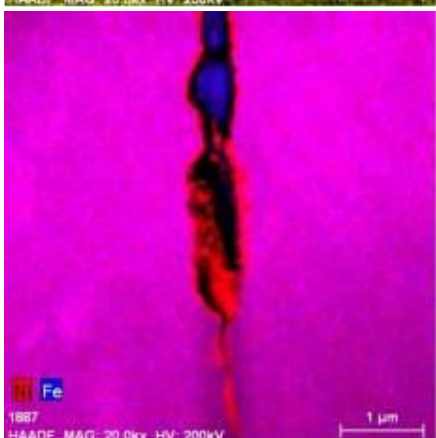
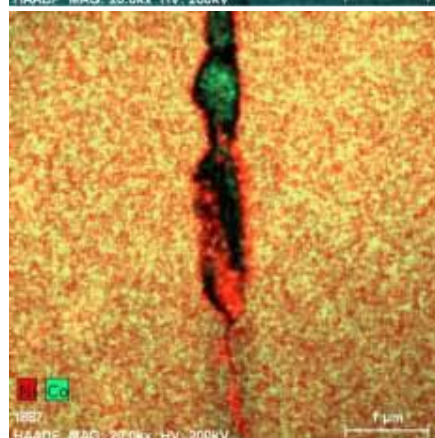
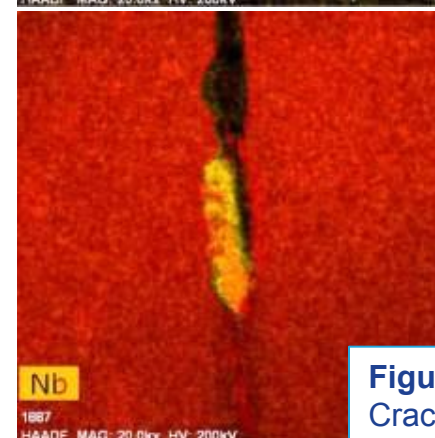
- Layered spinel oxide structure in the wake of mature crack followed by Al-rich oxide ahead of the tip.
- Consistent with hold time fatigue crack growth under low oxygen partial pressure.
- Partially oxidized  $\delta$ .

**Figure 91:** TEM analysis of the mature Crack 2 in the intergranular fracture region.

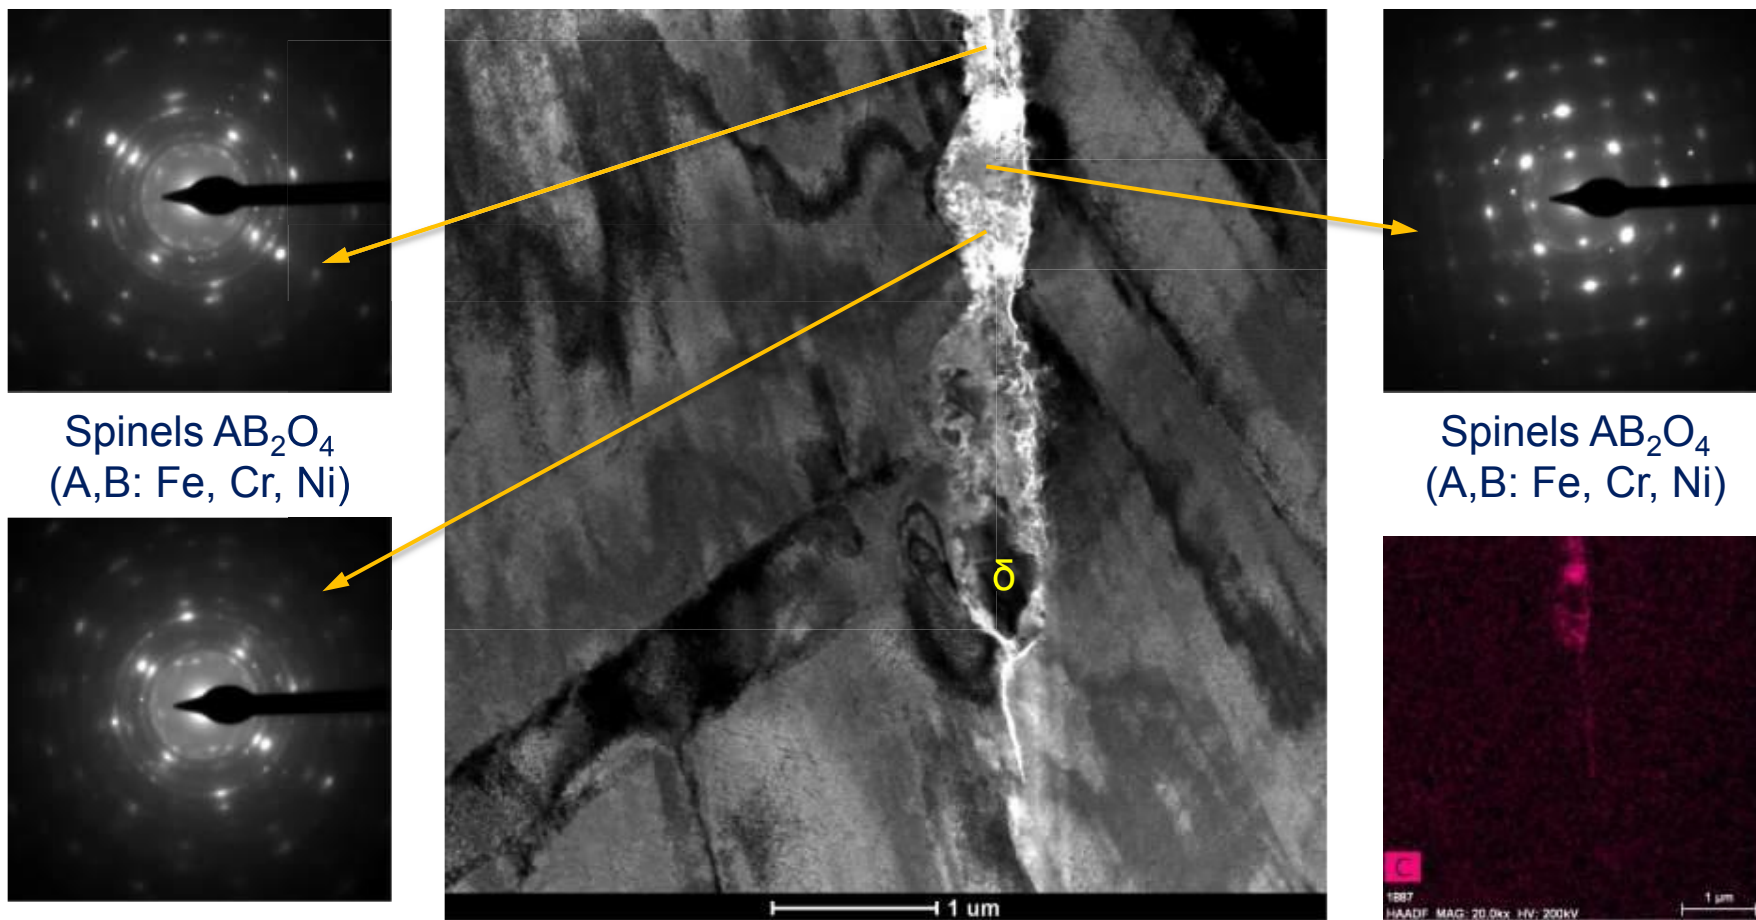
Figure 92: TEM analysis of the mature Crack 2 in the intergranular fracture region.

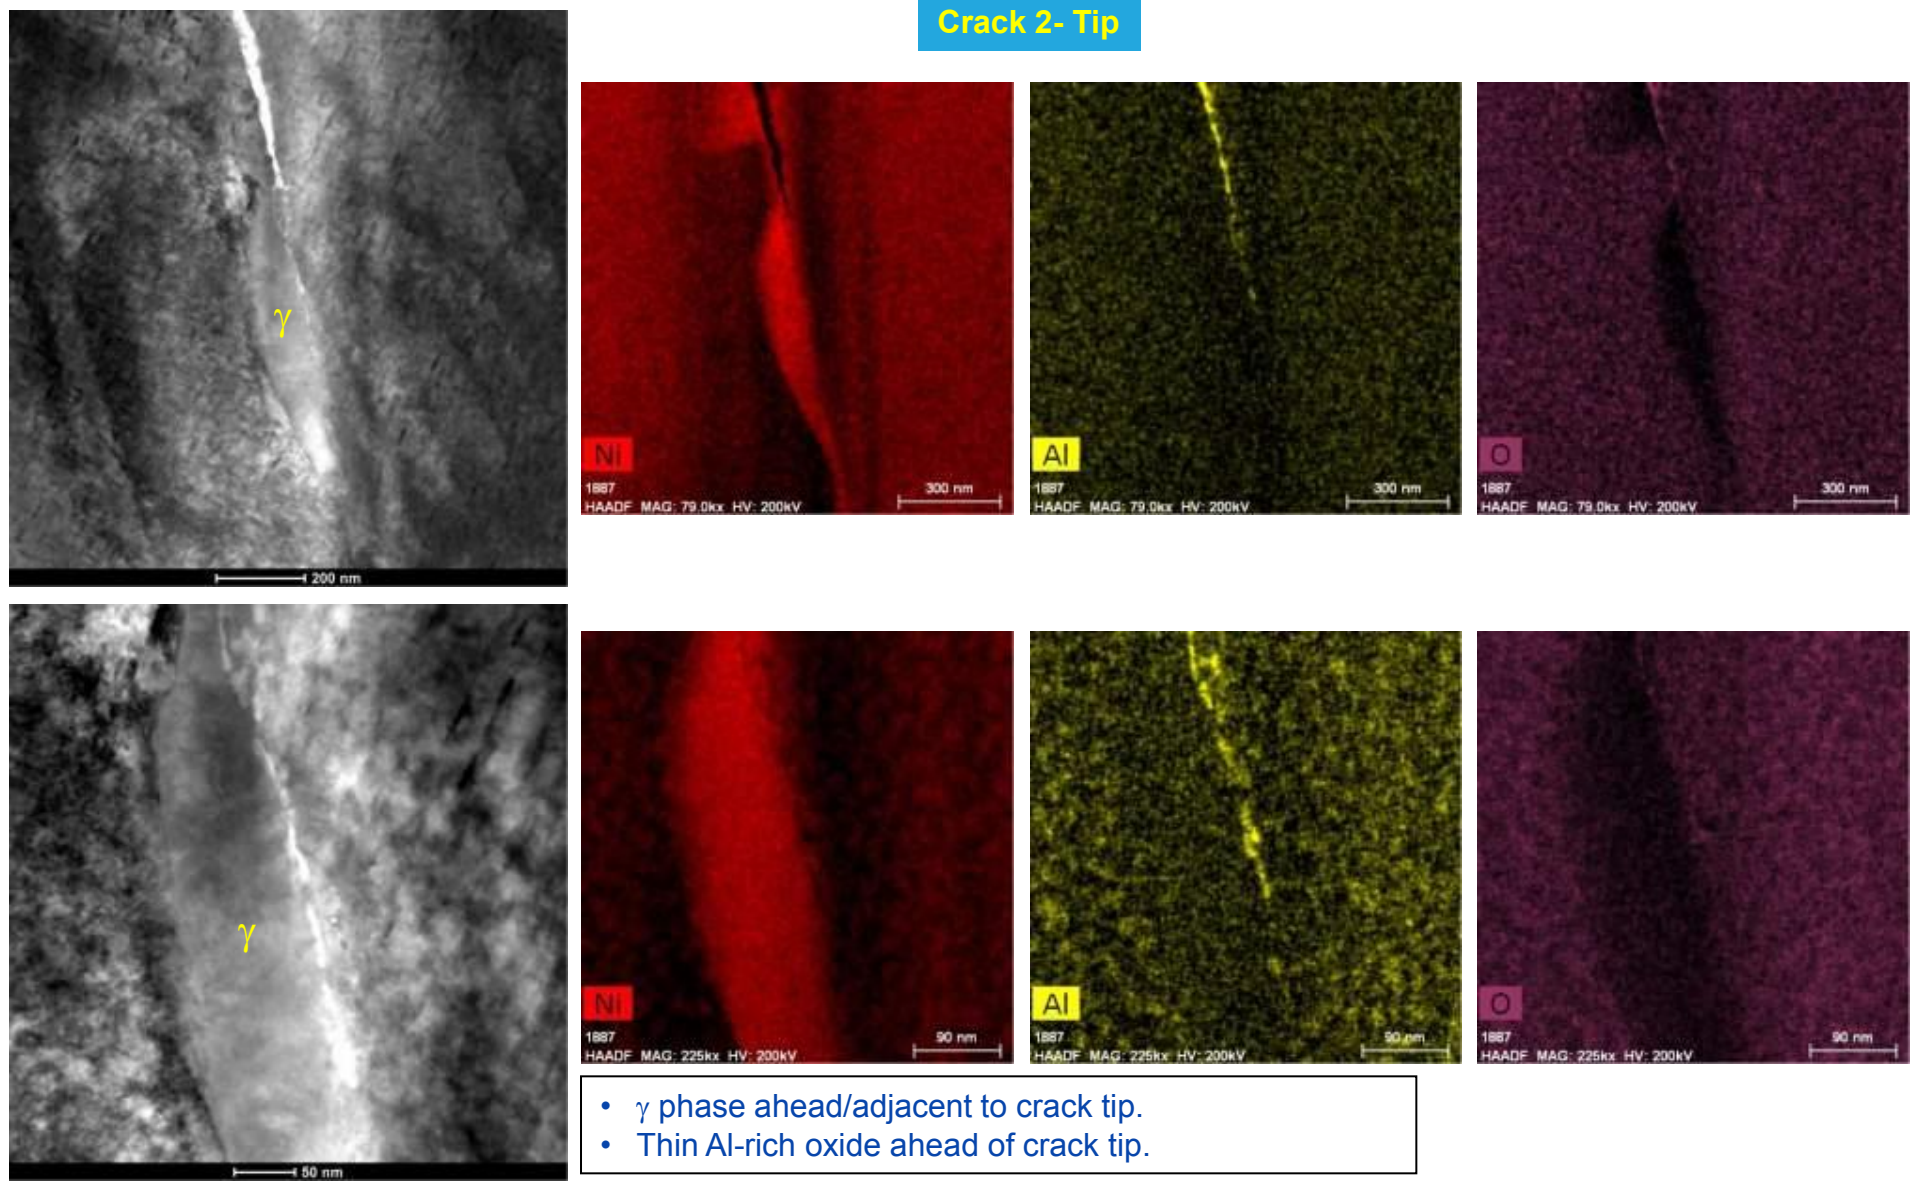
### Crack 2- Tip

- $\gamma$  phase ahead/adjacent to crack tip.
- Thin Al-rich oxide ahead of crack tip.

**Figure 93:** TEM analysis of the tip of Crack 2 in the intergranular fracture region.

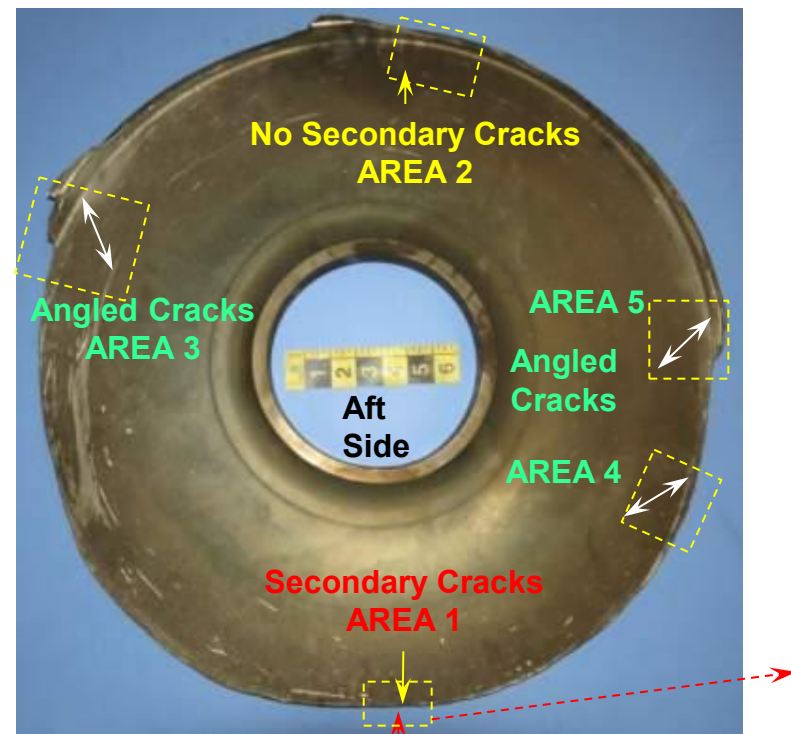
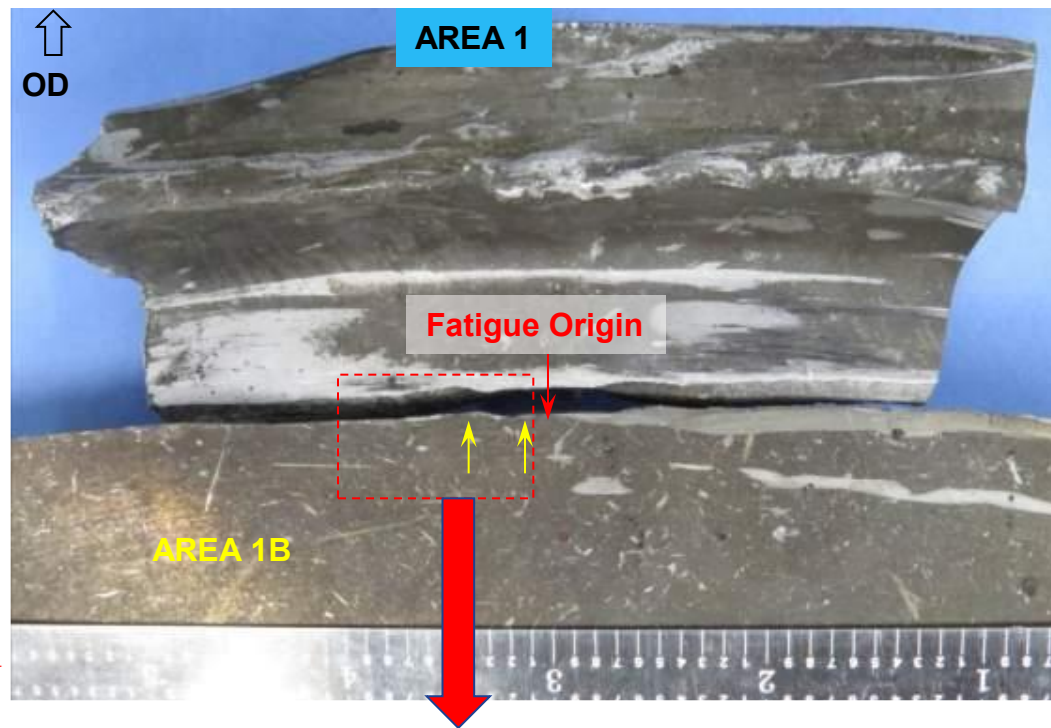
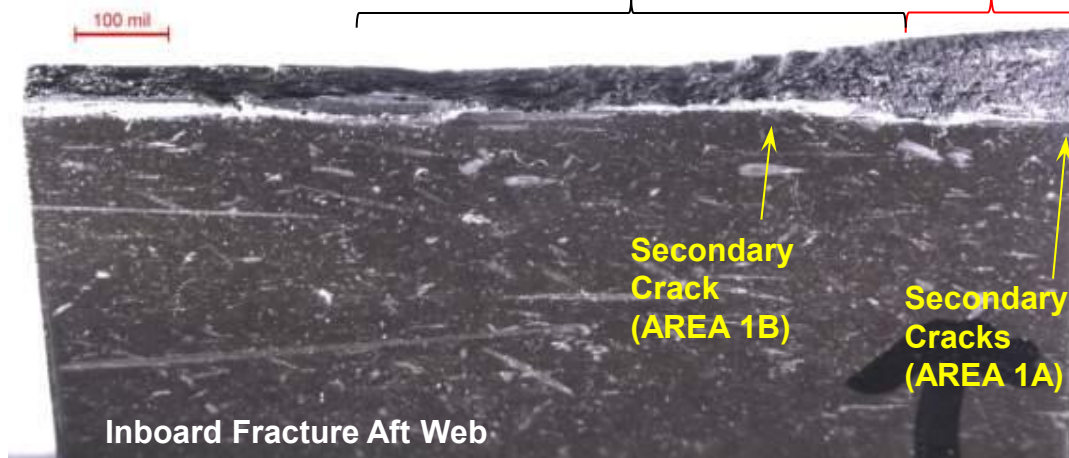
- SEM examination showed that on the aft web face **within 16 mils** of the fatigue fracture were **secondary cracks** at the base of etched/oxidized carbides (Figures 94-96 and 98). These circumferential cracks were up to approximately **3 mils** long and were up to **0.5 mil deep** (based on the metallographic mounts). Secondary cracks were not observed further inboard (Figure 97), on the corresponding forward face, except for a single crack at/next to the cyclic tensile fracture (Figure 99), nor on either face on the opposite side of the disk (Figures 100 and 101). Cracks extending on opposing 45 degree planes were found near the rim fracture ends, consistent with event-induced shear cracks (Figures 102-104).

**Figure 94:** Optical views showing where secondary cracks were observed on the aft web adjacent to the fatigue region. A group of secondary cracks was found just inboard of the planar fatigue region (Area 1A) and 1 crack was observed in the cyclic tensile region, but in a similar radial plane (Area 1B).

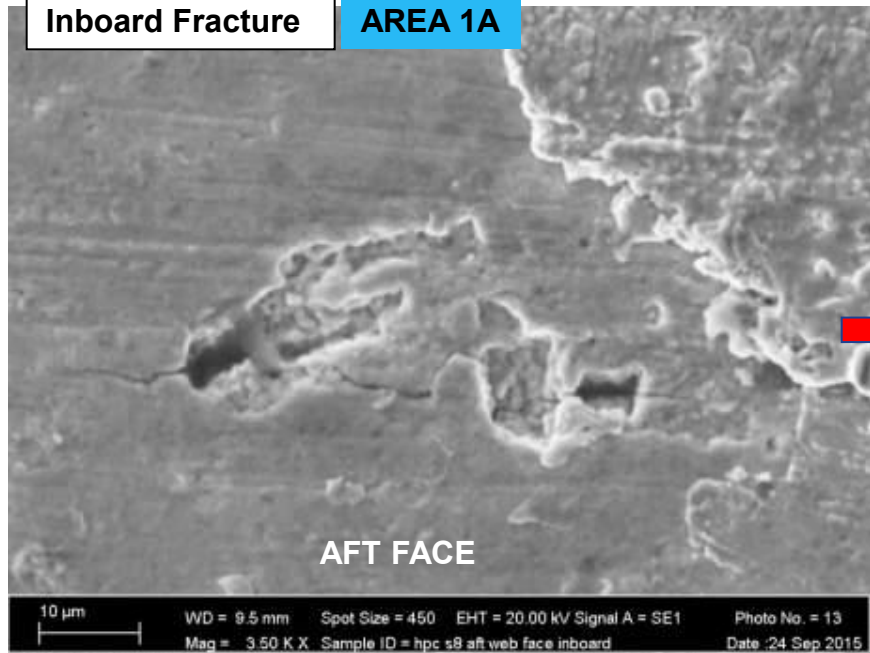
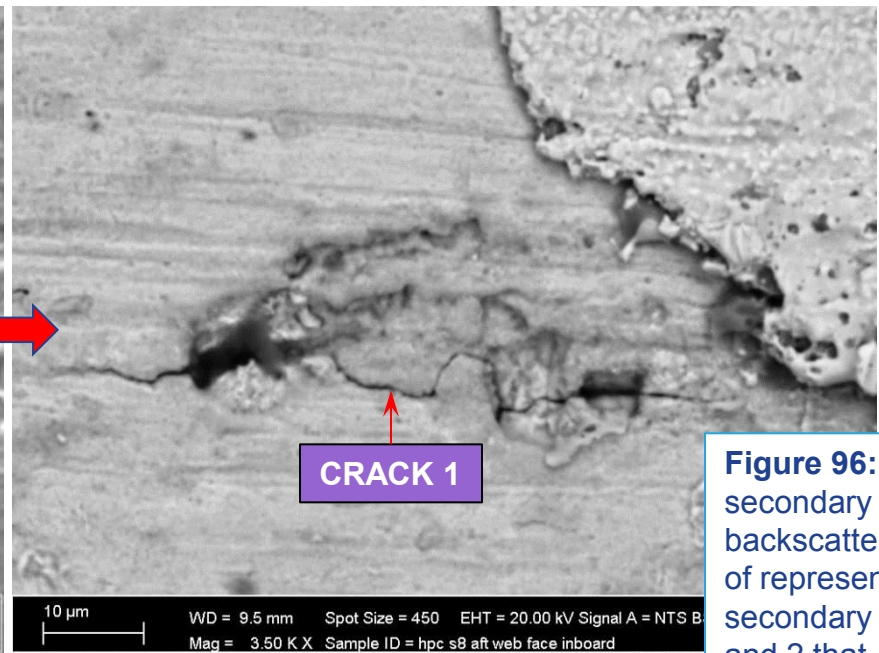
AREA 1A

**Figure 96:** SEM secondary and backscatter images of representative secondary cracks 1 and 2 that extended from the base of oxidized/etched carbides.

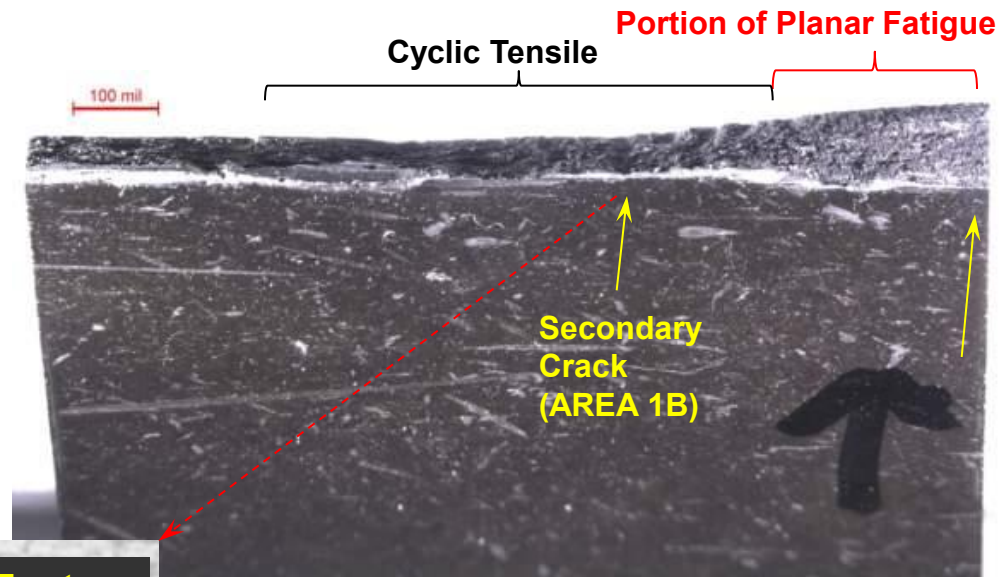
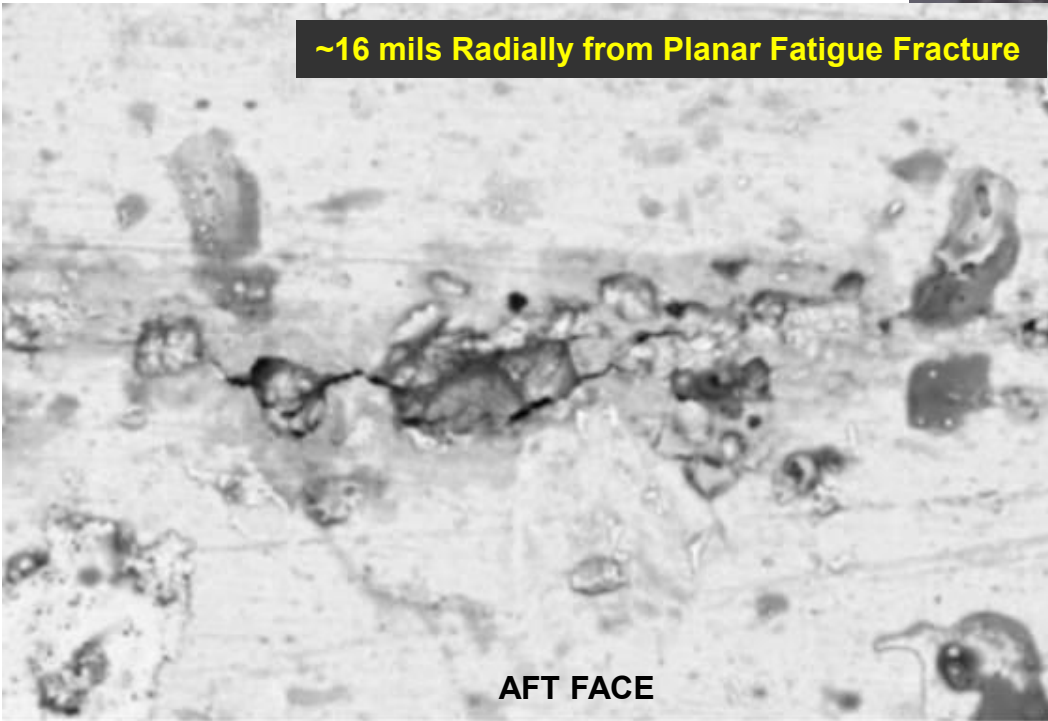
AREA 1B

**Figure 98:** A separate secondary crack was observed in the cyclic tensile region of the web that was approximately 16 mils radially from the planar fatigue region.

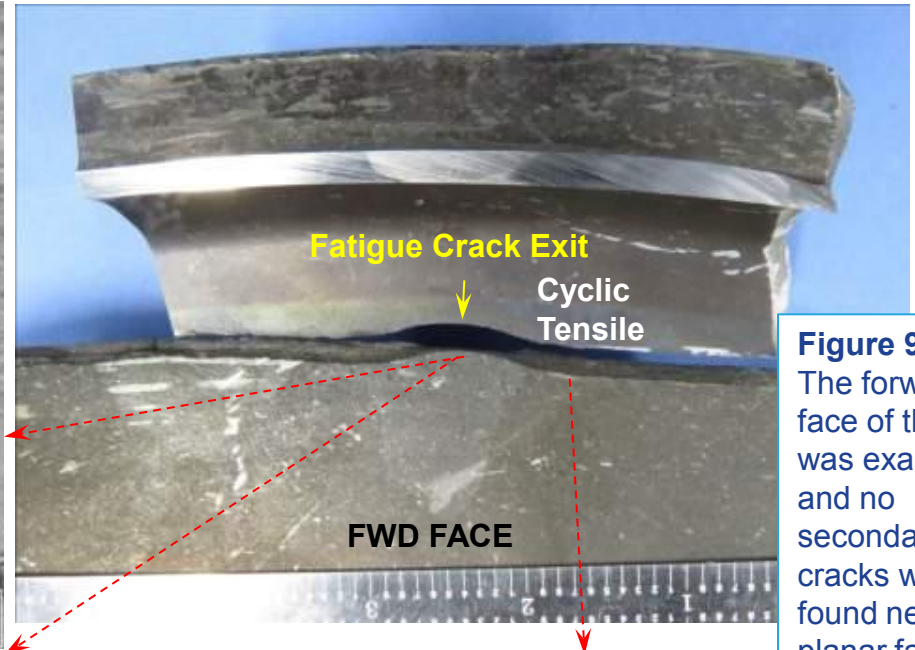
**Figure 99:** The forward face of the web was examined and no secondary cracks were found near the planar fatigue region. Only a single secondary crack was found at/near the cyclic tensile fracture.
