# NATIONAL TRANSPORTATION SAFETY BOARD

MATERIALS LABORATORY FACTUAL REPORT

Report No. 15-131

Place : Las Vegas, Nevada  
Date : September 8, 2015  
Vehicle : Boeing 777-200, G-VIIO  
NTSB No. : DCA15FA185  
Investigator : Lorenda Ward, AS-10

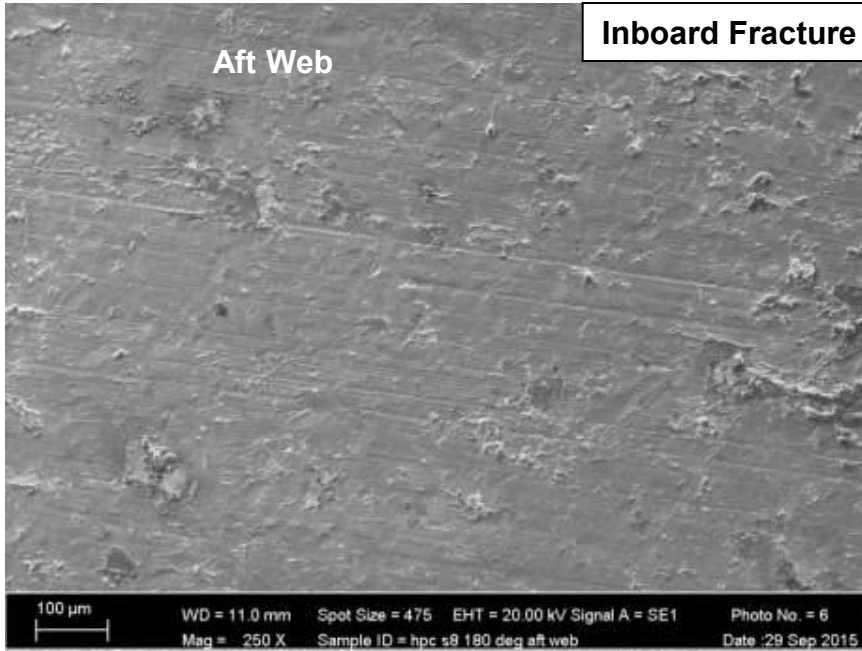
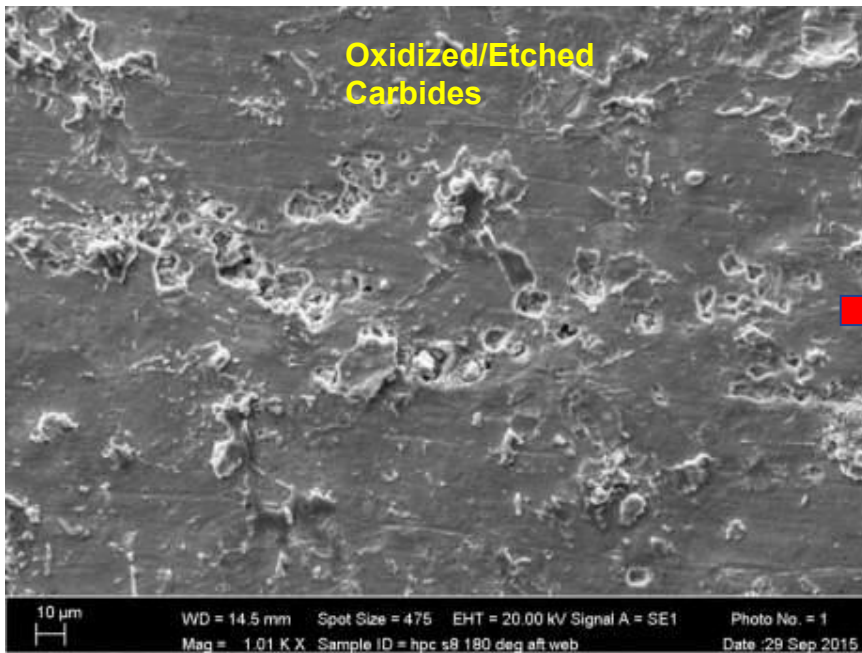
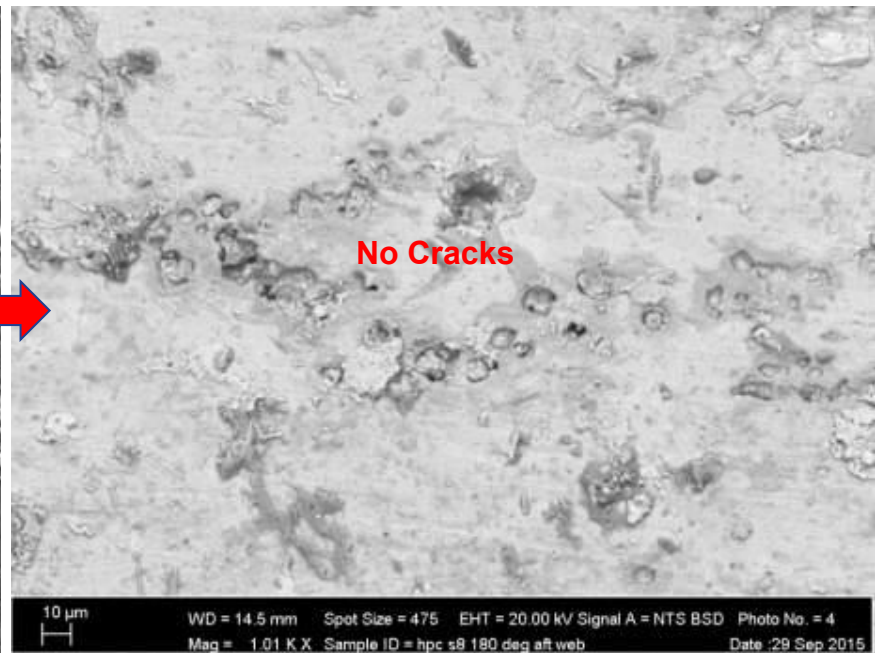
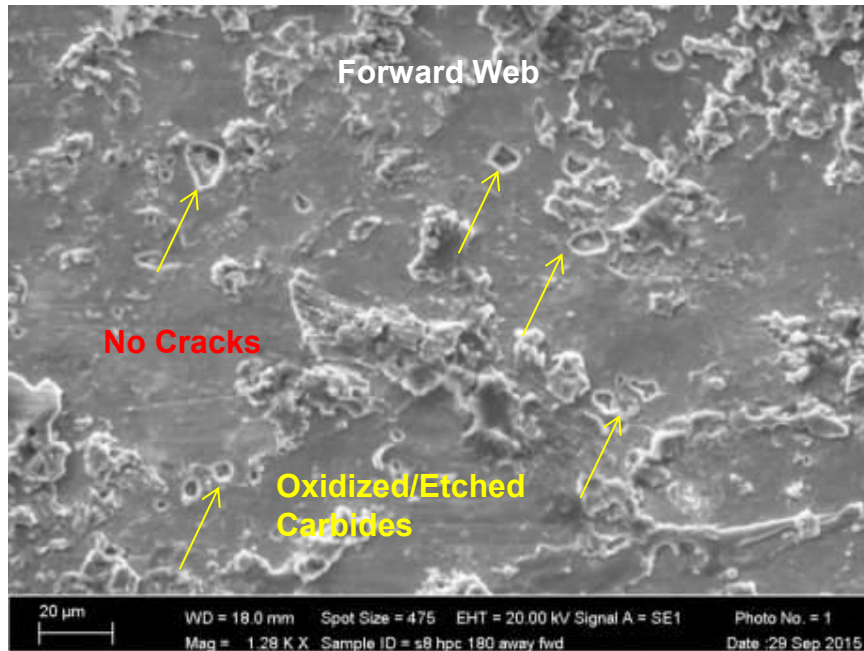
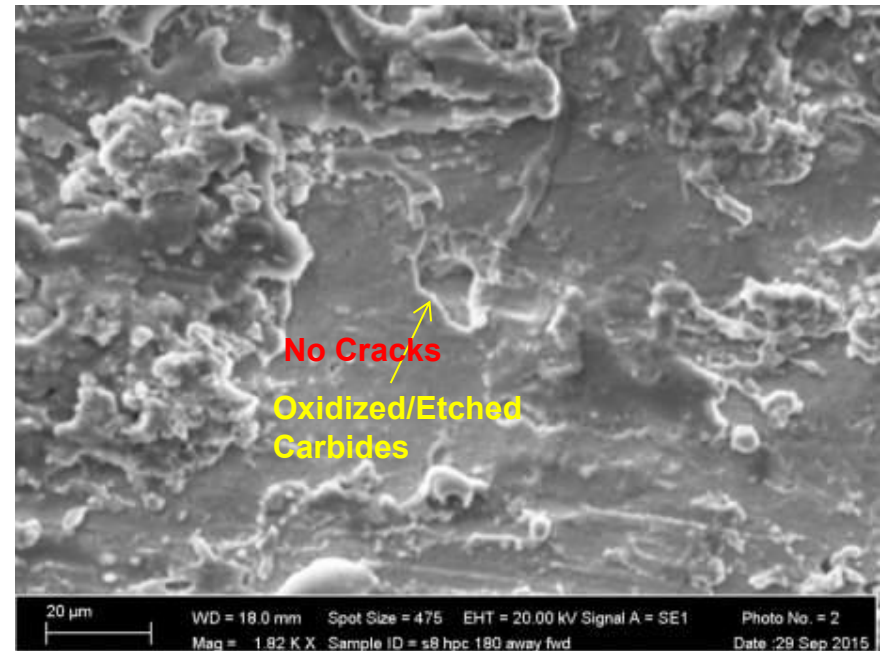
**Figure 101:** SEM examination showed that on the diametrically opposite side of the disk from the fatigue region there were oxidized/etched carbides with no observable cracks on the forward face in the same radial plane as the fracture.

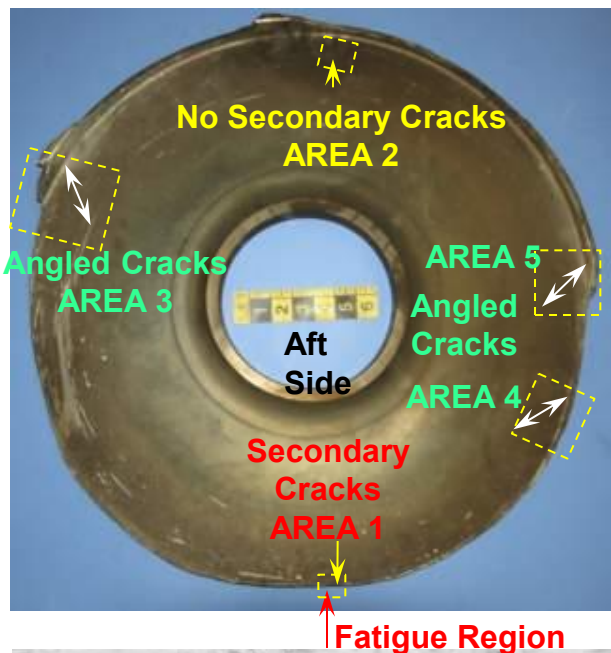
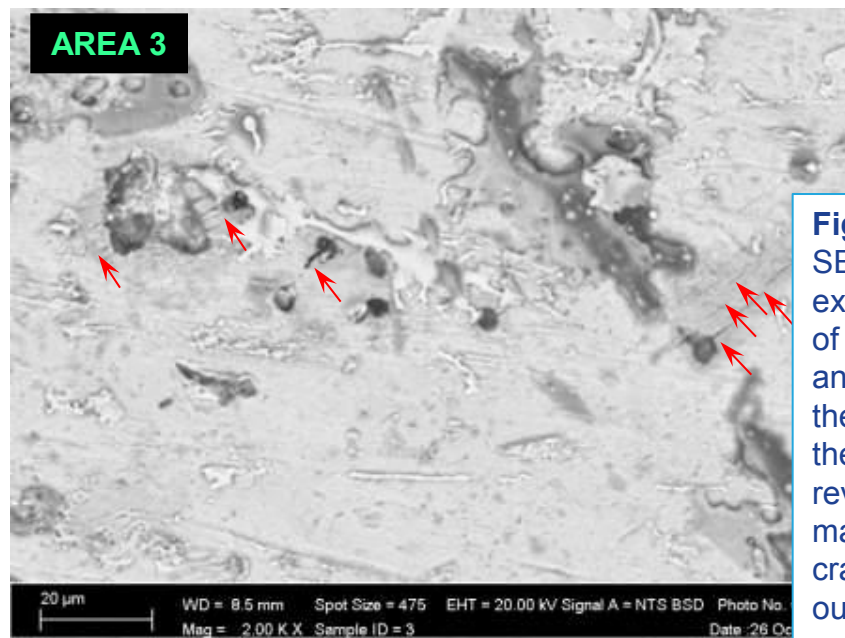
**Figure 102:** SEM examination of areas 3, 4, and 5 near the ends of the rim tear revealed many small cracks in and outside of surface carbides that extended at 45 degree angles (in opposing directions), consistent with event-related shear cracking.

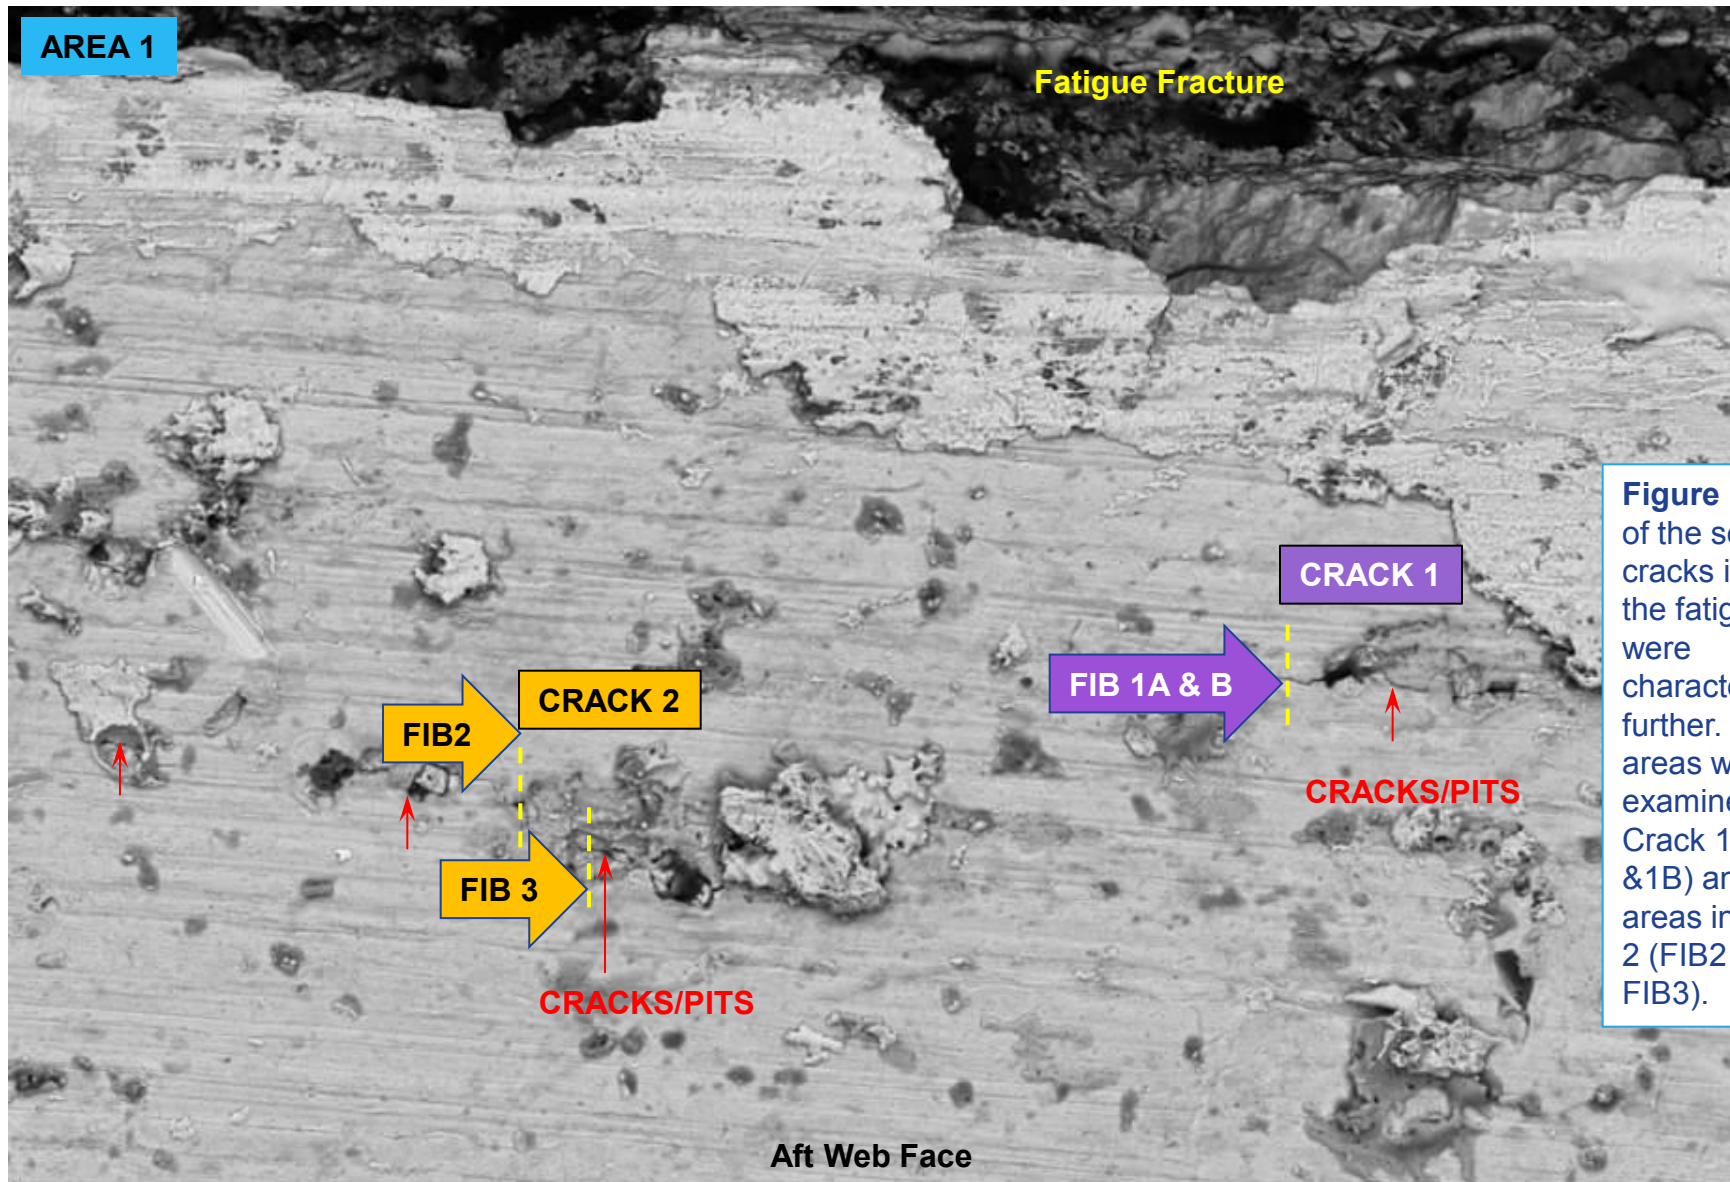
AREA 1

**Figure 105:** Two of the secondary cracks inboard of the fatigue region were characterized further. Two FIB areas were examined into Crack 1 (FIB 1A & 1B) and two areas into Crack 2 (FIB2 and FIB3).

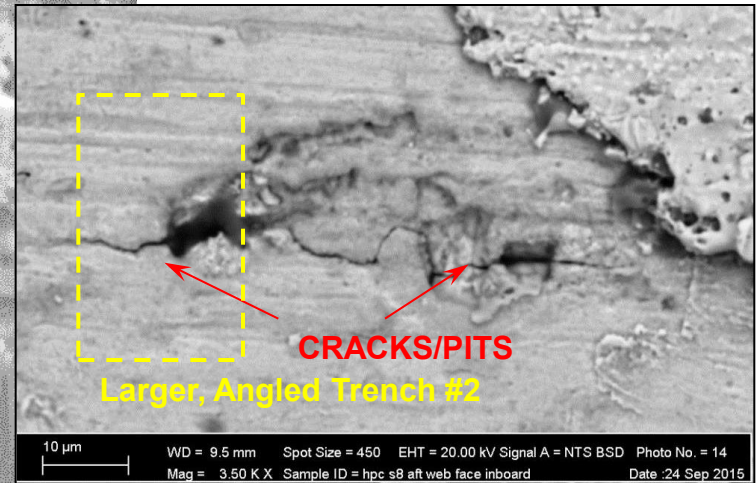
FIB1B (Larger Angled Trench)

**Figure 108:** A second trench was generated into secondary Crack 1 that showed cracking below the surface carbide with branched features.

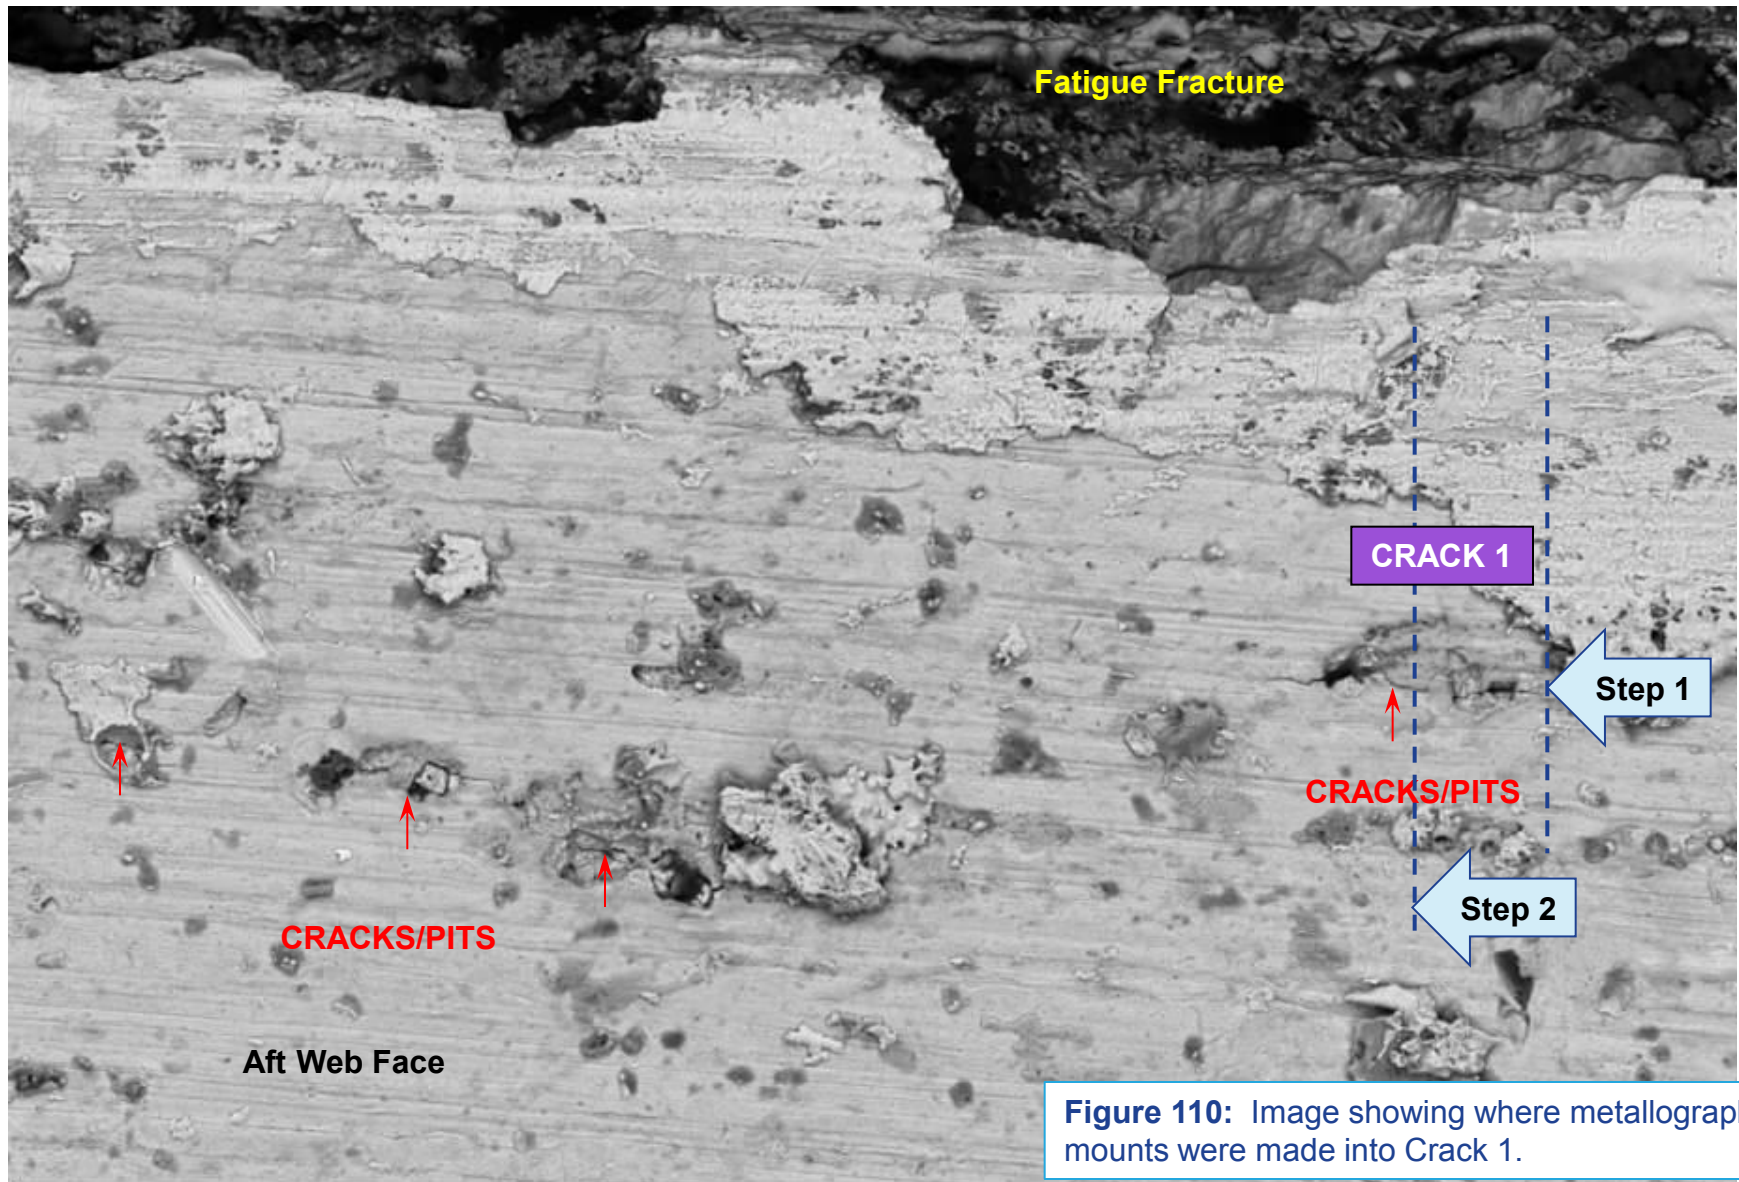
**Figure 110:** Image showing where metallographic mounts were made into Crack 1.

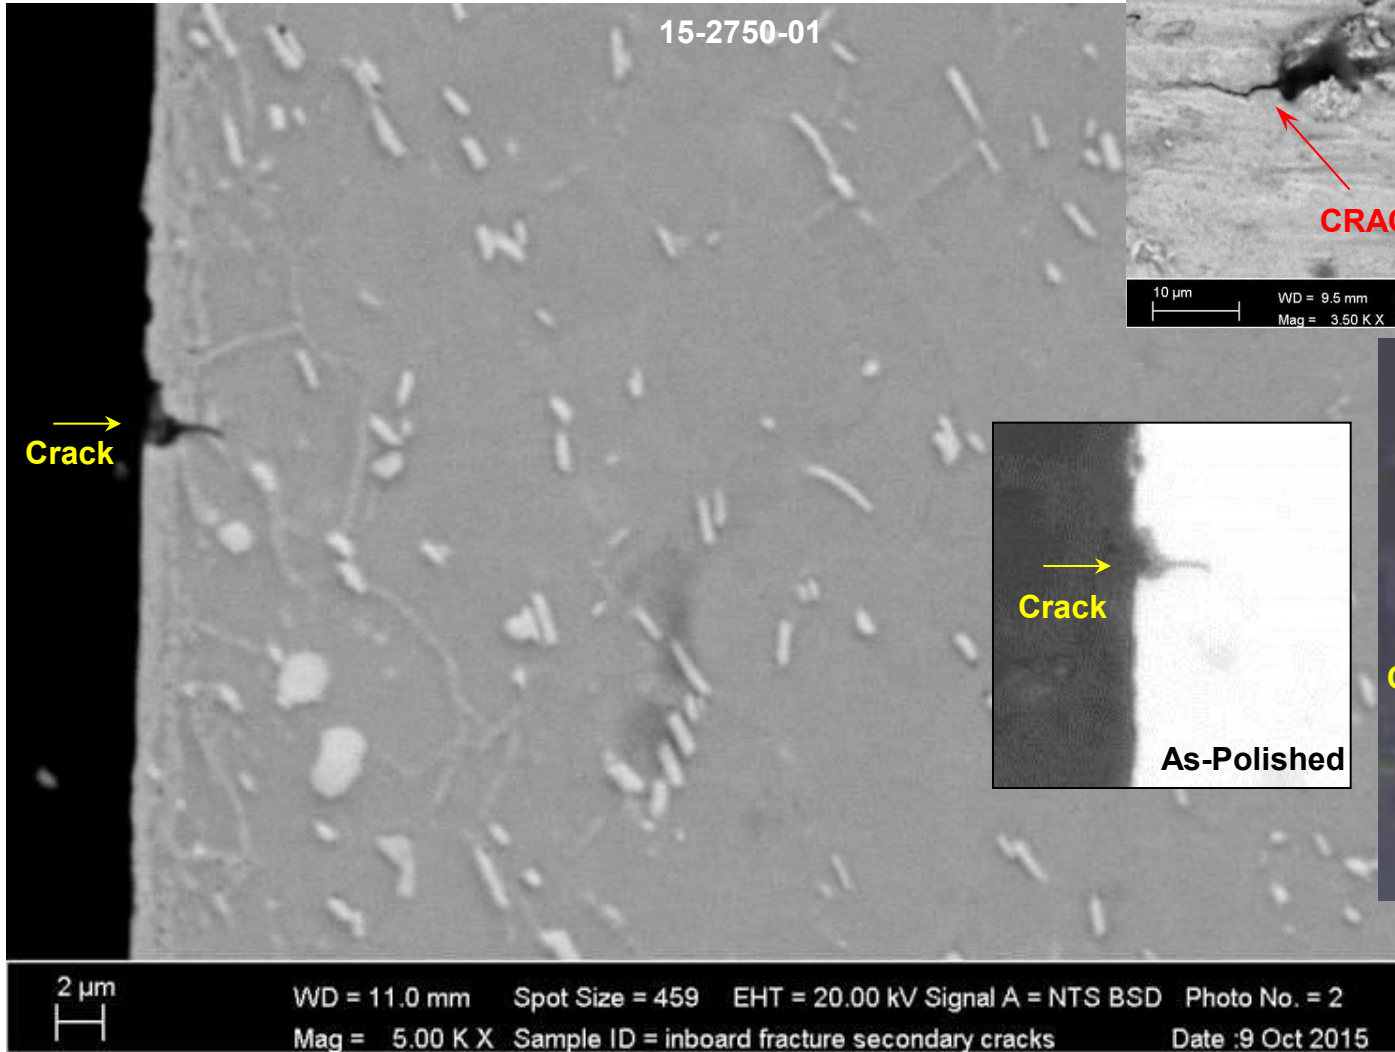
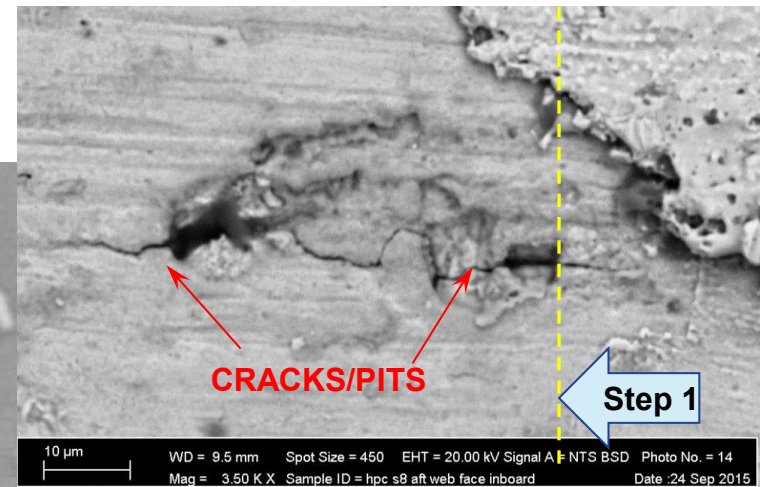
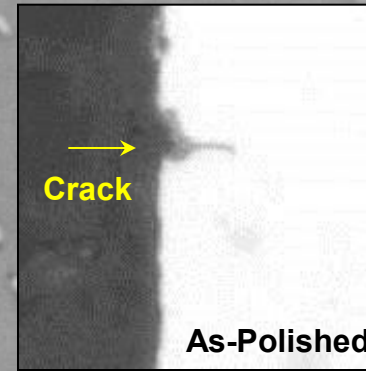
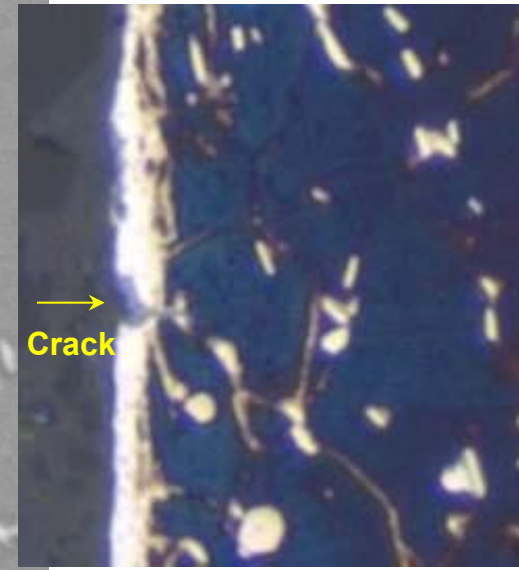
CRACK 1- Mount (Step 1)

**Figure 111:** As-polished and etched views of the mount through Crack 1 that showed cracking normal to the surface that in the plane of polish was less than 0.1 mil deep and had more transgranular features. No microstructural anomalies/damage was noted.

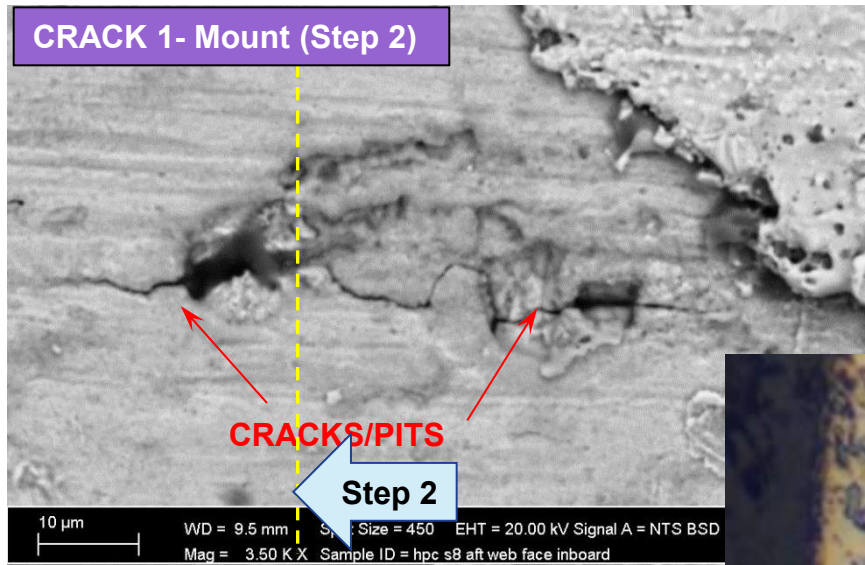
**CRACK 1- Mount (Step 2)**

**Figure 112:** View of the 2<sup>nd</sup> step polish into Crack 1 that was still shallow and the local microstructure showed no damage/anomalies.

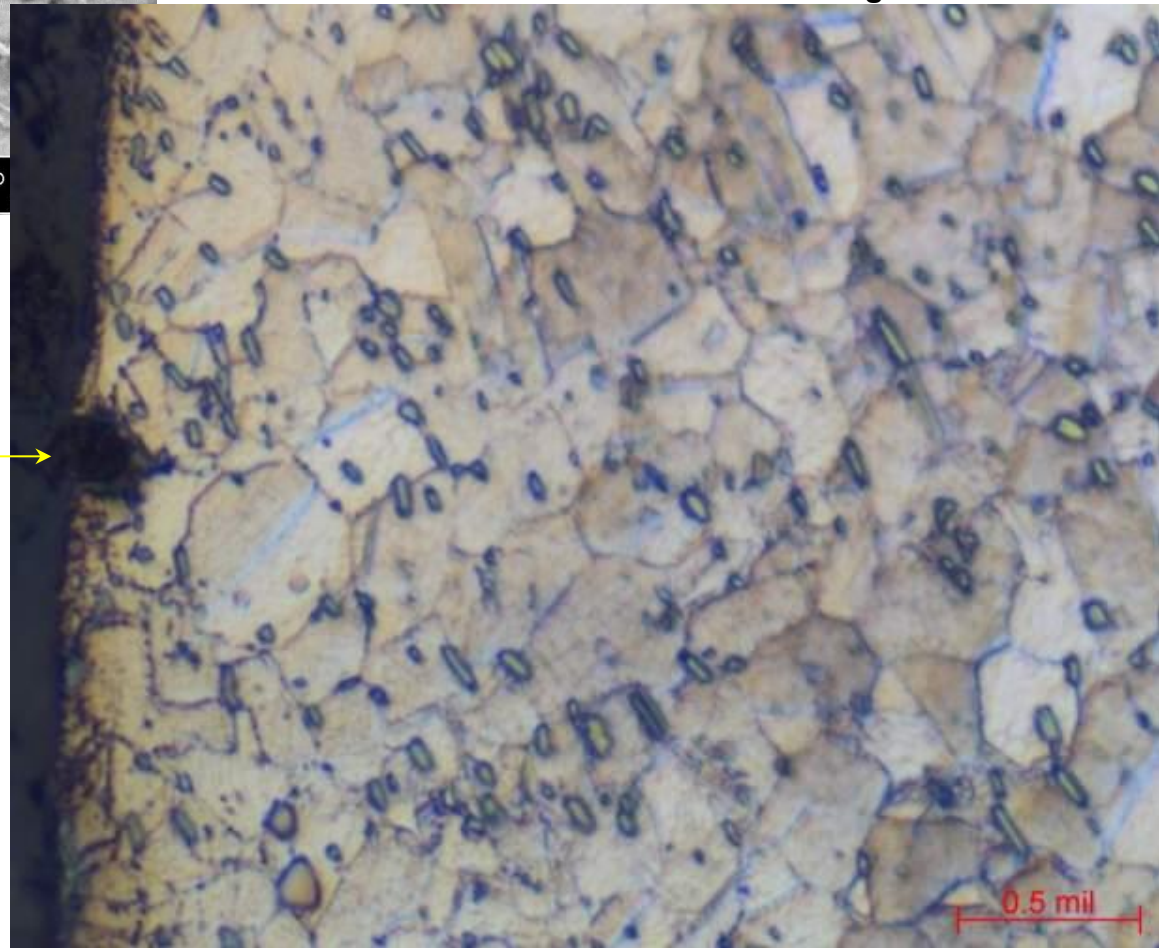
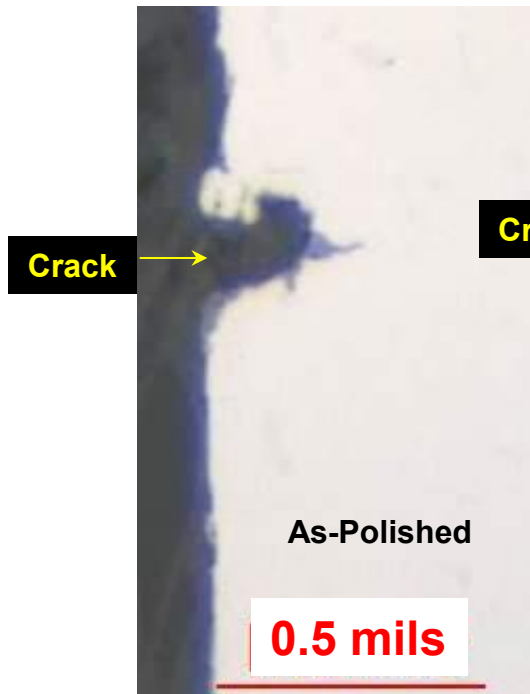
**FIB 2 (Edge of Crack 2)**

**Figure 113:** SEM views of Crack 2 showing where the 2 FIB trenches were made.

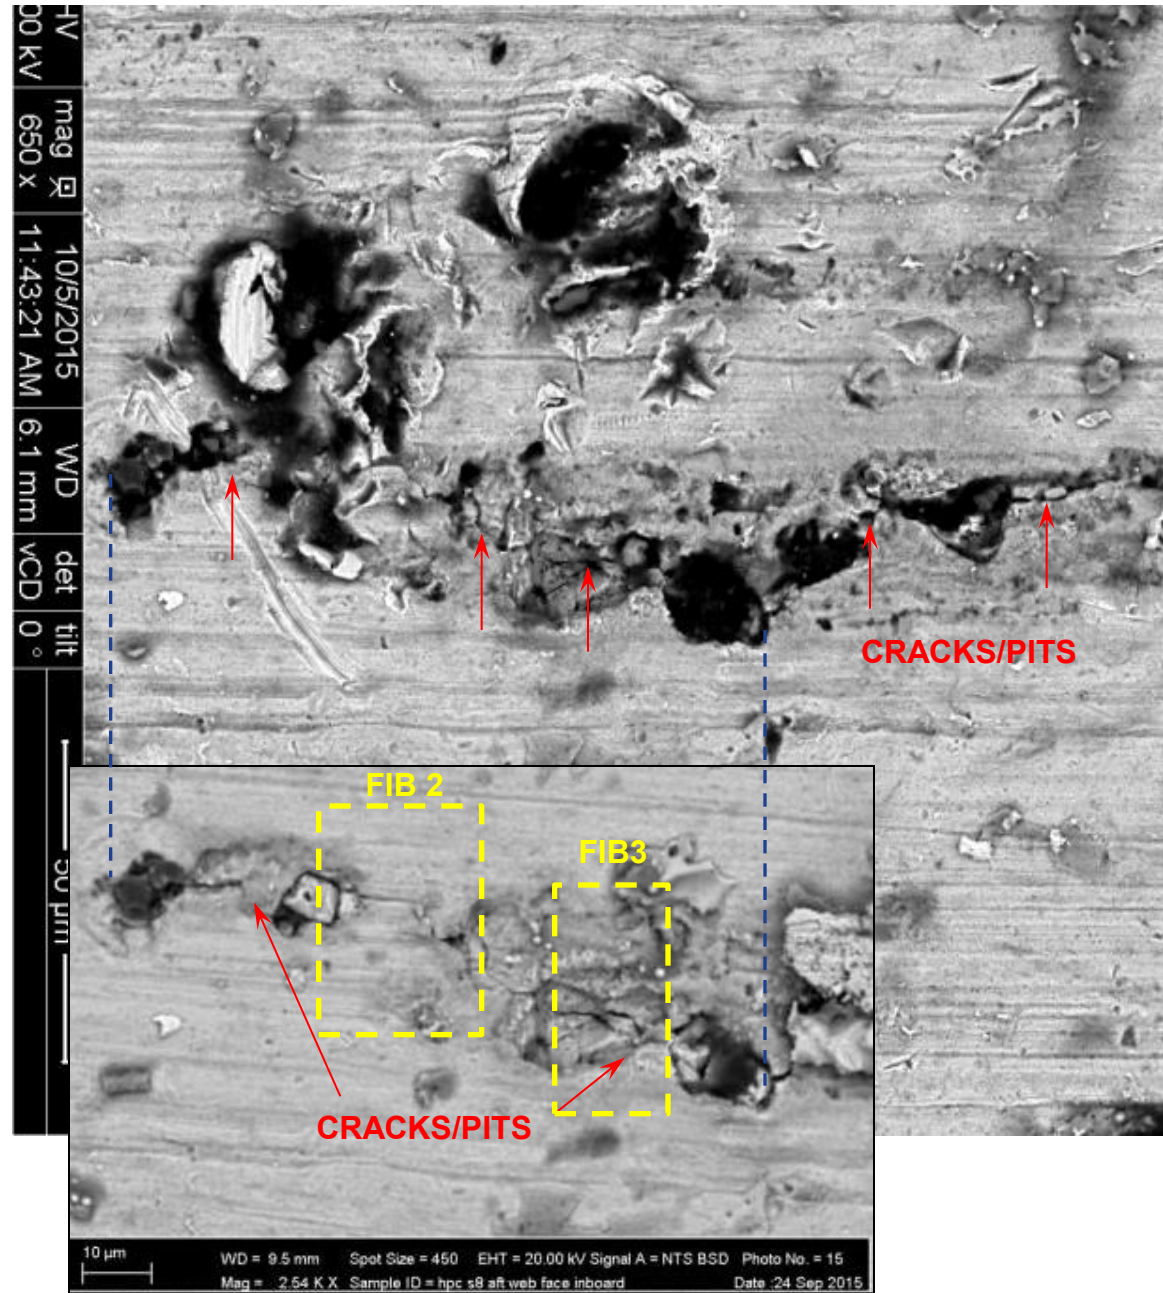
**FIB 2 (Edge of Crack)**

**Figure 114:** SEM views of FIB 2 into Crack 2 showing that the cracks were oxidized, branched/meandering and appeared blunted.

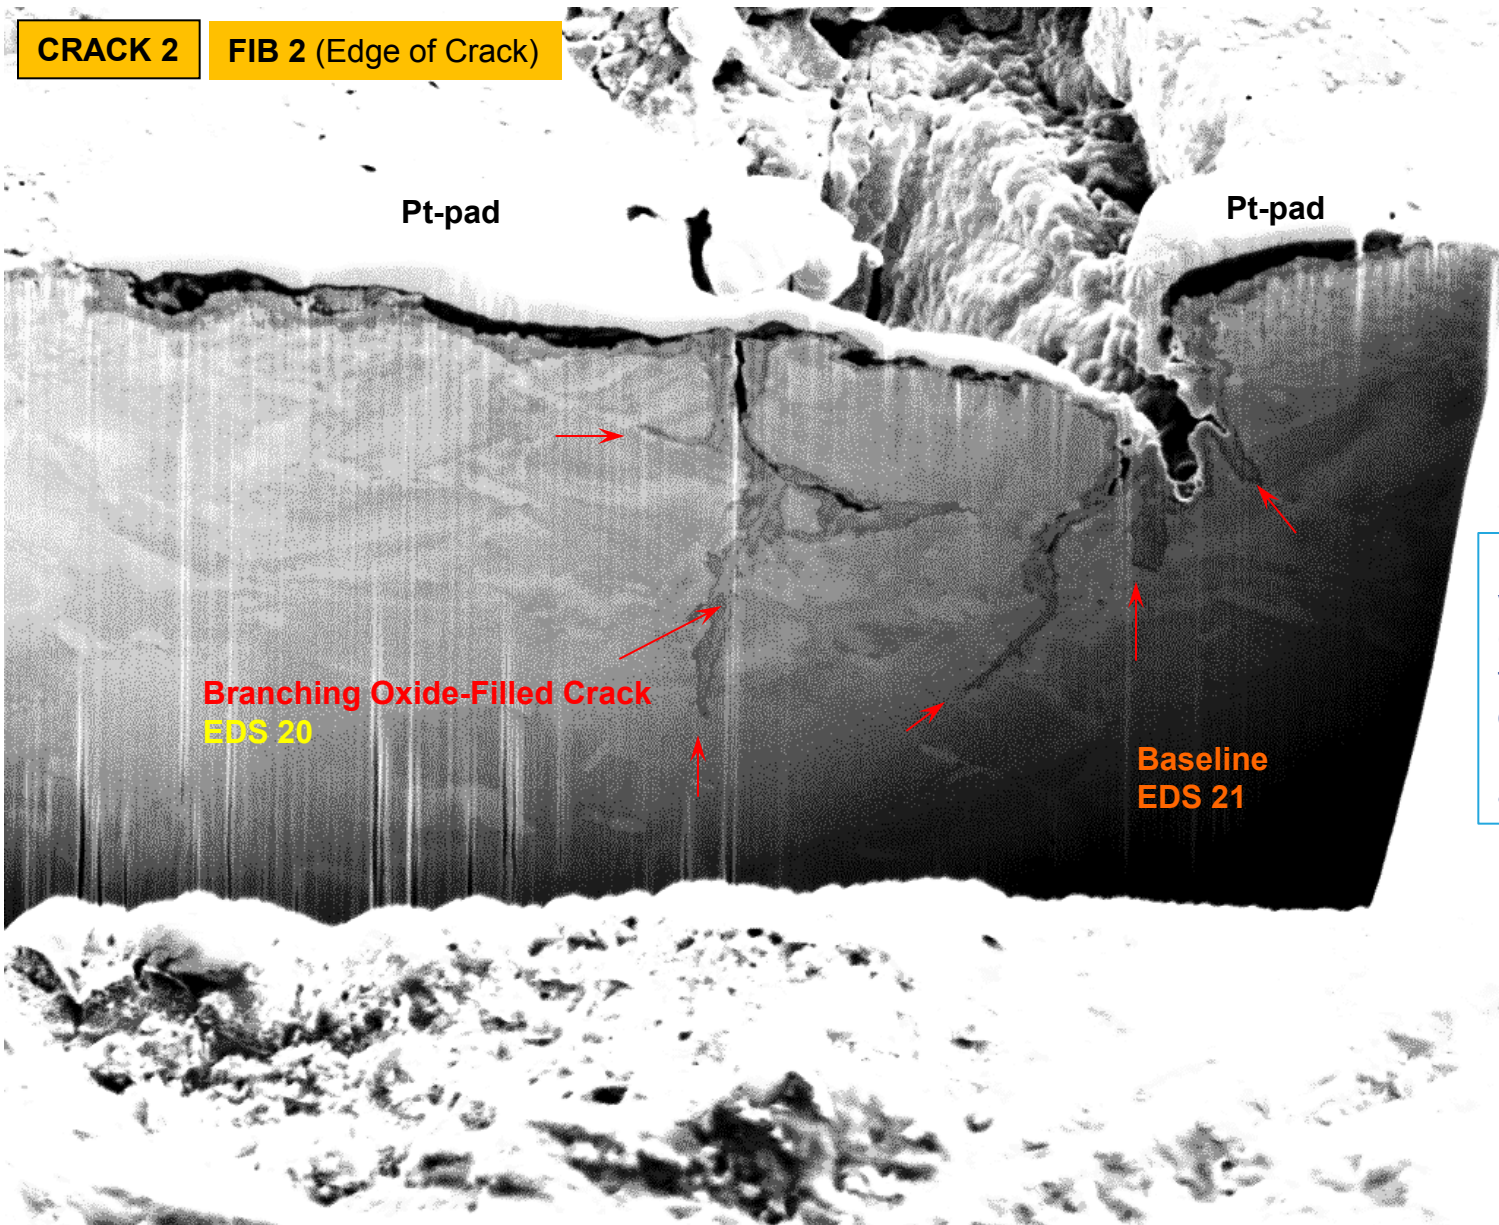
**Figure 115:** Superimposed EDS spectra showed that the crack only had elements consistent with oxidized base material (EDS 20), with the baseline shown in EDS 21. No detrimental species were found in the oxides.

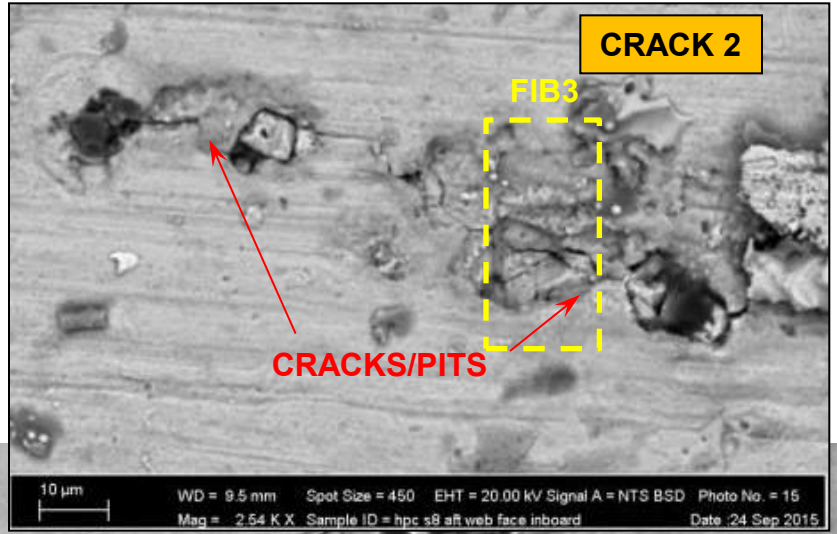
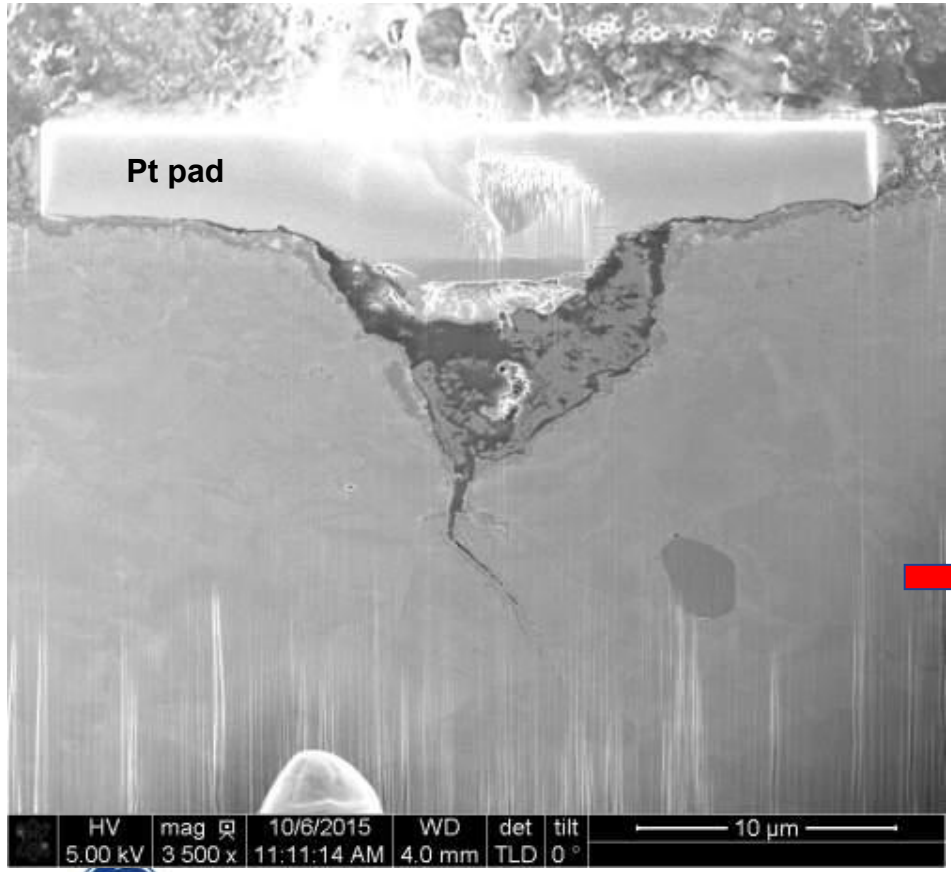
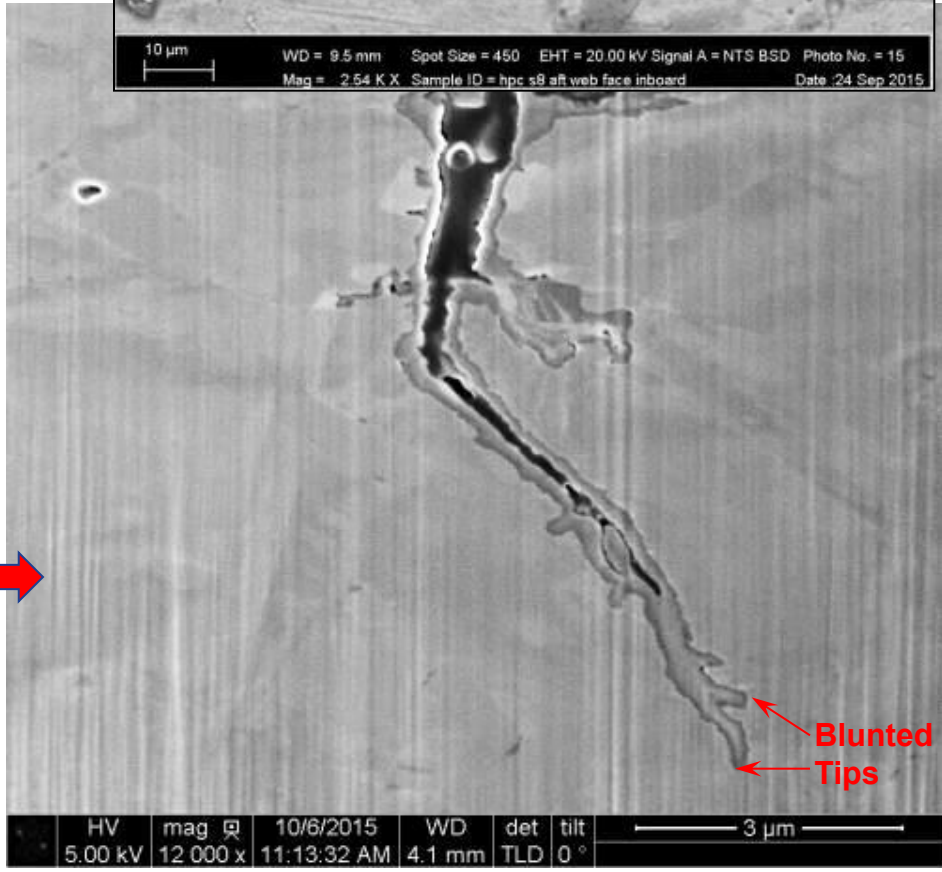
**FIB 3 (Within Crack 2)**

**Figure 116:** SEM views of FIB 3 into Crack 2 showing that the cracks were oxidized, branched/meandering, and appeared blunted.

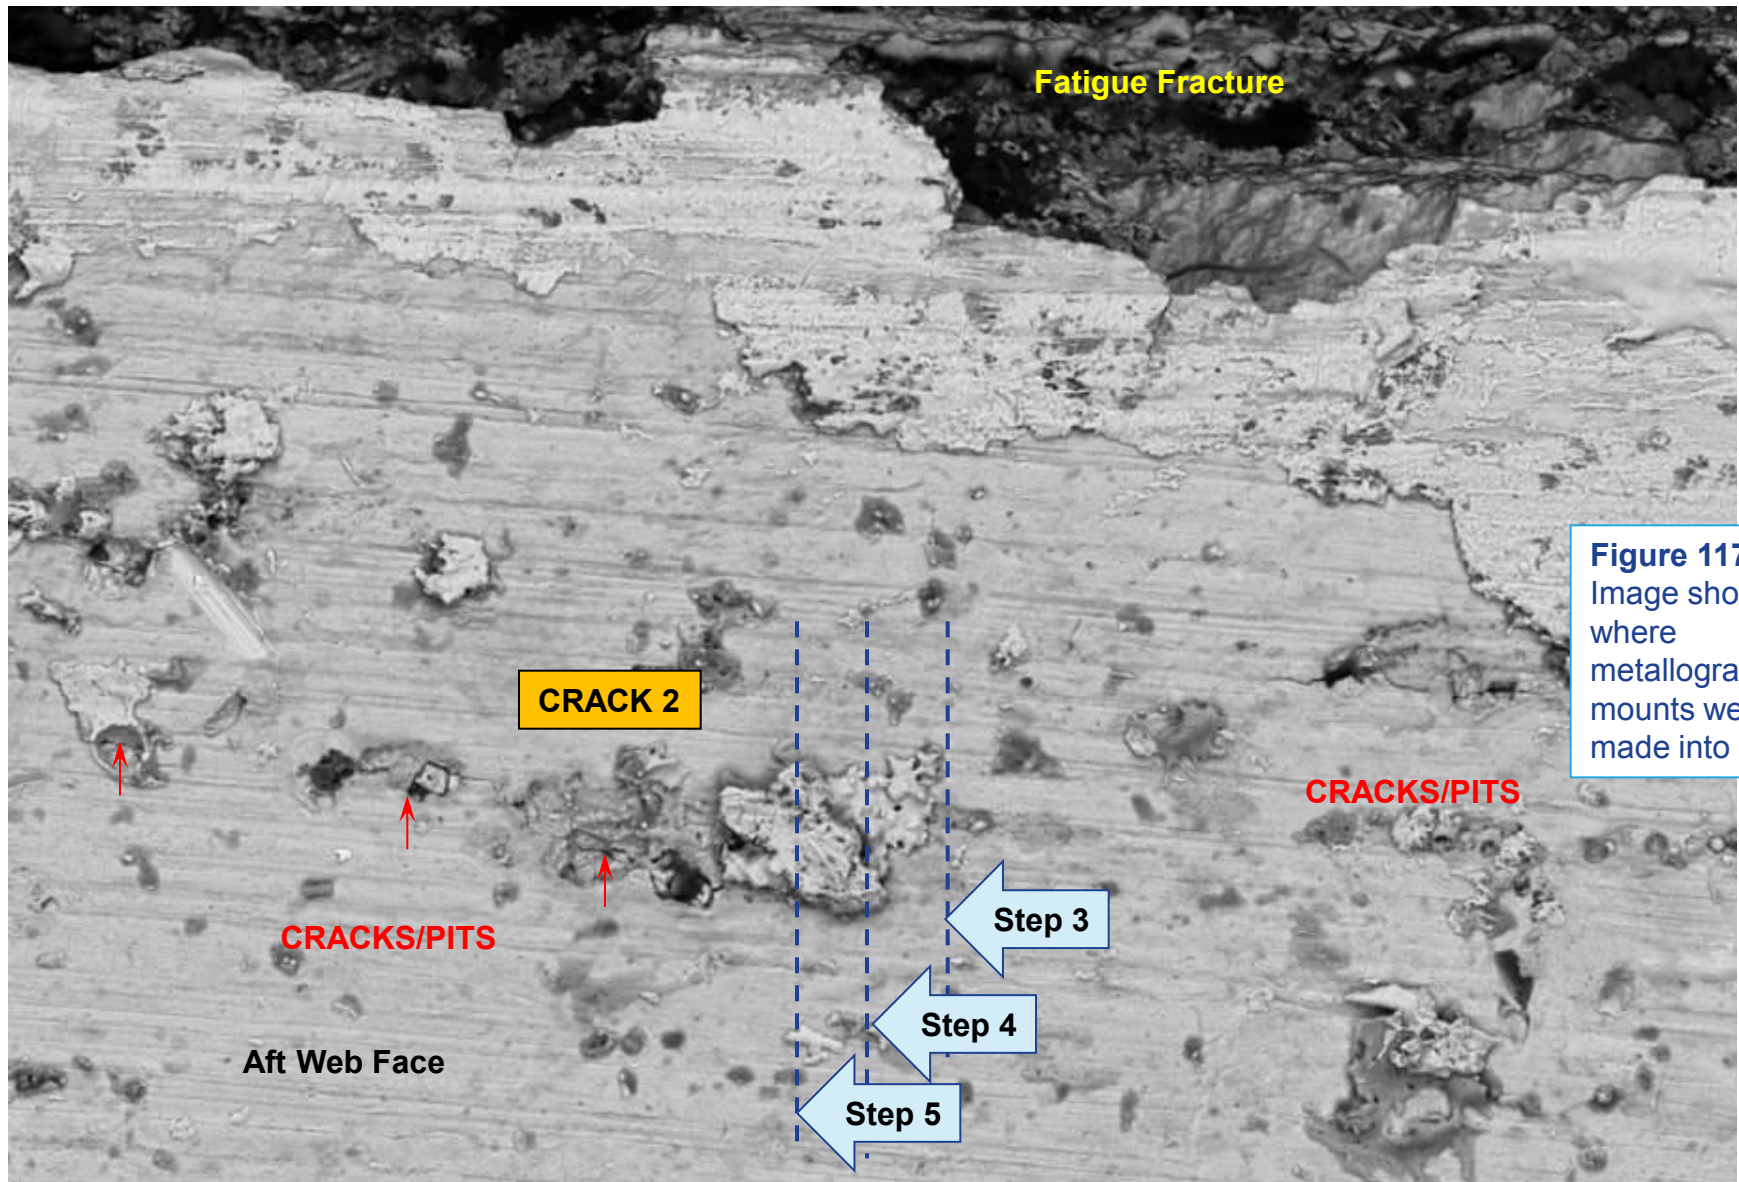
**Figure 117:** Image showing where metallographic mounts were made into Crack 2.

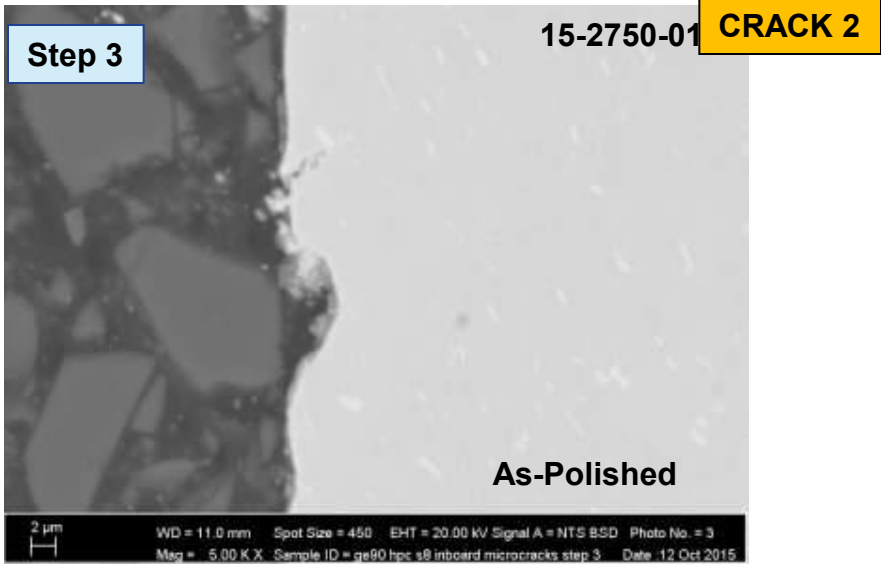
- SEM/EDS analysis of the secondary cracks revealed only base metal oxides with no detrimental species (Figs. 107, 109, 115).
  - Step-polishes were made into the same 2 secondary cracks and they showed similar meandering/branching features, that were more transgranular in some areas and more intergranular in others (Figures 111, 112, 116-121). **No damage/microstructural anomalies** were found and the cracks were up to **0.5 mil deep**.

**Figure 118:** Three step polishes approximately 1 mil apart were made into Crack 2. At the last step (step 5 in the mount) a meandering crack approximately 0.5 mils long was observed extending from the carbide area.

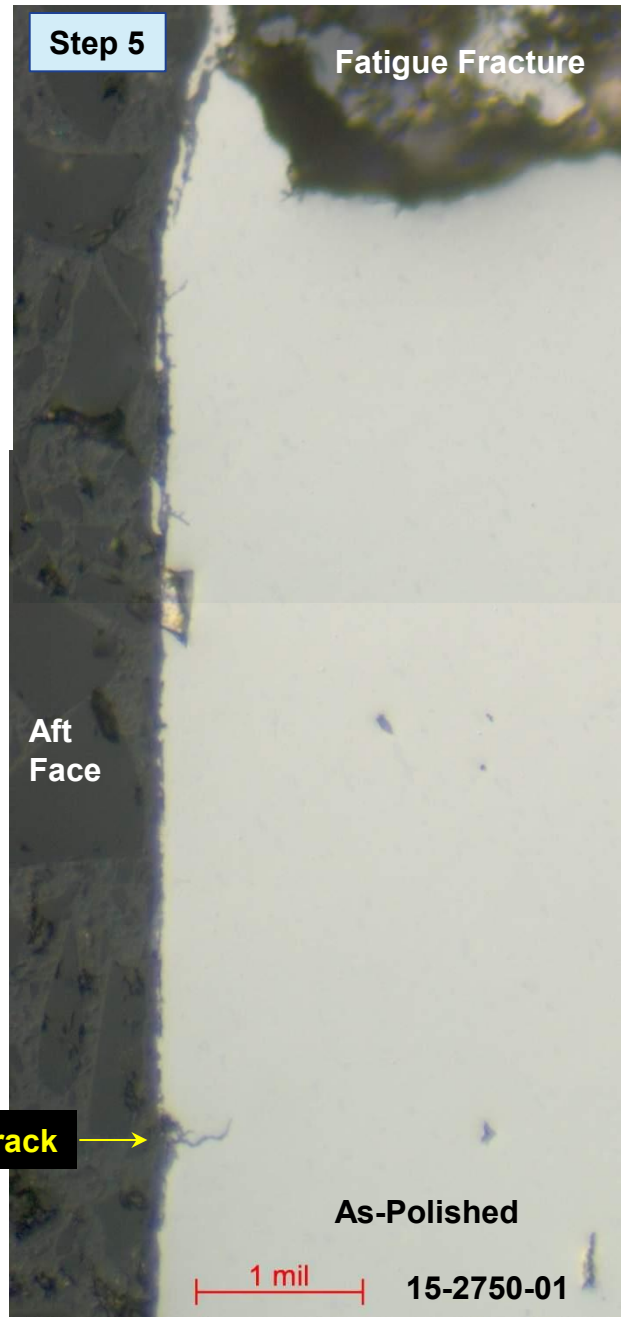
**CRACK 2- Mount (Step 5)**

**Figure 119:** Higher magnification views of the as-polished and etched microstructure showing a meandering crack that had more intergranular features initially. The grain structure looked normal and no damage or material anomalies were observed.
