# NATIONAL TRANSPORTATION SAFETY BOARD

MATERIALS LABORATORY FACTUAL REPORT

Report No. 15-131

Place : Las Vegas, Nevada  
Date : September 8, 2015  
Vehicle : Boeing 777-200, G-VIIO  
NTSB No. : DCA15FA185  
Investigator : Lorenda Ward, AS-10

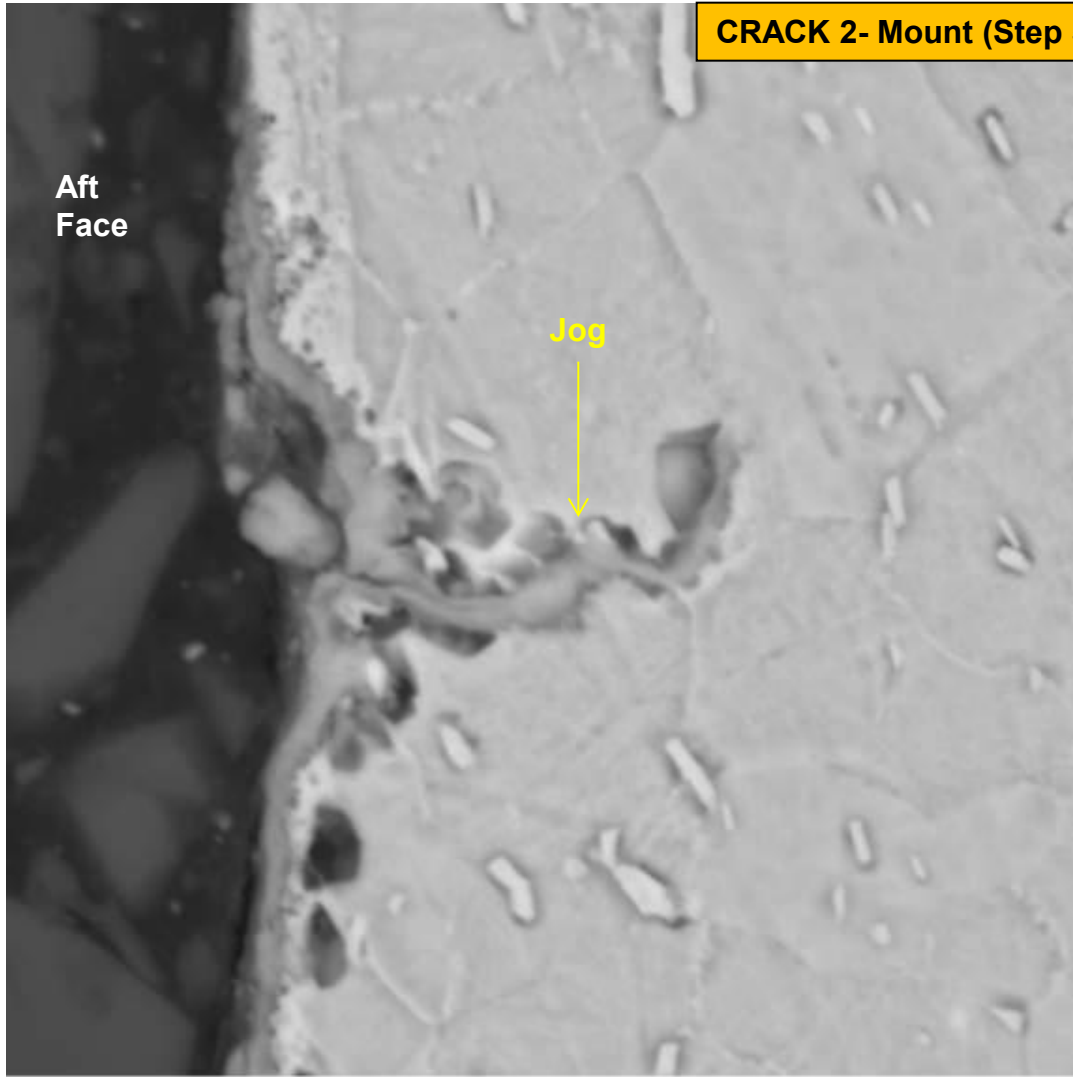
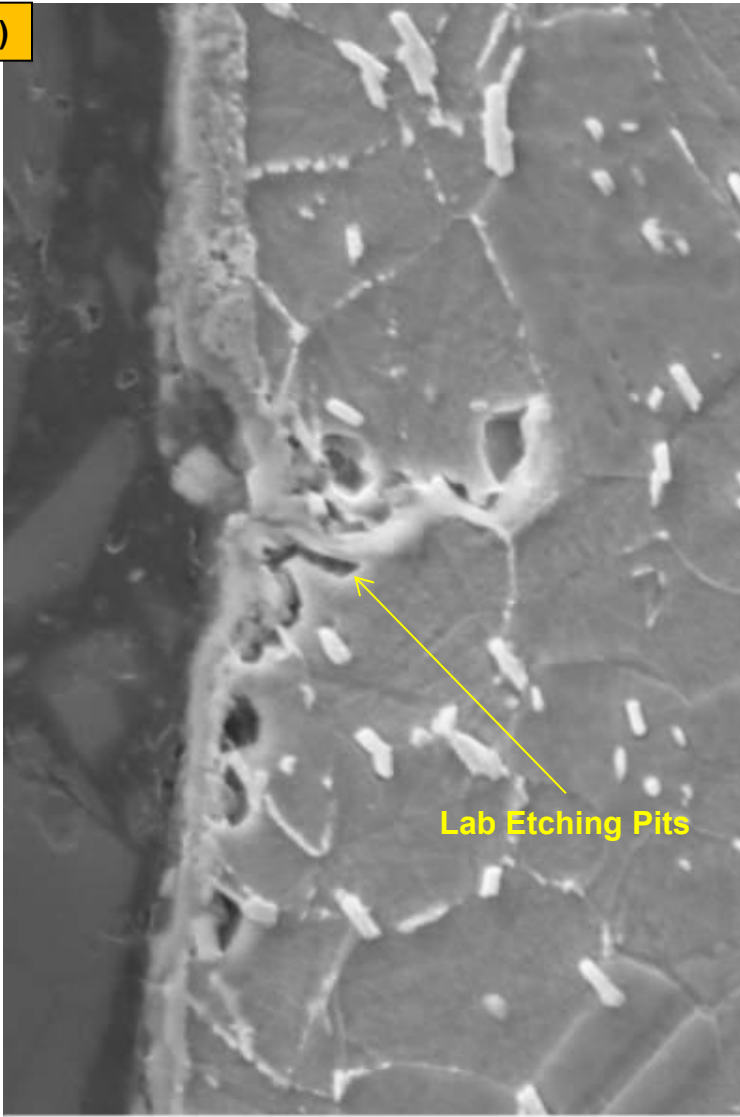
CRACK 2- Mount (Step 5)

**Figure 120:** SEM views of the etched structure showing a meandering oxidized crack extending at the base of carbides with no material anomalies noted. The crack was more intergranular initially.

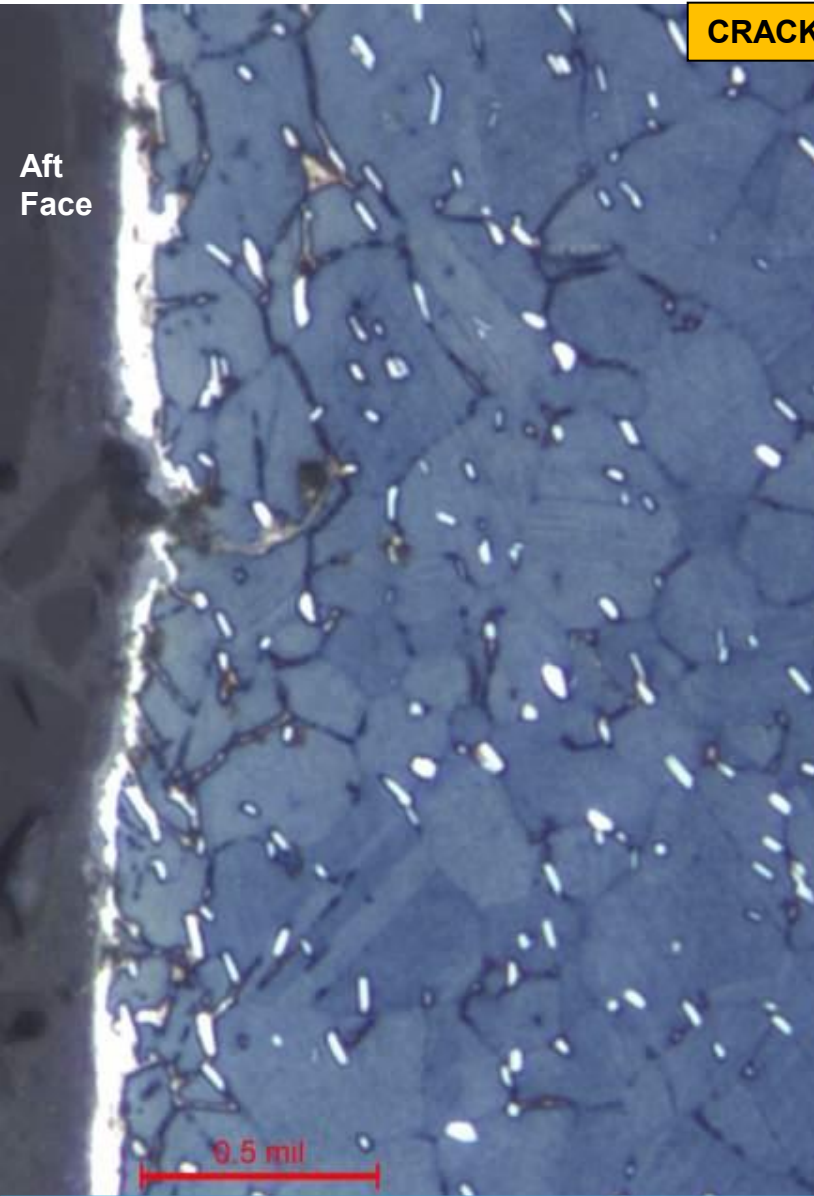
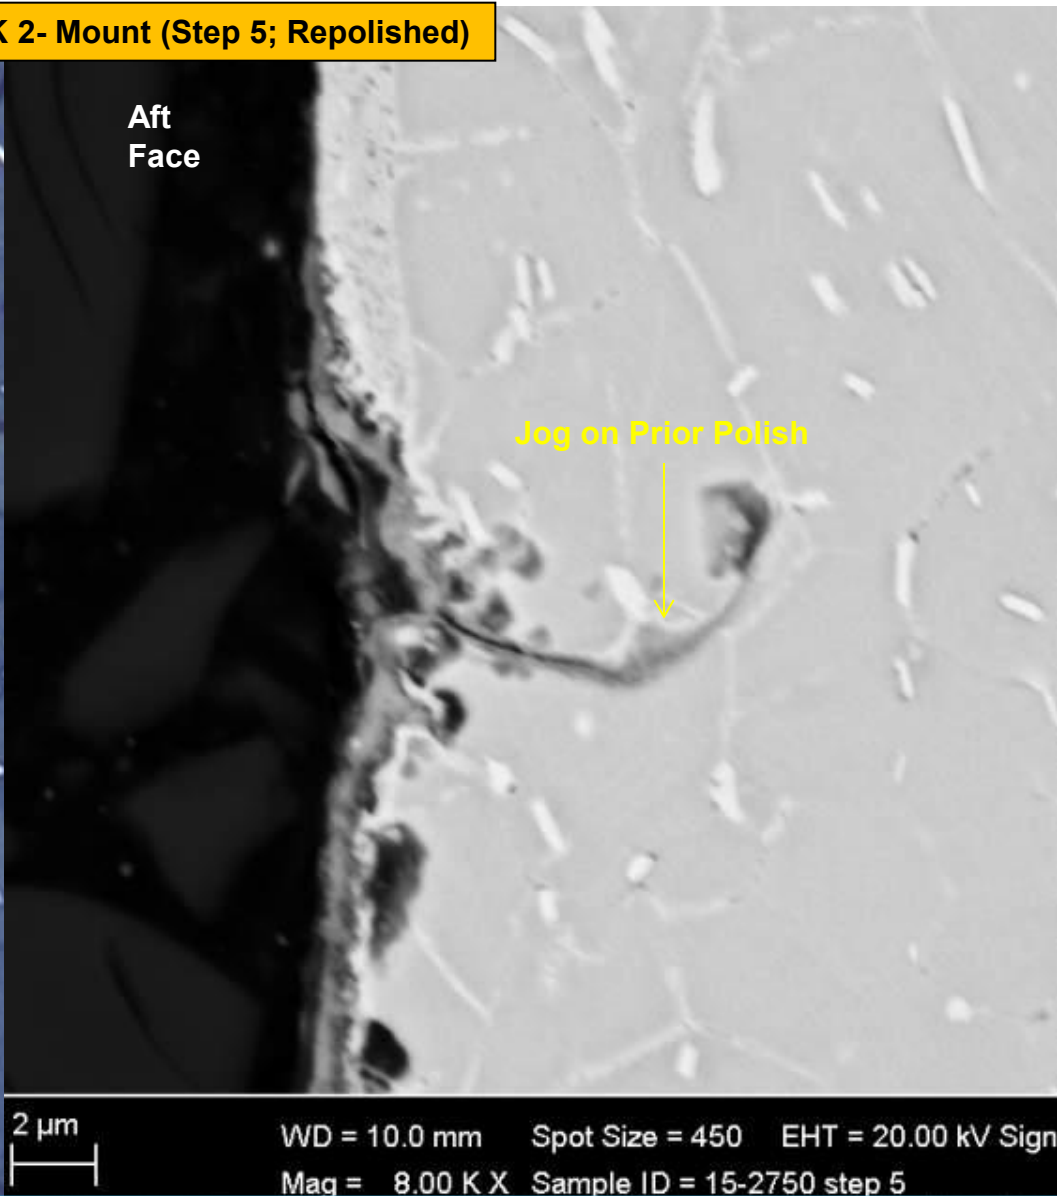
CRACK 2- Mount (Step 5; Repolished)

Figure 121: After re-polishing and etching the crack was found to have more intergranular features initially and then a transgranular end region.

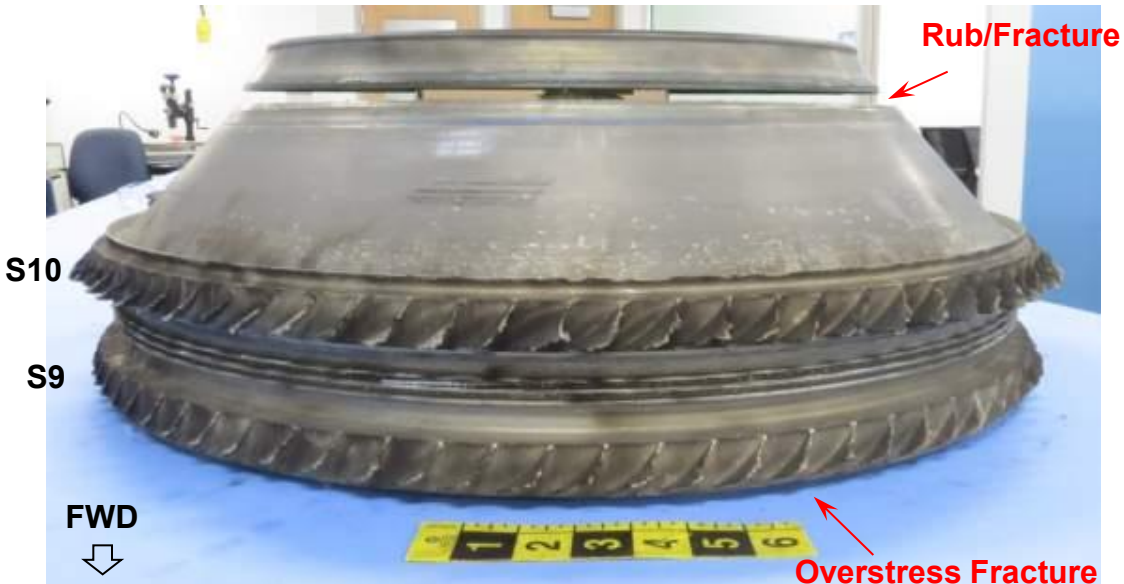
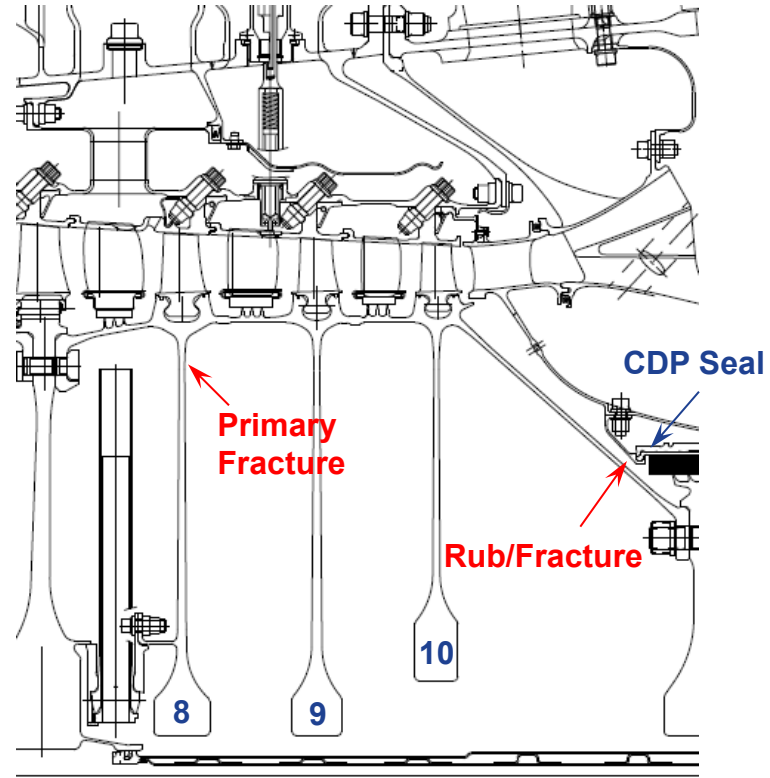
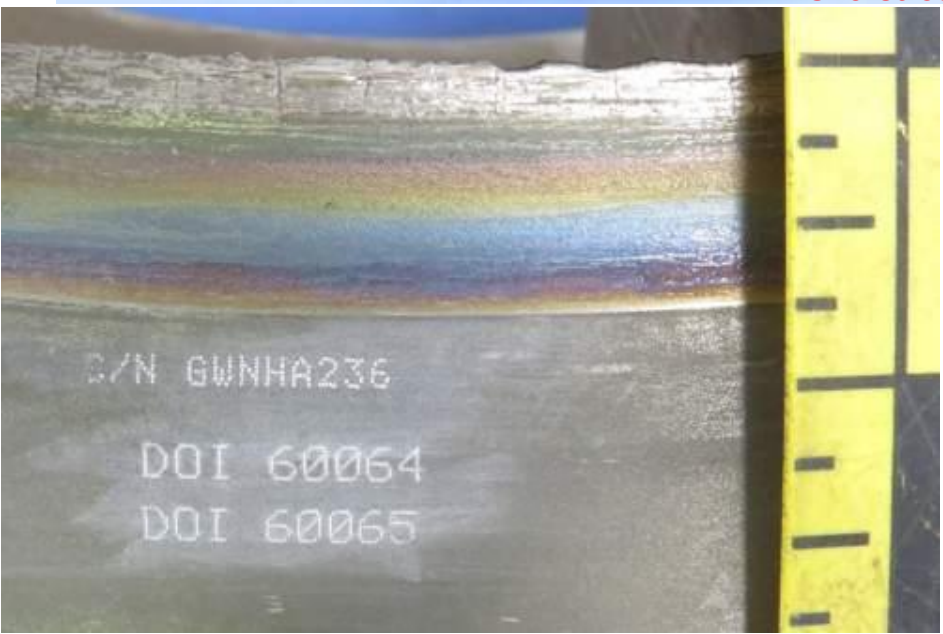
**Appendix A1:** Optical views of the aft end of the 8-10 spool showing the part markings and fracture locations. There was a fracture forward of the stage 9 disk, consistent with the liberation event, and the aft cone arm was fractured consistent with rubbing against the static structure/CDP seal.

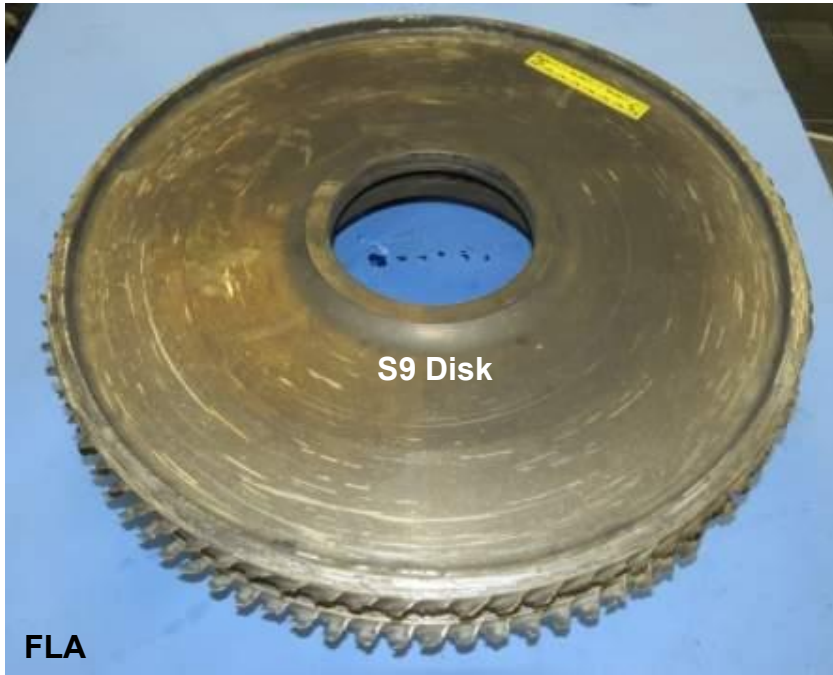
**Appendix A2:** Representative views of the stage 9 disk forward arm fracture consistent with overstress.

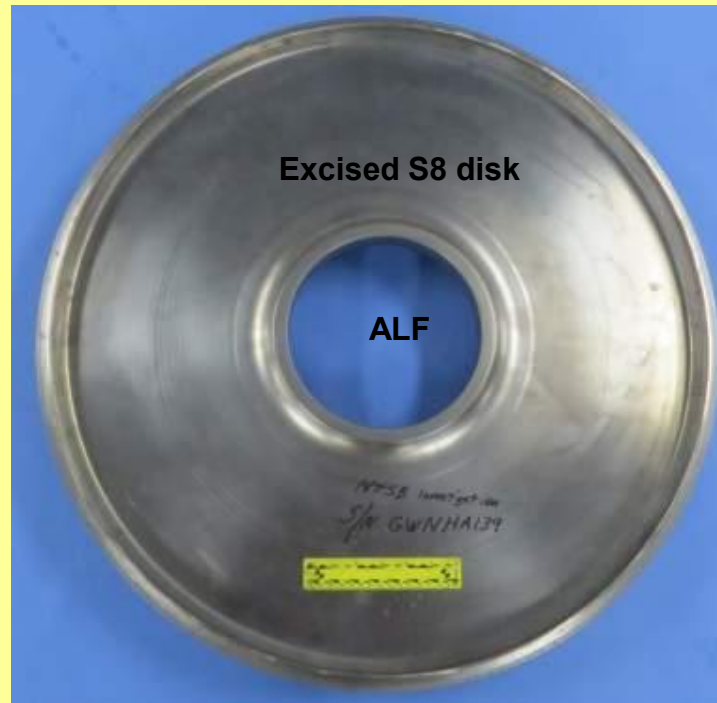
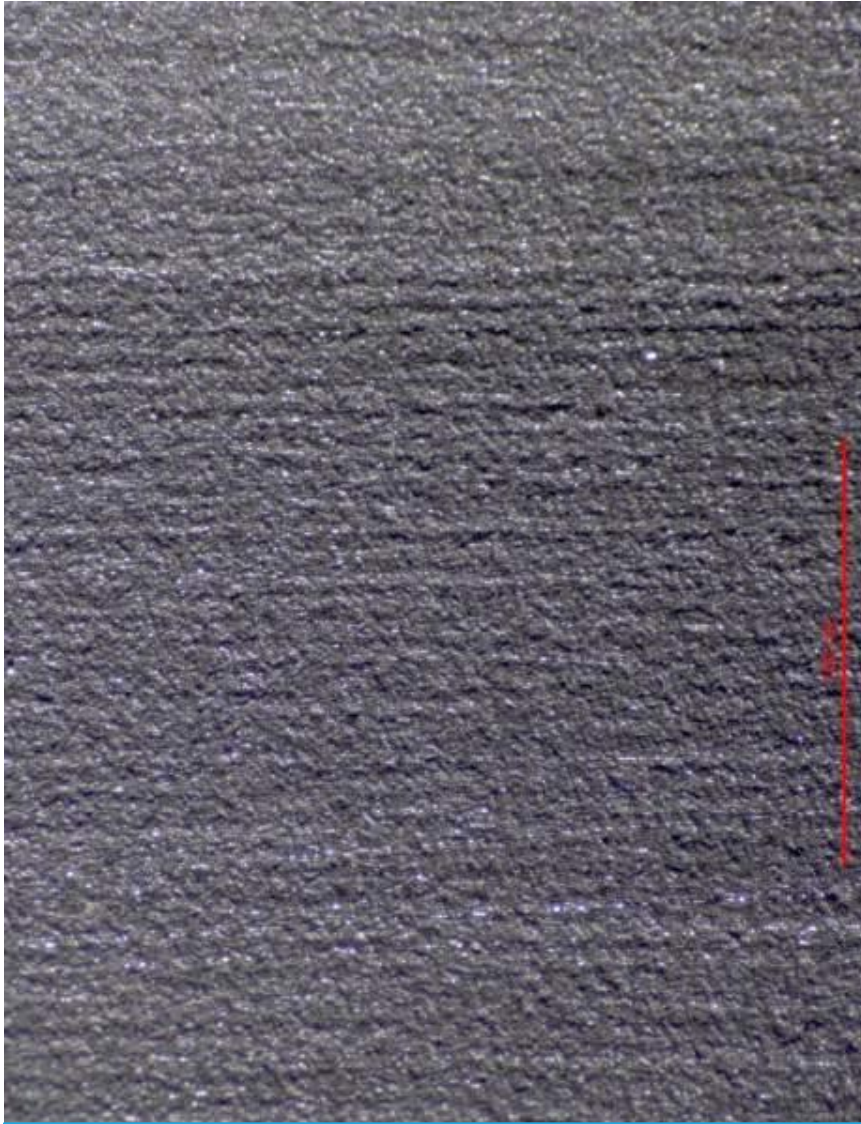
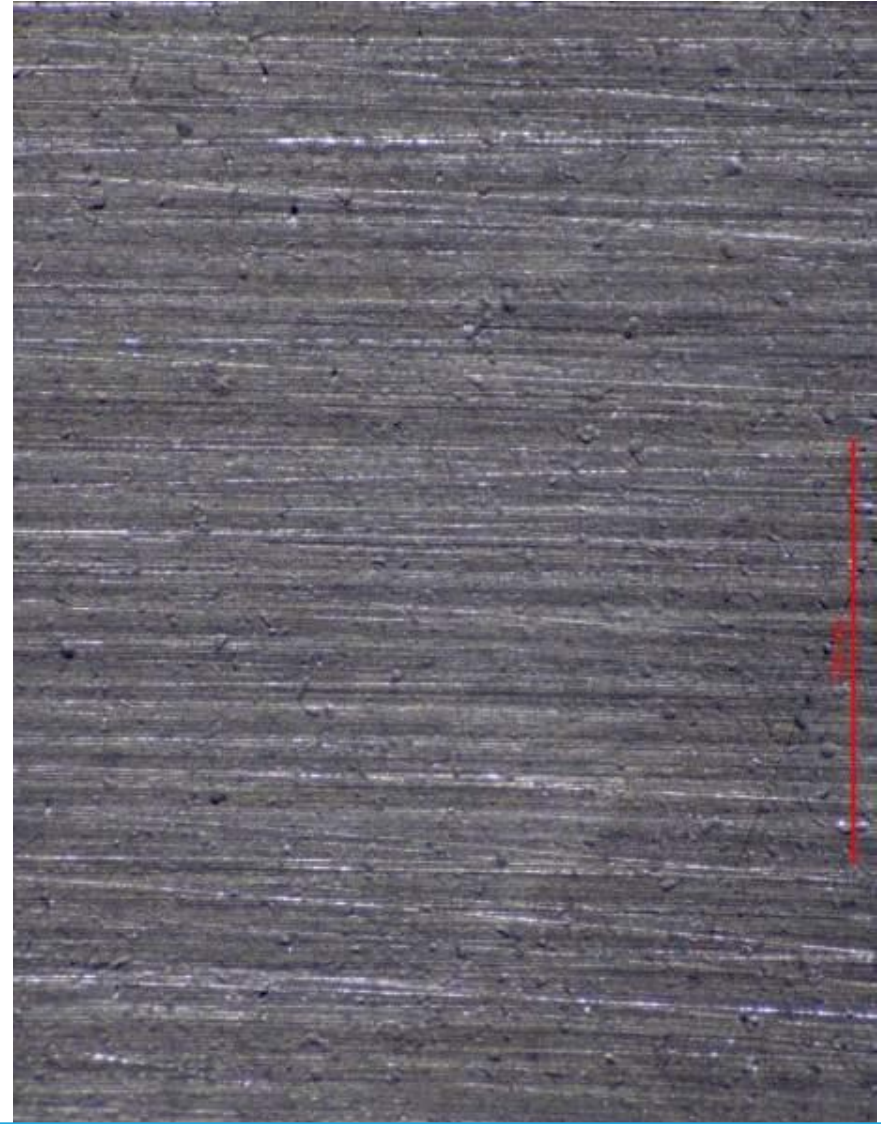
**Appendix B1:** Representative views of the stage 8 disk forward and aft web faces from spool S/N GWNHA139 showing visual differences in the peening with the forward side being more pronounced, like the event disk.

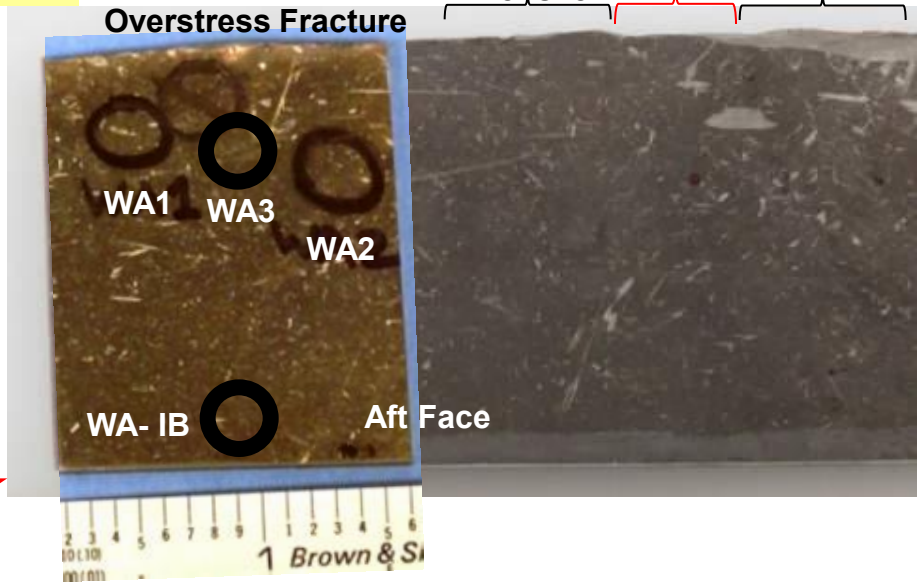
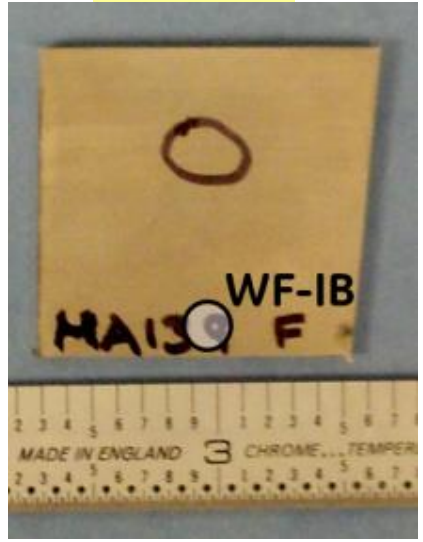
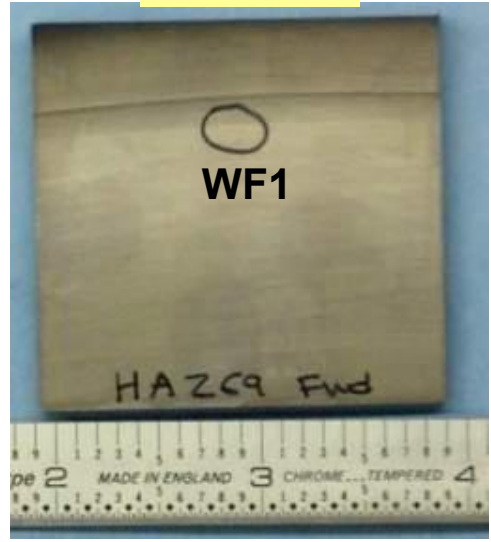
**Appendix C1:** Optical views showing where residual stress measurements were taken on both the aft and corresponding forward sides of the web near the fatigue region of the event disk (top images). Readings were also taken on both faces of 2 sister comparison disk webs of similar vintage (S/N GWNHA139 and GWNHA269) and on the diametrically opposite side of the fatigue region on the event disk.

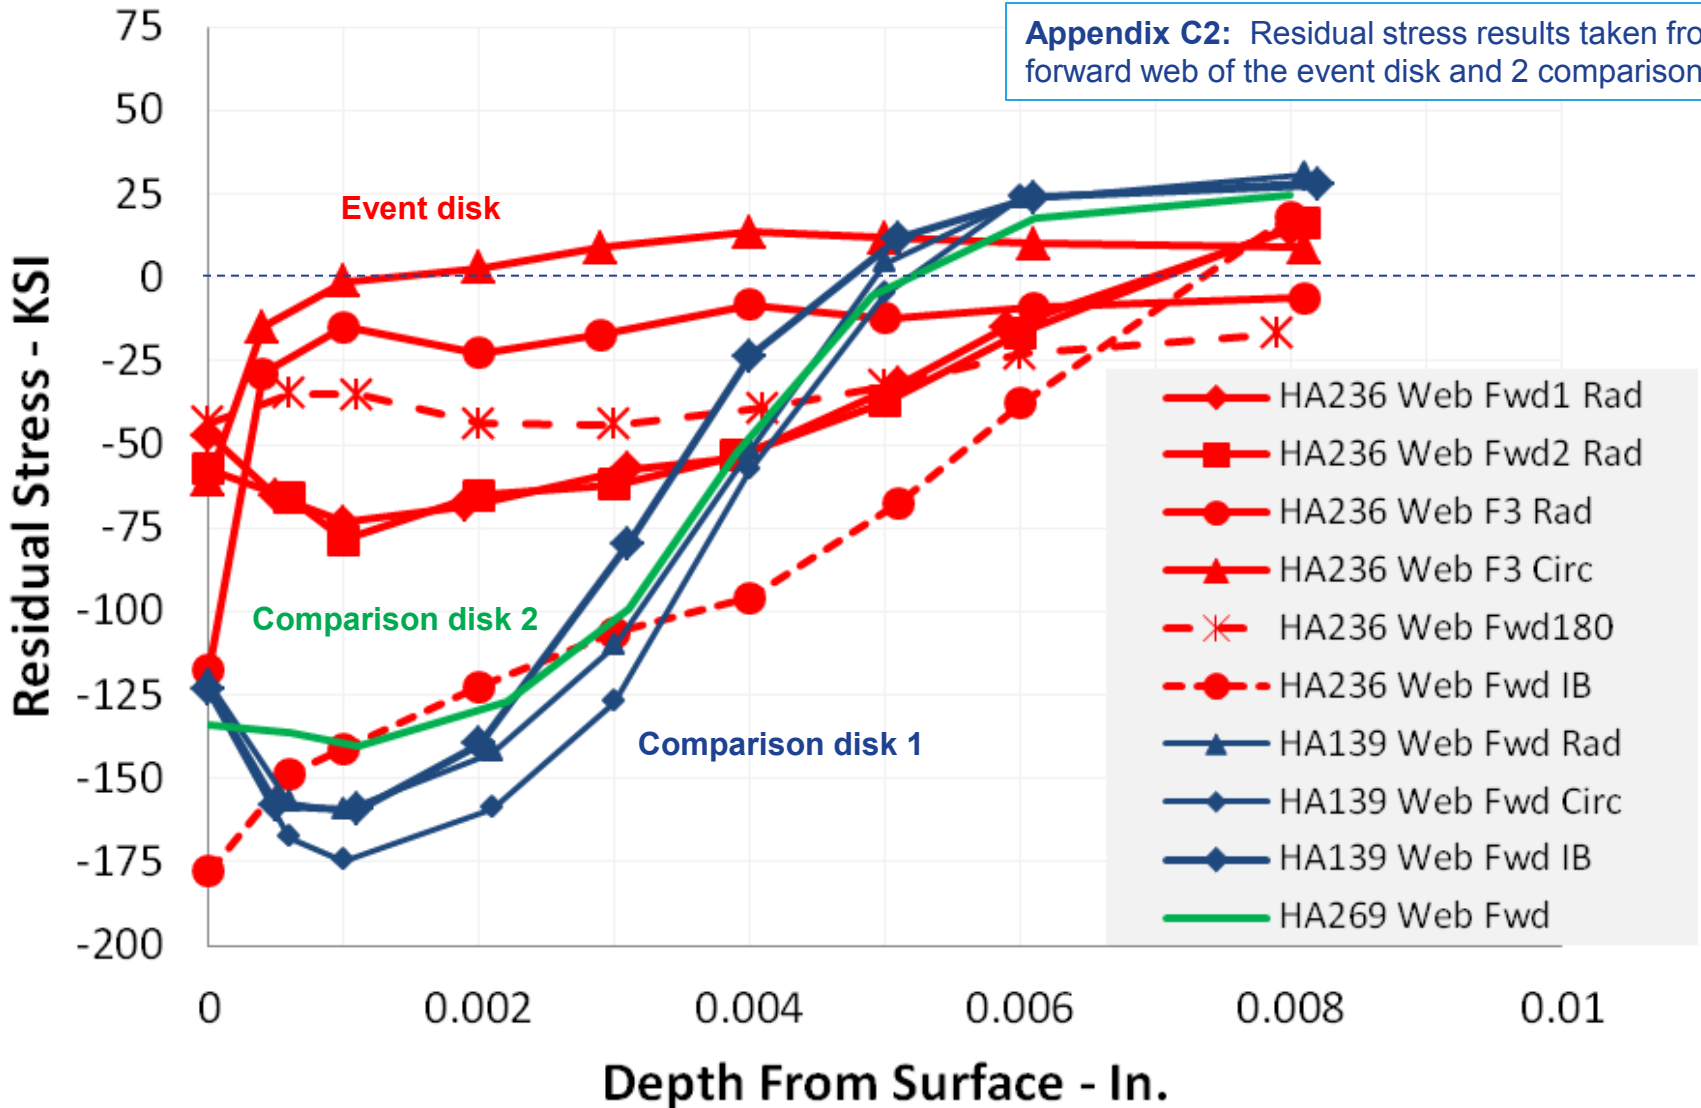
# Fwd Web Measurements

Appendix C2: Residual stress results taken from the forward web of the event disk and 2 comparison disks.

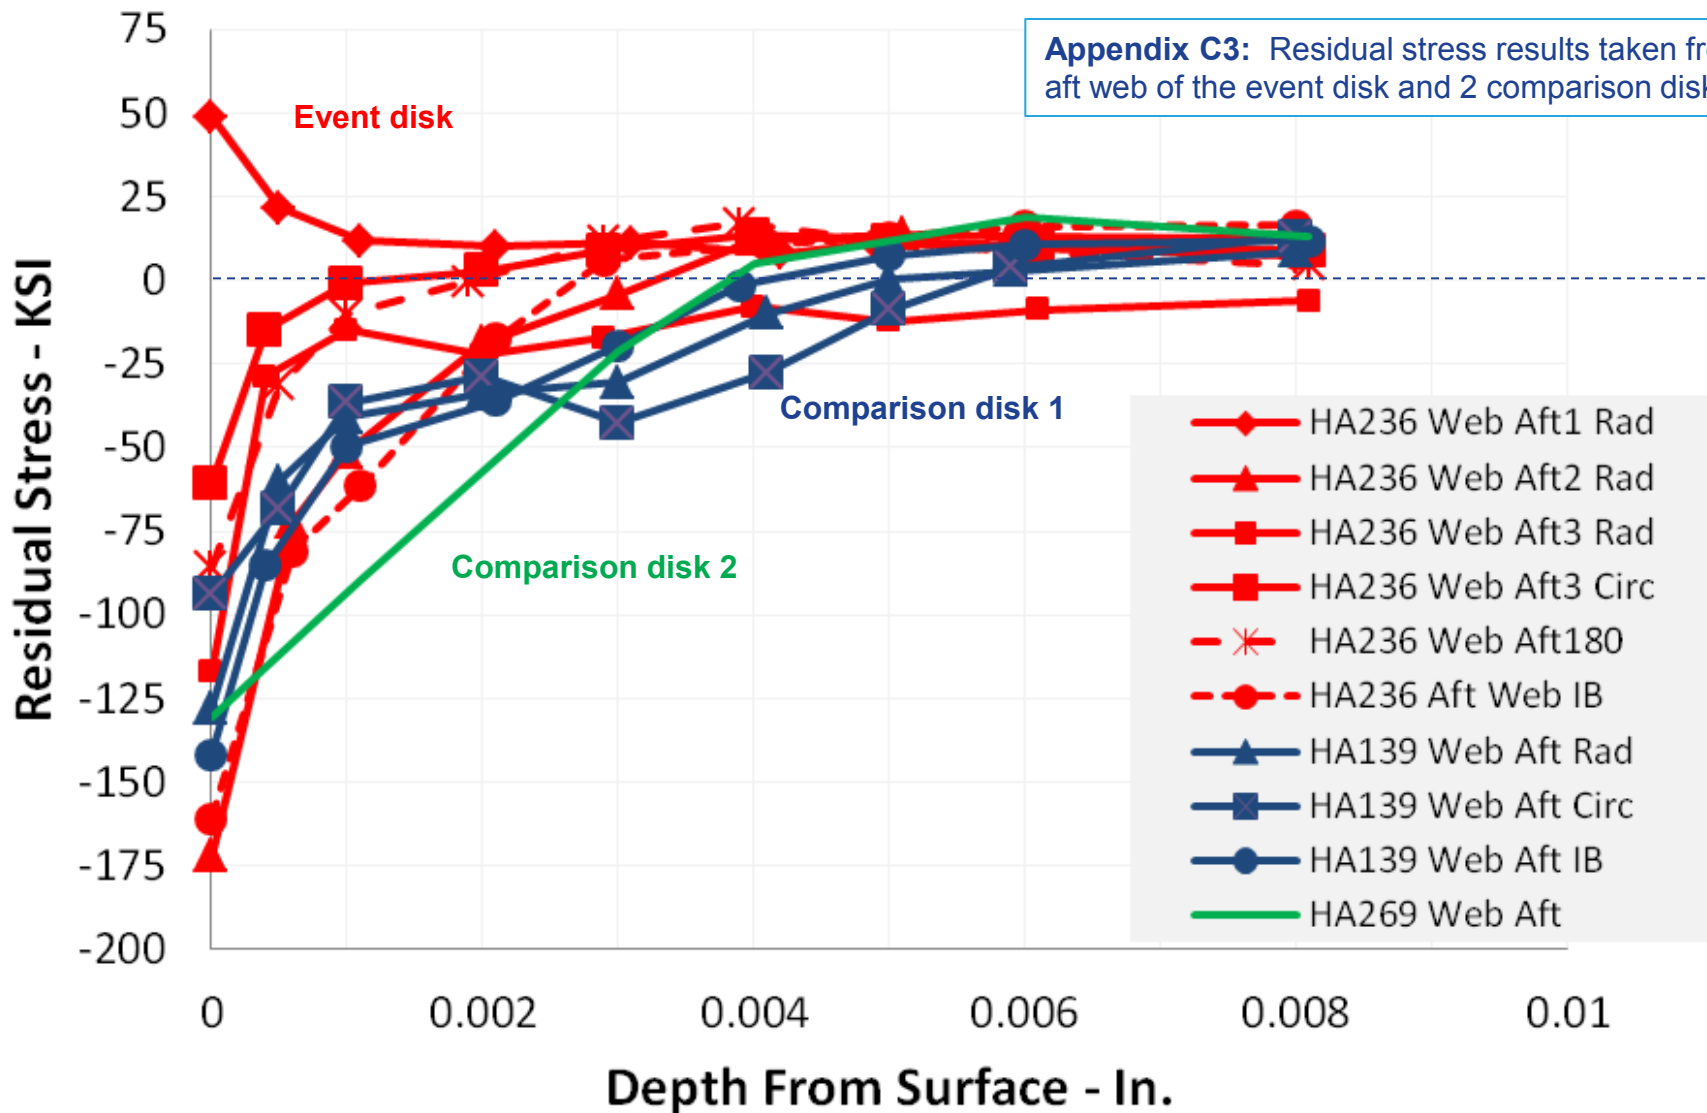
# Aft Web Measurements

Appendix C3: Residual stress results taken from the aft web of the event disk and 2 comparison disks.

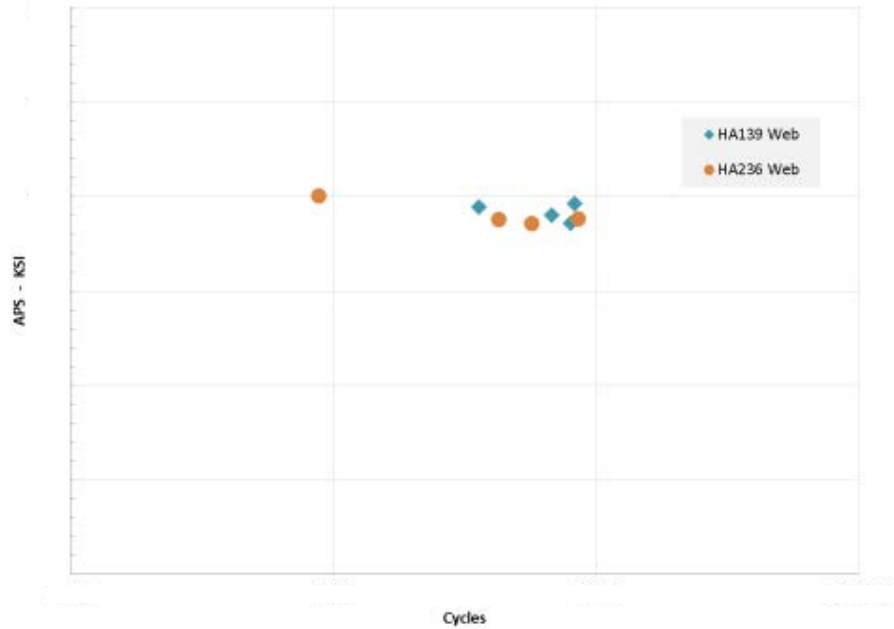
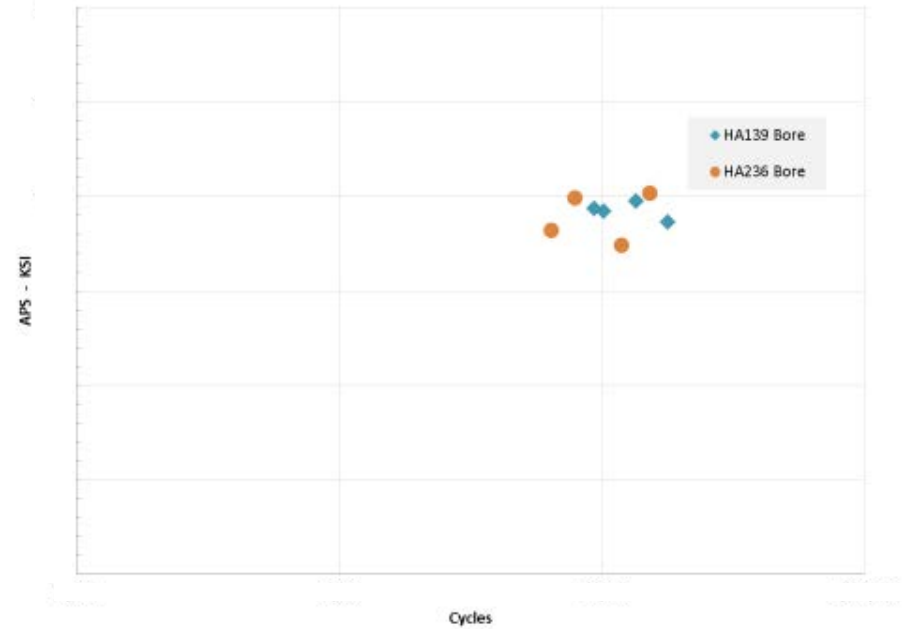
**Appendix D1:** Radial sheet specimens from the web and circumferential smooth bar bore specimens were taken from the event disk (GWNHA236) and comparison disk (GWNHA139). The results from the tests revealed nearly equivalent lives and all were within GE design expectations for the material.

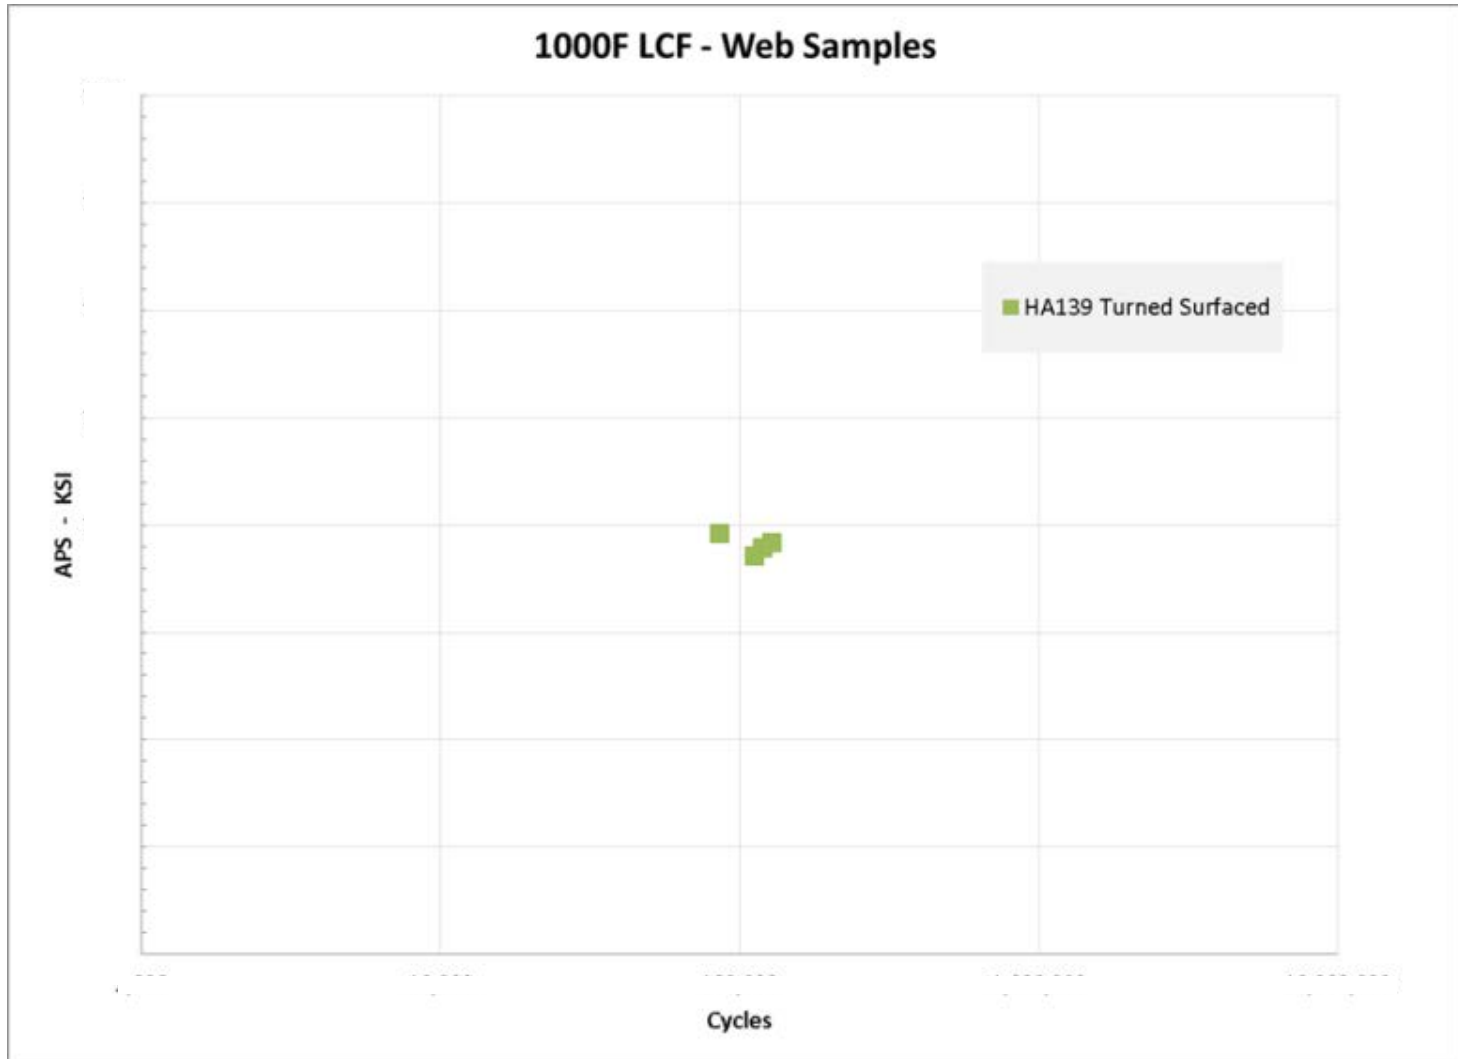
**Appendix D2:** Radial sheet specimens were tested from comparison disk S/N GWNHA139 with an as-manufactured aft surface with similar peening features to the event disk and the fatigue lives were at/near the average data for DA718. The event part was not tested due to event-related surface damage.

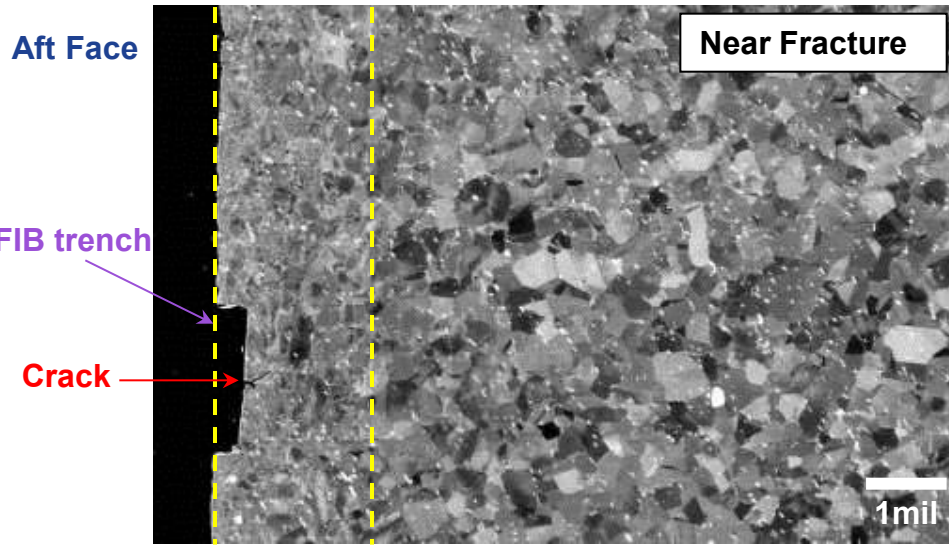
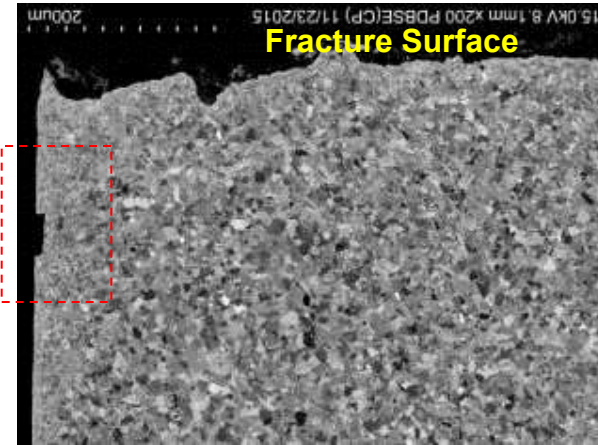
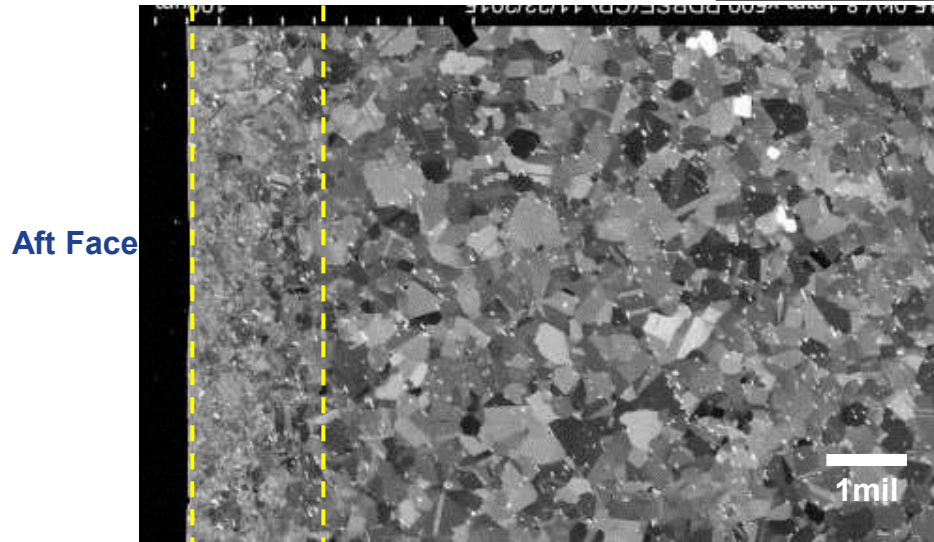
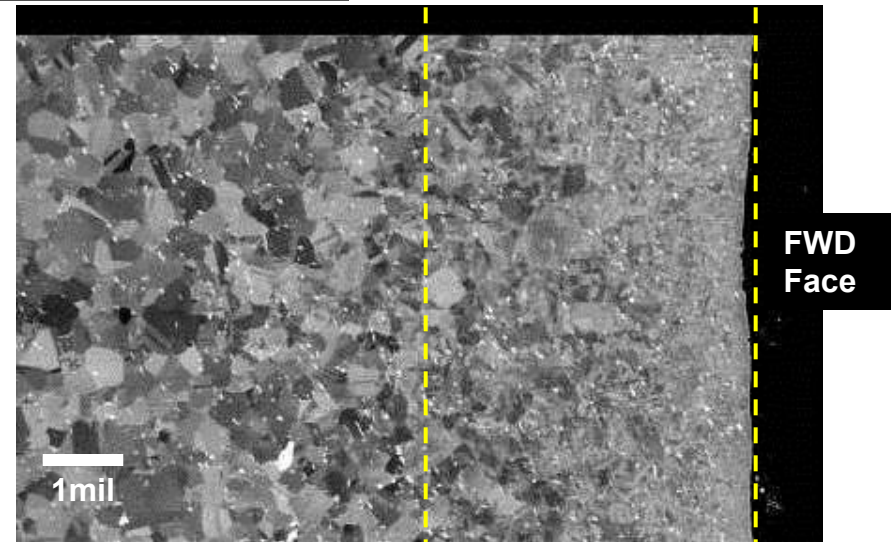
Appendix E2:  
High contrast  
backscatter  
images  
showing the  
difference in  
visual grain  
distortion  
along the  
forward and aft  
faces of the  
web.

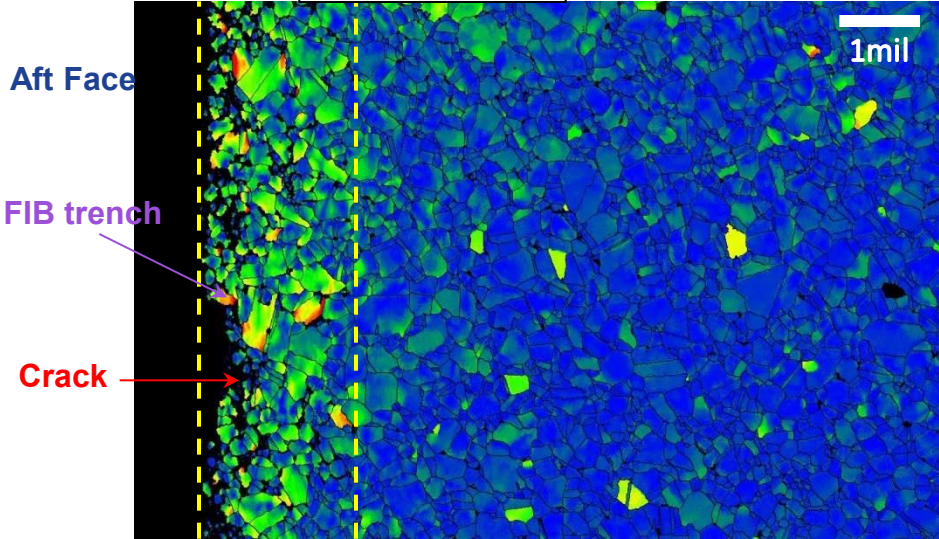
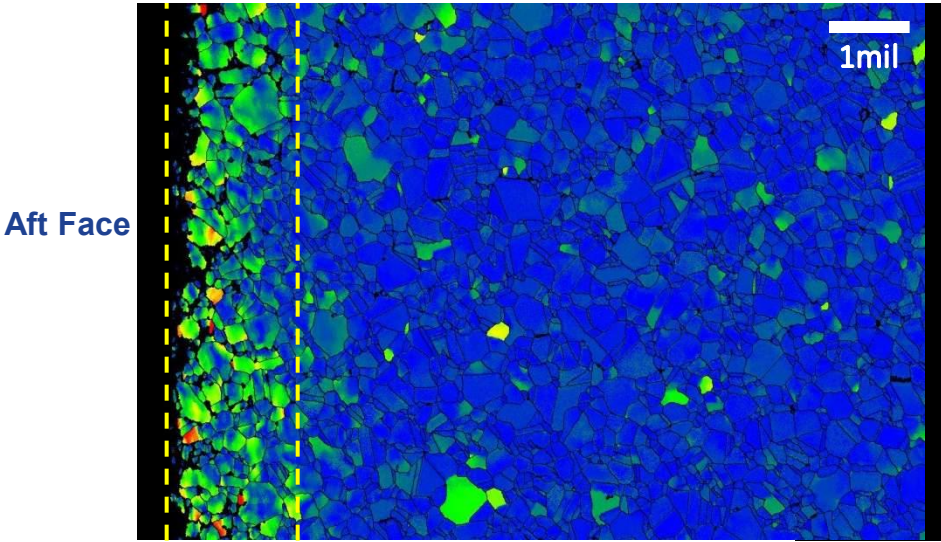
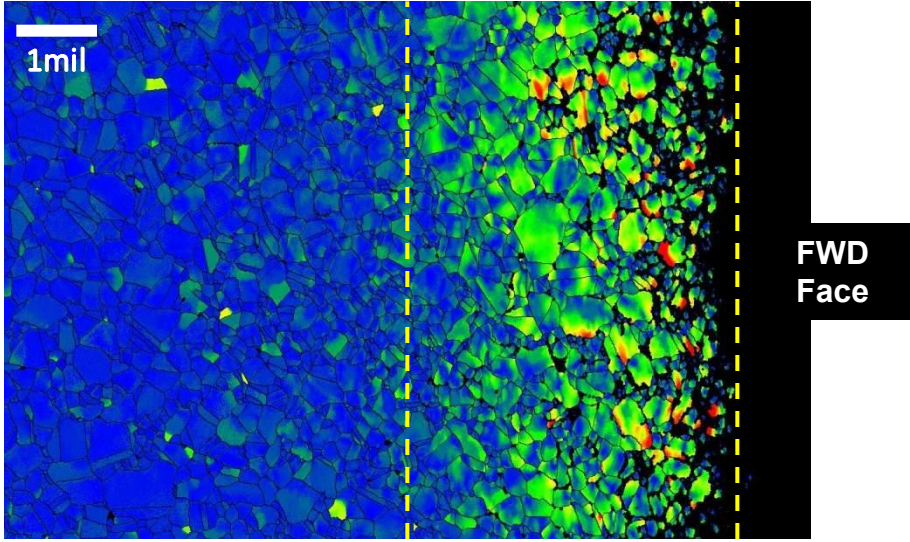
**Appendix E3:** Similar magnification EBSD misorientation maps showing the grain structure near/far from the fracture on the aft web face and on the forward face. The region where a secondary cracking was observed near the fracture had a uniform level of distortion very similar to further inboard radially on the part. The FIB trench was remnant from the prior examination. The forward face had more distortion (was more heavily peened).

strain at edge too high to index/measure (true for all three locations)

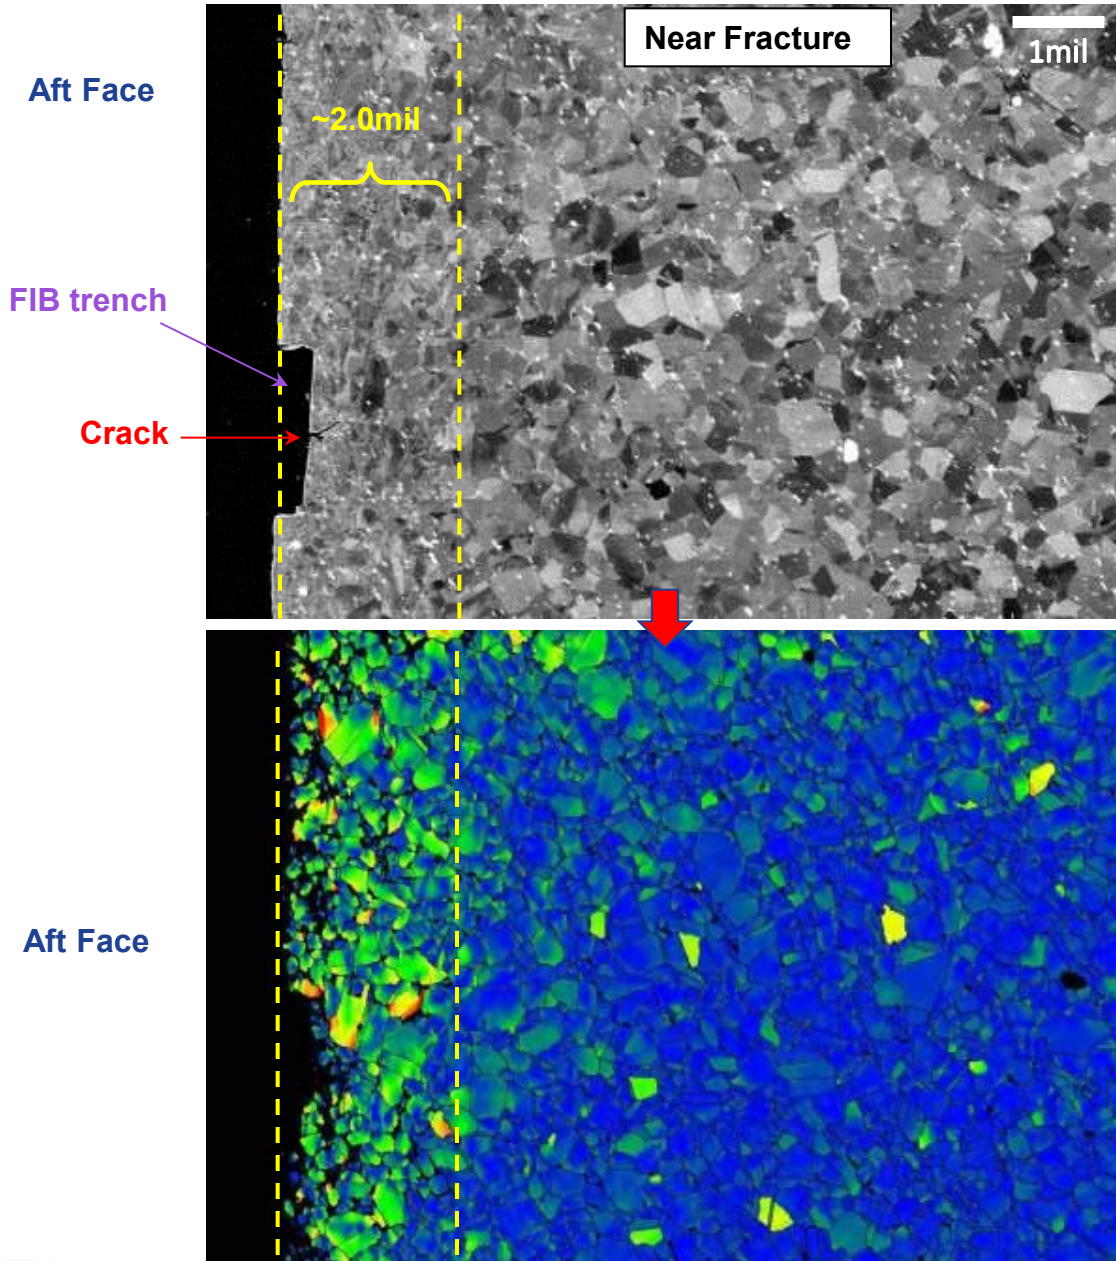
**Appendix E4:** Higher magnification comparison backscatter and EBSD images of the area with the small secondary crack near the main fracture.
