NATIONAL TRANSPORTATION SAFETY BOARD

MATERIALS LABORATORY FACTUAL REPORT

:	Oldenburg, Indiana
:	December 16, 2017
:	Cessna T210M, N761YZ
:	CEN18FA053
:	Timothy Sorensen, ASI-CEN
	::

Report No. 18-028

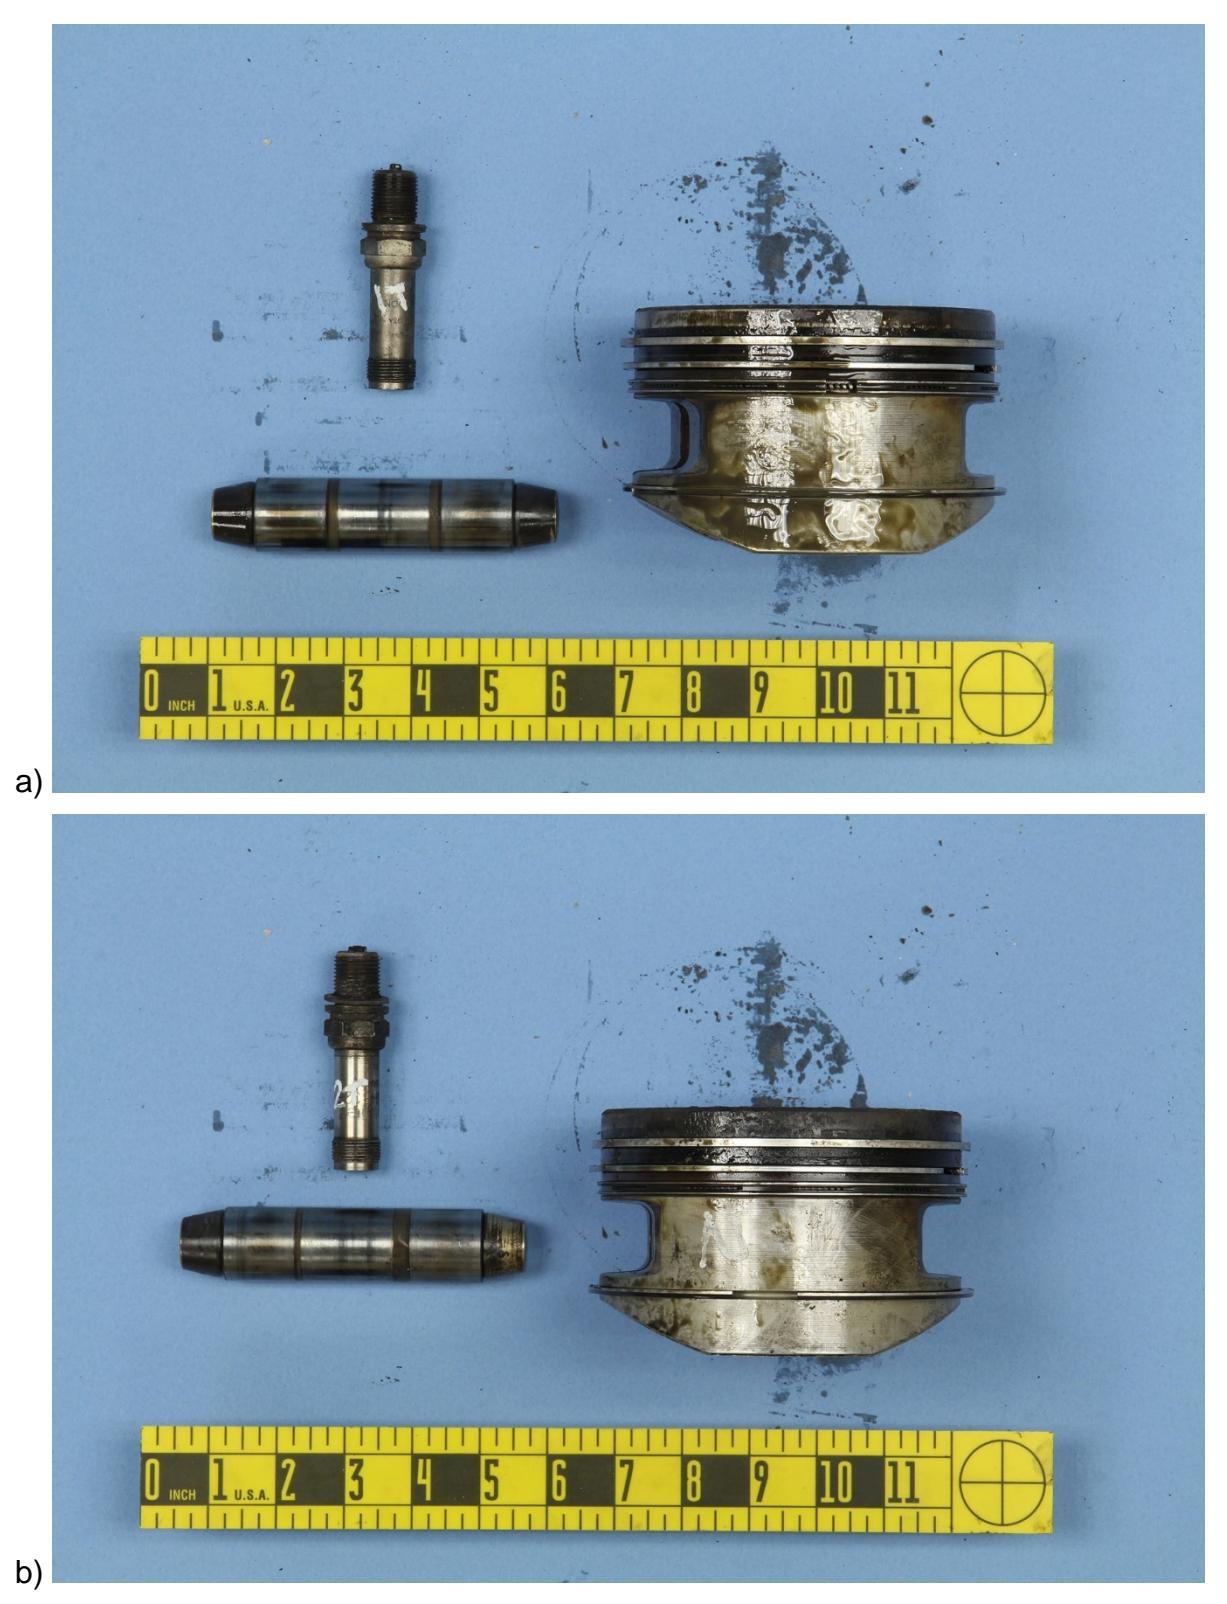
The numbers 1 through 6 cylinder pistons, along with their corresponding upper spark plugs and pins, are shown in figures 1a through f, respectively, as they were received by the lab. A photo of the number 4 cylinder, as received, is shown in figure 2. A schematic cross section of the piston is shown in figure 3. Initial examination indicated that pieces of the number 4 piston, including the top land, top ring groove, top compression ring, and outer portion of the piston crown had separated from the piston body. This report details the findings from the examination of the piston and other cylinder assembly components. Before presenting the findings, background information is given on the fabrication of the piston.

Figure 1: a) Image of the number 1 cylinder piston, piston pin, and upper spark plug; b) image of the number 2 cylinder piston, piston pin, and upper spark plug;

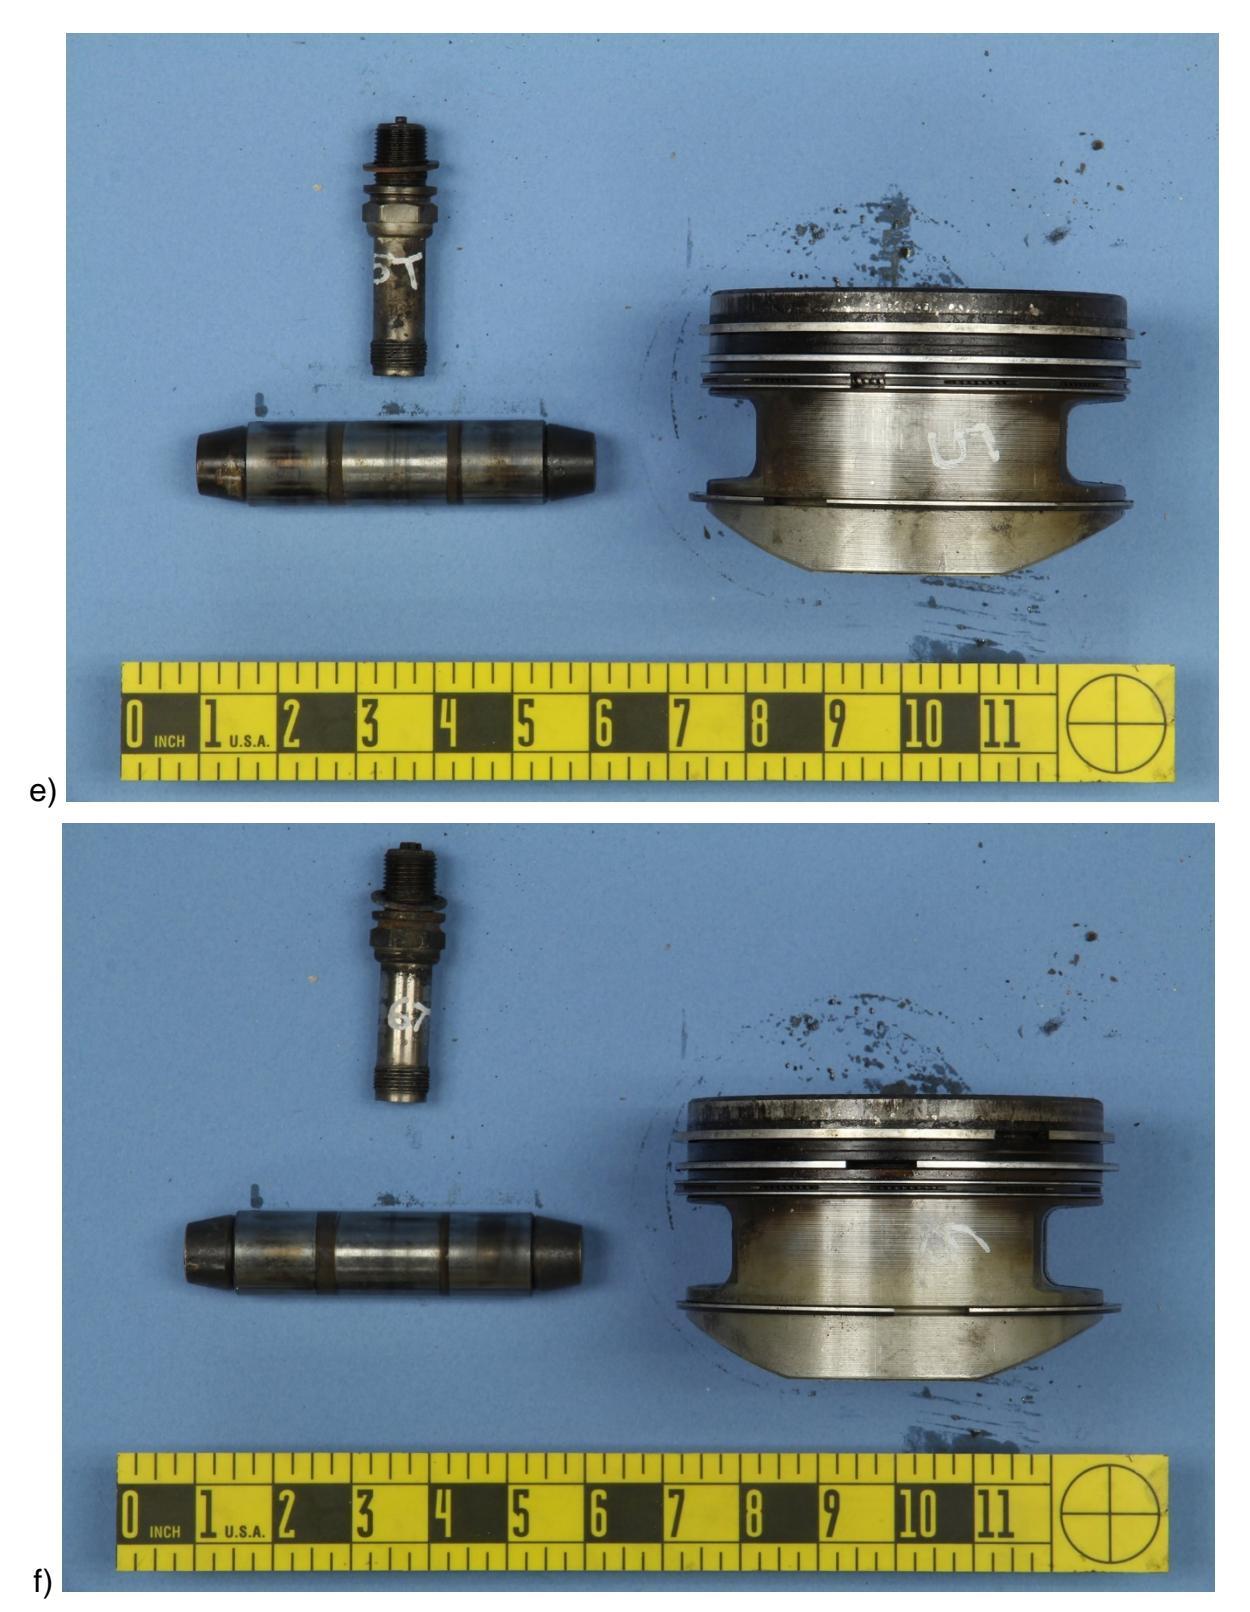
Figure 1 (cont.): e) image of the number 5 cylinder piston, piston pin, and upper spark plug; and f) image of the number 6 cylinder piston, piston pin, and upper spark plug.

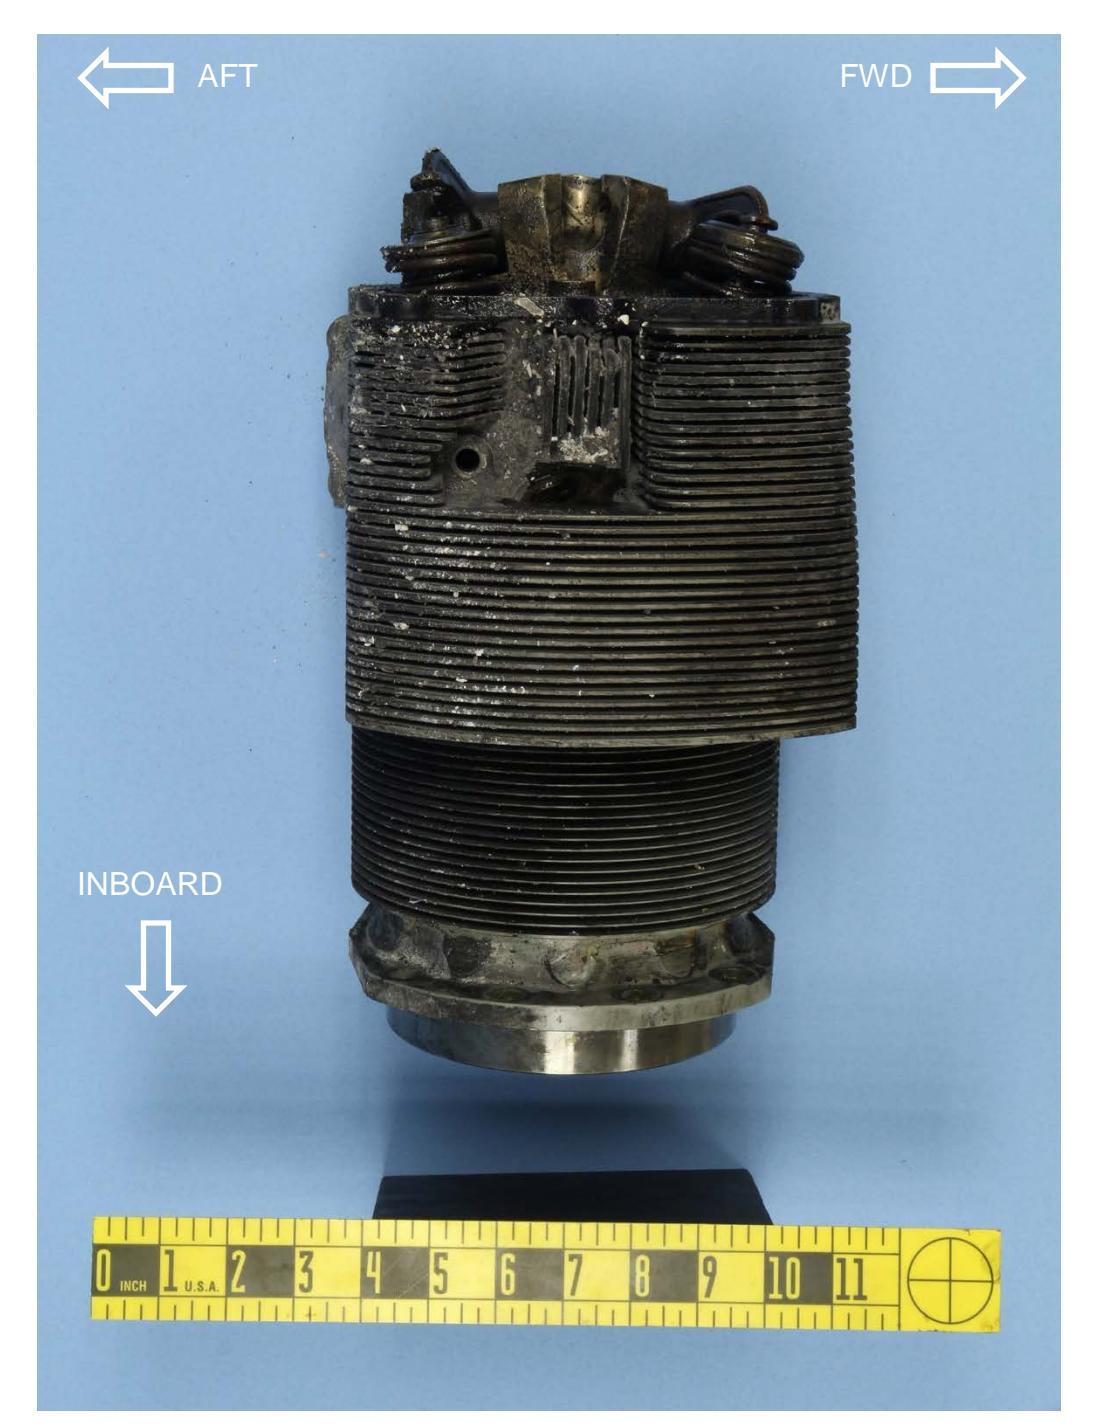
Figure 2: Image of the number 4 cylinder viewed from the top down as installed on the engine.

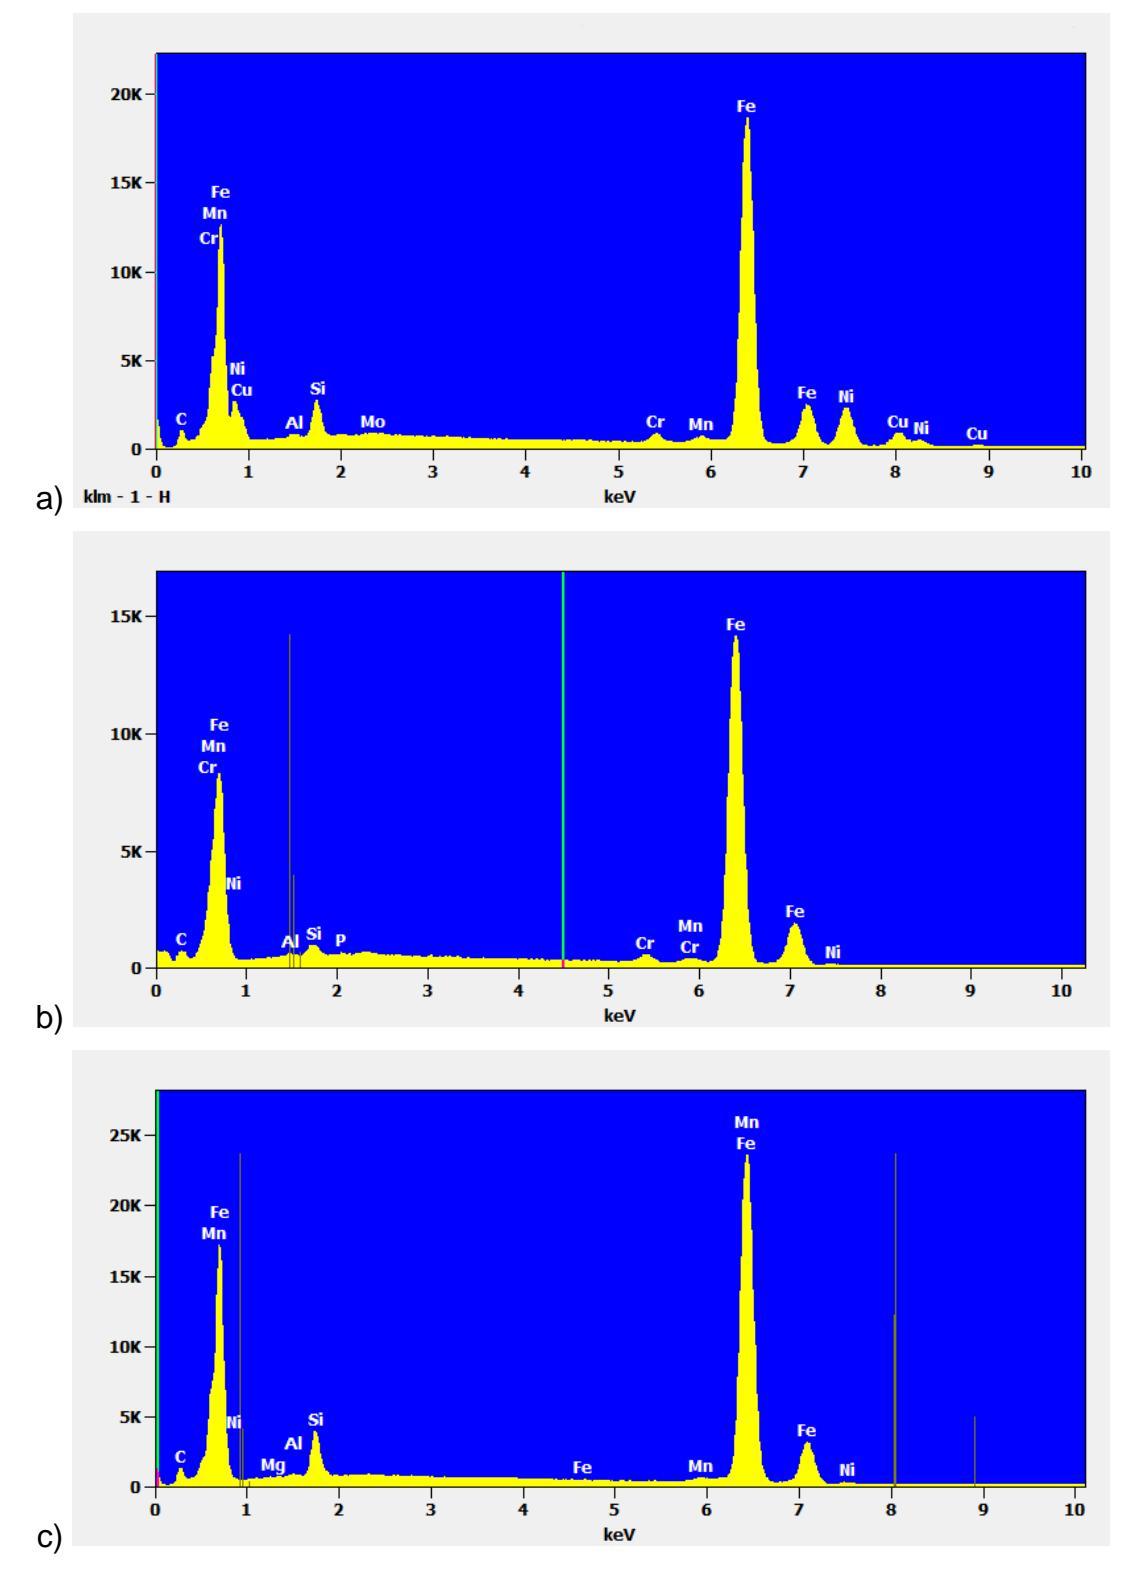
Reference spectra of the insert material, cylinder wall, and top compression ring were collected using EDS and are shown in figures 12a-c, respectively. All three materials were iron-based. However, of the three, only the insert material exhibited a Cu peak and only the insert and cylinder wall materials exhibited a chromium (Cr) peak.

Figure 12: Reference EDS spectra of: a) a piece of insert material; b) a piece of the number 4 cylinder wall; and c) a piece of the top compression ring.

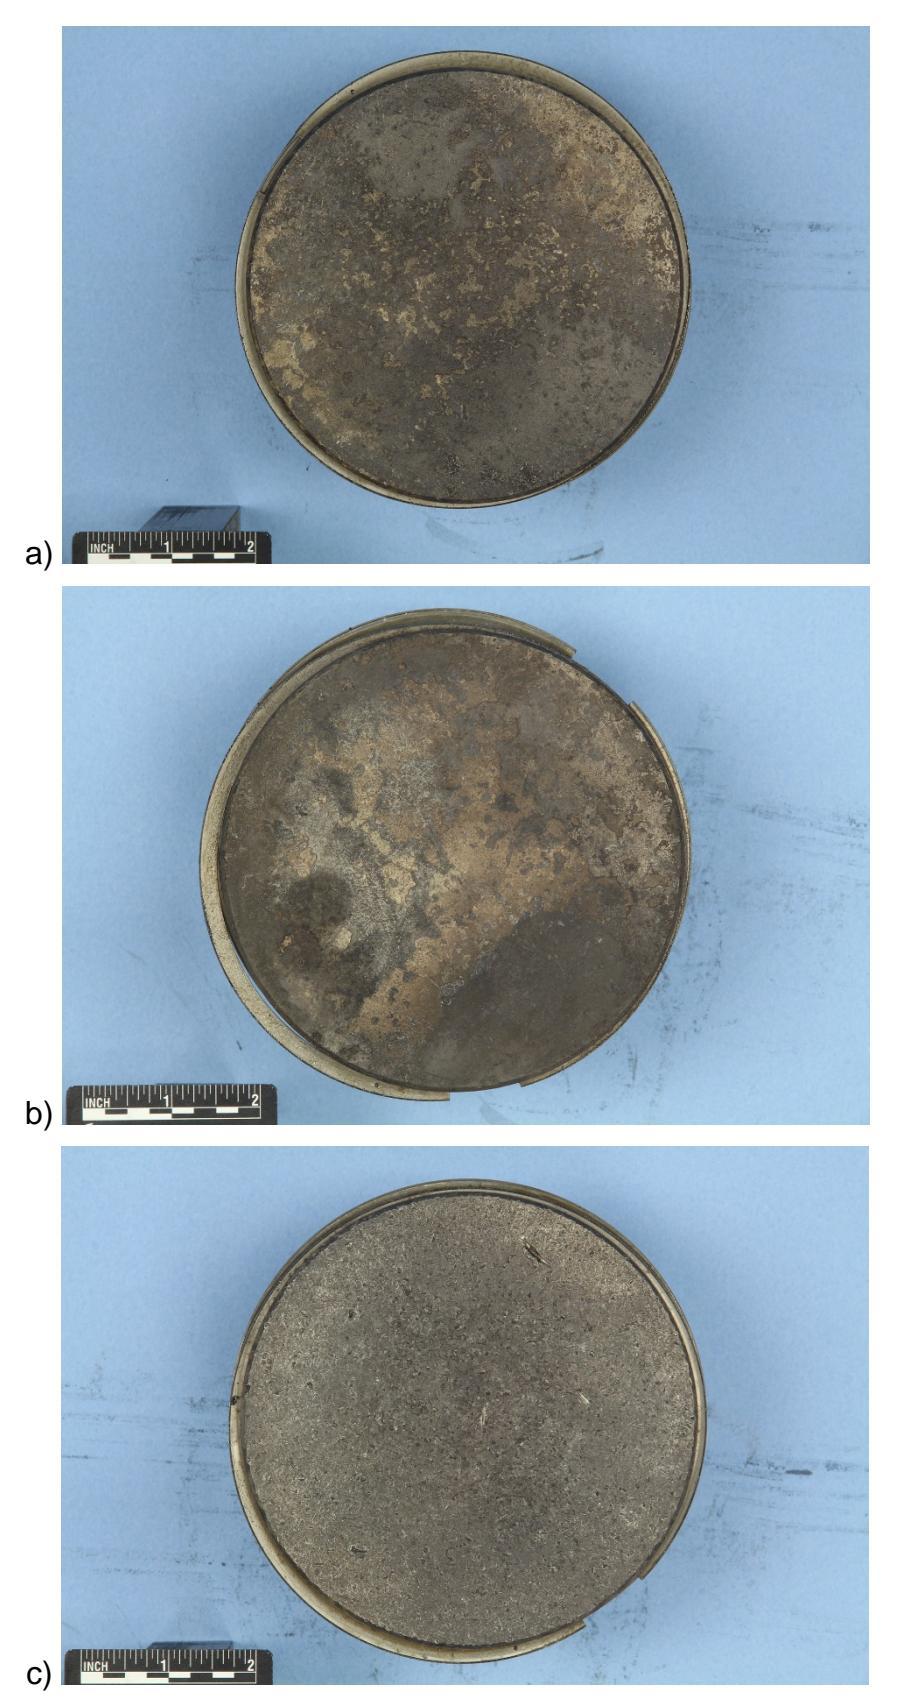
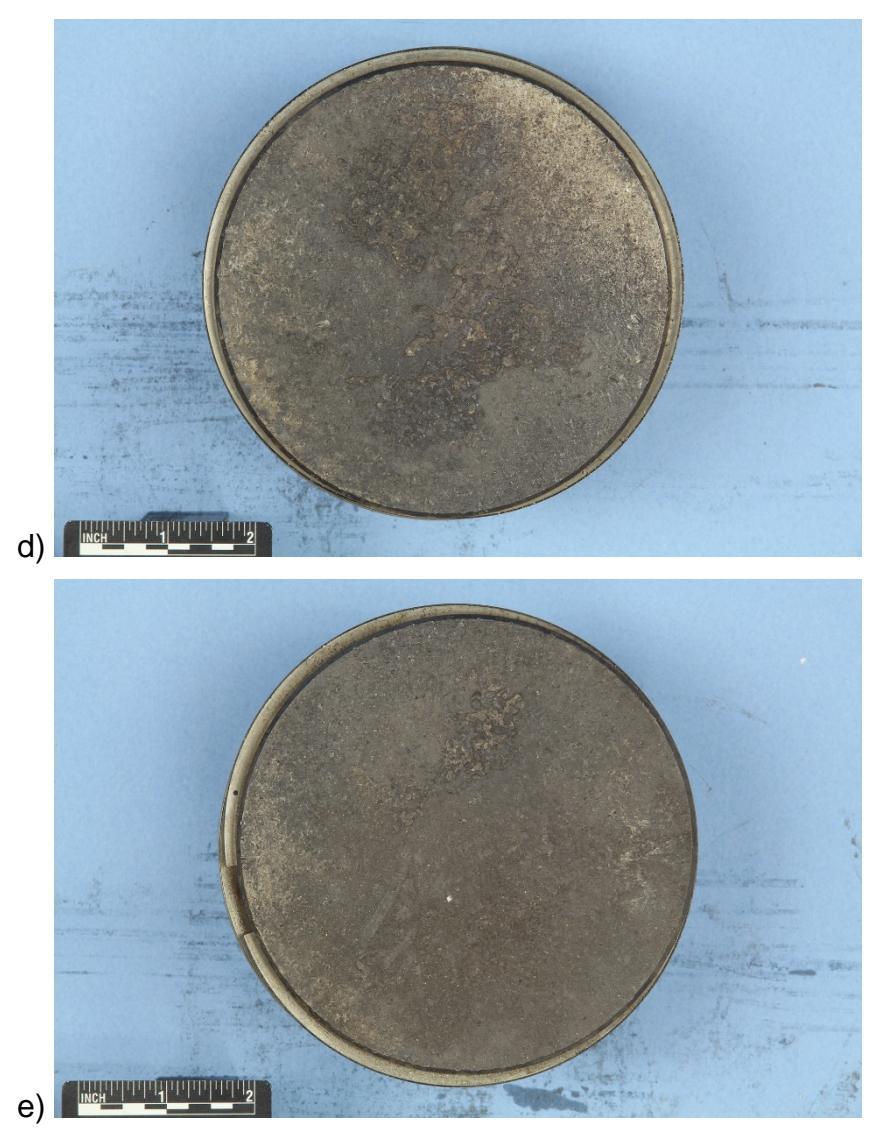
The crowns for the five remaining pistons are shown in figures 17a - e for cylinders 1, 2, 3, 5, and 6, respectively. The piston crowns were comparatively clean. The crowns on pistons 1, 2, 5, and 6 exhibited a thin intermittent layer of residue with a cream-colored appearance in spots. Piston 3 opposite of piston 4 exhibited a pitted appearance similar to that observed on the piston 4 crown, consistent with impact damage.

Figure 17: Images of piston crowns for: a) number 1 piston; b) number 2 piston; and c) number 3 piston;

Figure 17 (cont.): d) number 5 piston; and e) number 6 piston.

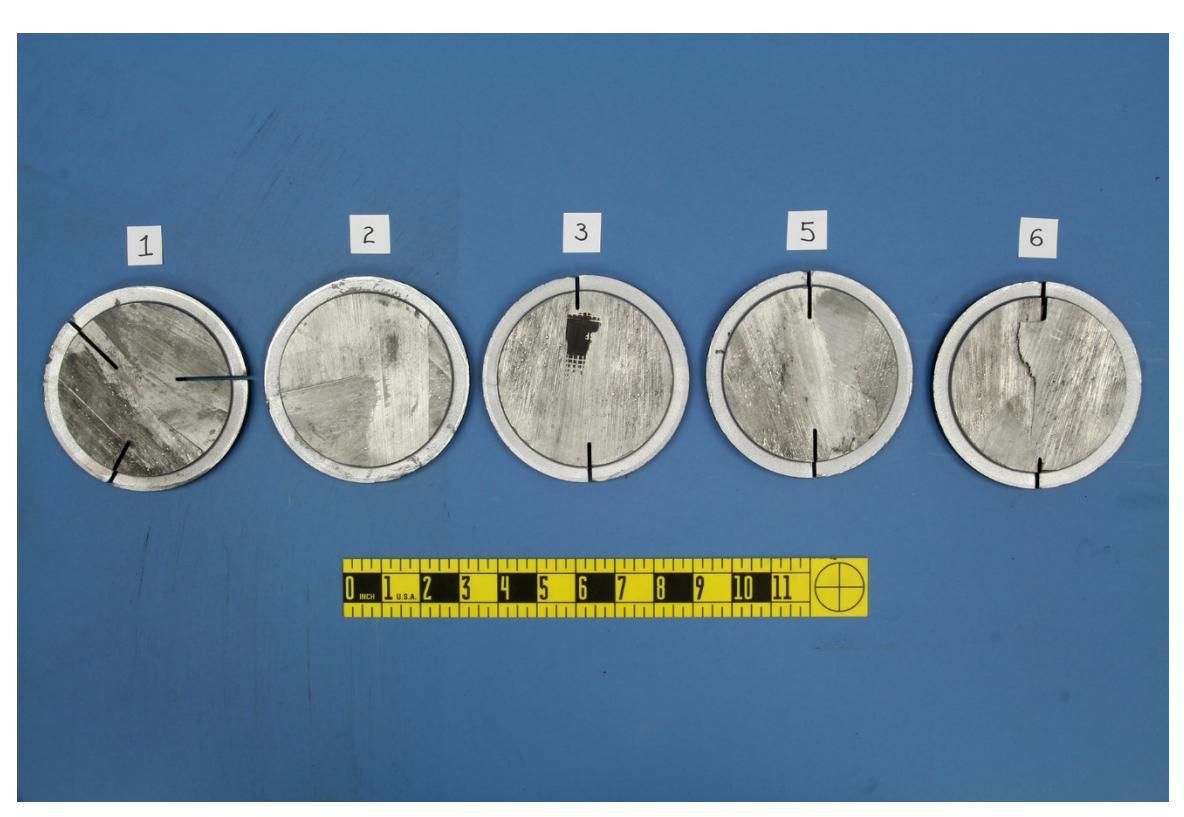
The top compression ring inserts and the aluminum material cast around them were examined by sectioning the pistons in two in the radial/circumferential plane through the ring groove using a band saw. The sectioned crown and top land regions are shown in figure 18 after removal of the insert pieces. The insert pieces were removed using a hammer and chisel. The chisel was placed along the insert/aluminum interface and the two materials were mechanically separated by striking the chisel with a hammer, moving the chisel along the interface as it separated. The first insert piece removed, on piston 2, was done so without cutting the insert but due to the difficulty, subsequent insert pieces were removed by first radially cutting through the insert in two or three places and starting the chisel at one of the cuts.

Figure 18: Image of the sectioned piston crowns after removal of the inserts for pistons 1, 2, 3, 5, and 6.

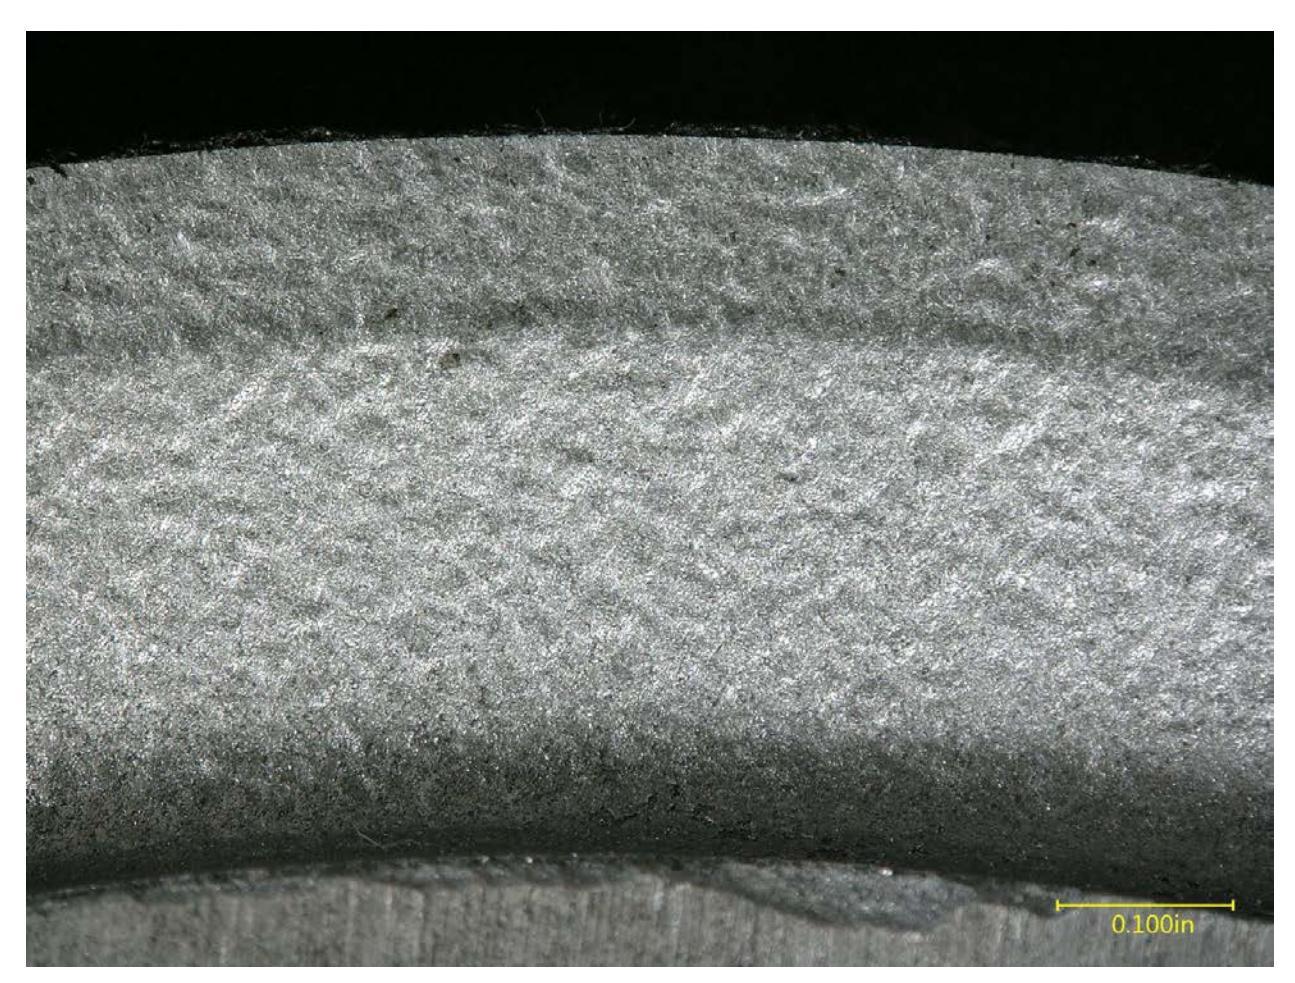
Visual examination of the aluminum backing material indicated that none of the other pistons exhibited the step that was observed along the edge of the lower insert support material, as shown in figure 19 for a typical region on piston 3. Nor did any of the

Figure 19: Image of the insert lower arm support material for the number 3 piston. No stepped region was observed along the outer edge of the support material.

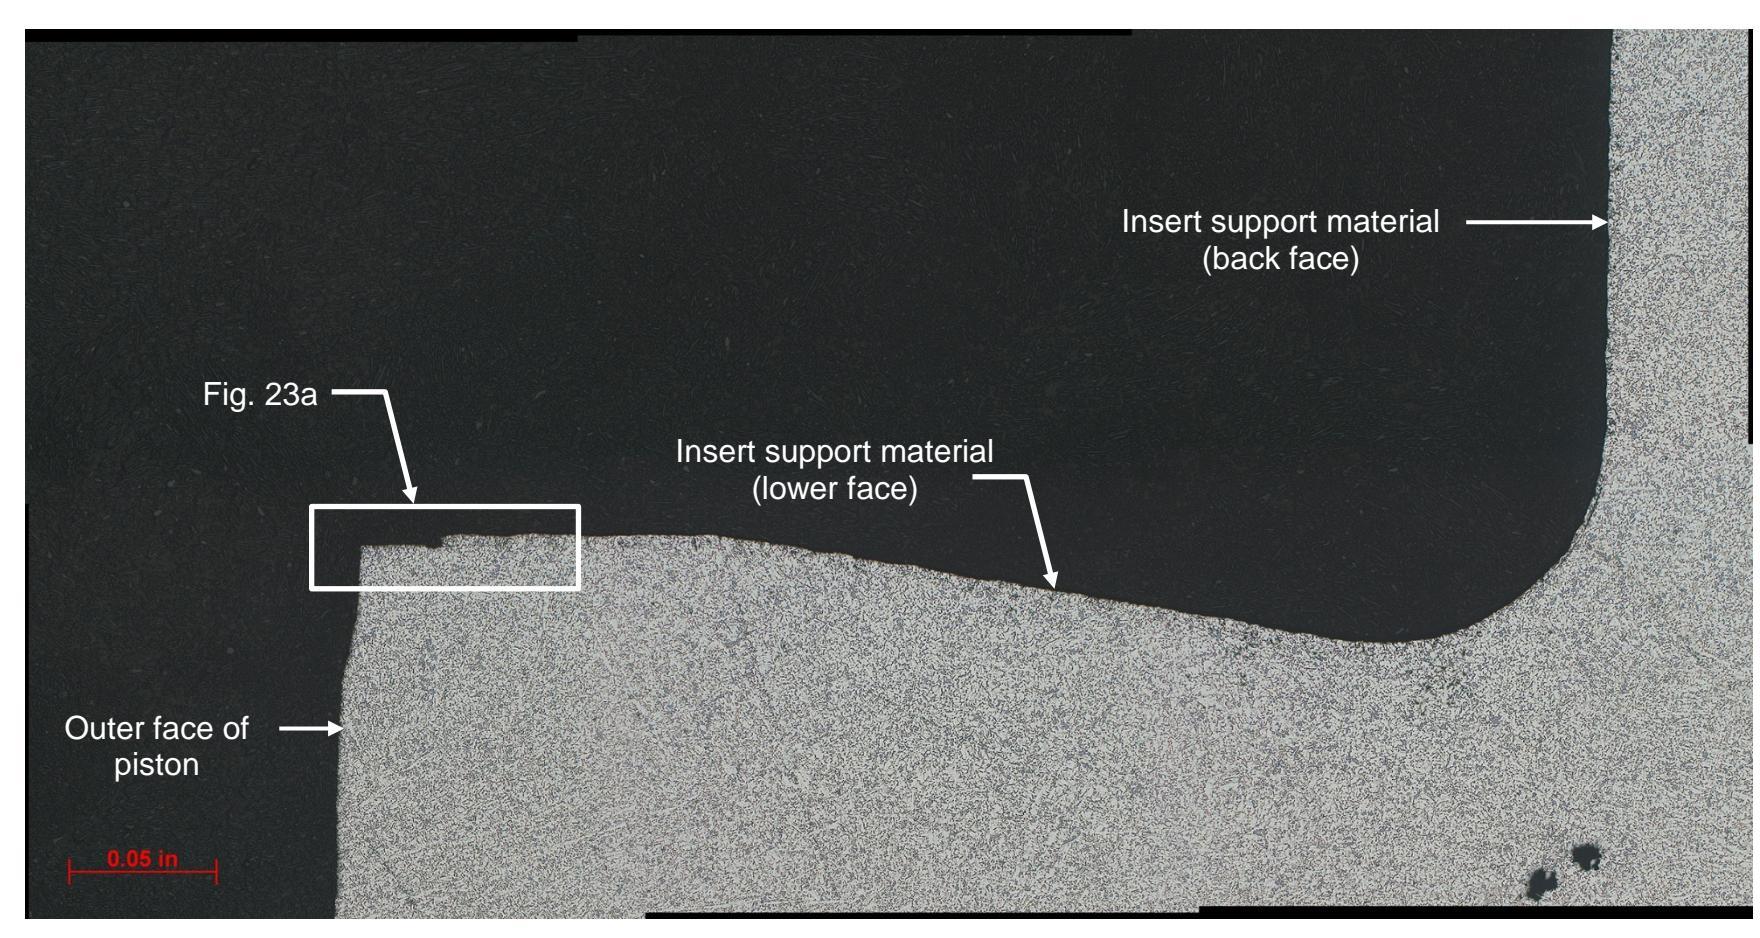
The material microstructure for the number 4 and number 3 pistons were evaluated on metallurgical cross sections through the lower insert support material. Pieces of the numbers 4 and 3 pistons were sectioned in the radial/axial plane using a water-cooled abrasive cutting saw. The cut faces were placed face down in a mounting press and mounted in a diallyl phthalate resin. The mounted samples were ground and polished through a series of silicon carbide papers, diamond suspensions, and colloidal silica suspension in accordance with standard laboratory procedures. A mosaic image of the number 4 piston cross section is shown in figure 22 for reference. The insert support material for the insert lower face and back face are indicated in the figure. Also indicated is the location of a higher magnification image at the intersection of the lower support material and the outer face of the piston that is shown in figure 23a.

Figure 22: Mosaic image of a metallographic cross section through the number 4 piston insert support material including the lower arm and back face. The cross section was taken near the 12:00 position.
