# NATIONAL TRANSPORTATION SAFETY BOARD

MATERIALS LABORATORY FACTUAL REPORT

Report No. 15-021

Place : Bedford, Massachusetts  
Date : May 31, 2014  
Vehicle : Gulfstream IV  
NTSB No. : ERA14MA271  
Investigator : Adam Huray (AS-40)

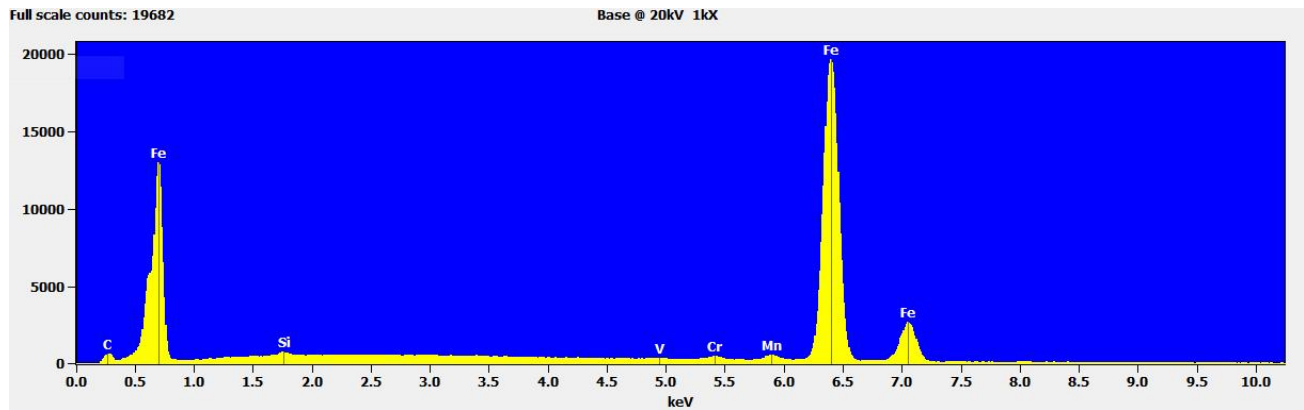
Per Gulfstream personnel, the lock pin (Part Number (P/N) 43906-463) assembled within the gust lock handle assembly (P/N 43083-402-1) is supposed to be made from drill rod material. A representative of Rockwell Collins, the manufacturer of the gust lock handle assembly, reported the drill rod material should have been Type A2 tool steel that met the requirements of ASTM A681, according to the Rockwell Collins material supplier. A standard-less semi-quantitative EDS analysis revealed that while the composition could meet the parameters for drill rod, it did not meet the ASTM A681 specification for Type A2 tool steel. An EDS spectrum representative of the base material is shown in Figure 18. The hardness was measured on the cross-section through the outboard lock pin piece using a LECO automatic microindentation hardness tester per ASTM E384.<sup>1</sup> The hardness of the outboard lock pin piece averaged 30 HRC (302 HV<sub>500</sub>), which indicates the material was not quench hardened and tempered. The microstructure of the outboard lock pin piece material, shown in Figure 19, consisted of spheroid carbides in a ferrite matrix, which is consistent with steel in a spheroidized condition.

**Figure 18:** Semi-quantitative EDS spectrum of the base material of the outboard lock pin piece.

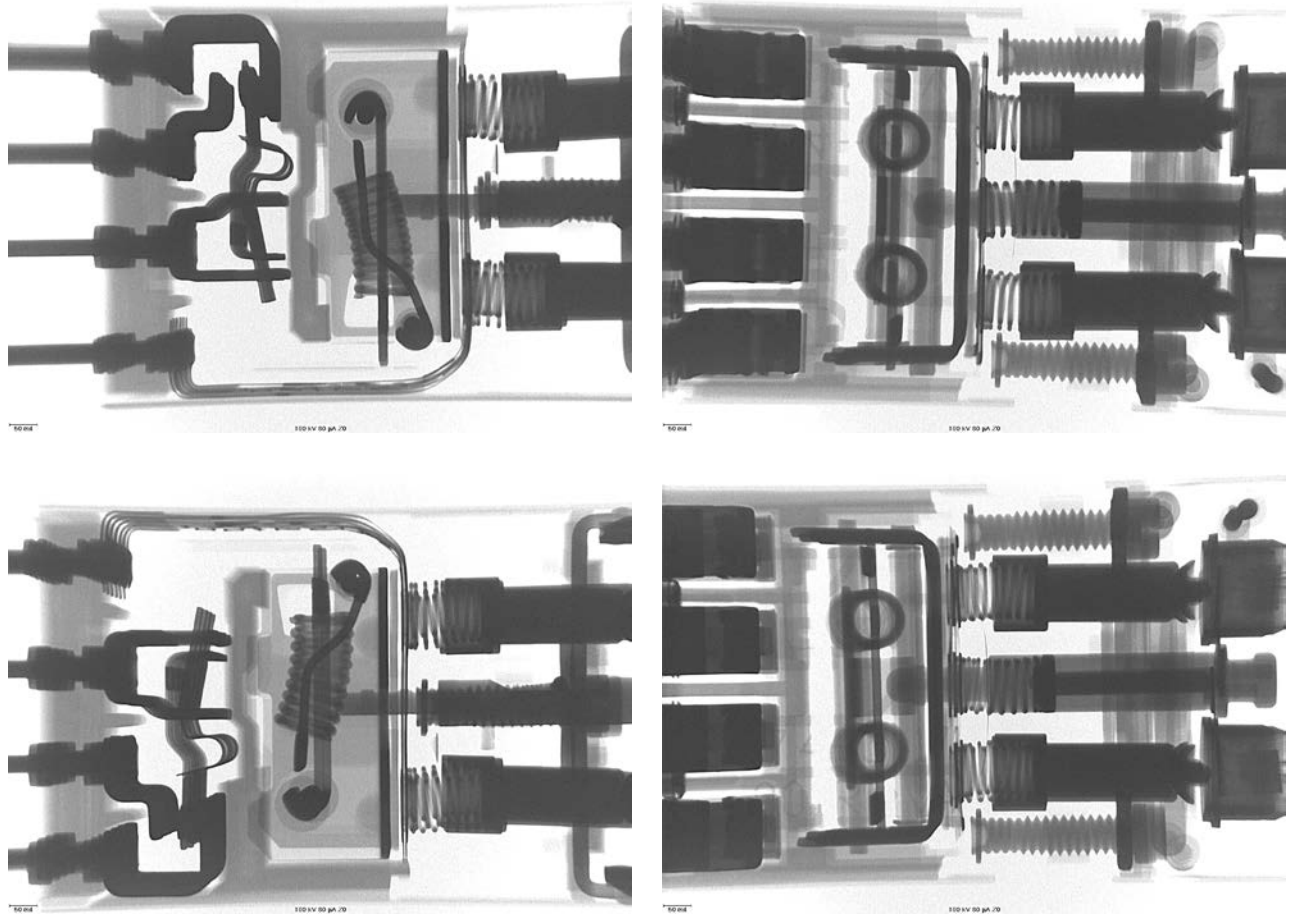
**Exemplar Switch, Wiring Scheme #1 – Depressed**

The four non-test switches were manually disassembled from the switch assembly and x-rayed in the as-submitted position. The Thrust Reverser Emergency Stow, Ground Spoiler, and Anti-Skid switches had similar connections, while the Stall Barrier switch had different wiring. Radiographs of the Thrust Reverser Emergency Stow, Ground Spoiler, Anti-Skid, and Stall Barrier switches are shown in Figure 34-Figure 37, respectively. Unused exemplar switches that represented each wiring scheme were provided by Gulfstream for comparison, and were also x-rayed. The exemplar switches were examined in both the depressed and extended positions. Figure 38 and Figure 39 show radiographs of the first wiring scheme in the depressed and extended positions, respectively, while Figure 40 and Figure 41 show radiographs of the other wiring scheme in the depressed and extended positions, respectively.

**Figure 38:** Radiographs of the 4 sides of the exemplar switch with the first wiring scheme in the depressed position.

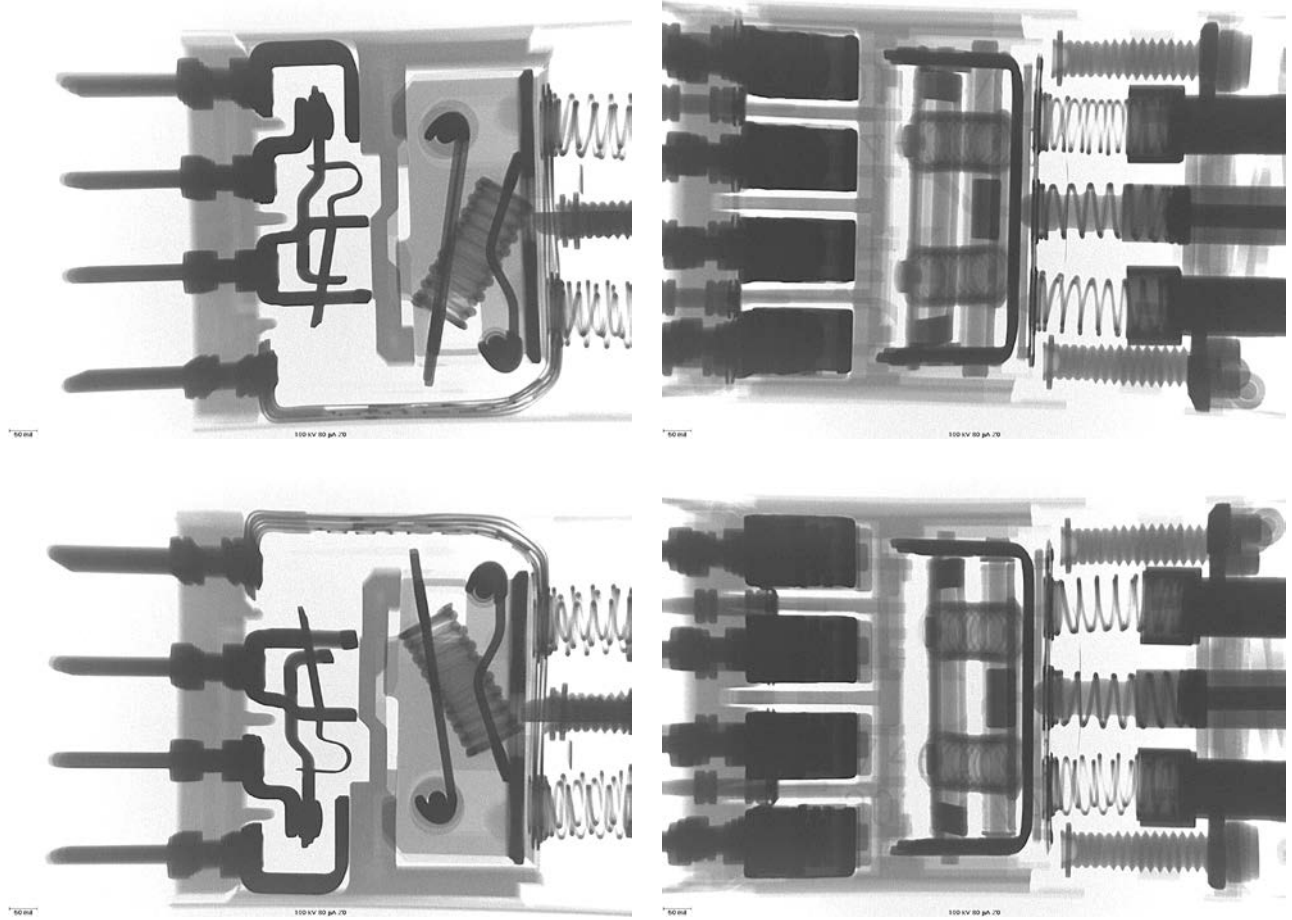
**Exemplar Switch, Wiring Scheme #1 – Extended**

**Figure 39:** Radiographs of the 4 sides of the exemplar switch with the first wiring scheme in the extended position.

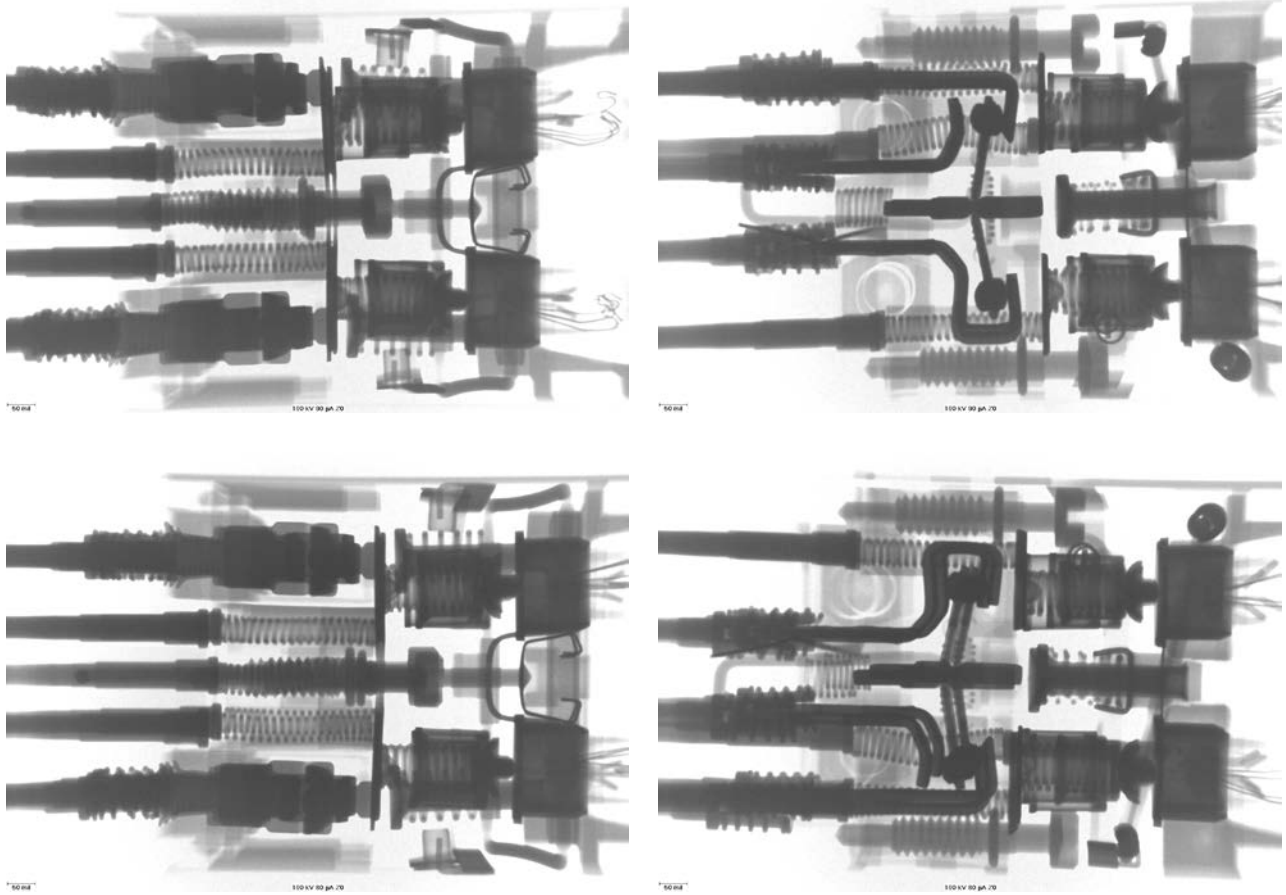
**Exemplar Switch, Wiring Scheme #2 – Depressed**

**Figure 40:** Radiographs of the 4 sides of the exemplar switch with the second wiring scheme in the depressed position.

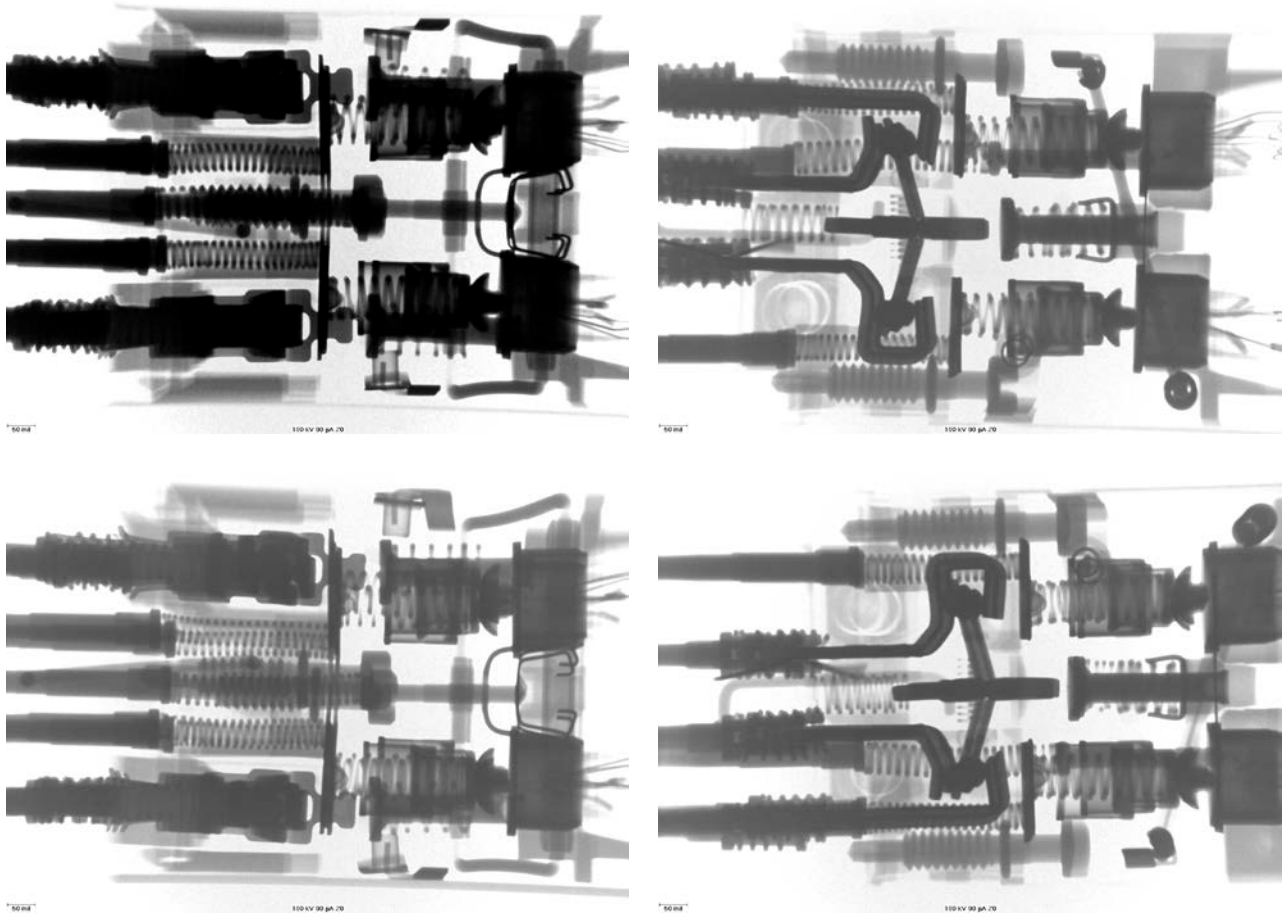
**Exemplar Switch, Wiring Scheme #2 – Extended**

**Figure 41:** Radiographs of the 4 sides of the exemplar switch with the second wiring scheme in the extended position.
