NATIONAL TRANSPORTATION SAFETY BOARD

MATERIALS LABORATORY FACTUAL REPORT

Report No. 14-010

Place : Birdseye, Utah
Date : June 27, 2013
Vehicle : Cessna 172
NTSB No. : WPR13FA294
Investigator : Michael Huhn
AS-WPR

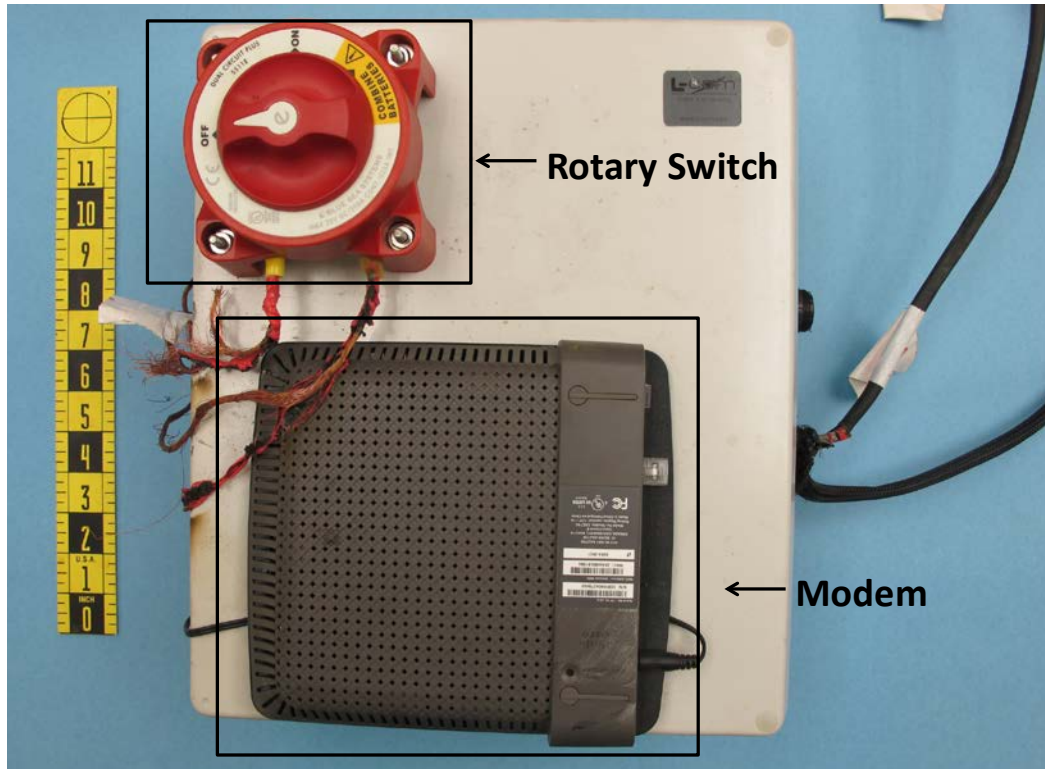
Figure 5. Top view photograph of power distribution box.

The configuration of the top of the power distribution box is shown in Figure 5. The power distribution box sustained sooting, paint discoloration, paint blistering and warping of the lower corner (sidewall and bottom) of the case as shown in Figures 6 and 7. The damage to the battery box corresponded to the damage on the lower corner of the power distribution box as shown in Figure 8. The interior of the distribution box had minimal
