NATIONAL TRANSPORTATION SAFETY BOARD

MATERIALS LABORATORY FACTUAL REPORT

Report No. 15-077

Place : Anchorage, Alaska
Date : March 14, 2015
Vehicle : Eurocopter AS350-B2
NTSB No. : ANC15LA015
Investigator : Shaun Williams

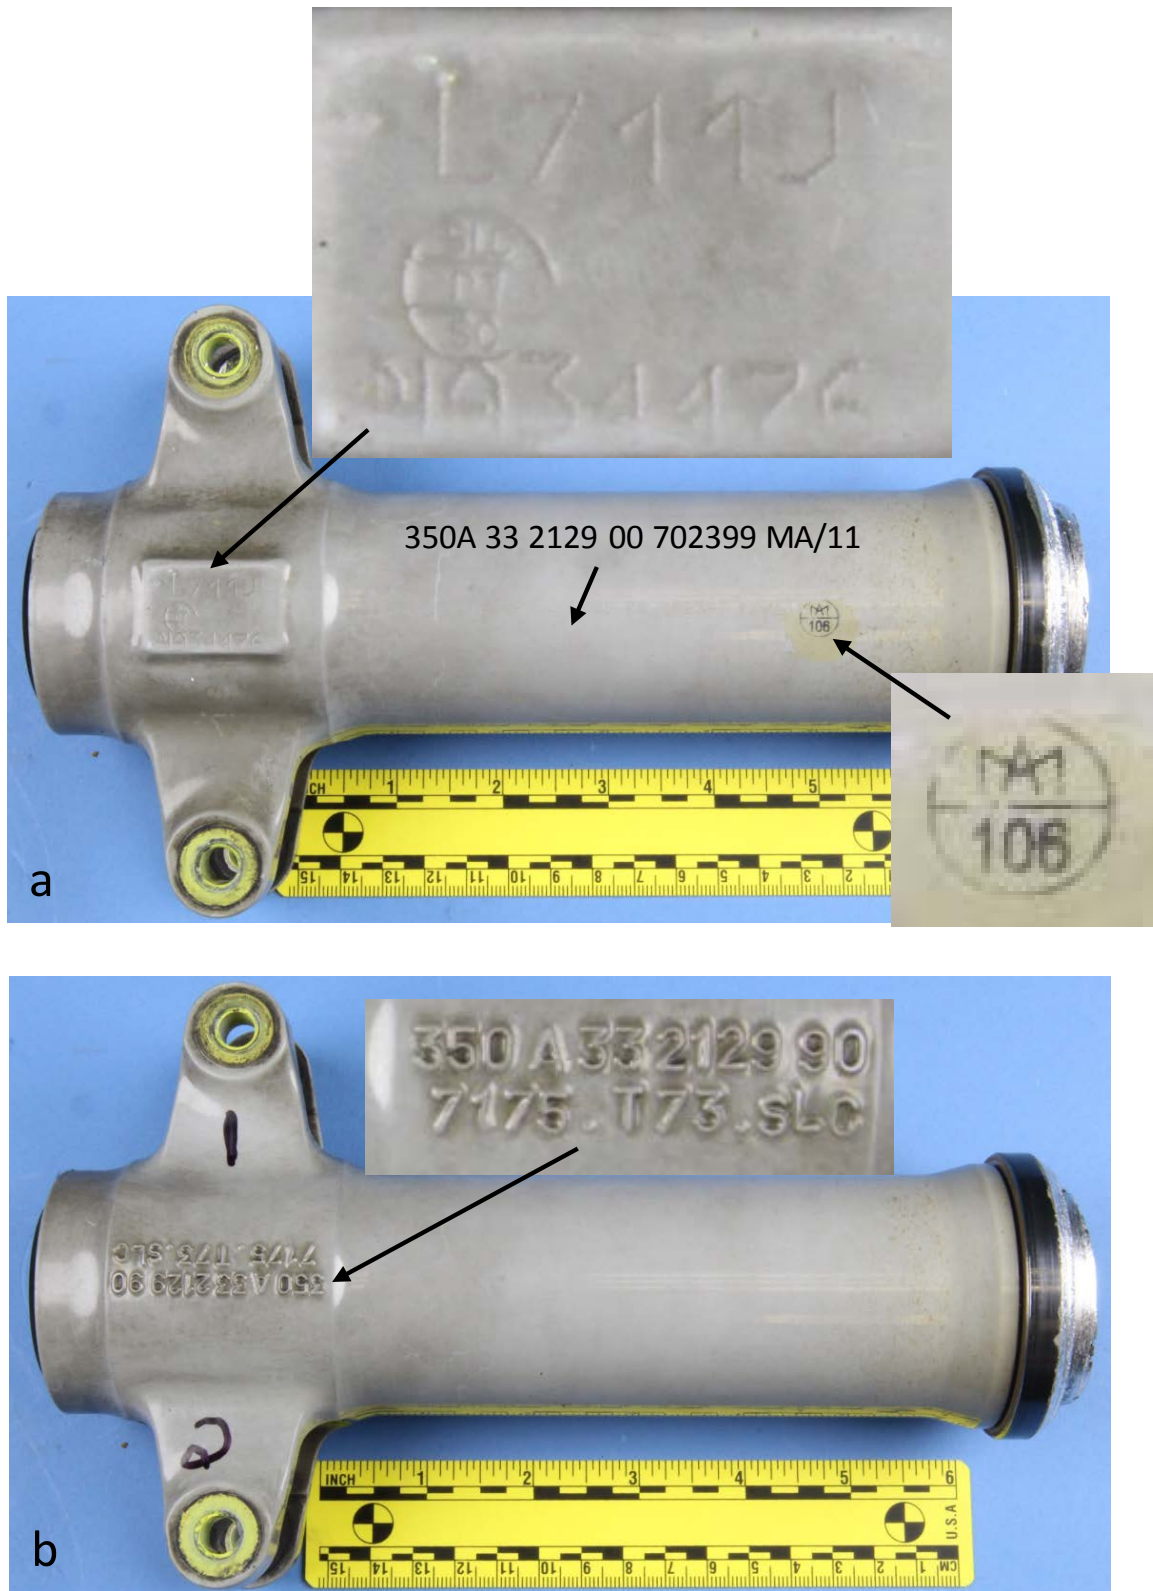
Figures 9 and 10 show pieces of rotating plate and stationary pate respectively. The part markings are identified.

Figure 9 Image of a portion of the rotating plate, showing part identification markings.

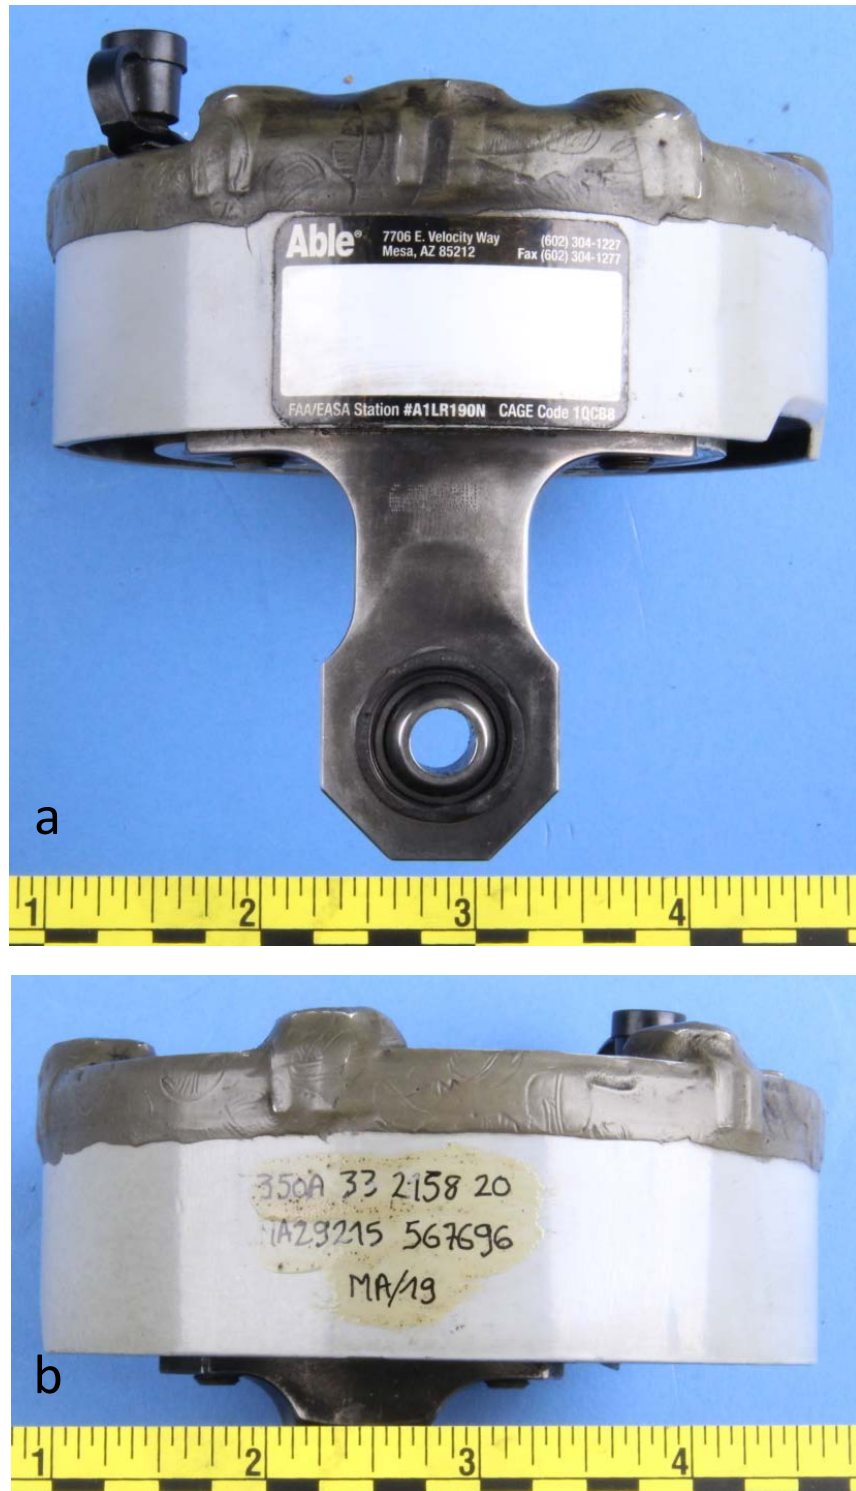
Figure 10 Image of the stationary plate showing part identification markings.
