NATIONAL TRANSPORTATION SAFETY BOARD

MATERIALS LABORATORY FACTUAL REPORT

Report No. 17-081

Place : Medford, New Jersey
Date : September 8, 2017
Vehicle : Schweizer 269C1, N204HF
NTSB No. : ERA17FA317
Investigator : Brian Rayner, ASI-ERA

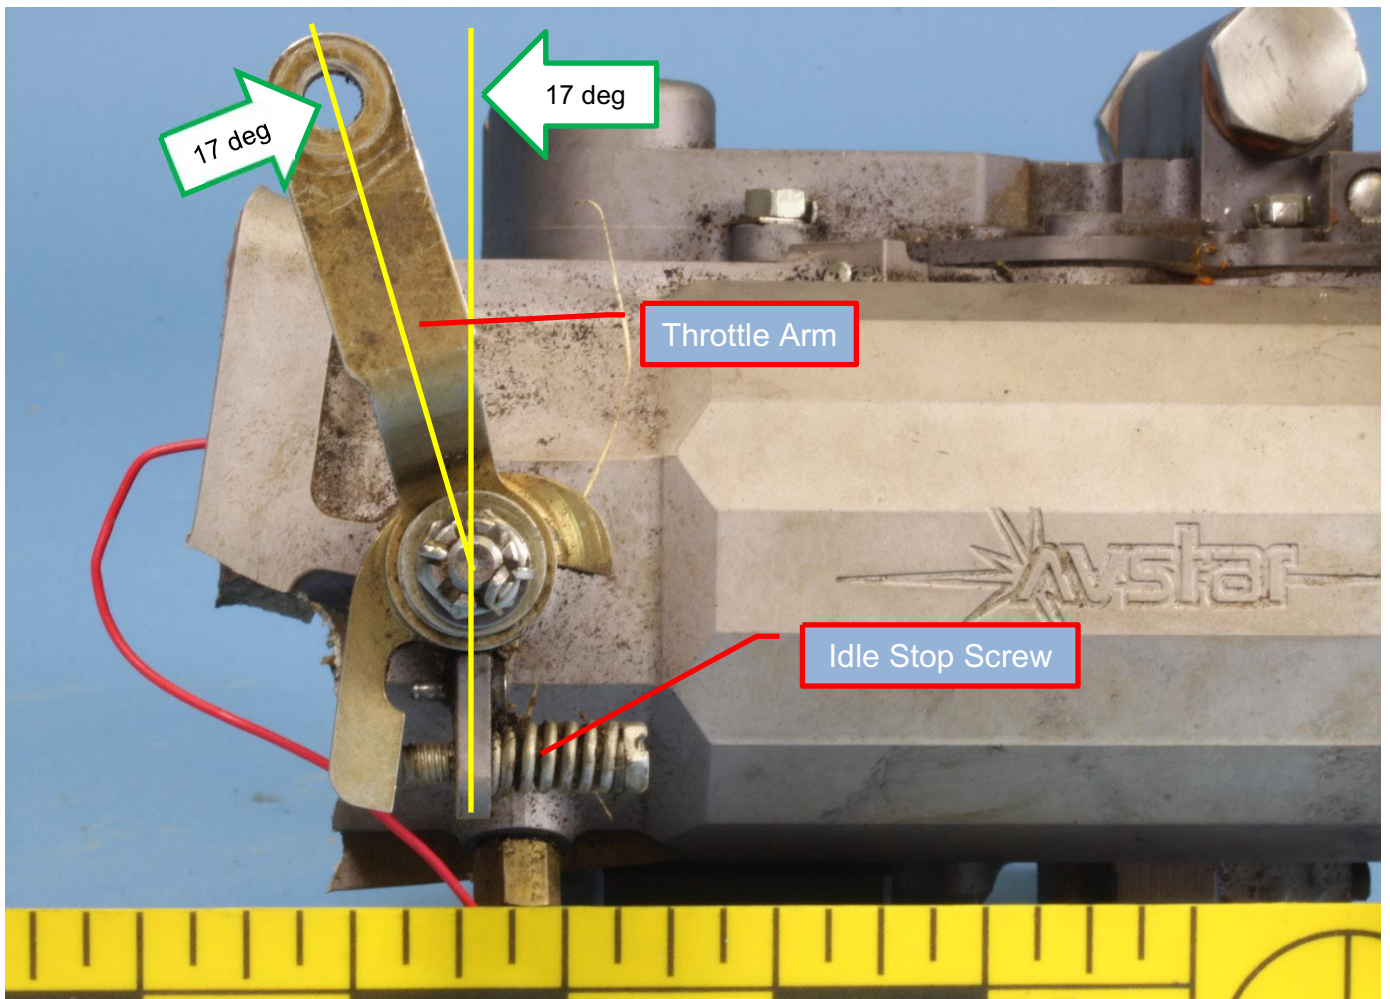
The carburetor is displayed in the upper view of figure 8 with the bellcrank and tie rod pieces positioned in their approximate original positions. The mounting structure for the bellcrank was fractured and deformed. The inlet and outlet flanges of the carburetor were also distorted and fractured. The throttle arm and idle stop screw appeared intact and undistorted. The maintenance documents indicated that with the throttle arm at idle (against the stop) The arm should be at approximately 17 degrees from vertical. The angle of the arm was photographically measured using three different reference lines on the carburetor. All three measurements were within 1 degree of 17 as depicted in the lower view of figure 8.

Figure 8. The carburetor with the linkage roughly positioned in the upper view. Lower view illustrates the 17 degree angle of the throttle arm at idle setting.
