Derailment of BNSF Grain Train G-RYLRGT9-26A
and Subsequent Collision BNSF Oil Train U-FYNHAY4-05T

Casselton, North Dakota

Mechanical Group Factual

NTSB Accident Number: DCA-14-MR-004
Date of Accident: December 30, 2013
Time of Accident: 2:11p.m. (CDT¹)
Type of Trains: BNSF Freight Trains, G-RYLRGT9-26A & U-FYNHAY4-05T
Railroad Owner: BNSF Railroad
Train Operator: BNSF Railroad
Fatalities: 0
Injuries: 0
Location of Accident: Casselton, ND

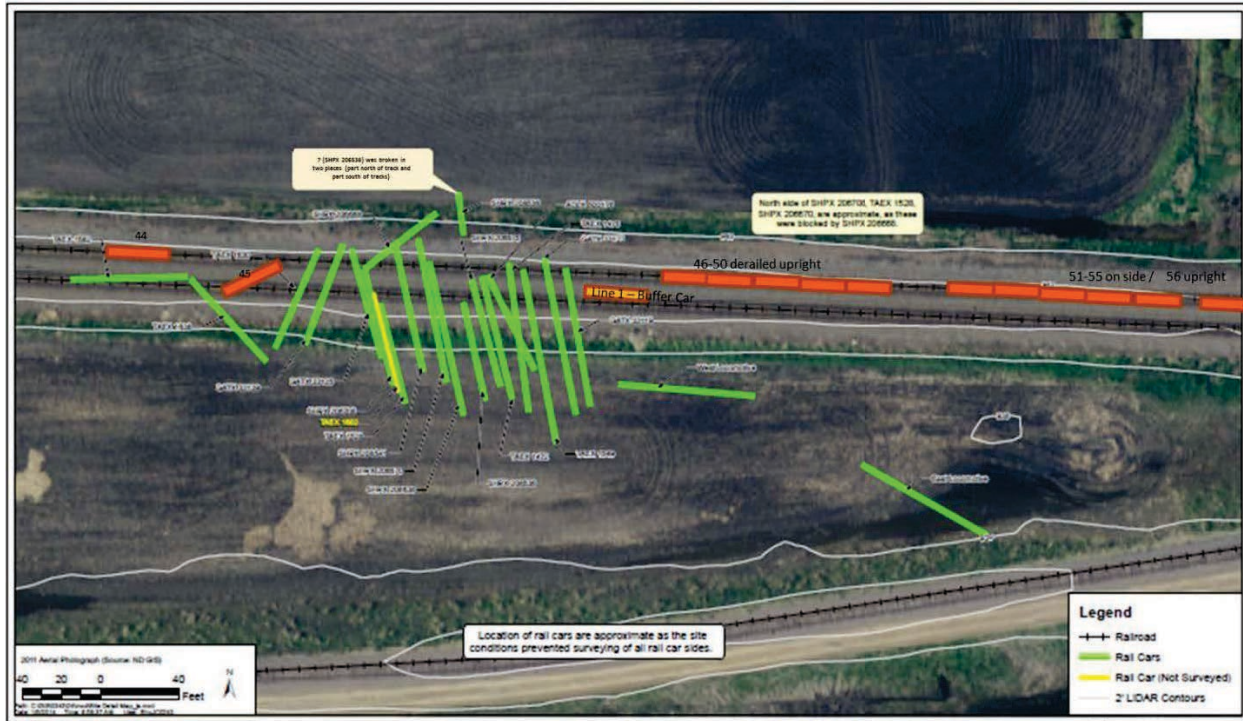
Figure 2-Accident Diagram

The next 20 cars from this train derailed in a general pile-up. The cars were overturned, smashed and left lying in a zigzag pattern. See figure 2. The trailing trucks from the 21st car derailed upright and undamaged. The 1st car in the line was a buffer car hauling sand. The next 20 cars were tank cars hauling petroleum crude oil. 18 of those cars tank cars breached as a result of the collision and released full loads of product resulting in a large fire.
