National Transportation Safety Board

Collision of Southeastern Pennsylvania Transit Authority
Trolley Car 9085 with Trolley Car 9101
At 38th Street and Lancaster Avenue in
Philadelphia, Pennsylvania
January 4, 2017

Mechanical Group Factual Report
Mike Hiller, Mechanical Group Chairman

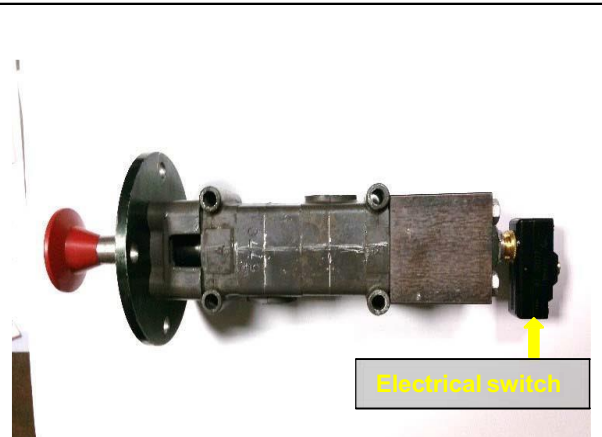
Figure 3. Emergency brake push-button with the electrical switch labeled

Investigators observed that the track brake did not function during tests 3 and 4 when using the emergency brake push-button. After post-accident brake performance testing, investigators returned LRV 9085 to the Elmwood maintenance facility to troubleshoot the inoperative track brake. Investigators removed the inspection panel under the operator console and found a broken electrical switch no longer attached to the emergency brake push-button.⁷ (See figure 5.)

The electric switch is a type of plunger switch with a threaded portion inserted in the end of the emergency stop push-button. (See figure 6.) When the emergency stop push-button is depressed, the plunger on the electrical switch is depressed thus activating the electromagnetic track brake. The track brake was not functional for brake test numbers 3 and 4 because the switch was damaged.

In January 2017, SEPTA completed a fleet inspection of all LRVs equipped with an emergency brake push-button to ensure the electrical switches were unbroken, correctly installed and performed as designed. On February 3, 2017, SEPTA developed an engineering change notice for the electrical switch detailing an installation procedure along with the addition of a support bracket to mitigate future switch failure potential. A copy of their procedure appears as attachment 3 in the NTSB Docket, DCA17FR003.
