ERA12LA535

Millville, New Jersey

Beech Aircraft Corporation 95-A55 – N71BM

NTSB ENGINE EXAMINATION NOTES

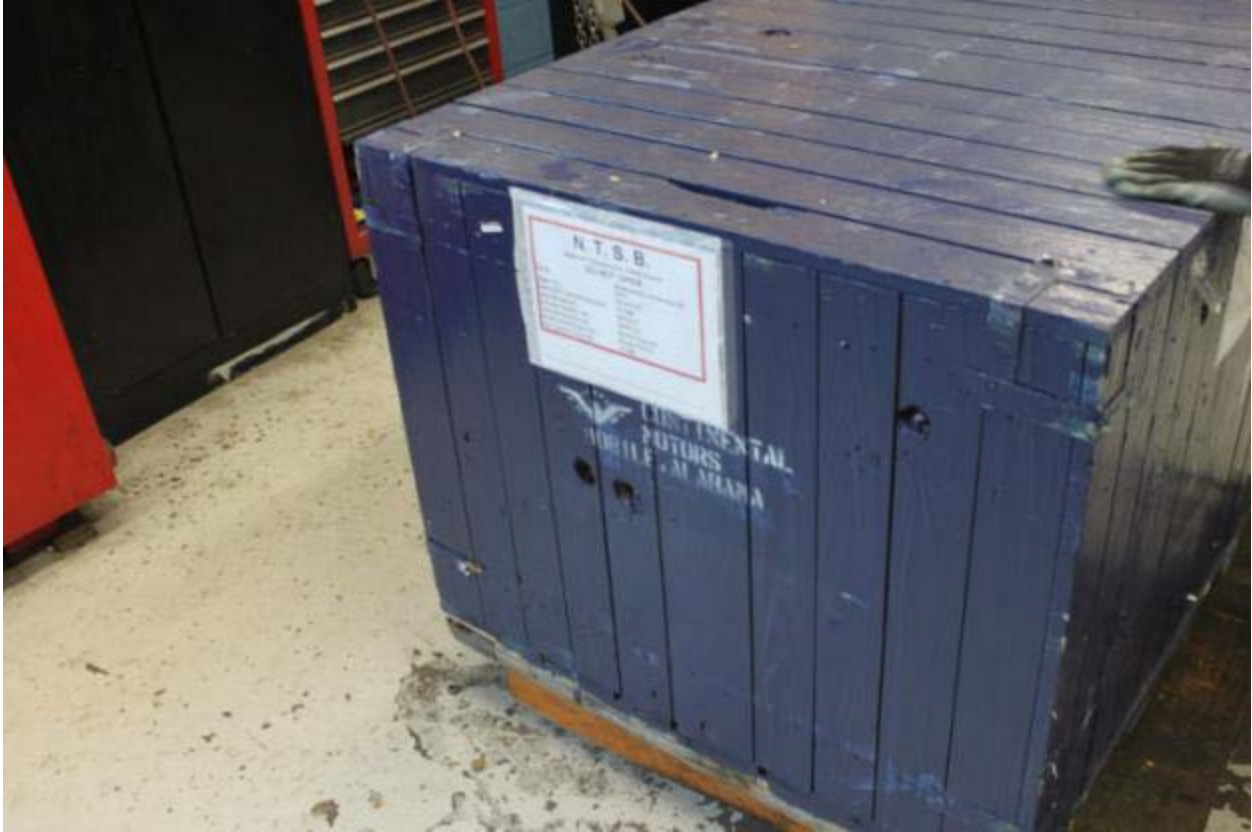
Photo 5: Right Engine Packaged

The engine was shipped from the accident airport to CMI's facilities in Mobile, Alabama via crate and bonded shipment. Upon receipt the engine was immediately logged and placed in bonded/secure storage and was not opened. The crate was viewed by the IIC as unopened; it was photographed and opened for examination. The examination revealed that four (4) mounting legs were impact separated and will need to be replaced in order to facilitate examination. The oil sump exhibited a breach of the structure which resulted in a loss of engine oil. The left side exhaust exhibited compression damage near the No. 1 Cylinder area. The right side exhaust exhibited slight compression damage on the aft side of the engine which resulted in a breach of the tubing. The generator pulley rim exhibited impact damage; however, the generator remained attached to the rear accessory drive. The starter was impact separated; however, was found placed on the right side of the engine's exhaust. Induction tubes exhibited impact damage at the coupling near cylinders No.s 1 and 2.
