May 28, 2002

N.T.S.B.

RE: Examination of Failed Aluminum Spars From a Cessna Aircraft
N444JV LAX02FA101; SEAL Job No. 9034

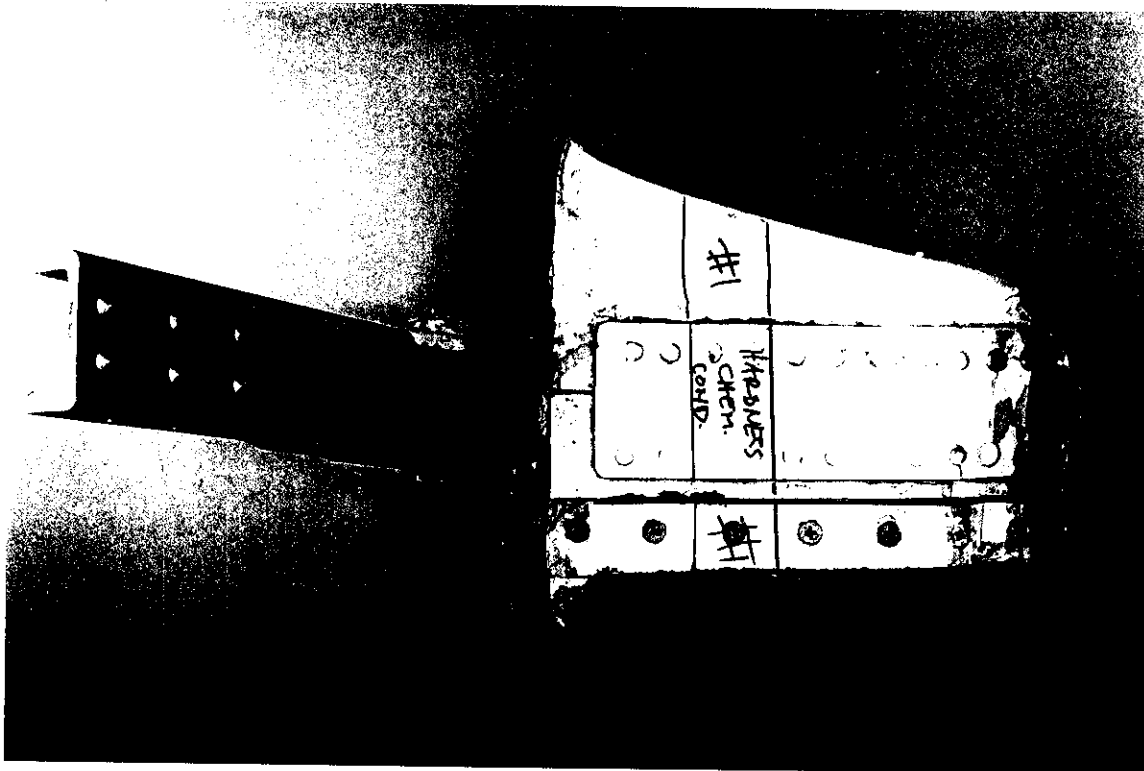
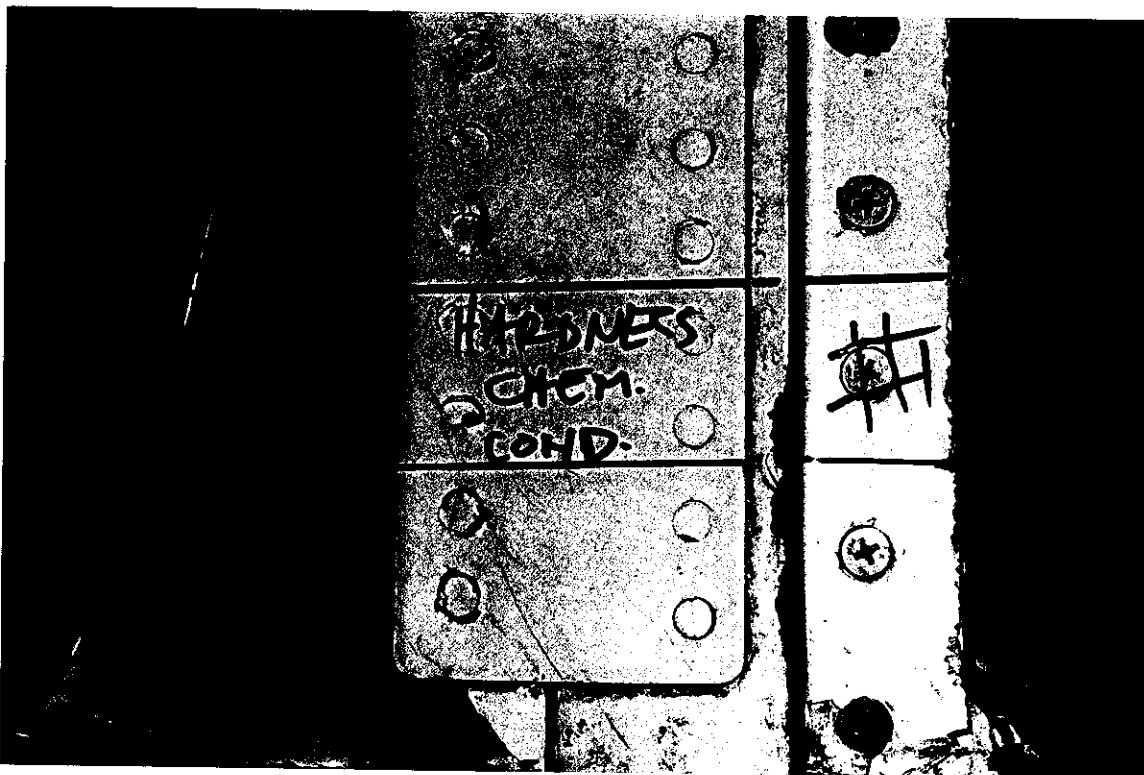
Figure 18. Color photographs of the failed "Front Bottom Spar", showing the new location of specimen for chemical analysis, hardness testing and electrical conductivity. (a) Overall view. (b) Close-up view.

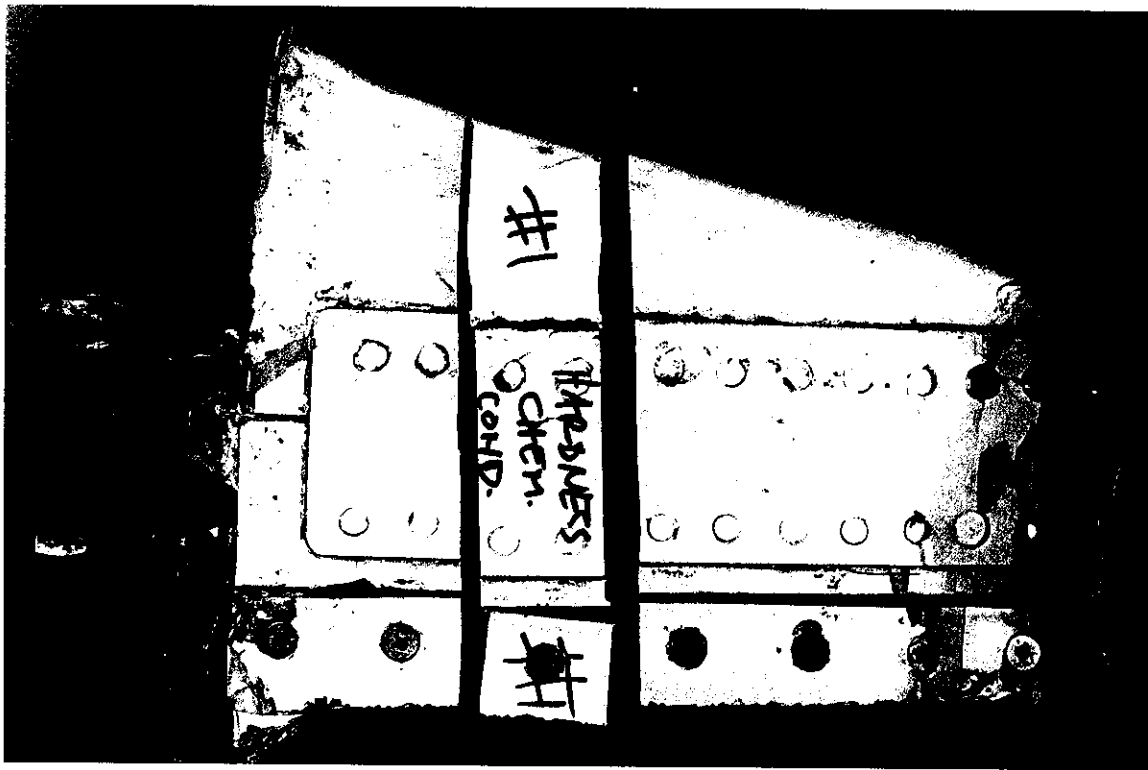
Figure 19. A color photograph of the failed "Front Bottom Spar", showing the specimen for chemical analysis, hardness testing and electrical conductivity after cutting.

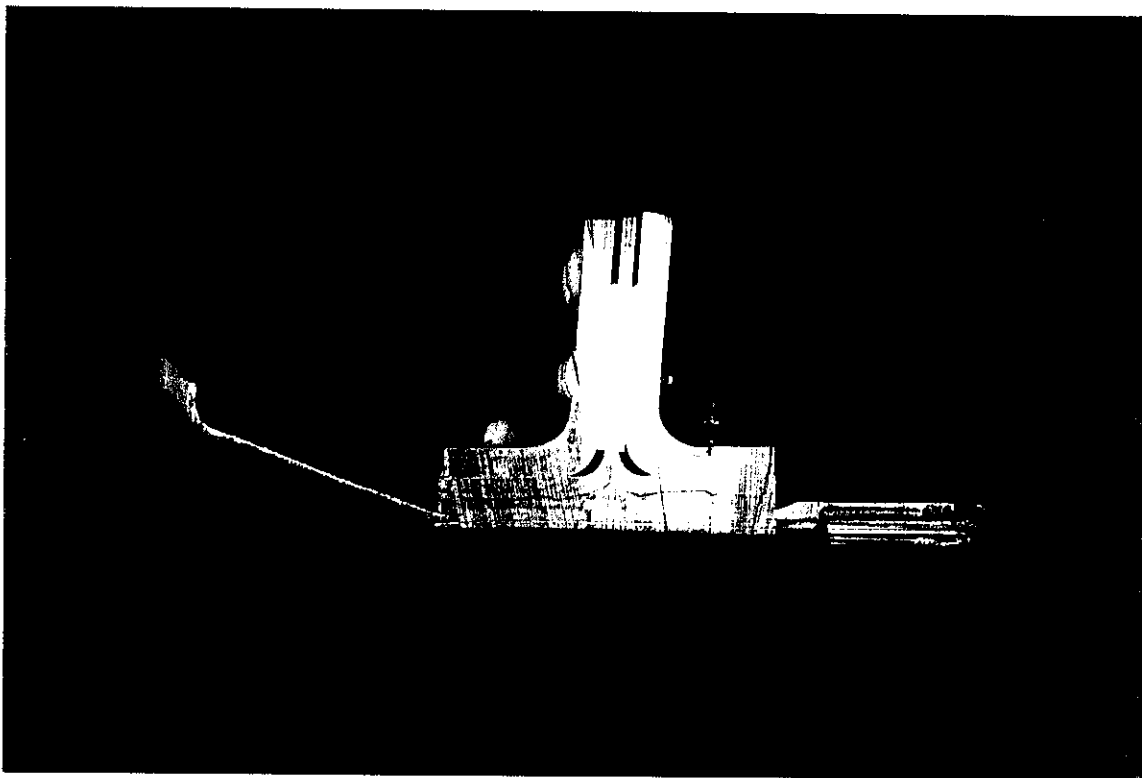
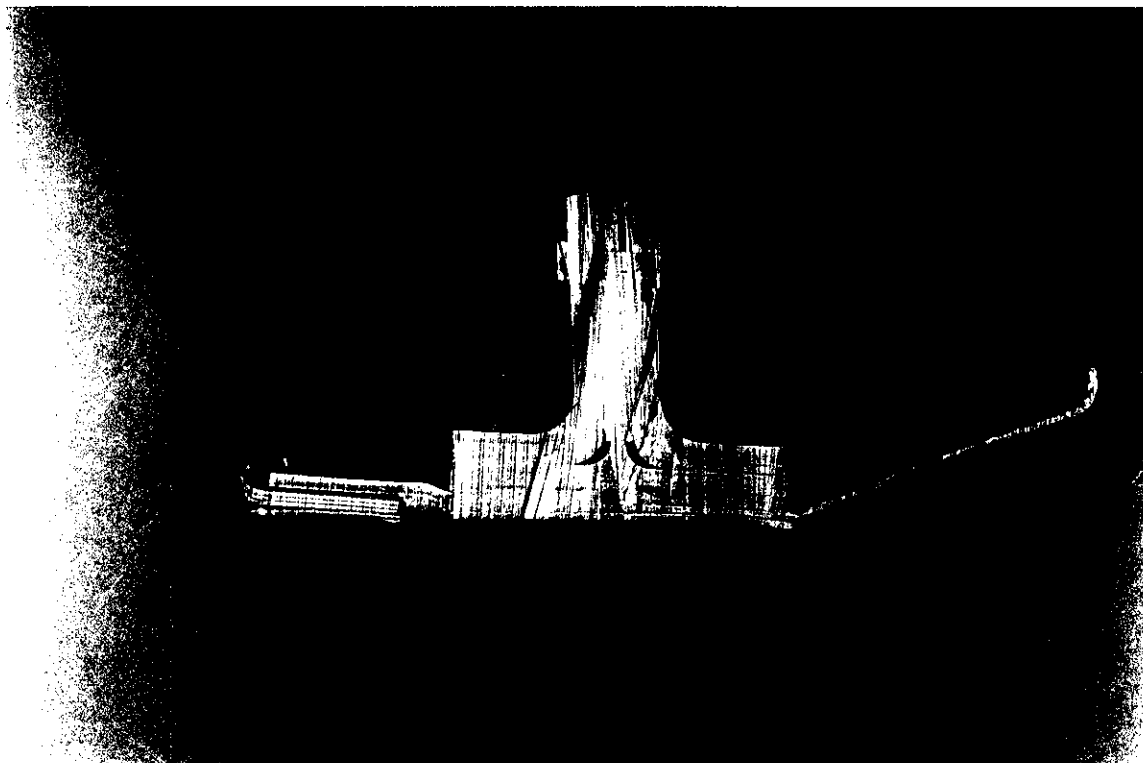
Figure 20. Color photographs of the failed "Front Bottom Spar", showing the cut specimen for chemical analysis, hardness testing and electrical conductivity. (a) Side 1. (b) Side 2.

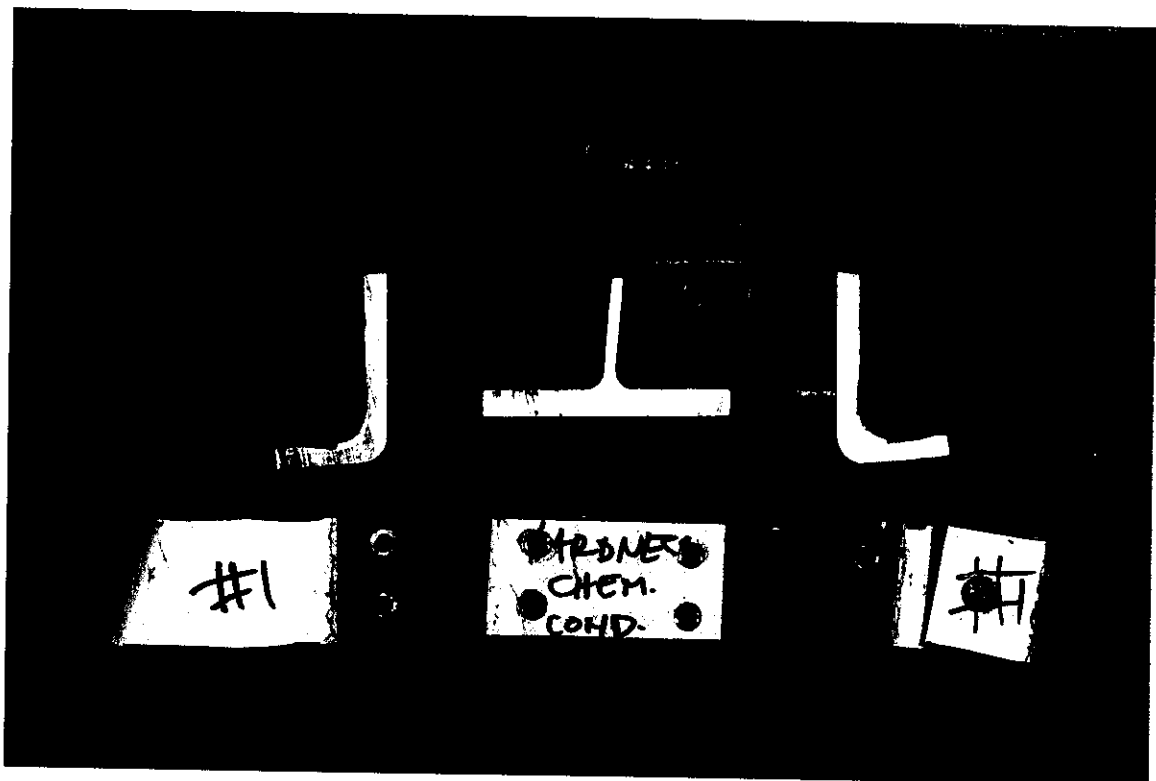
Figure 21. A color photograph of the failed "Front Bottom Spar", showing the disassembled cut piece and the removed specimen for chemical analysis, hardness testing and electrical conductivity after cutting.
