NATIONAL TRANSPORTATION SAFETY BOARD

METALLURGIST'S FACTUAL REPORT

Report No. 96-57

Place : Aliquippa, Pennsylvania
Date : September 8, 1994
Vehicle : Boeing 737-3B7, N513AU
NTSB No. : DCA94-M-A076
Investigator : Thomas A. Haueter

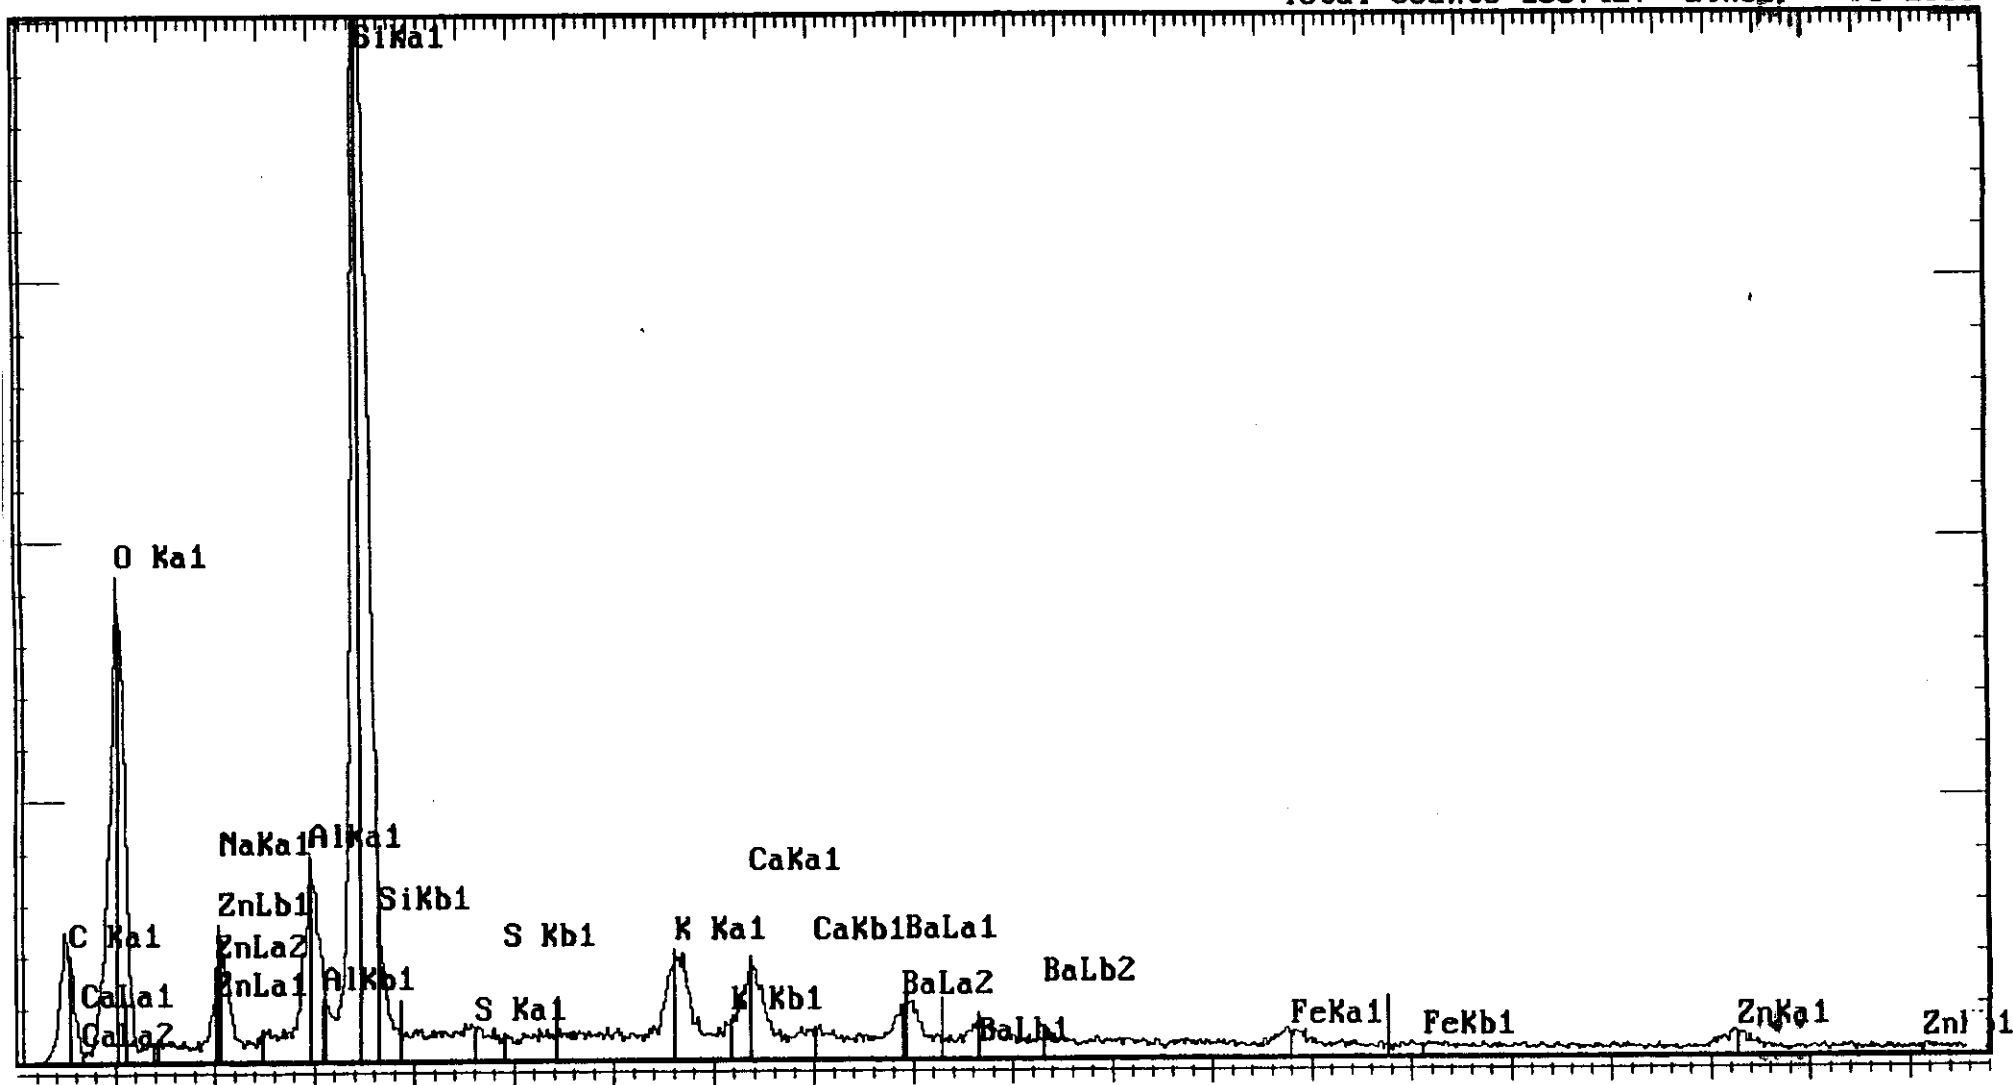
Spectrum: SAMPLE4

The plug denoted by arrow "1b" in figure 1 was relatively intact. A close up view of this plug is shown in figure 4. Numerous areas of the external surface of the plug were covered with loose brown deposits of what appeared to be a dried and compacted soil. At some locations, green fibrous material, similar in appearance to the fibers found adjacent to the connecting screw in plug "1a" was embedded into the soil (see arrow "e" in figure 4). EDS analysis of a sample of these fibers produced spectra containing the characteristic peaks of C, O, Mg, Al, Si, S, K, Ca, Fe, Zn, Ba, and possibly Na (see spectrum for SAMPLE 3 in Appendix). Similar fibrous deposits were found in the threads on one side of the connector (see arrow "f" in figure 4). The EDS analysis of these deposits produced spectra containing the characteristic peaks of C, O, Na, Mg, Al, Si, P, S, K, Ca, Zn, Cd, Ba (see spectrum for SAMPLE 4 in Appendix).

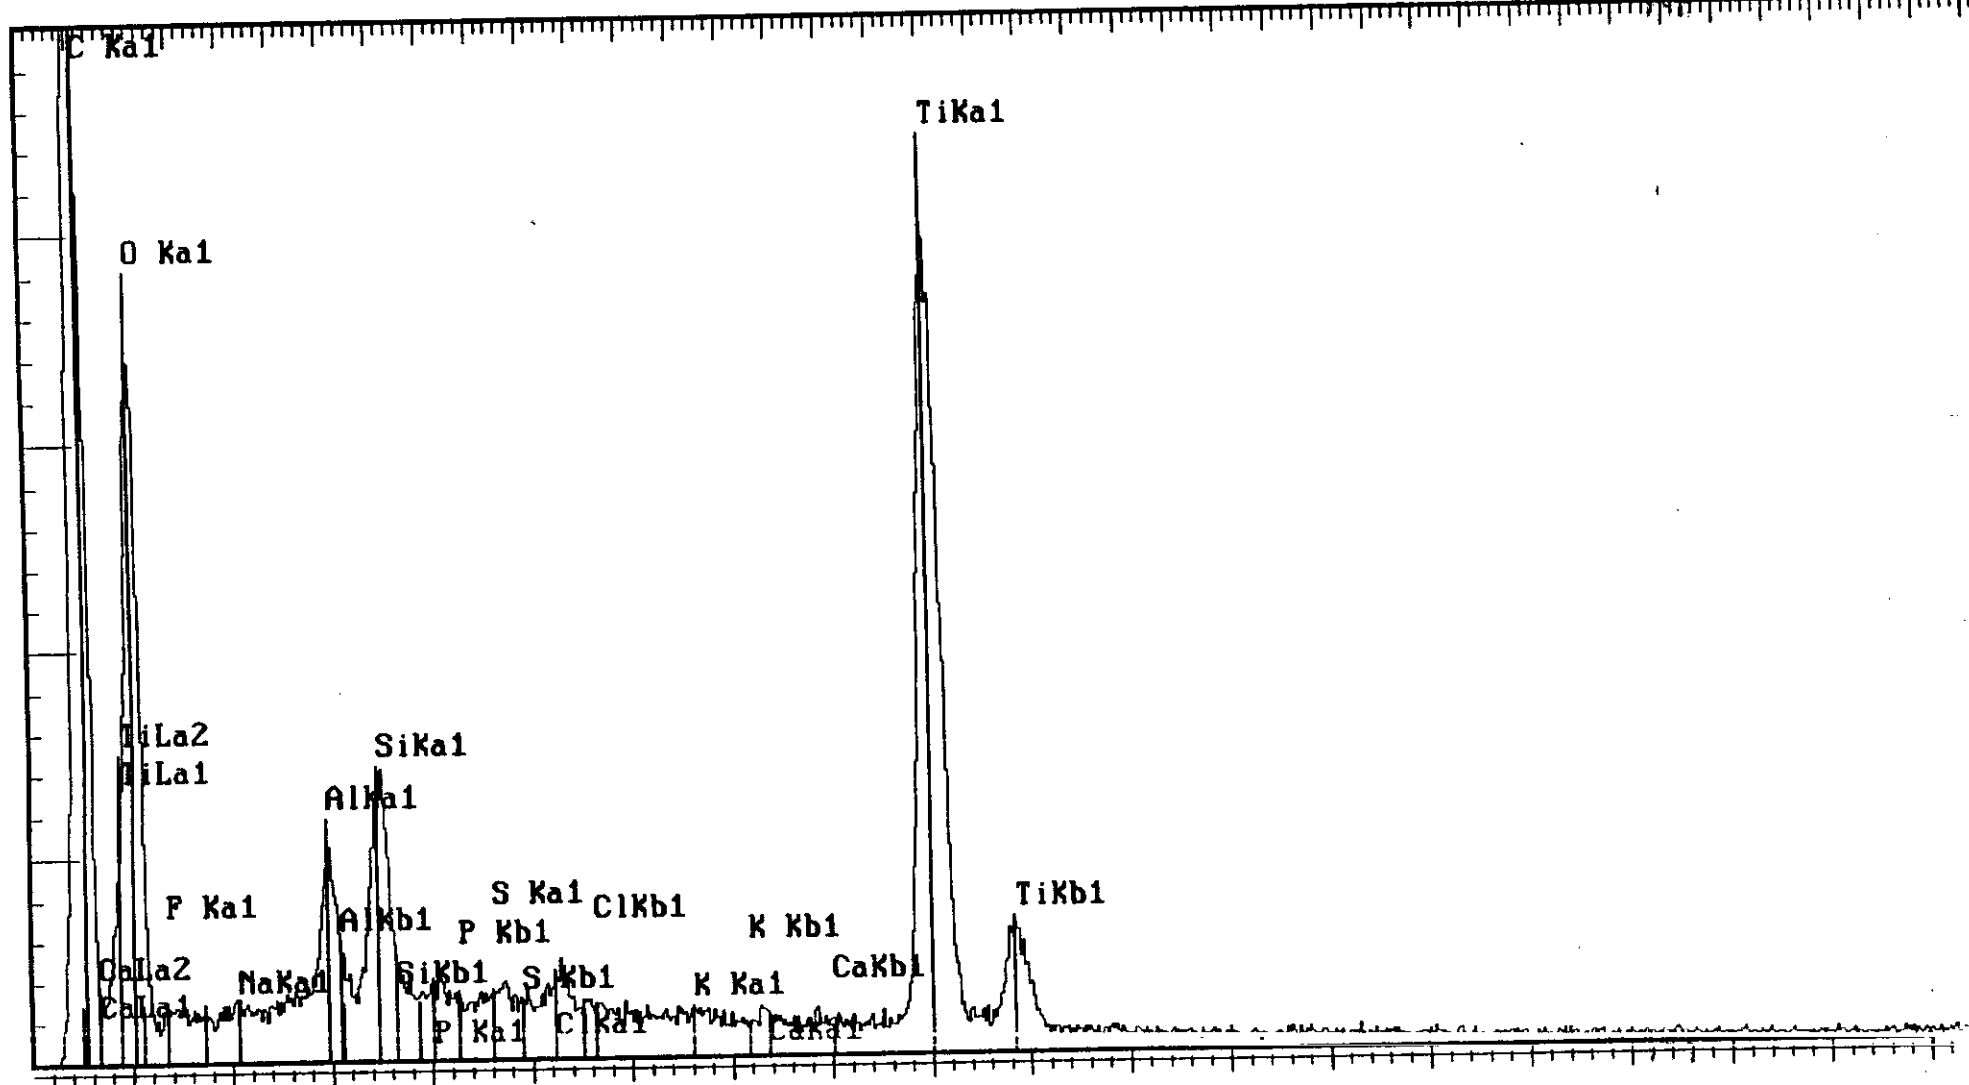
A piece of distorted aluminum bracket was attached to plug "1b" (see arrow "i" in figure 4). Blue colored areas were noted on the white painted surface of the piece. The opposite surface of the piece was unpainted and also contained some areas of bluish discoloration. Small chips of the paint containing blue stain were removed for EDS analysis. The EDS analysis of white (not stained) areas of the paint on the chips produced spectra containing the characteristic peaks of C, O, Na, Al, Si, P, S, Cl, Ca, and Ti (see spectrum for SAMPLE 5W in Appendix). The EDS analysis of blue regions of paint produced spectra containing the characteristic peaks of C, O, Na, Al, Si, P, S, Cl, Ca, and Ti (see spectrum for SAMPLE 5B in Appendix).
