NATIONAL TRANSPORTATION SAFETY BOARD

Group Chairman's Factual Report

METEOROLOGY

ANC15MA041

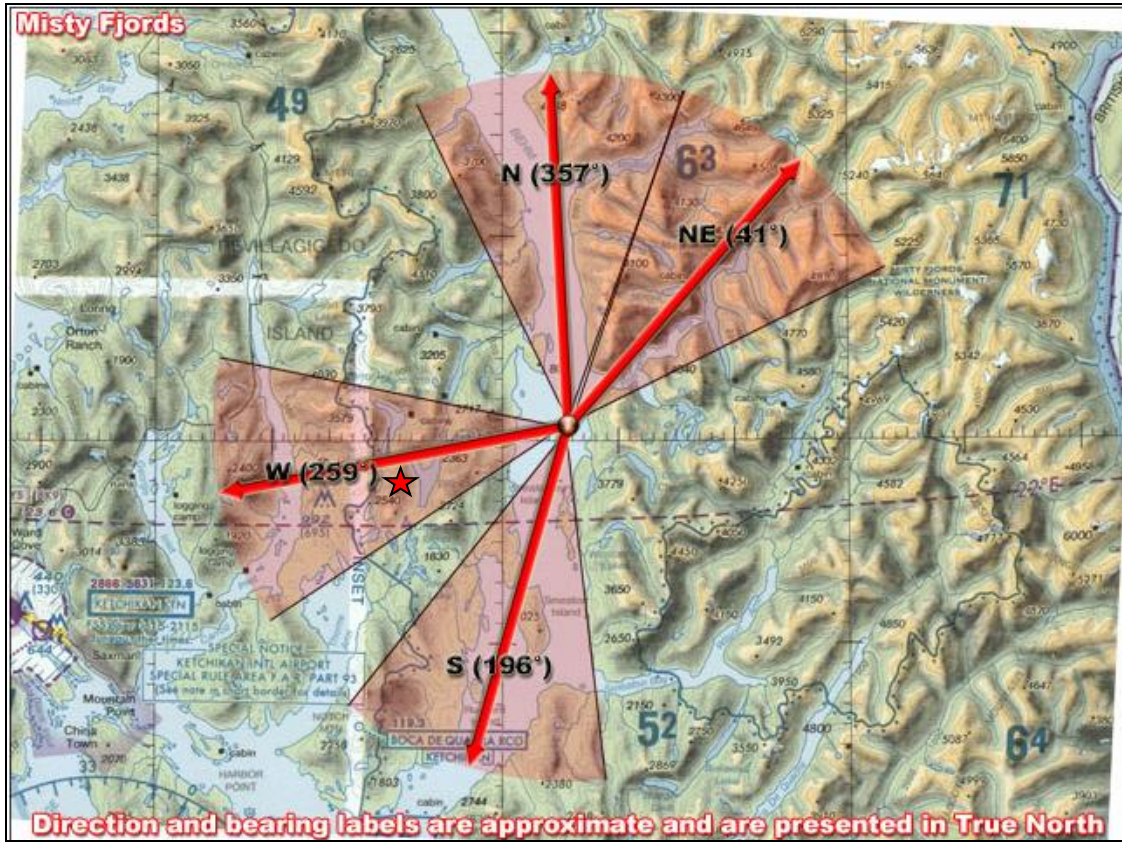
Figure 12 - Camera views for Misty Fjords

The weather camera at Misty Fjords (QA6B) was location at 55.5125° N and 130.9098° W at sea level, with camera views to the North, Northeast, South, and the West. The camera views are depicted in figure 11 over a sectional chart and with the accident site marked by a red star. The

reference points in the four camera views provided in statute miles are provided in figures 12 and 13. The camera facing to the West or towards 259° best captured the accident site, which was on an azimuth of 248° and 10 statute miles (8.8 NM) from the camera site. New Eddystone Rock is located on the left side of the West camera viewing angle at the 240° azimuth and 1 statute mile from the camera.

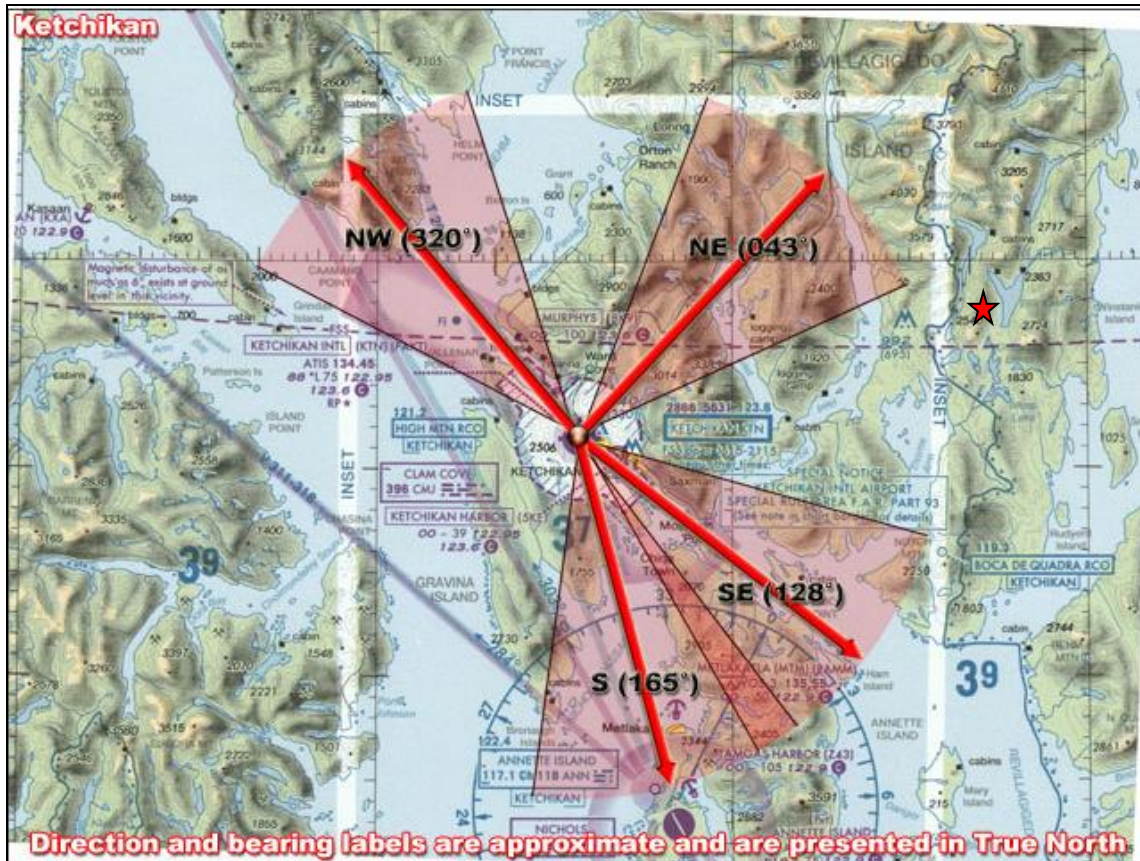
Figure 30 - FAA weather camera views from Ketchikan

Figure 30 is the Ketchikan weather camera viewing location with the accident site marked, followed by figures 31 and 32 providing the reference points for the various views. The weather conditions in the vicinity of the accident site were best captured on the extreme right hand side of the Northeast camera view, with the accident site located at 23 statute miles at an azimuth of 71°.

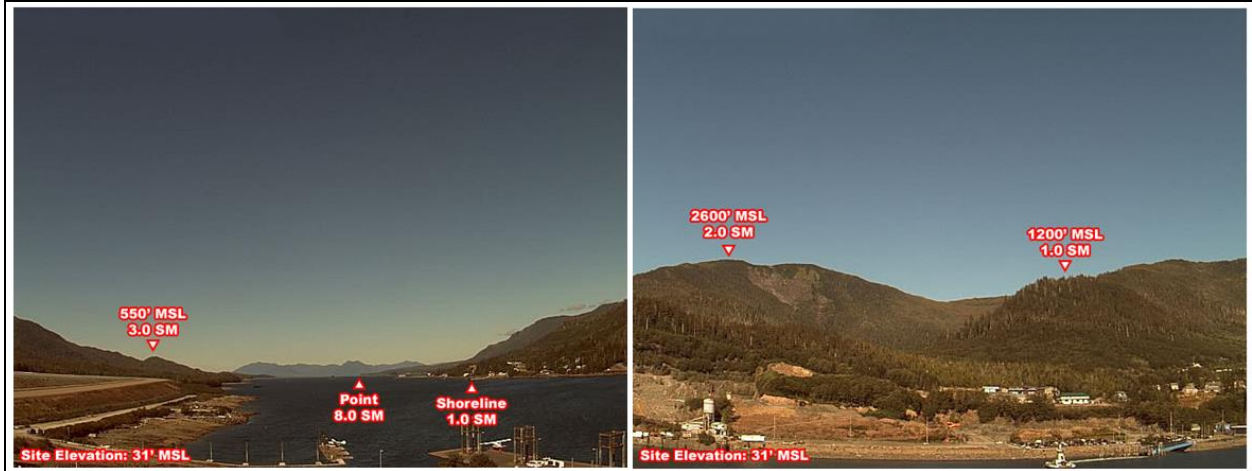
Figure 31 - Ketchikan camera view reference points to the Northwest and Northeast

Figure 31 are the Ketchikan weather camera reference points to the Northwest and Northeast, and figure 32 the reference points to the south and southeast. The northeast camera best depicted the conditions in the direction of the accident site, but did not capture the accident at 23 statute miles at an azimuth of 72° from Ketchikan.

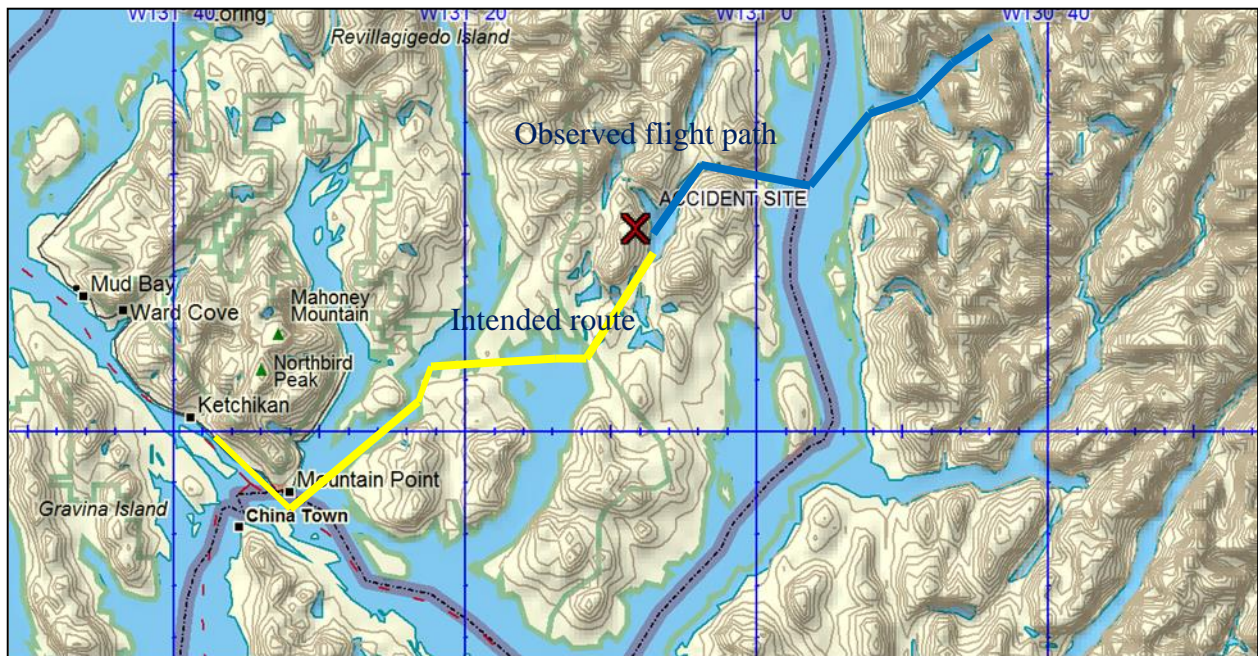
Figure 45 – Topographic map of the region

Topographical maps of the area with the accident site marked are included as figures 45-48, with the approximate flight track overlaid and spot elevations from the NOAA sectional map.
