RE: ERA17FA190

We appreciate the opportunity to respond to the draft factual report. Please accept the attached as Metro Aviation's submission on ERA17FA190.

Addendum for ERA17FA190

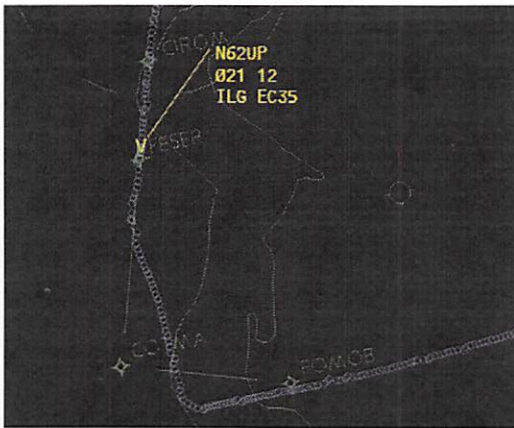
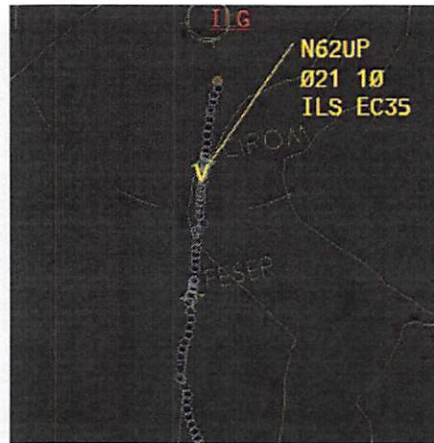
Statements from the ATC controllers on duty at the time of the accident indicated a moderate work load and traffic complexity based on a scale of 1 being light and 5 being heavy. The PHL SD controller at the time of the accident was the SD combined with two additional positions, DuPont and South High respectively. The handoff to the ILG LC was considered routine by the PHL SD. The FALCON displays N62UP crossing Hadin and intercepting the course but not descending when intercepting the glideslope. No additional attempts were made to contact N62UP until radar contact had been lost.

Both the PHL and ILG ATC facilities failed to notice or react to N62UP not descending on glide slope after passing the final approach fix on course. Controllers at both facilities stated they would ordinarily provide advisories to both course and azimuth to aircraft inside the final approach fix.
