**Mullen Trucking, LP
Technical Review Comments**

**Bridge Strike & Collapse
Mt. Vernon, WA
05/23/2013**

**HWY-13-MH-012
(51 Pages)**

Re: Collapse of Bridge Span
May 23, 2013, Mr. Vernon, Washington
NTSB Investigation: HWY13MH012

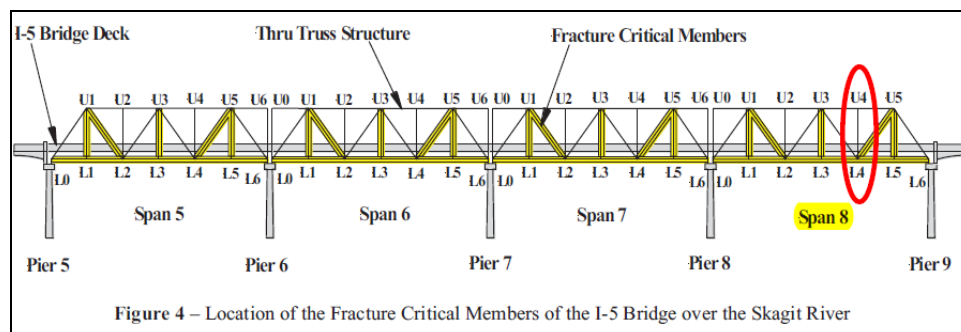
Figure 4 – Location of the Fracture Critical Members of the I-5 Bridge over the Skagit River

The analysis of the surveillance video performed by the NTSB shows that the connection between the west sway brace 4 to the vertical member U4W-L4W catastrophically failed during the initial stages of the collapse. For reference, here is the node drawing from page 27 of the Highway Report (red circle added):

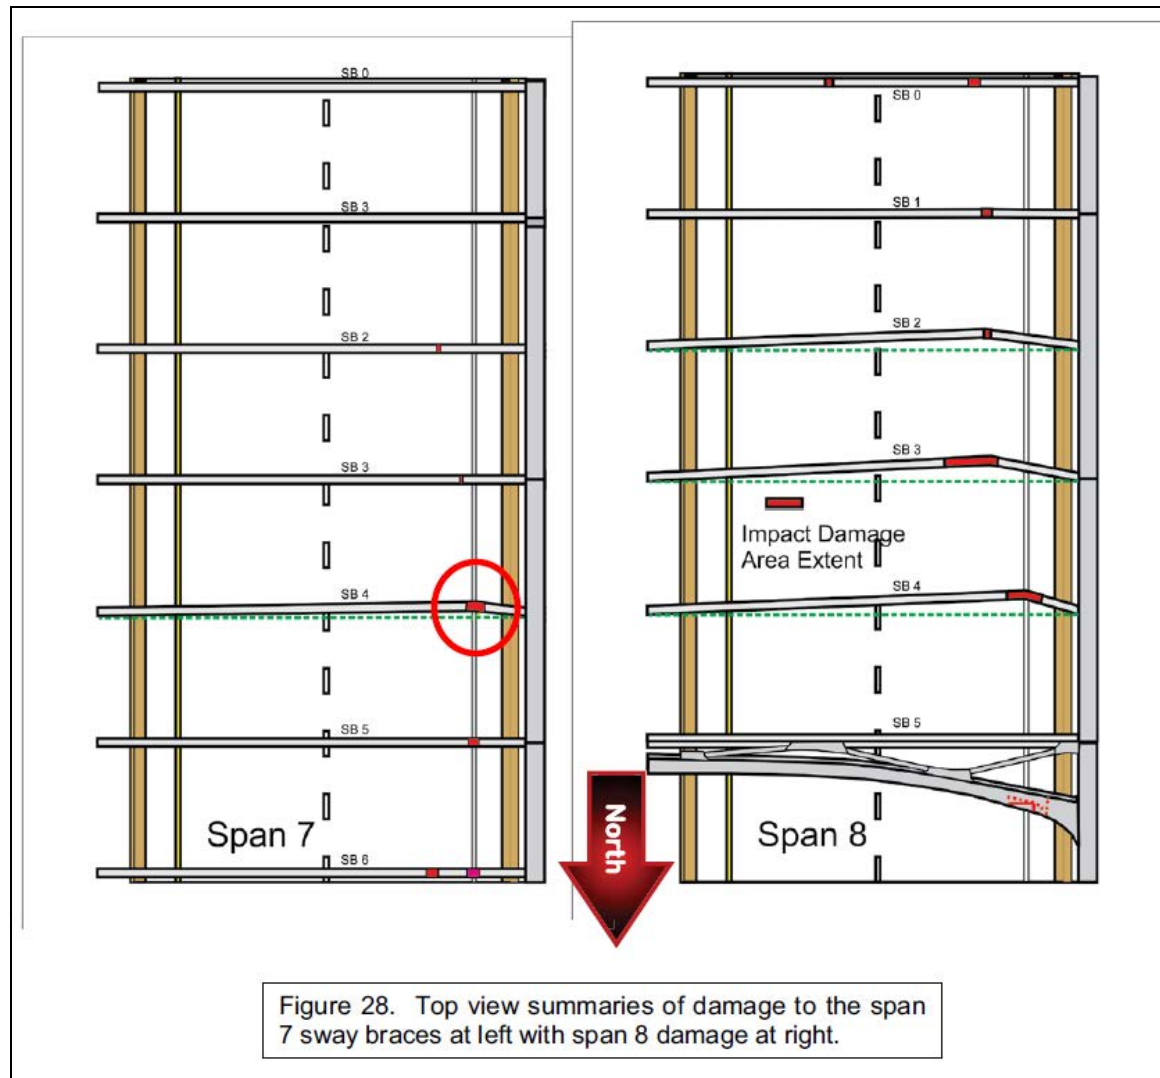
deflected condition of both the span 7 and span 8 sway braces relative to a dashed line. We believe this has the potential to mislead the reader.

We request that notation be made that the damage and deflection observed post-recovery in the sway braces on span 8 is likely a combination of (1) impact with the load, (2) the forces of the span collapse itself, and (3) recovery efforts.

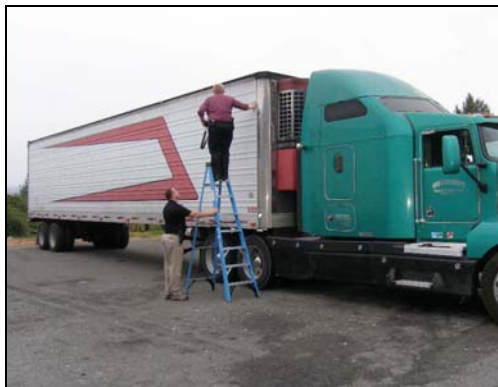
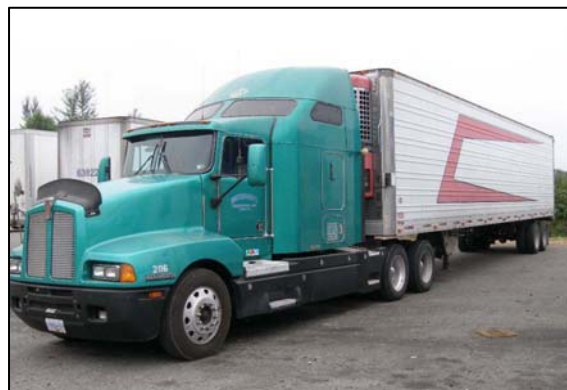
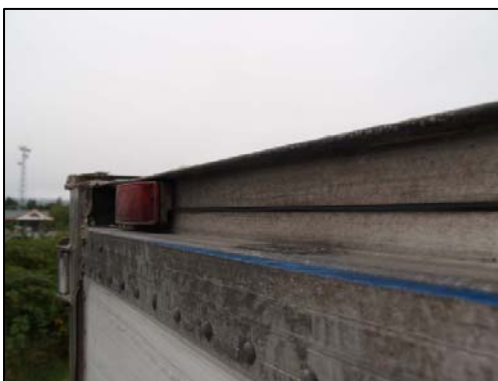
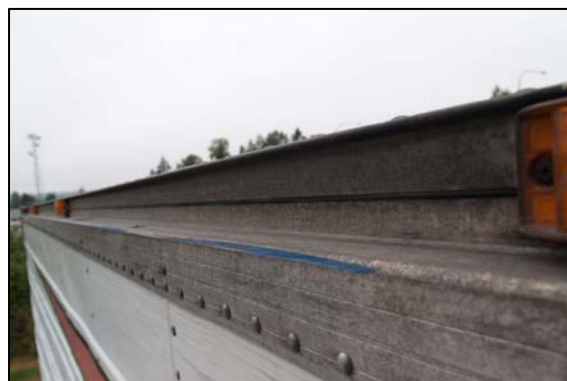
The report goes on to reference and provide 3D post-accident scans of the involved 2013 Subaru Crosstrek (2.3 on pages 18 & 19) and Dodge Pickup Truck (2.4 at pages 20 & 21). No reference, photos or 3D scans, however, are found of the involved 2000 Kenworth truck tractor and 1996 utility refrigerator semi-trailer also involved (and referenced in the Motor Carrier Factors Report at pages 24 & 25 and the Vehicle Factors Report at pages 18 & 19). We respectfully suggest that

reference to this other vehicle be made and that some photographs be included. Here are four photographs from the investigation that are submitted for possible inclusion:

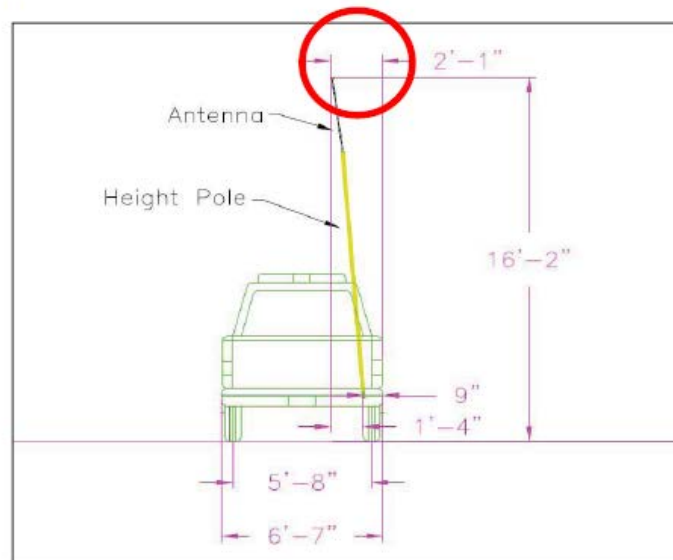
Figure 2. Rear view diagram of the pilot car

The attachment point where the height pole was secured onto the front bumper of the pickup truck was a metal tube (holder), which was leaned slightly in toward the center of the vehicle. As a result, the height pole also leaned in toward the center of the vehicle, with the rubber ball at the top of the pole being about 1 foot 4 inches inward from the holder, or just over 2 feet inward from the right side of the pickup truck. **Figure 2** depicts a rear view of the pilot car and dimensions of the vehicle and height pole as they were documented during the inspection.

We recommend that a comparison be inserted in this report as to the height of the pole as compared with clearances at various locations within the southbound lanes and the sway braces at issue, taking into account the 2 feet 1 inch offset from the right side and possibly using both the 16 feet 0 inch and the 16 feet, 2 inch heights.

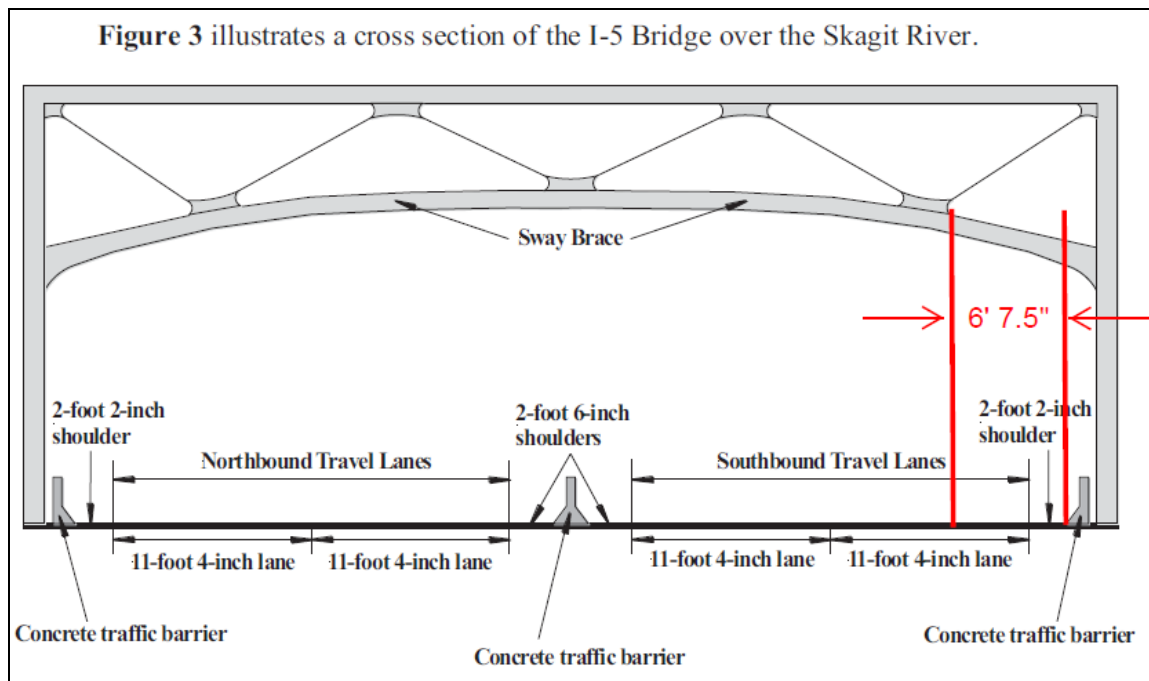
Consider Figure 3 from page 13 of the Highway Report, a copy of which is below. If, for instance, the 6-foot-7-inch wide pole car was in the center of the 11-foot-4-inch right south-bound lane, there would have been 2 feet 4.5 inches before the 2-foot-2-inch shoulder, ending at the concrete traffic barrier. But with the pole another 2 feet 1 inch toward the center of the pole car, the pole itself would have been at least 6 feet 7.5 inches from the concrete barrier (2 feet 4.5 inches + 2 feet 2 inches + 2 feet 1 inch). The red lines have been added to this Figure.

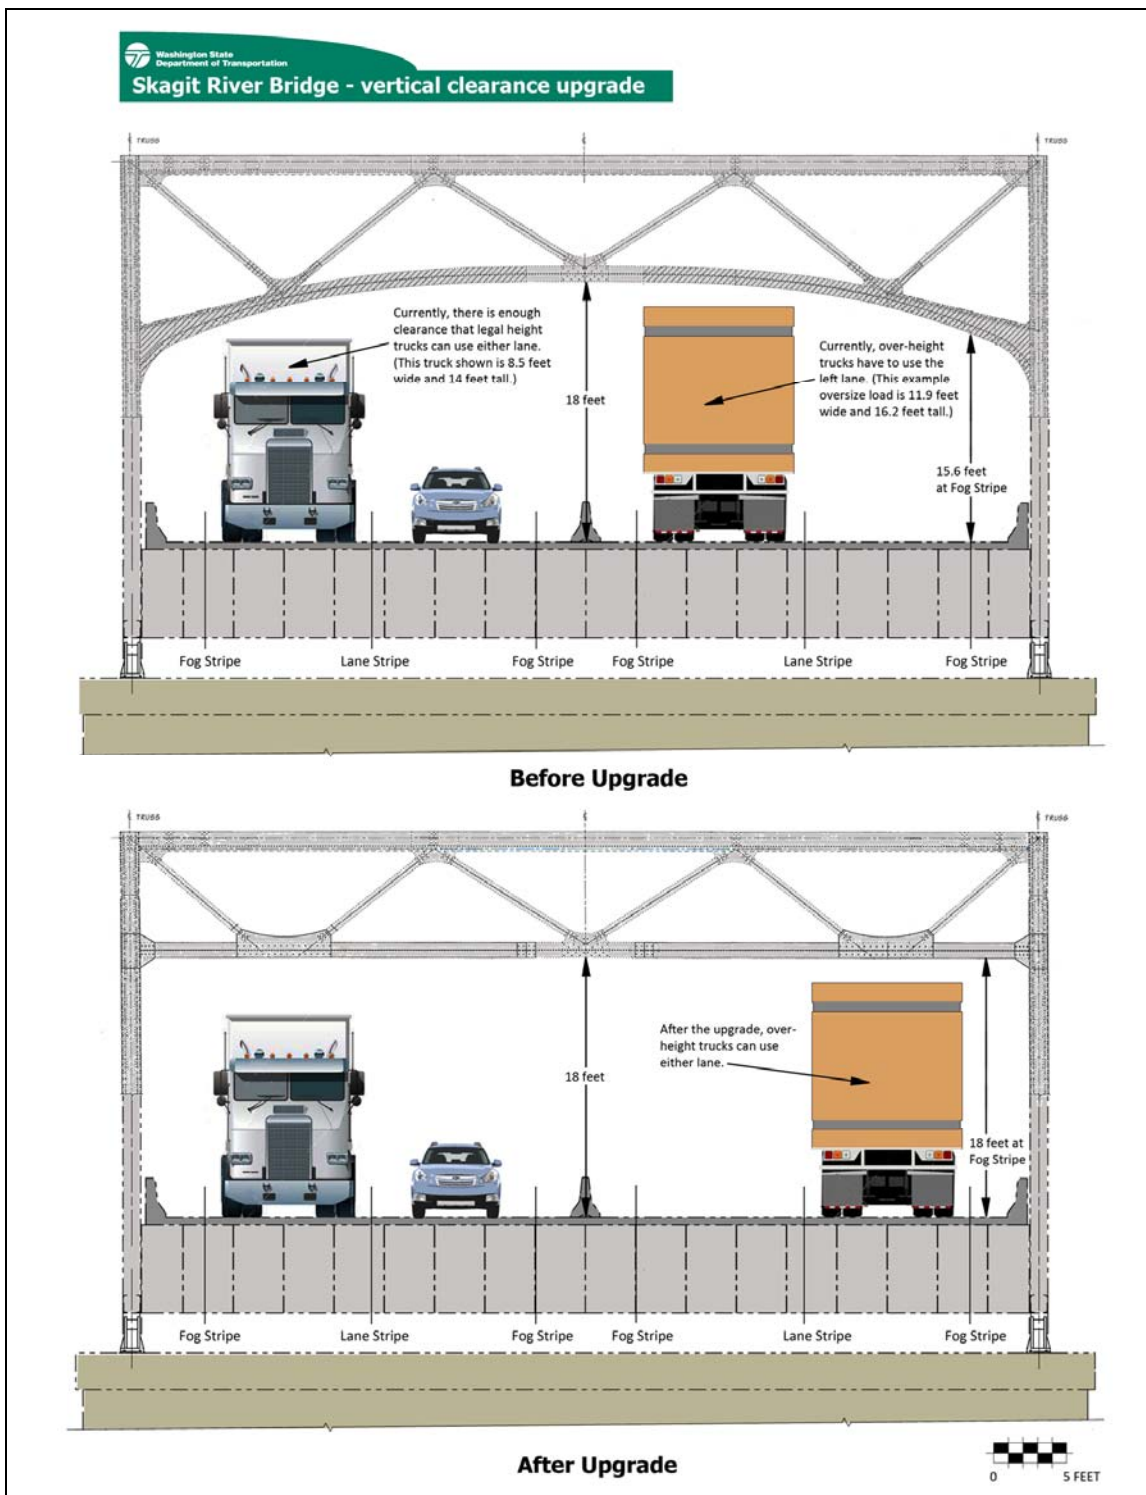
I-5 Bridge vertical clearance upgrade to 18 feet across all lanes.

The WSDOT awarded a contract in August 2013 to upgrade the vertical clearance of the I-5 Bridge to 18 feet across all lanes in the remaining 3 thru truss spans (Spans 5, 6 and 7). The contract also included a proposal to retrofit several bridge supports with reinforced steel components to add strength to the bridge in the event it was struck again in the future. The work began on September 9, 2013 and the estimated completion date was late November 2013. Figure 6 illustrates the vertical clearance upgrade to 18 feet across all lanes. The WSDOT project web page indicated the following:

"When crews finish raising and reinforcing the structure by November, the bridge will have an equal 18 foot vertical clearance across all lanes. Several bridge supports will also be retrofitted with reinforced steel components to add strength if the bridge is struck again."
