NATIONAL TRANSPORTATION SAFETY BOARD

Multiple Electronic Devices

Specialist's Factual Report
by Bill Tuccio, Ph.D.

Location: Bloomington, Illinois
Date: April 7, 2015
Aircraft: Cessna 414A
Registration: N789UP
Operator: Make It Happen Aviation, LLC
NTSB Number: CEN15FA190

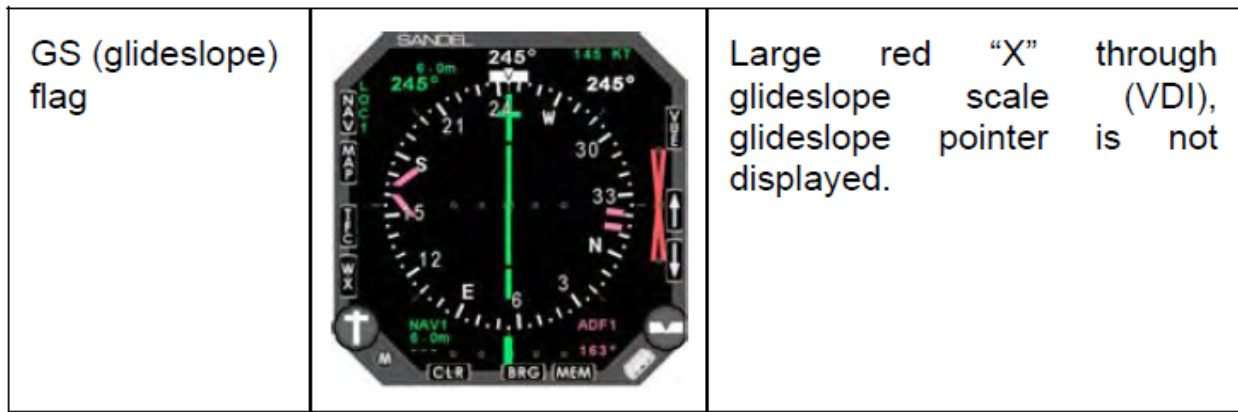
Figure 11. Excerpt from Sandel SN3500 Pilot’s Guide.

According to Sandel, an ARINC 429⁷ input provided glideslope deviation and validity information. Figure 11 provides an excerpt from the Sandel SN3500 EHSI Pilot's Guide (82005-PG-E, page 9-2), showing that a glideslope invalid input to the SN3500 results

in a red “X” displayed through the glideslope scale and removal of the glideslope pointer (i.e., the glideslope pointer is replaced by the red “X”).

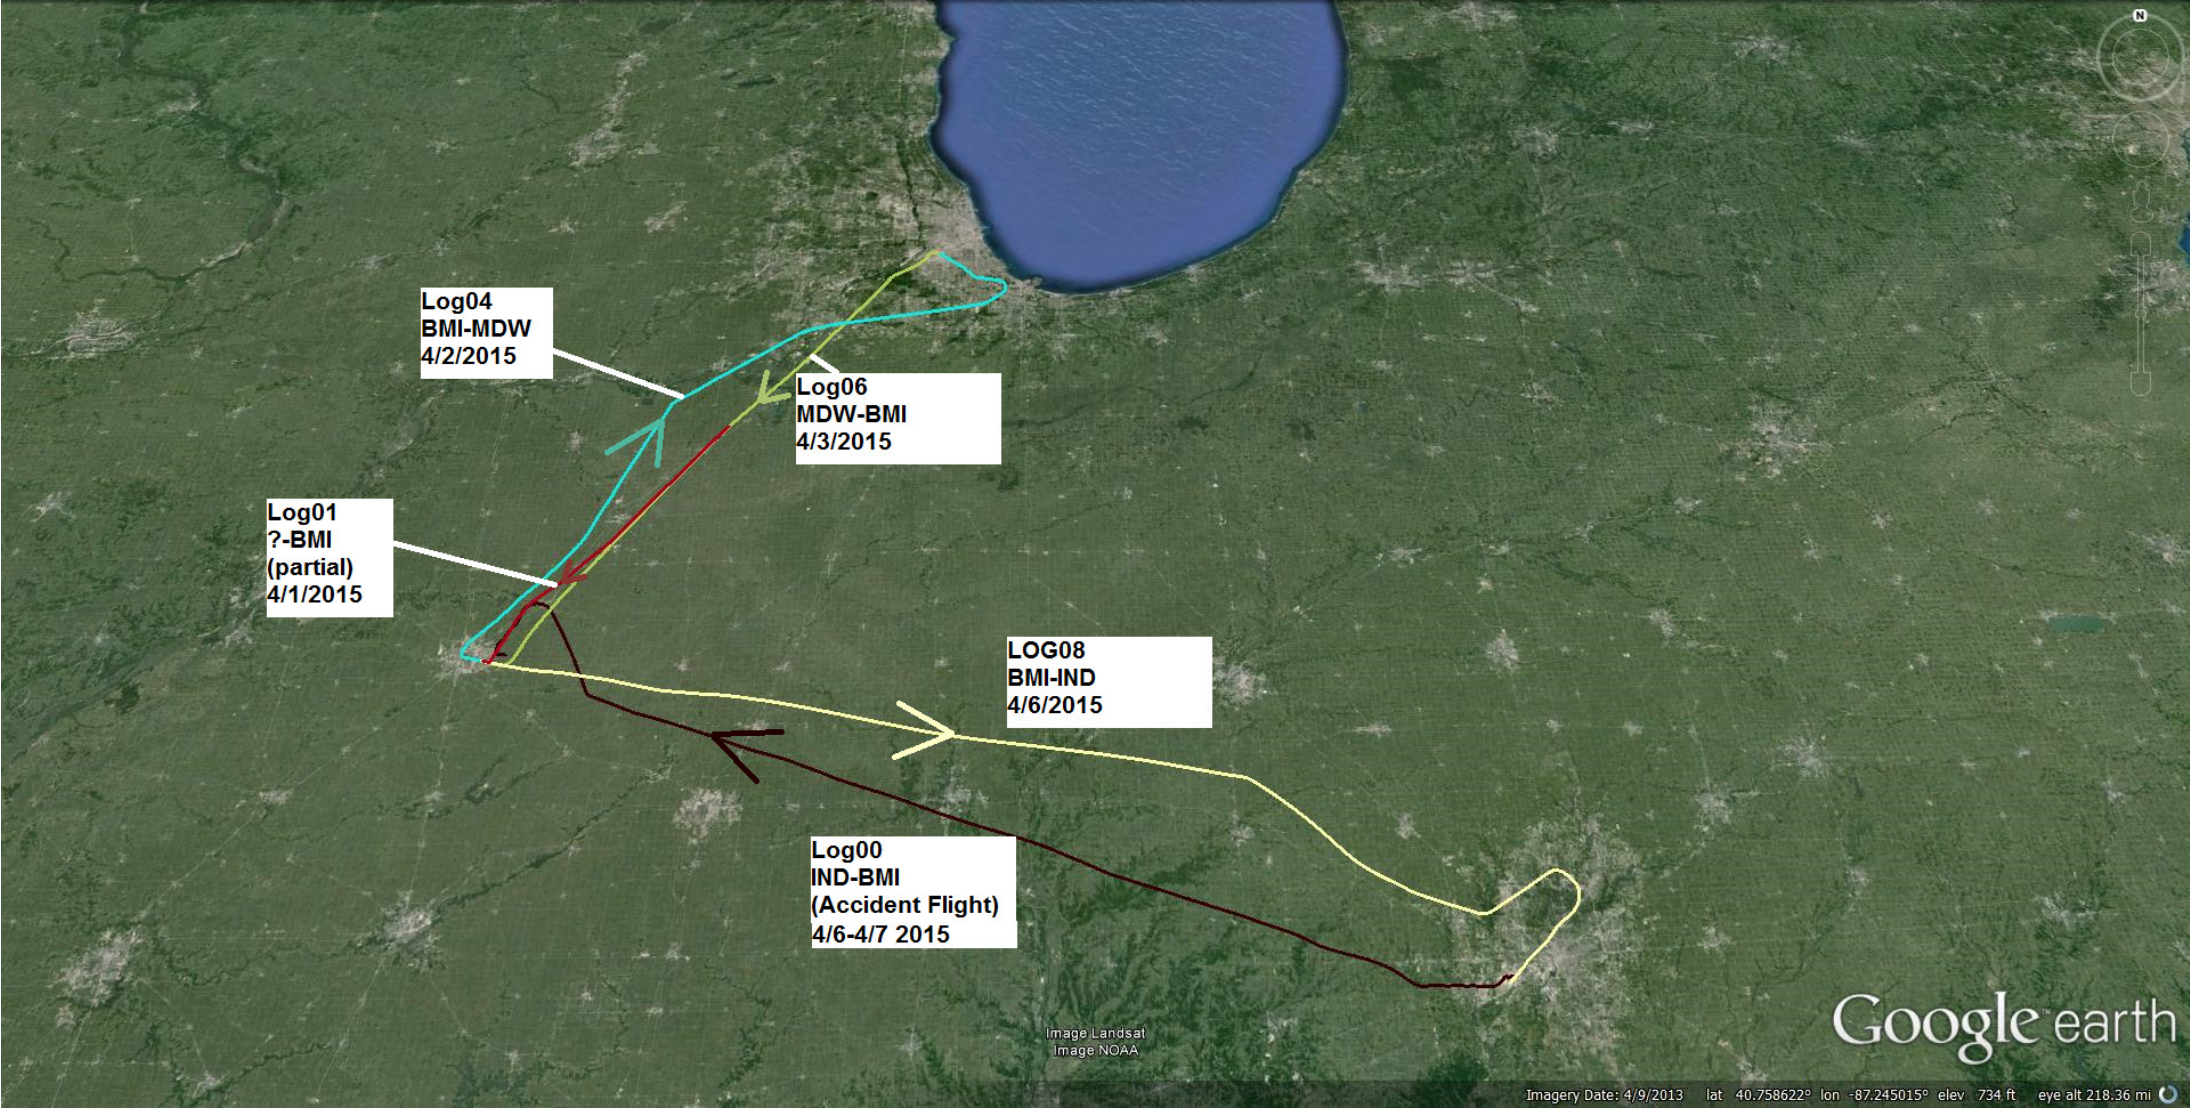
Figure 13. Overview of all Sandel SN3500 recorded flights.

Figure 13 provides an overview of all recorded flights. The accident flight was the last recorded flight from IND to BMI.

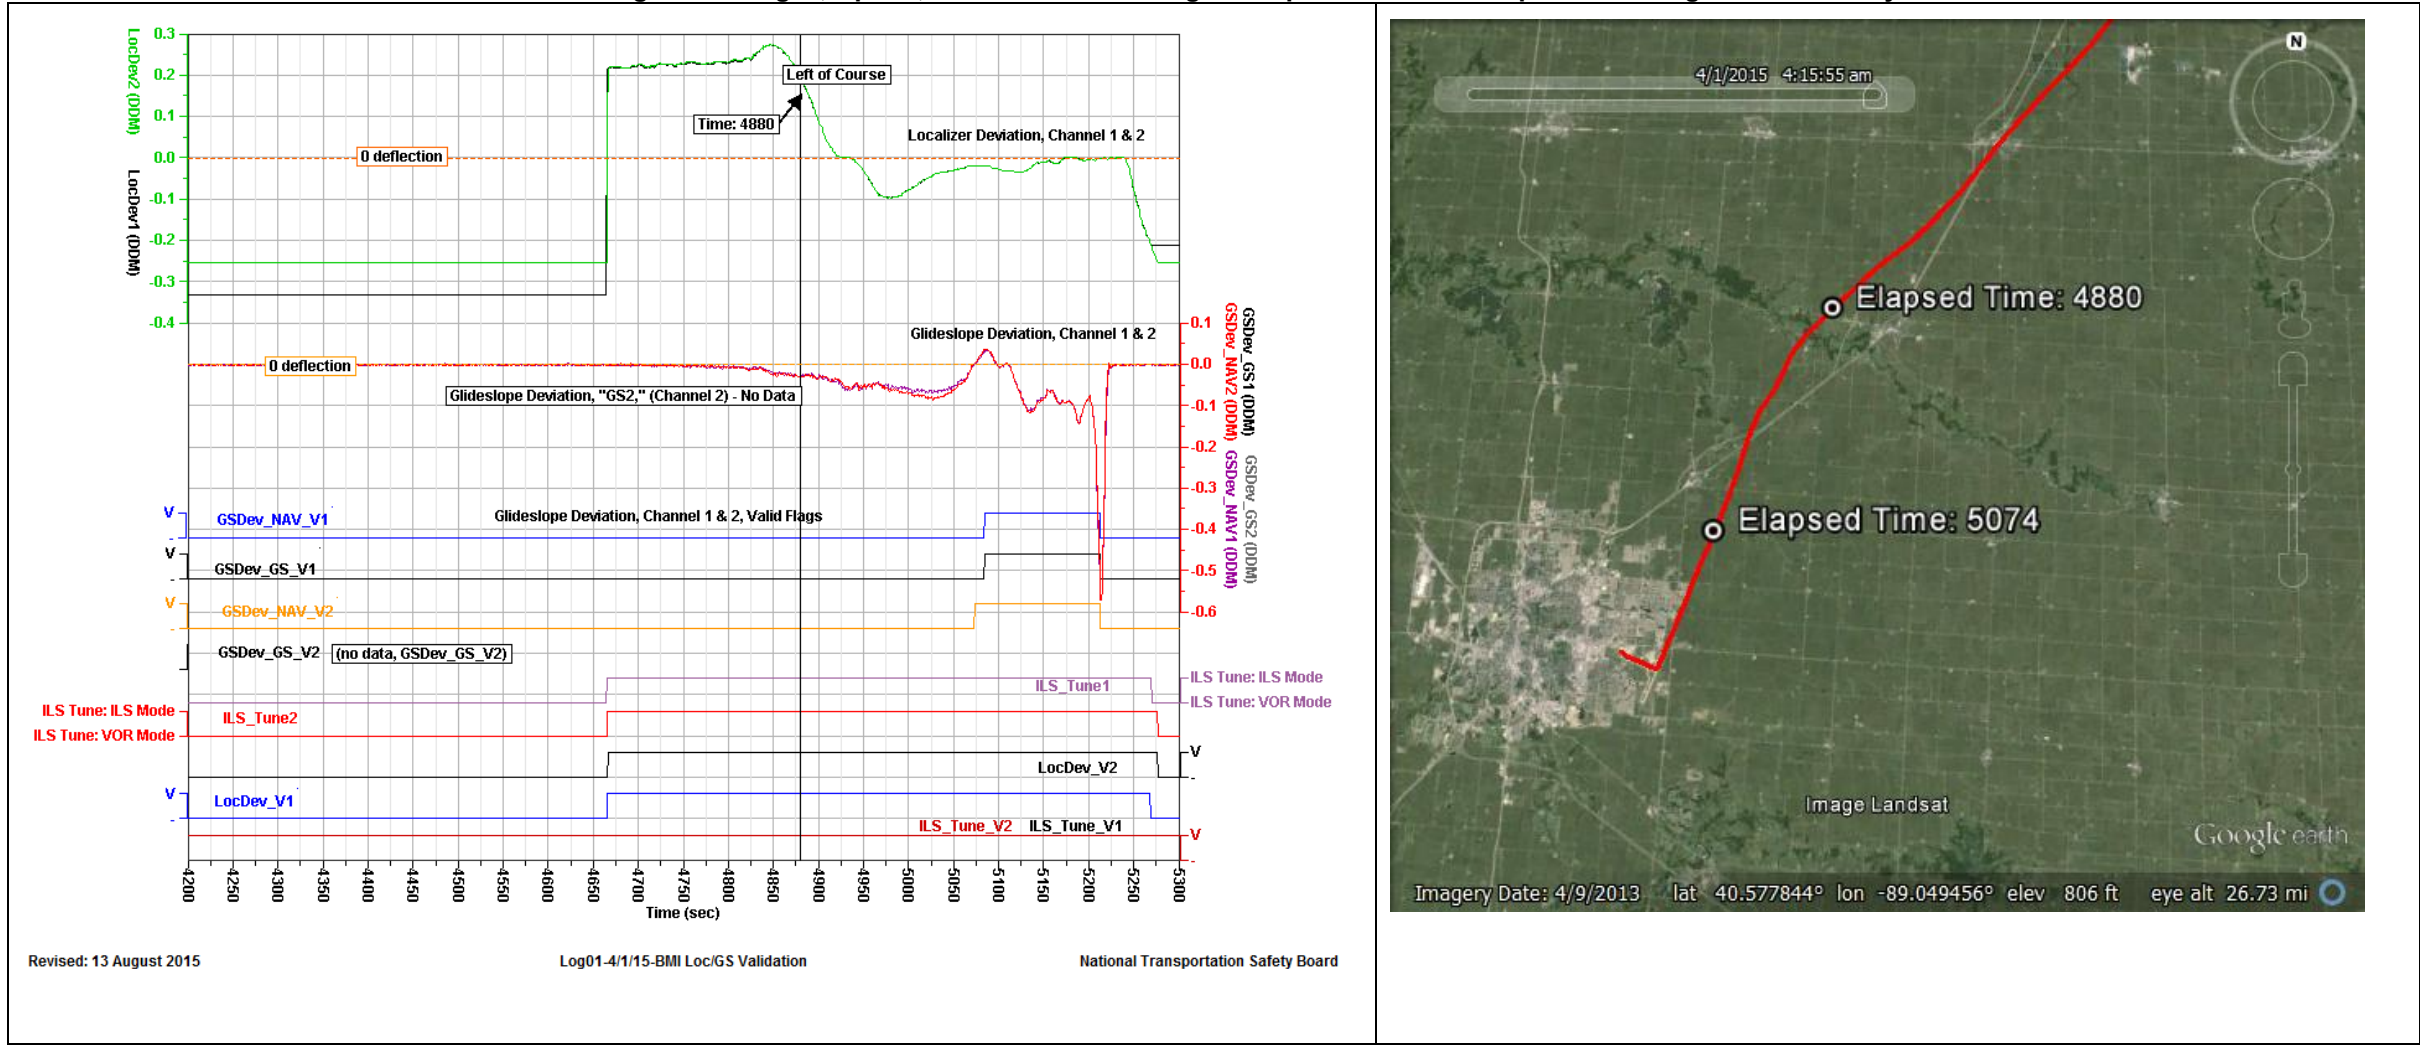
Figure 14. Log01, April 1, 2015 - localizer and glideslope deviations compared to Google Earth overlay.

Figures 14 through 18 compare parametric localizer and glideslope deviations to Google Earth overlaid flight paths¹¹ for all recorded flights. Collectively these figures help relate parametric sign conventions to geographic meaning and also allow a comparison of localizer and glideslope usage on prior flights. Table 5 summarizes observations from the five figures. The sign convention of the glideslope could not be unambiguously determined, given the lack of altitude information.
